# LIMITED GEOTECHNICAL REPORT SEEPAGE EVALUATION OF THE EXISTING ARROYO GRANDE CREEK NORTH LEVEE SAN LUIS OBISPO COUNTY, CALIFORNIA

Prepared for: County of San Luis Obispo Department of Public Works

April 25, 2012

April 25, 2012 Project No. 04.6212.0004

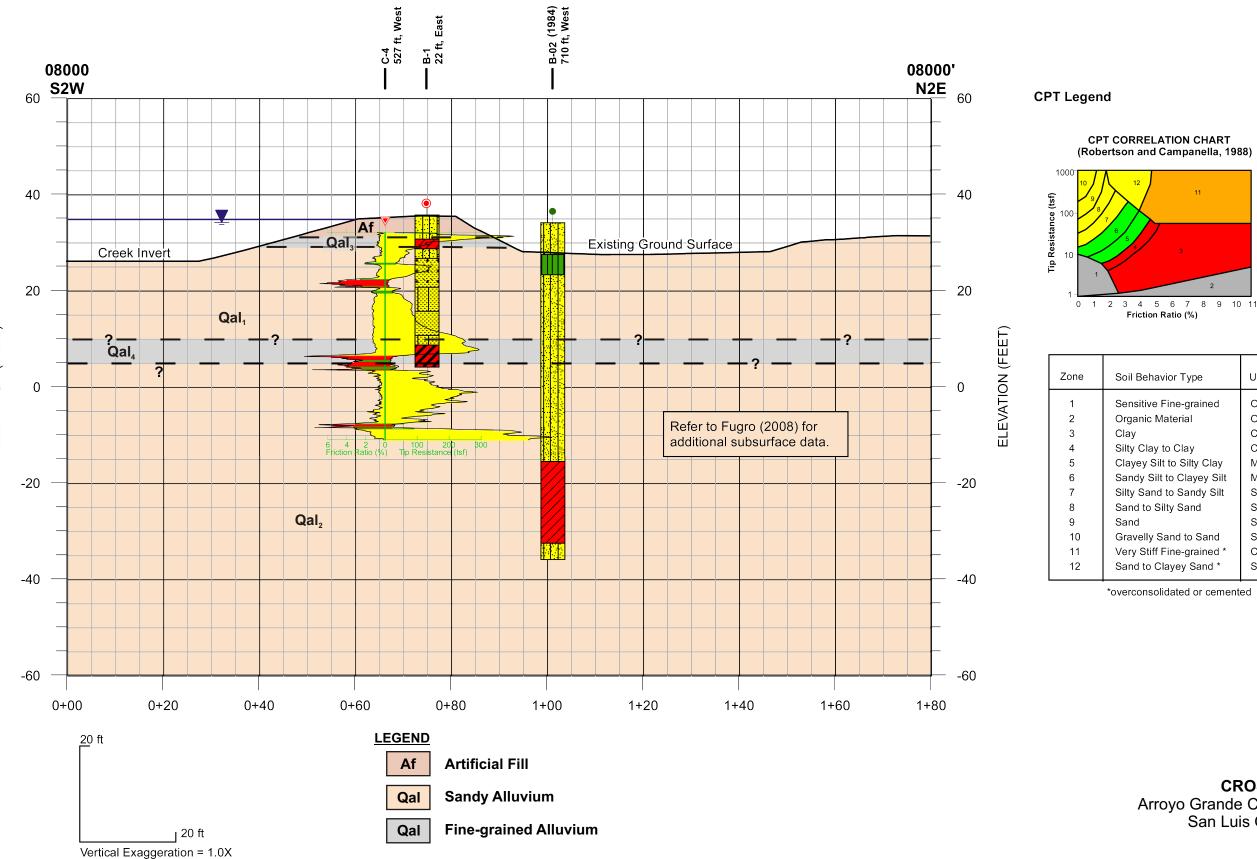
PLATE 4a

**CROSS SECTION 80+00** Arroyo Grande Creek Levee Seepage Evaluation San Luis Obispo County, California
