SAN LUIS OBISPO COUNTY CSA 23 – SANTA MARGARITA  
SYSTEM NUMBER CA4010024  
2010 WATERSHED SANITARY SURVEY UPDATE

Prepared by:  
COUNTY OF SAN LUIS OBISPO  
DEPARTMENT OF PUBLIC WORKS AND TRANSPORTATION

**COUNTY OF SAN LUIS OBISPO**  
**CSA 23 – SANTA MARGARITA**  
**WATERSHED SANITARY SURVEY UPDATE**

**January, 2011**

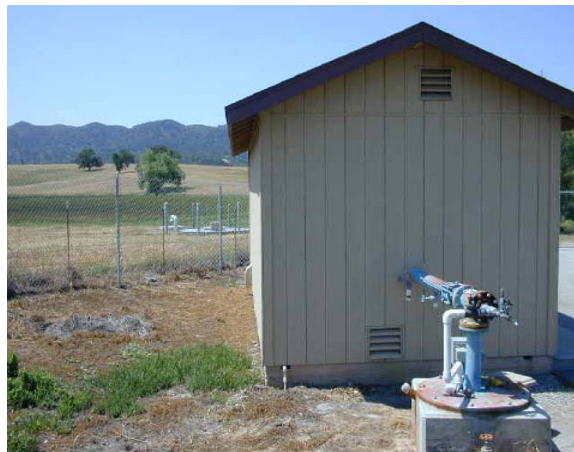
**Figure 4-1:** Well 3 Pump House

Well 3 exceeds the secondary standards for iron and requires treatment with potassium permanganate and subsequent filtration.

To help ensure system compliance with the Lead and Copper Rule, Well 3 is treated with a blended polyphosphate for corrosion control. Well 3 treated water complies with all drinking water standards and the distribution system complies with the corrosion control requirements.

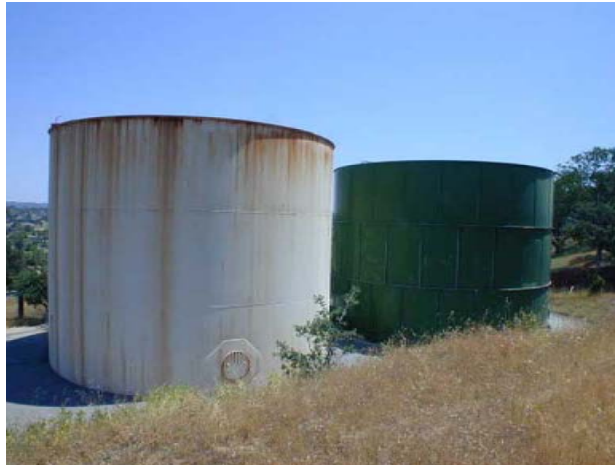
**Figure 4-3: Existing Storage Tanks  
Reservoir 01 (left) and Reservoir 02 (right)**

The system maintains two reservoirs which provide a total storage capacity of 300,000 gallons (150,000 gallons each). The tanks are located in a rural area west of Santa Margarita. There exists only one pressure zone in this system. Reservoir 01 was constructed in 1966 and Reservoir 02 in 1993. Both tanks are located above ground and are constructed of welded steel. The tanks are equipped with screened vents and overflows. Reservoir 02 was built to current standards and the coatings are in good condition. The original Reservoir 01, has had minimal repair work since its installation and has reached the end of its useful life.

Construction has begun on a new above ground steel reservoir with a capacity of 500,000 gallons. This new reservoir will replace the existing 150,000 gallon storage reservoir (Reservoir 01). The 150,000 gallon Reservoir 02, will be retained for a total storage capacity of 650,000 gallons. These two reservoirs will be large enough to accommodate the total storage volume of 645,000 gallons required for demand, fire and emergency storage. To aid in access to the tanks, a new 12-foot wide paved access road is being constructed from Wilhemina Avenue to the tank site. Completion is anticipated for June, 2011.

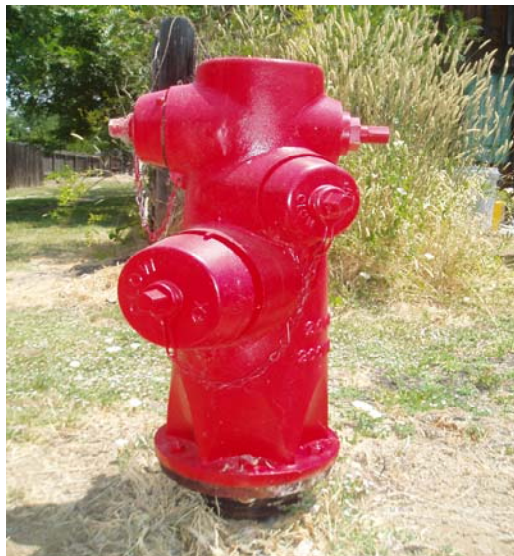
**Figure 4-4: One of the 17 New Hydrants installed**

In order to provide the needed water system capability to deliver the State required residential fire flow through town and improve system circulation and operation, the County completed several pipeline infrastructure improvements in 2009. Pipeline upgrades included upsizing of several pipelines, construction of water system loops, replacement of old wharf head fire hydrants with new standard fire hydrants and installation of over 20 new in-line valves.

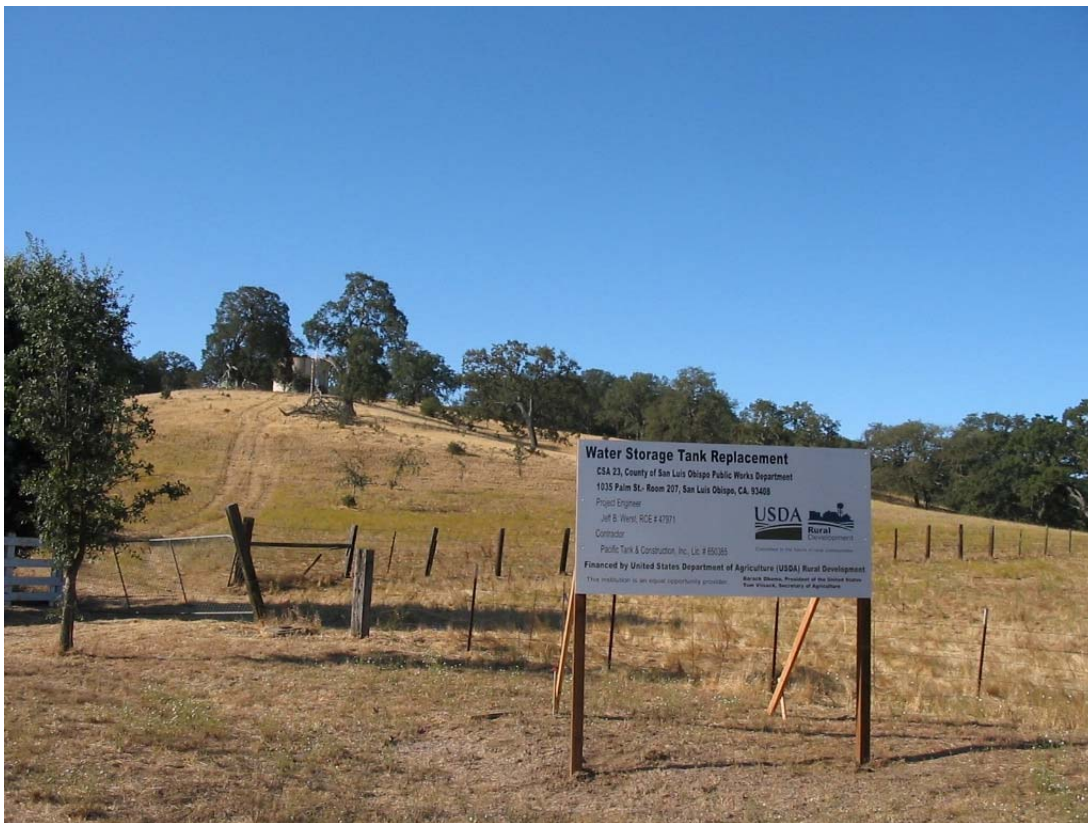
**Figure 7-1: Site of the new Water Storage Tank and Access Road (with the existing Reservoir 01 visible at the top of the hill)**

The new tank will replace the existing 150,000 gallon tank constructed in 1966, Reservoir 01. The diameter of the new tank will be 60 feet with a height of 27 feet and a high water level of 1164.6 feet. The location of the new tank will be located on the west side of Reservoir 01 and will occupy a portion of the existing tank's pad which will require the demolition of Reservoir 01. Reservoir 02, will remain in place and provide storage during construction. The construction will be completed in June of 2011.

Construction is underway to install a new above ground steel reservoir with a capacity of 500,000 gallons. As part of this project, a new parallel 12-inch diameter pipeline will be constructed to connect the new tank to the Santa Margarita community (at Wilhelmina Ave.). A 12-foot wide paved road will also be constructed to provide access from Wilhelmina Ave. to the tank site. These needed improvements will provide increased water storage and help meet fire flow requirements

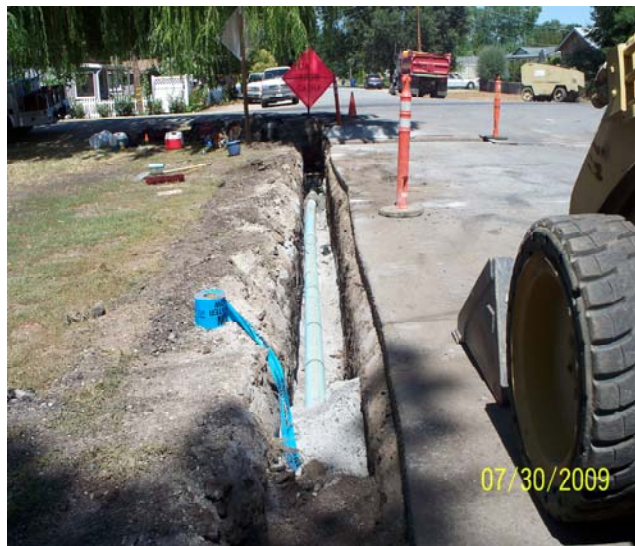
**Figure 7-2: Pipeline Upgrade**

Existing 2 to 4-inch diameter pipelines were replaced with 6 to 8-inch diameter pipelines within Encina Avenue and K Street. Within F Street east of Pinal Avenue, 6-inch diameter pipeline was replaced with 8-inch diameter pipeline. A 670-foot long, 6-inch diameter water system loop was constructed to join the dead-ends at F Street and Maria Avenue. The upgrade also involved replacing 22 wharf heads with new standard fire hydrants and installing 21 new in-line valves.

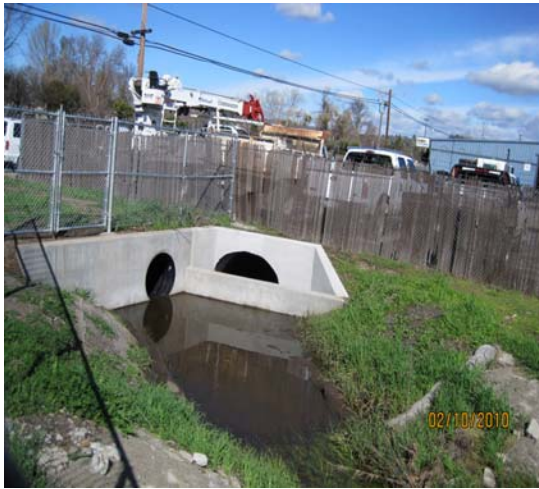
**Inlet at Highway 58**

This new storm drain diverts the larger storm flows that normally flow east along El Camino Real. Completion of this project has improved the drainage functionality of the downstream wet-swales (bioswales) and has further reduced the frequency of flooding in the Murphy Ave./F Street neighborhood.
