Damaged Lines in Morro Bay's Wastewater Collection System

Causes and Effects

August, 2007

Condition of the Morro Bay Wastewater Collection System

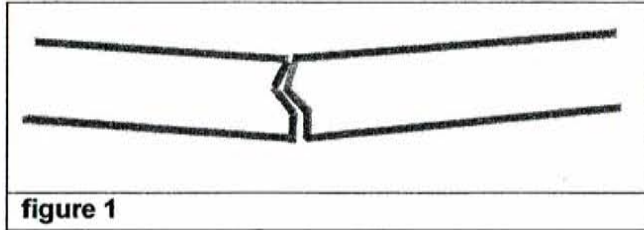
Crack/Break

Clay pipe is rigid, and will crack, and eventually break, if sufficient force is applied (**figure 1**).

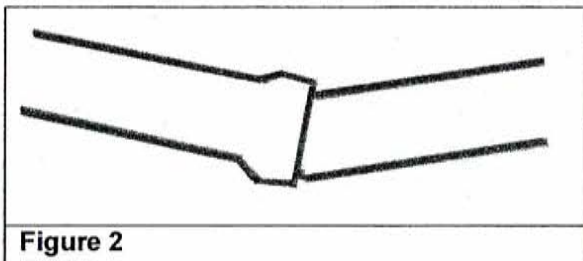
Broken Joint

Joints between pipe sections may break open under sufficient force. (**figure 2**) The overlap of two clay pipe sections is only about 1 ½ inches.

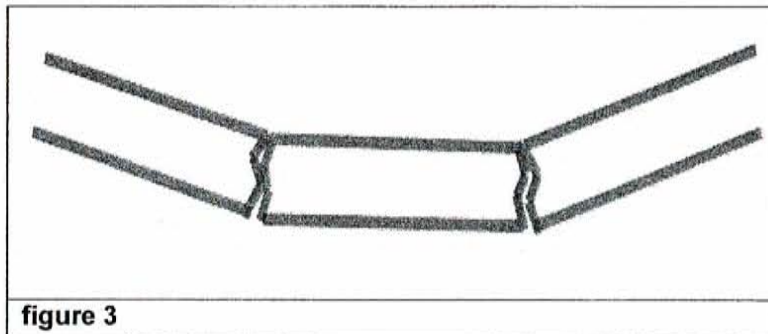
Belly

Multiple cracks, and broken joints may form a configuration known as a "belly" (**figure 3**).

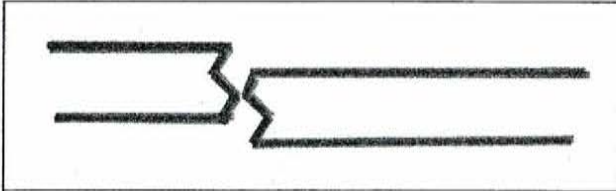
figure 4

In some cases, after a break occurs the pipe on one side of the break moves at a different rate than the section on the other side, offsetting the ends of the pipe (**figure 4**).

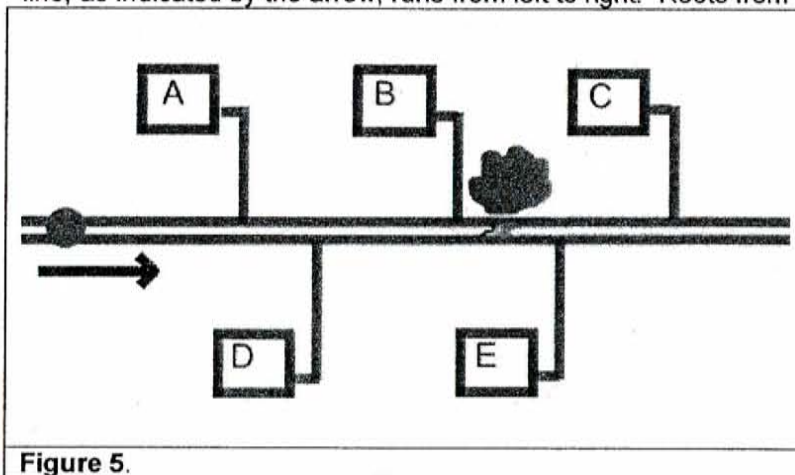
Figure 5.

Figure 5 represents an aerial view of a Morro Bay neighborhood. Several homes are connected, by typical 3"–4" lateral lines to a typical 6"–8" sewer line owned by the City. The direction of flow in that line, as indicated by the arrow, runs from left to right. Roots from a tree between houses

B and C have entered the sewer line through a crack, and formed a root ball.

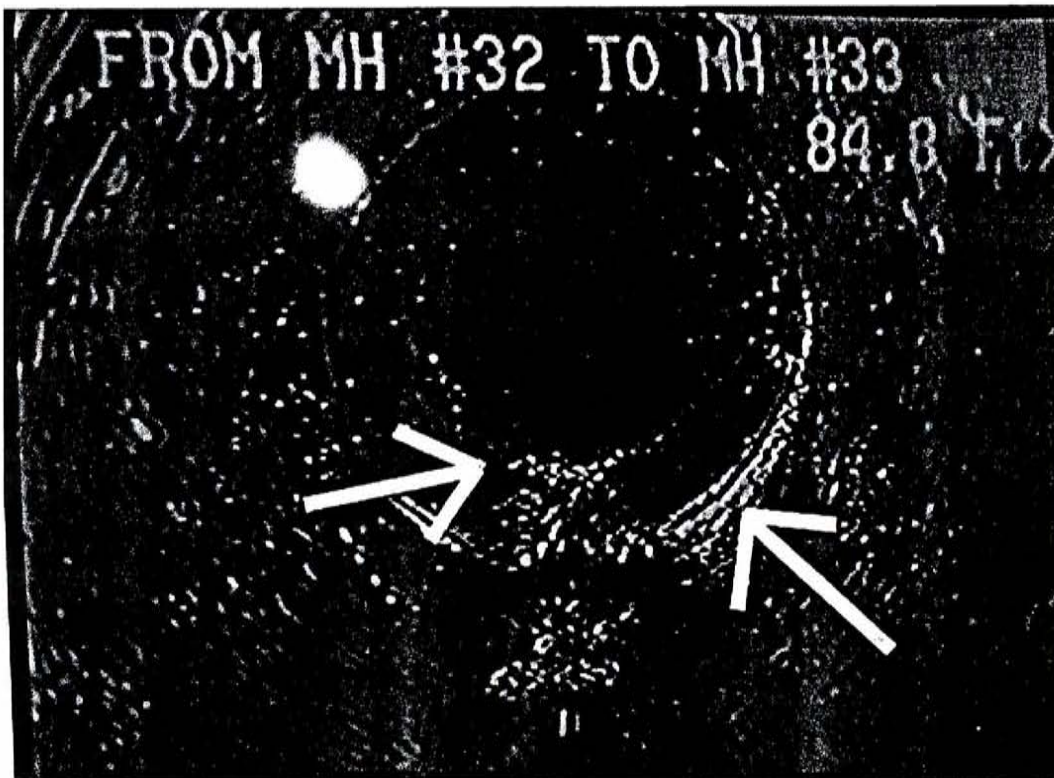
Offsets Between Manholes 32 and 33

The image in Figure 1 is from an inspection tape made in January, 2007. This line is on Koa, a hillside street in North Morro Bay. In this image, two significant offsets are visible, creating a sort of "waterfall" effect. The potential for exfiltration to occur at these joints is high.

However, the log (Figure 2) mentions only the lateral connection near these two offsets.

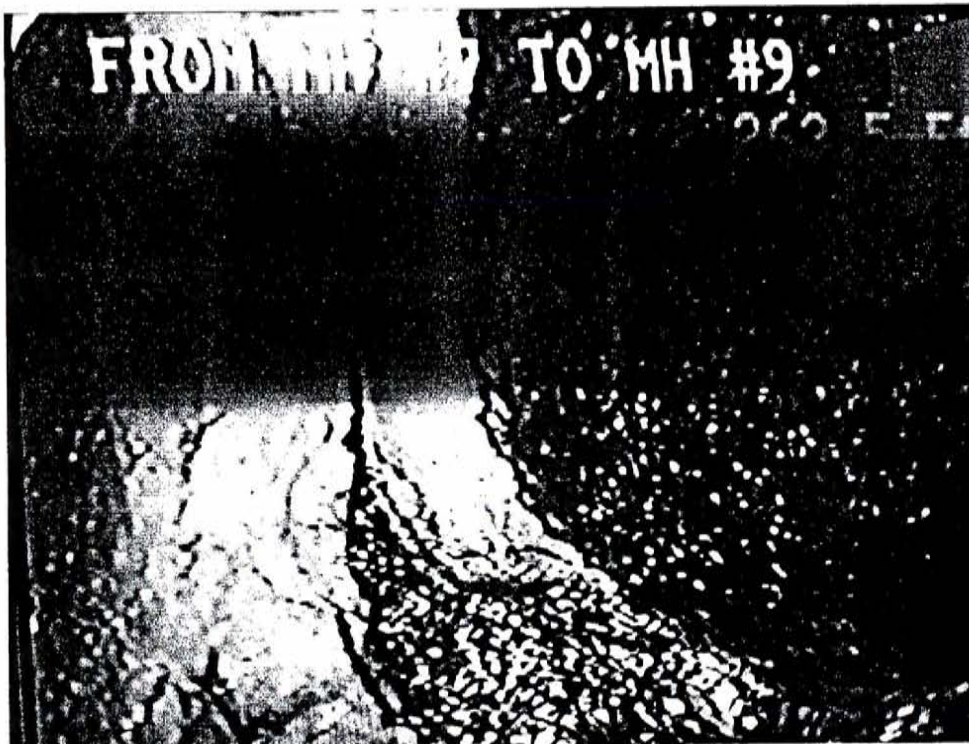
Figure 5

Bad Lateral Joint Between Manholes 7 and 9

In the following image, also from a January, 2007 inspection, we see a poorly installed lateral connection with offset, and with significant cracking visible in the left half of the image.

However, in the log (see figure 4, previous page), the notation for 264 feet, says only, "right tap – roots in tap". The next and last entry in this log is for the end of the run.
