GEOTECHNICAL REPORT

Arroyo Grande Creek Channel Waterway Management Program

San Luis Obispo County, California

Yeh Project No.: 218-169

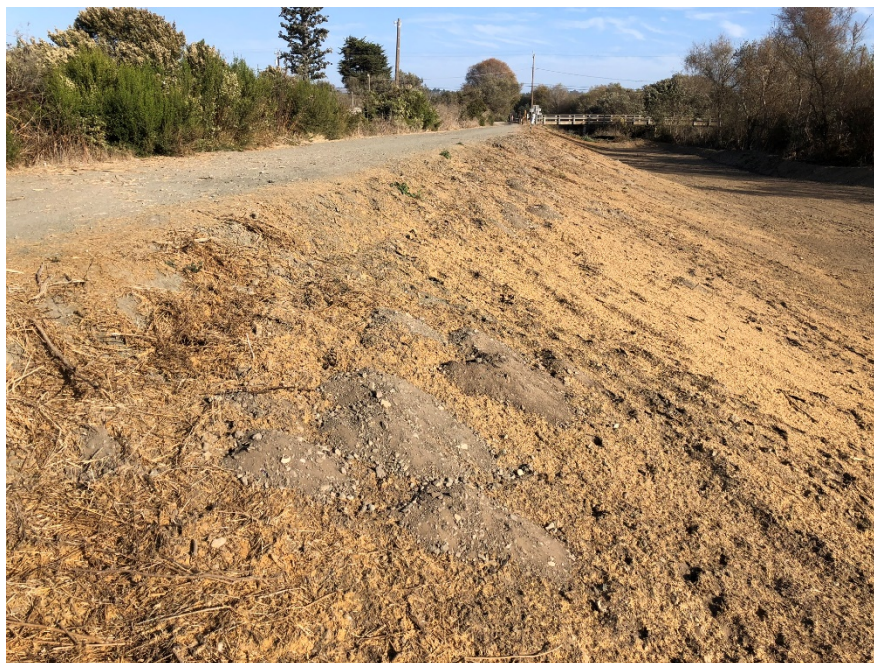
- We observed rodent burrows and loose surface soil on the existing interior and exterior levee slopes. Burrowing animals and large buried roots of vegetation such as trees that have been removed as part of a vegetation management program can cause extensive void systems. Subsurface voids generally shorten flow paths through the levee and increase the potential for seepage-related hazards and slope instability. The slope monitoring program should also document evidence of burrowing animals and deep-rooted vegetation.
- As directed by the County, the scope of the improvements is for flood protection only, and no seismic criteria were considered in evaluating the stability of the levee slopes. We understand potential seismic hazards and repairs to the levees would be performed in response to a damaging seismic event as part of the County's operation and maintenance of the levee.

We observed rodent burrows and loose surface soil on the existing interior and exterior levee slopes. Figure 3 shows evidence of rodent burrows on the interior levee slope at approximately Station 69+00. We understand the County periodically manages vegetation and rodent activity on the levee, which is common maintenance practice for hydraulic earth structures.

Figure 3: Rodent Burrows on north levee interior slope
(facing east; 22nd Street Bridge in background)

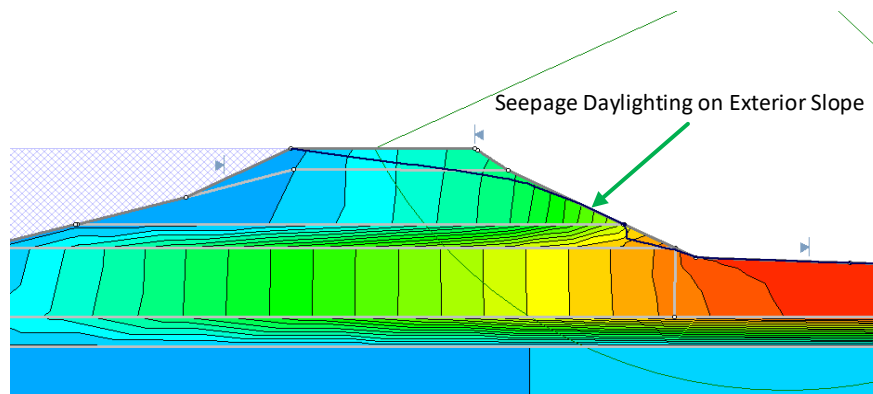
Through-seepage that daylighting on an exterior slope during a design storm event is typically not considered acceptable for design, particularly for erodible soils (DWR 2015). An example of seepage analyses results illustrating through-seepage is presented in Figure 5. SLIDE was used to estimate the phreatic surface during the design storm event and the potential for through-seepage to daylight on the exterior slope.

Figure 5: Through-seepage example

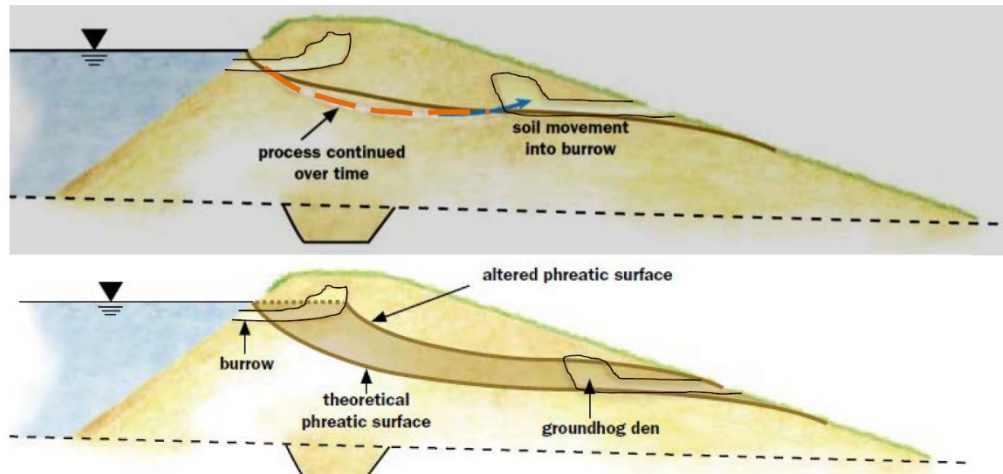
inclination, and regular maintenance to repair or re-grade the slope should be anticipated. We understand the County plans to implement a slope monitoring program to review levee slopes for evidence of instability on a regular basis. The slope monitoring program should also document evidence of burrowing animals and deep-rooted vegetation.

Figure 7: Seepage-related levee failure mechanism due to burrowing animals (FEMA, 2005)
