Insurance Claim of Infinite Horizons, Inc.

Avila Beach Resort Flooding
Investigations

Storms of January and March 1995

August 8, 1995

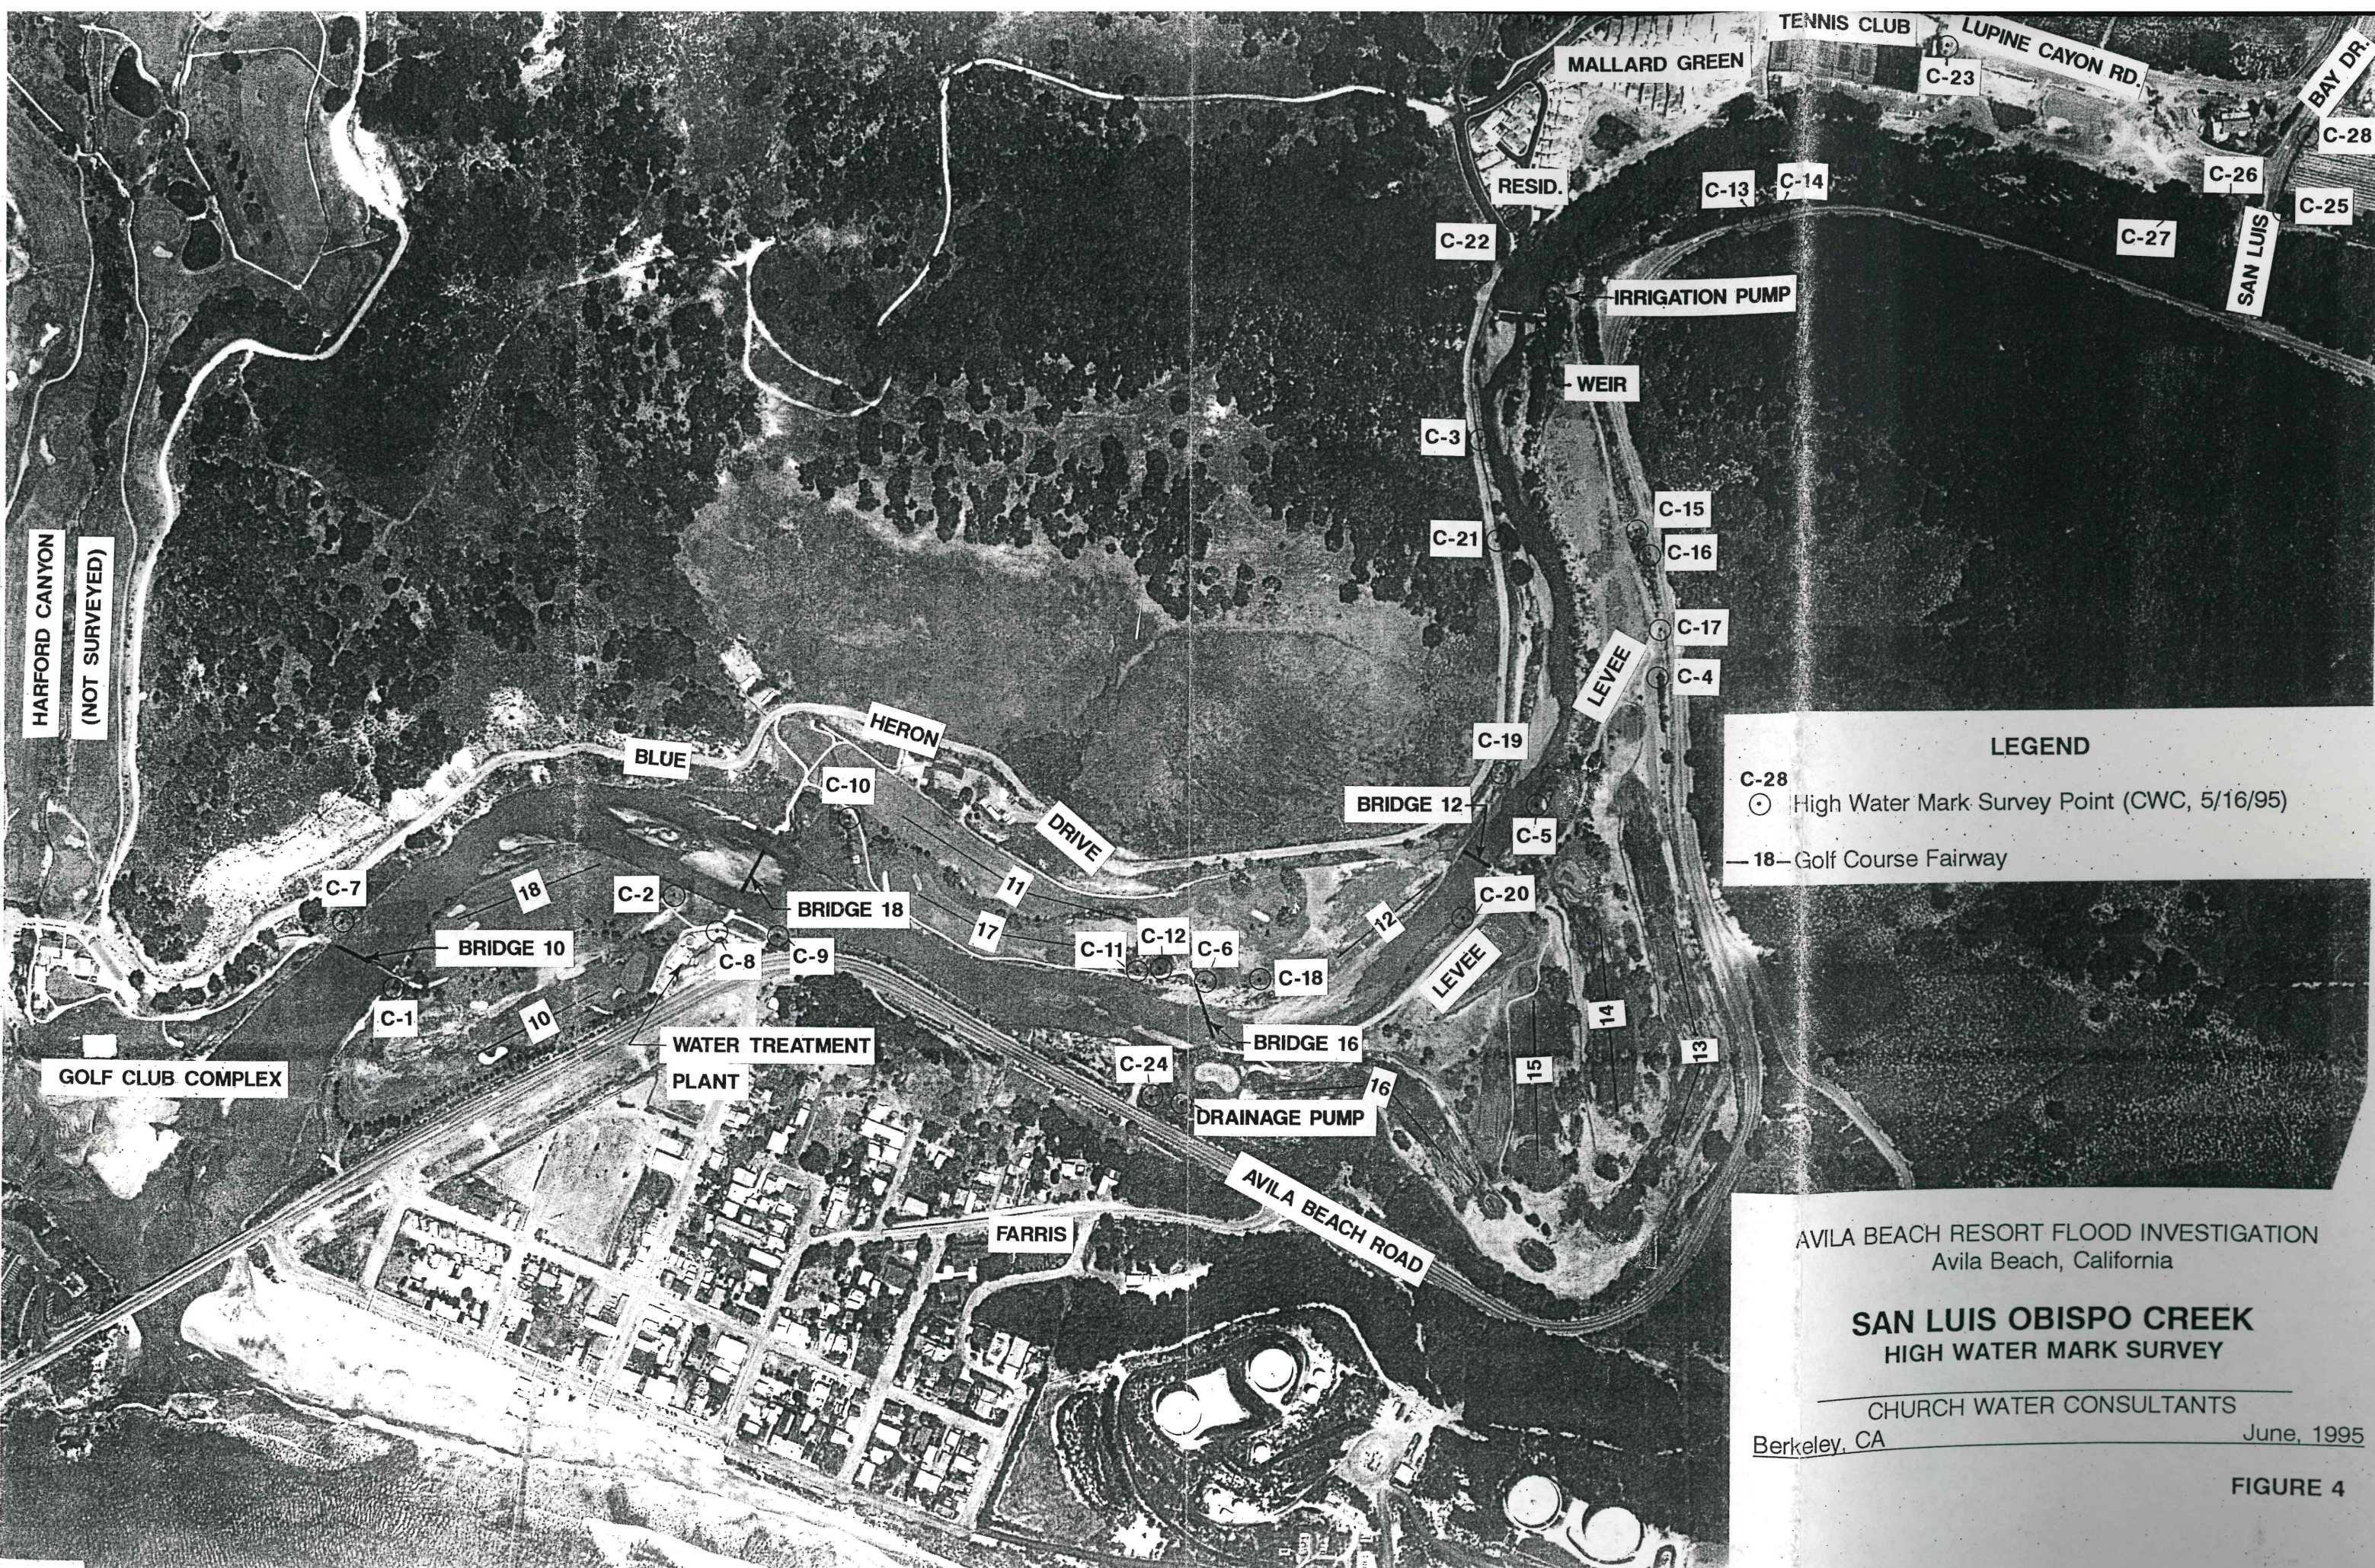
FIGURE 4

On May 16, 1995, Mr. Church made a tour of the golf course with the owner, Mr. Rob Rossi, to mark the high water that Mr. Rossi observed between 5:30 and 9:00 A.M. on March 10, 1995. Stakes labeled CWC- 1 to 6 (C-1 to 6, Figure 4) were set for subsequent level survey. Mr. Rossi also pointed out high water levels reported to him at a Mallard Green residence (Resid, Figure 4) and at the Tennis Club (C-23).

Subsequently Mr. Church made a detailed reconnaissance of the area between Bridge 10 and San Luis Bay Drive, identifying and staking 20 apparent high water marks. The selected high water marks were typically flotsam deposits or soil wash lines located in protected areas away from the main channel current and wave action. The high water mark may have been left by any of the 1995 floods, but are believed to primarily represent the high water of the evening of March 10th. On May 23rd Mr. Church directed a Central Coast Engineering, Inc. survey crew during their level survey of the high water marks. The bench mark for the survey was Reference Mark 56 as described on the FEMA Flood Insurance

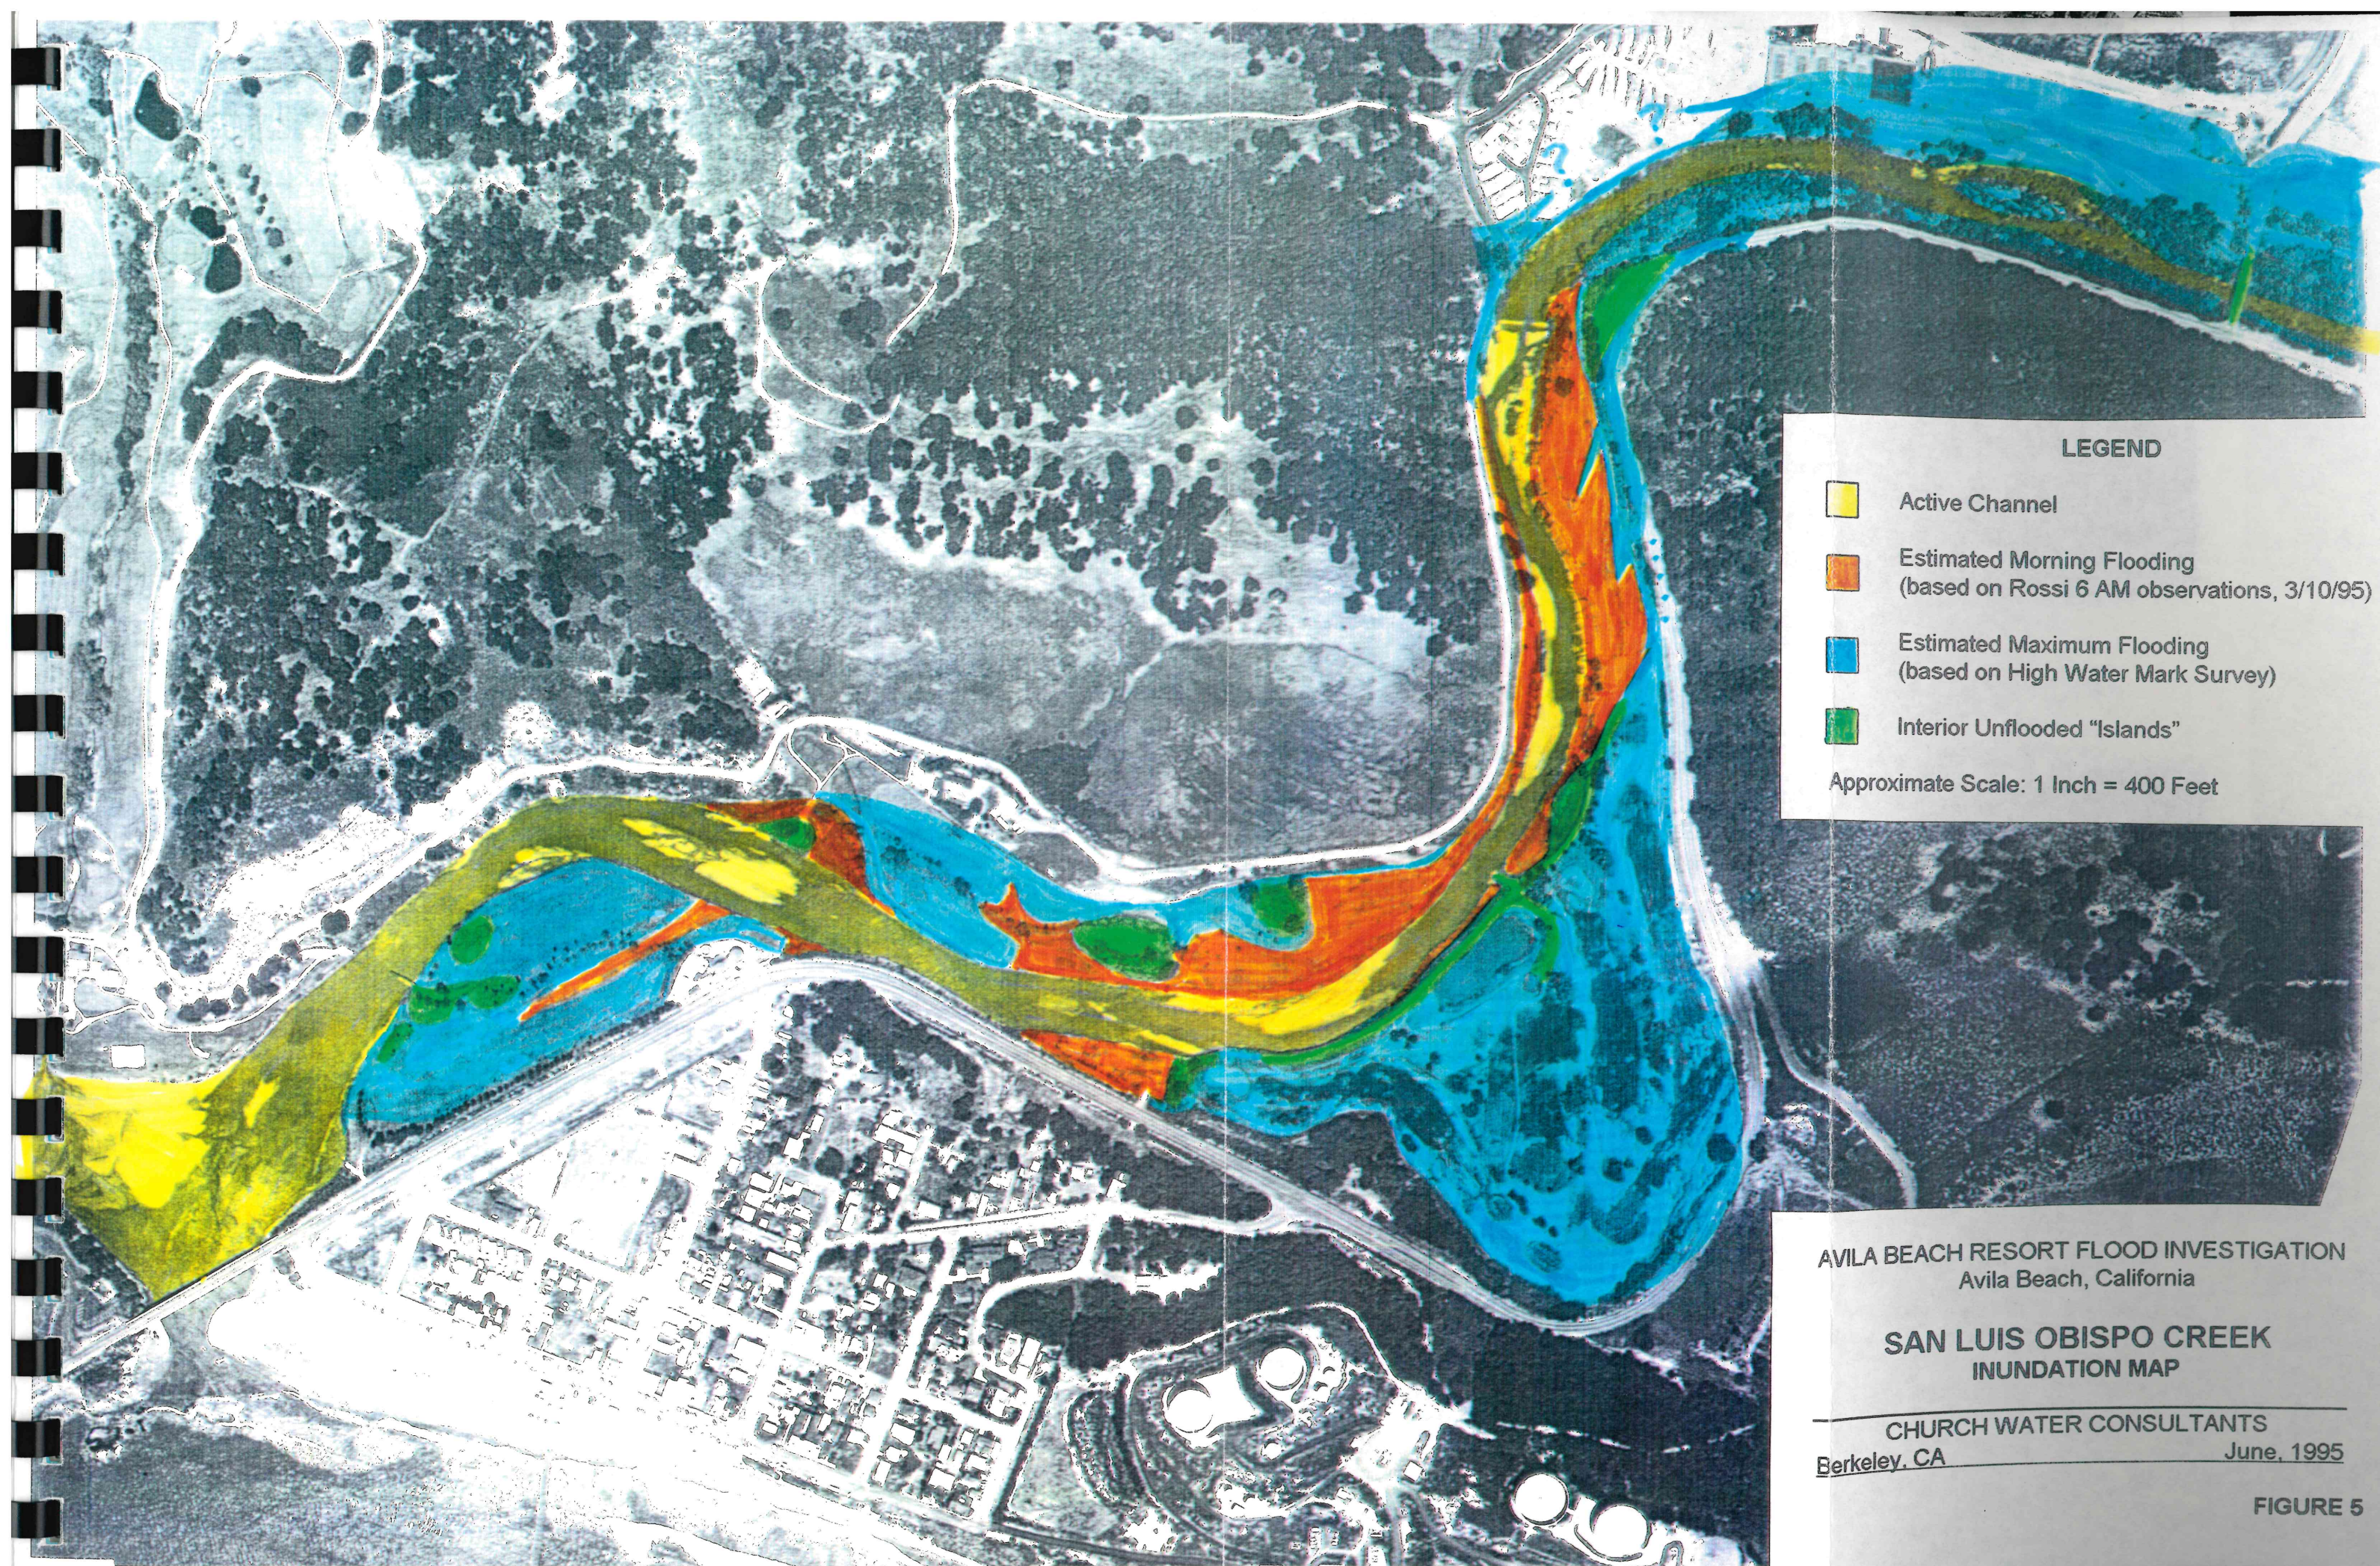
FIGURE 5

The results of the level survey are plotted on the High Water Mark Profile, Figure 6. The profile elevations were projected on the topography map to obtain an estimate of the extent of flood inundation for both Mr. Rossi's morning observations and the high water marks. The results of these projections are shown on the Inundation Map, Figure 5.

The extent of March 10 flood inundation was estimated based on interviews with Mr. Rob Rossi (Appendix A-1), the high water mark survey and various reports of water on Avila Beach Road. The results of investigation along San Luis Obispo Creek are shown on Figure 5. Note that portions of the levee and various other areas within the flood plain were not apparently inundated. Other areas, such as Mallard Green, are poorly interpreted due to land modifications subsequent to the 1989 topographic map.

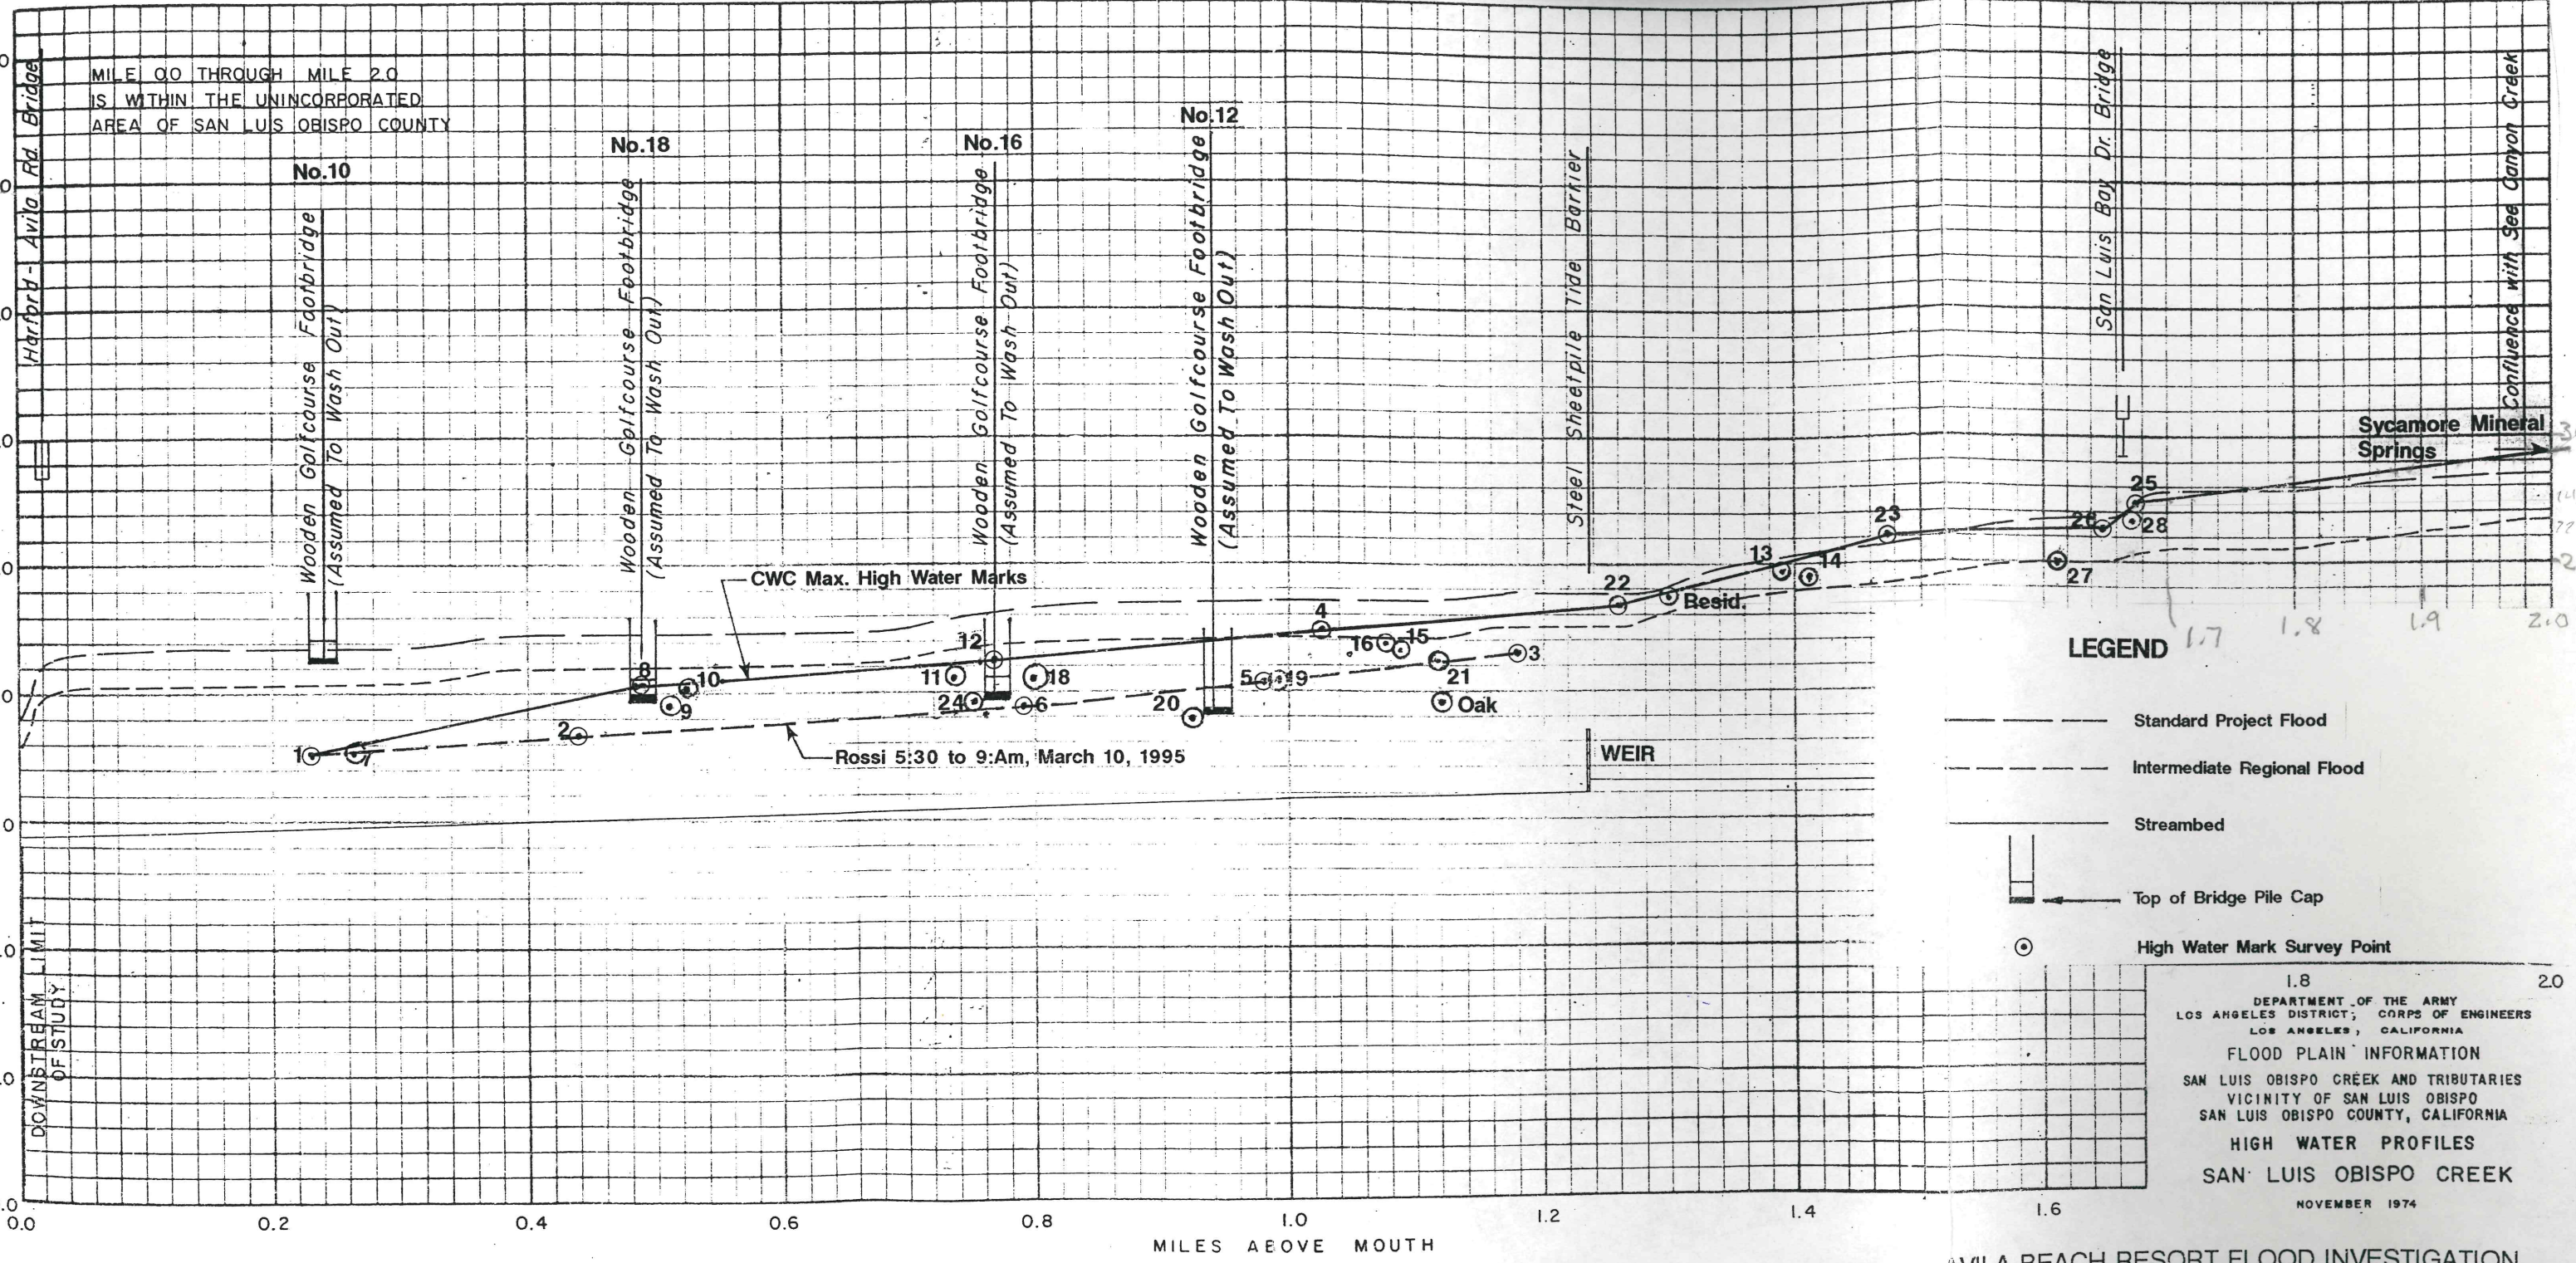
FIGURE 6

Mr. Rossi's morning observations of March 10, as indicated on Figure 6, are approximately 3 feet below the high water mark in the vicinity of Bridges 18, 16 and 12. High flows were apparently impinging on the bridge deck support beams only at Bridge 12 when he observed them. However, the high water mark survey indicates that the high velocity channel current impinged on and submerged Bridges 18, 16 and 12 at some time during the flood. The deck of Bridge 10 remained well above (7 feet +/-) the high water throughout the flood.

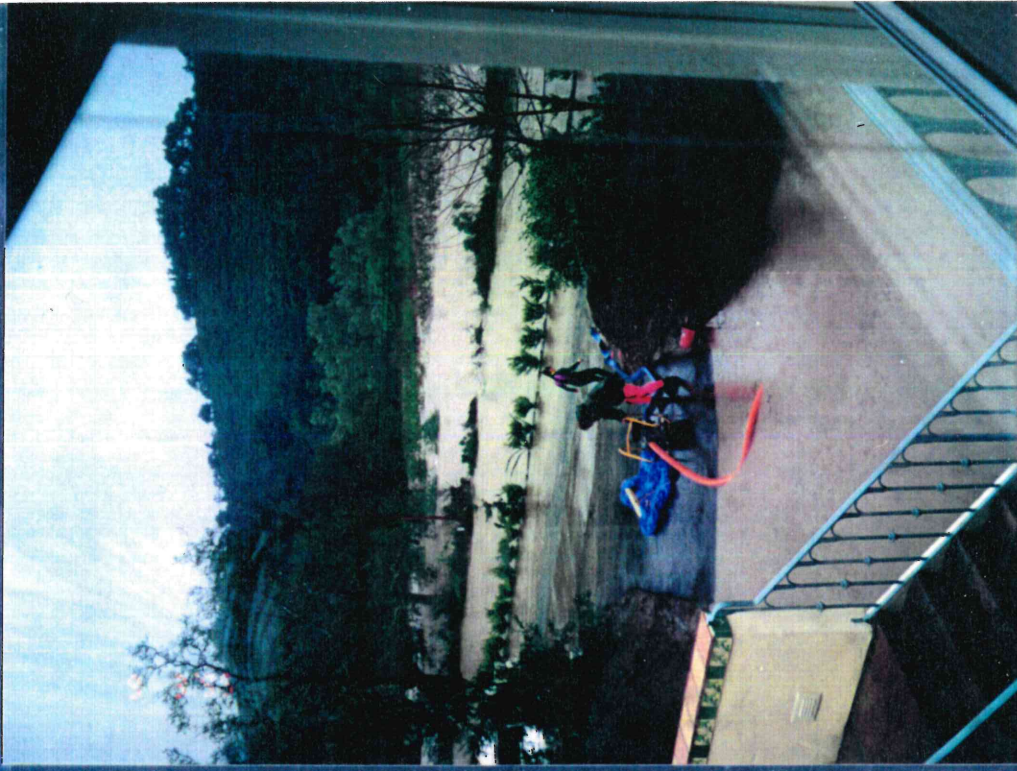
Photo 2.1
March 10, 1995
from Kiesigg residence

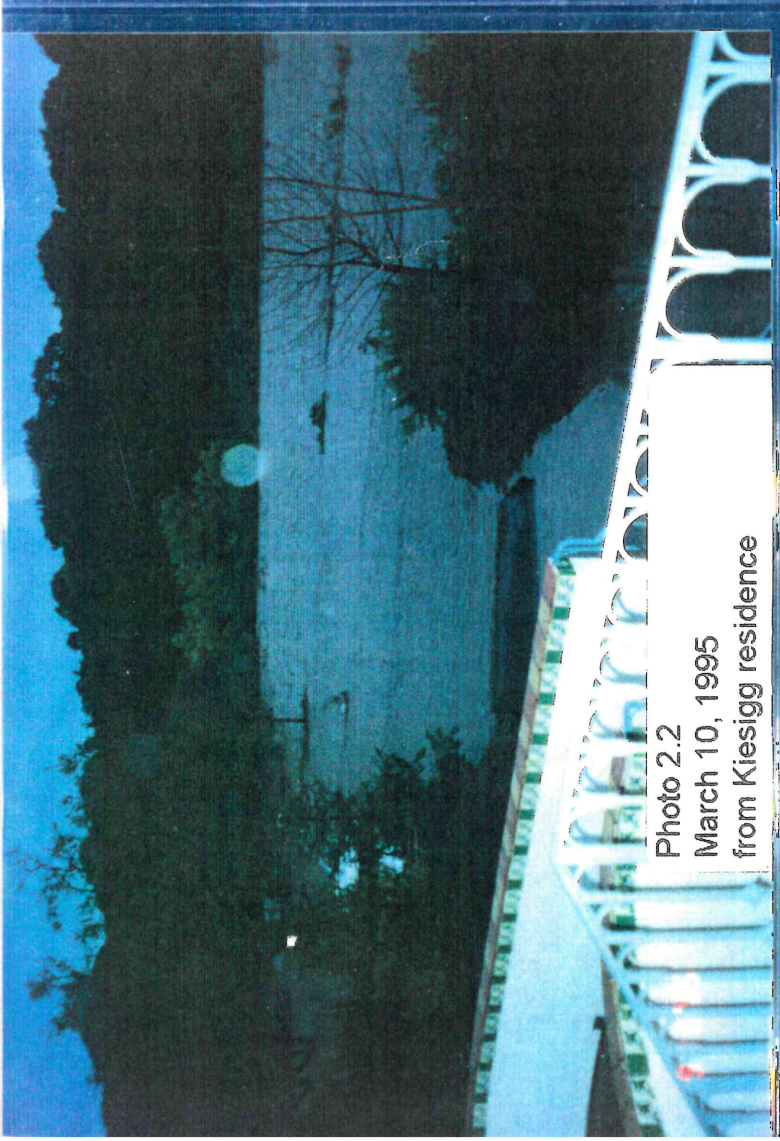
Photo 2.2
March 10, 1995
from Kiesigg residence

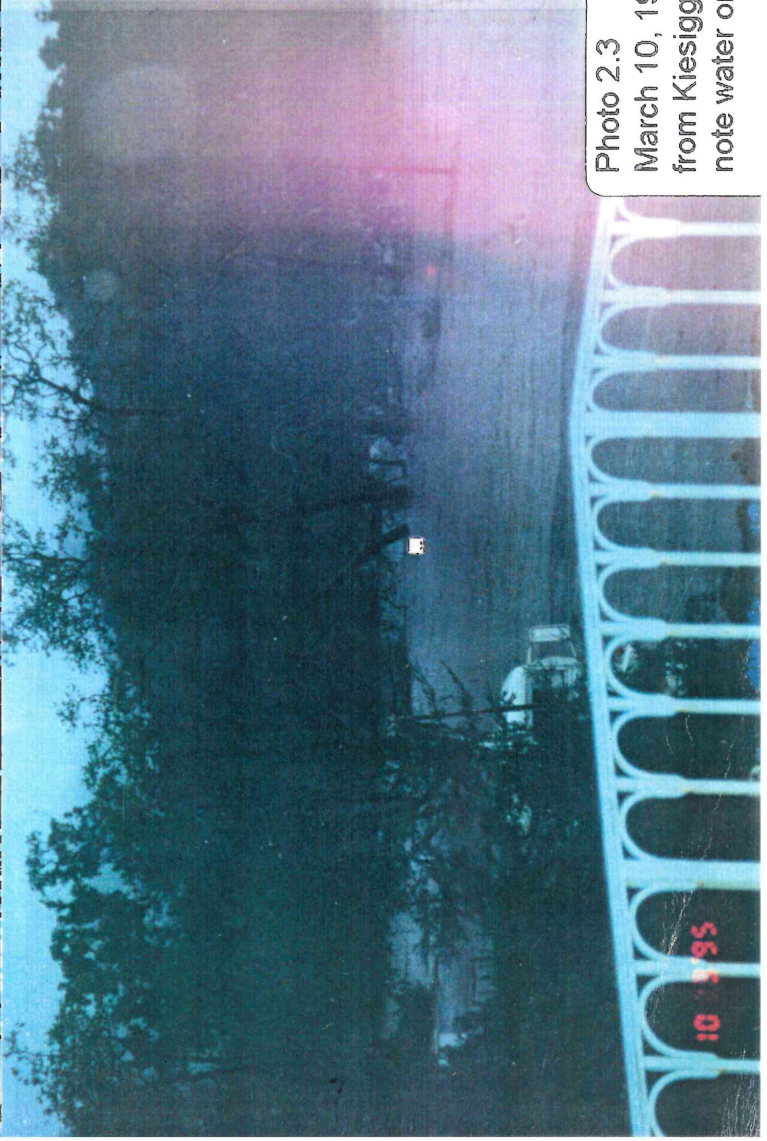
- 18/19:00 Sycamore Mineral Springs: **Maximum water level** (elev 29 ft., near top of speed limit sign). (Colleen Snyder) *E₂end*
- 19:00 Sycamore Mineral Springs: Maximum water level, receded 1 inch by 19:30. (Carol Kiessig)

Photo 2.3
March 10, 1995
from Kiesigg residence
note water on Speed Limit sign

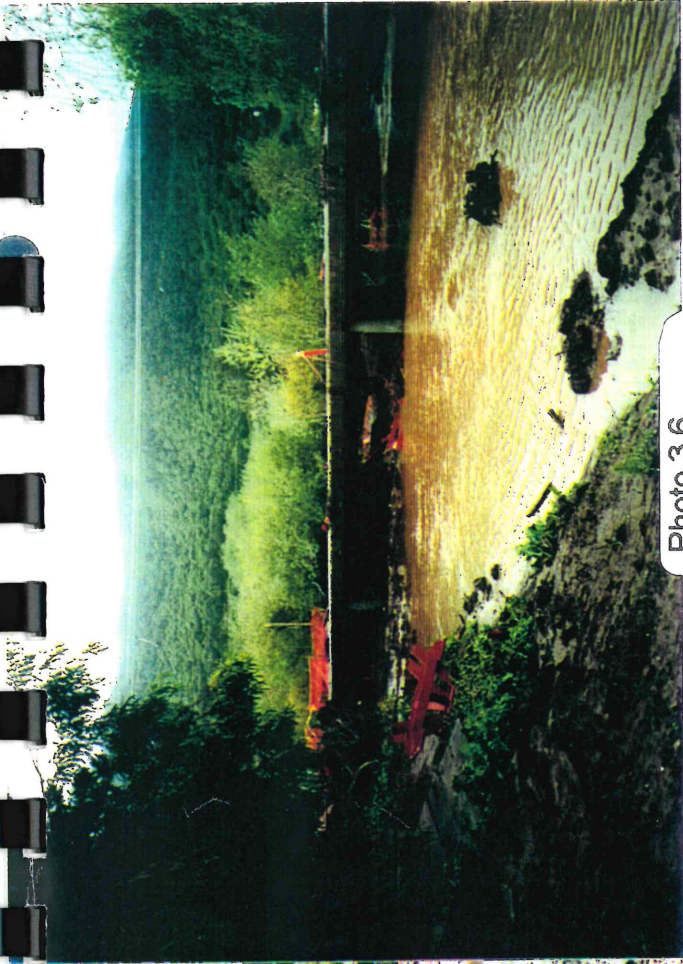
Photo 3.6
March 12, 1995
Ontario Bridge

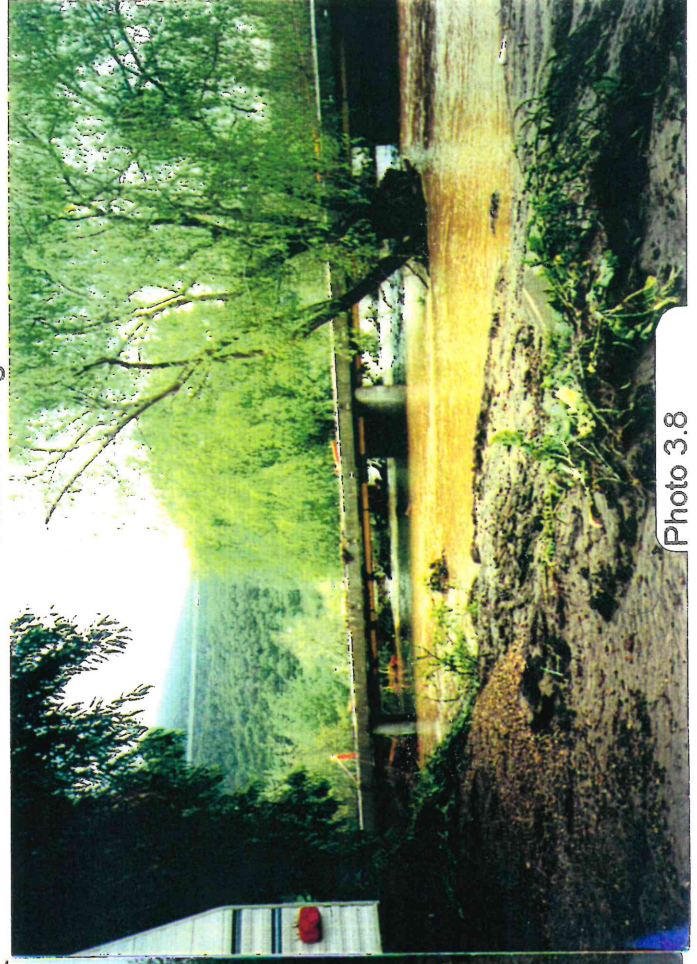
Photo 3.8
March 12, 1995
Ontario Bridge

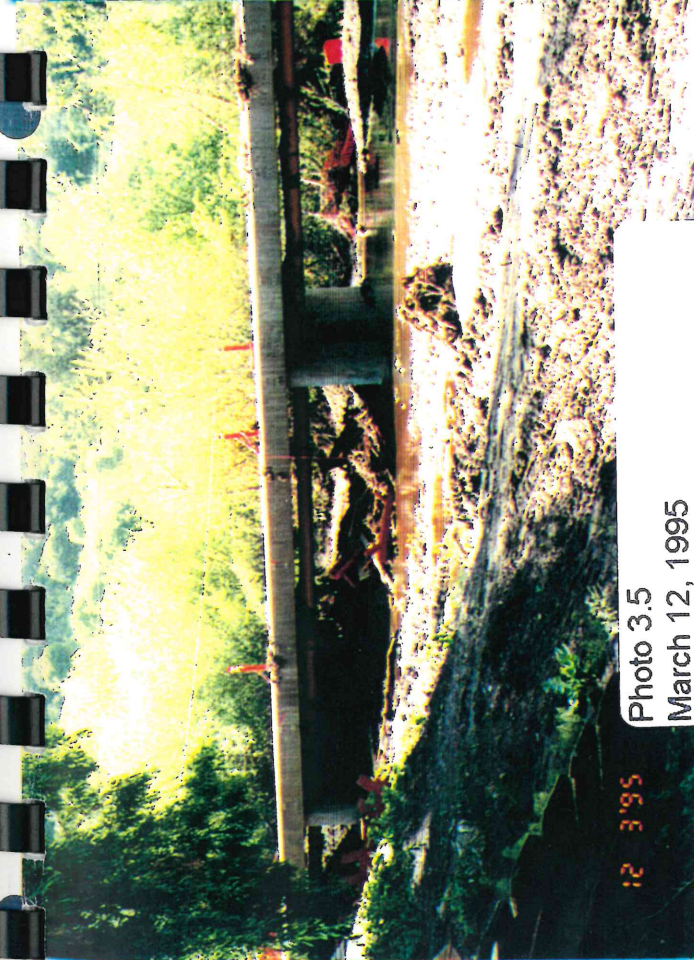
Photo 3.5
March 12, 1995
Ontario Bridge: Note debris/HWM
on right side of bridge deck

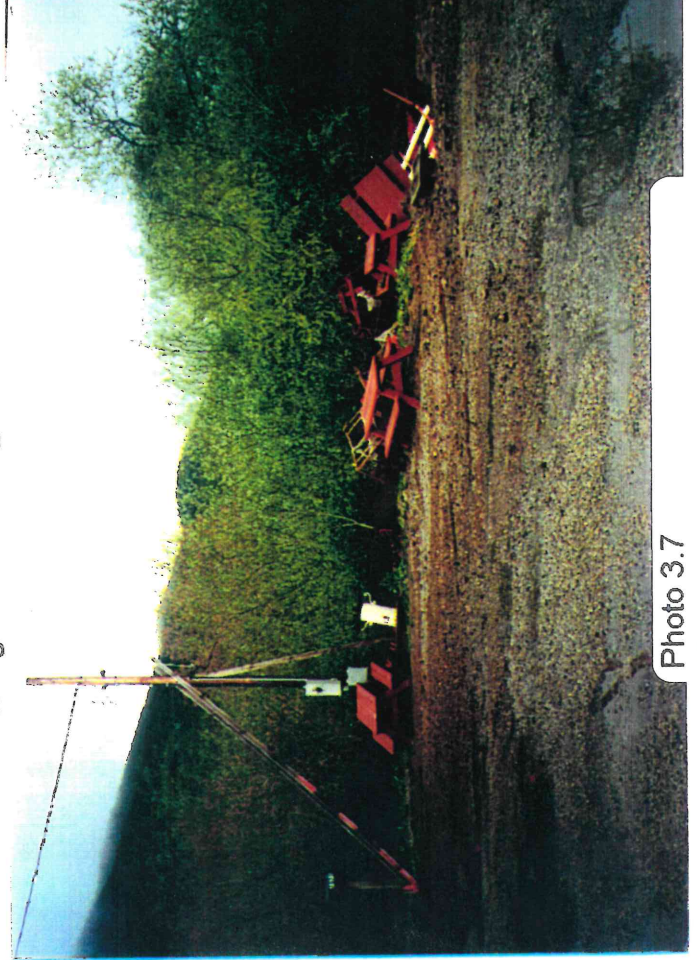
Photo 3.7
March 12, 1995
Ontario Bridge, left approach

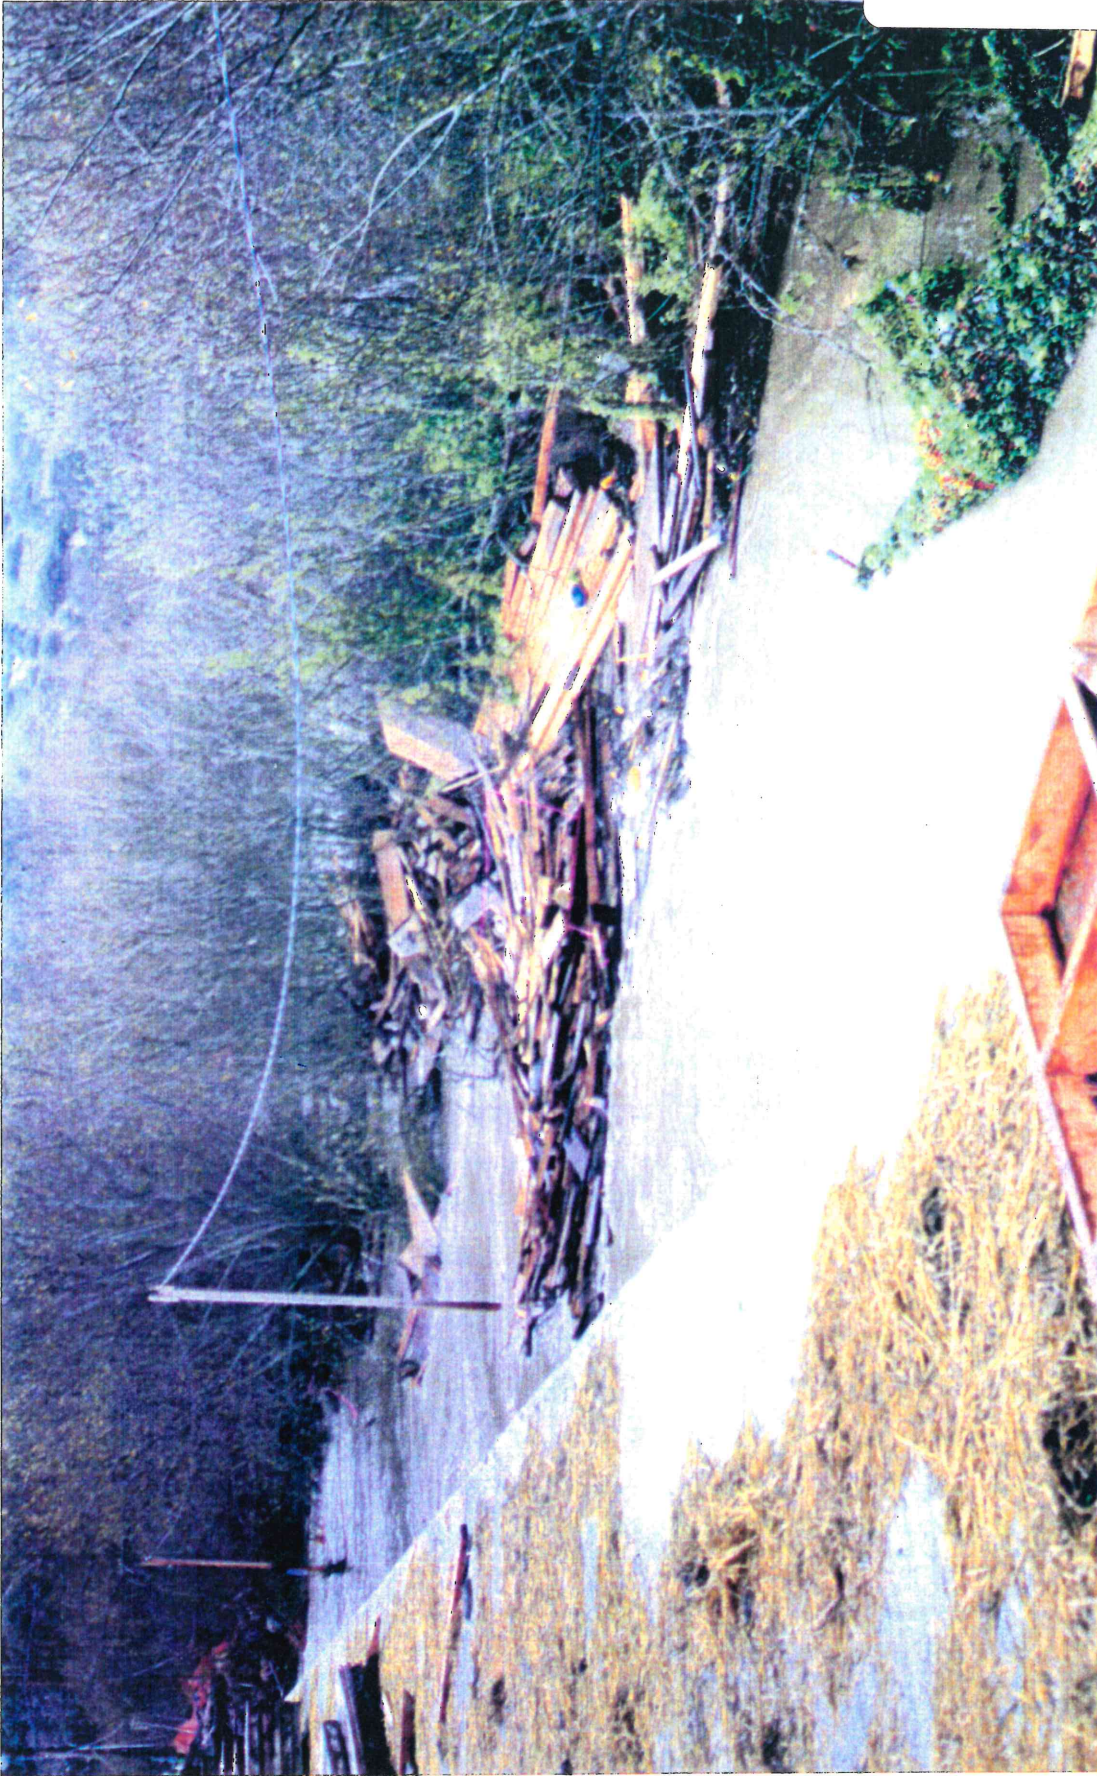
Photo 4.1
January 10, 1995
Ontario Bridge and downstream
debris
