# **Nacimiento Water Project Watershed Sanitary Survey Five-Year Update (2016 – 2020)**

# Nacimiento Water Project, San Luis Obispo County

## 2020 Watershed Sanitary Survey Five-Year Update

<b>SWRCB-DDW System No.:</b>	4010080
<b>System Name:</b>	San Luis Obispo County – Nacimiento Water Project
<b>Survey Period:</b>	January 1, 2016 through December 31, 2020
<b>Initial Survey Completed:</b>	2011
<b>Updates Completed:</b>	2016, 2021

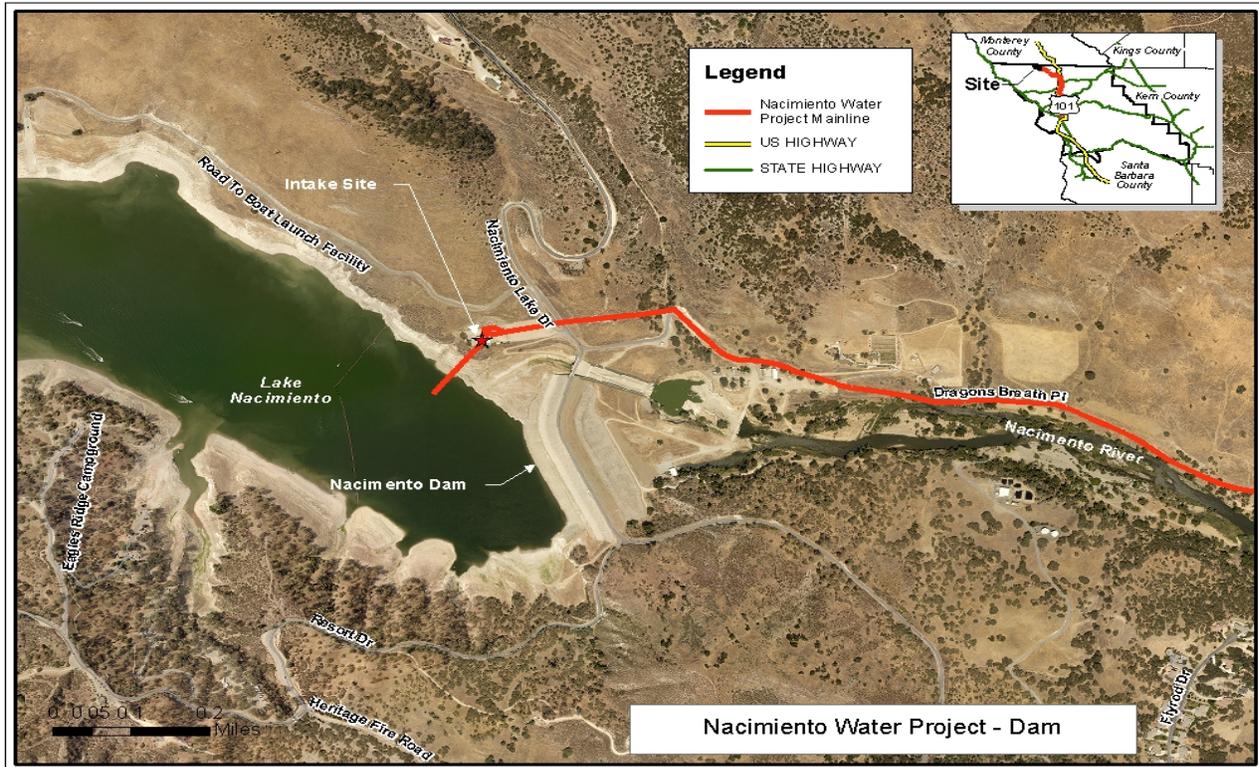
Figure 1: Intake Structure Aerial Map

- **Log Boom:** The old log boom that provided a safety buffer around the Nacimiento Dam was removed and replaced with a new log boom to protect the new Intake facilities and to eliminate recreational body contact with the water within 500 feet of the Intake pipe.

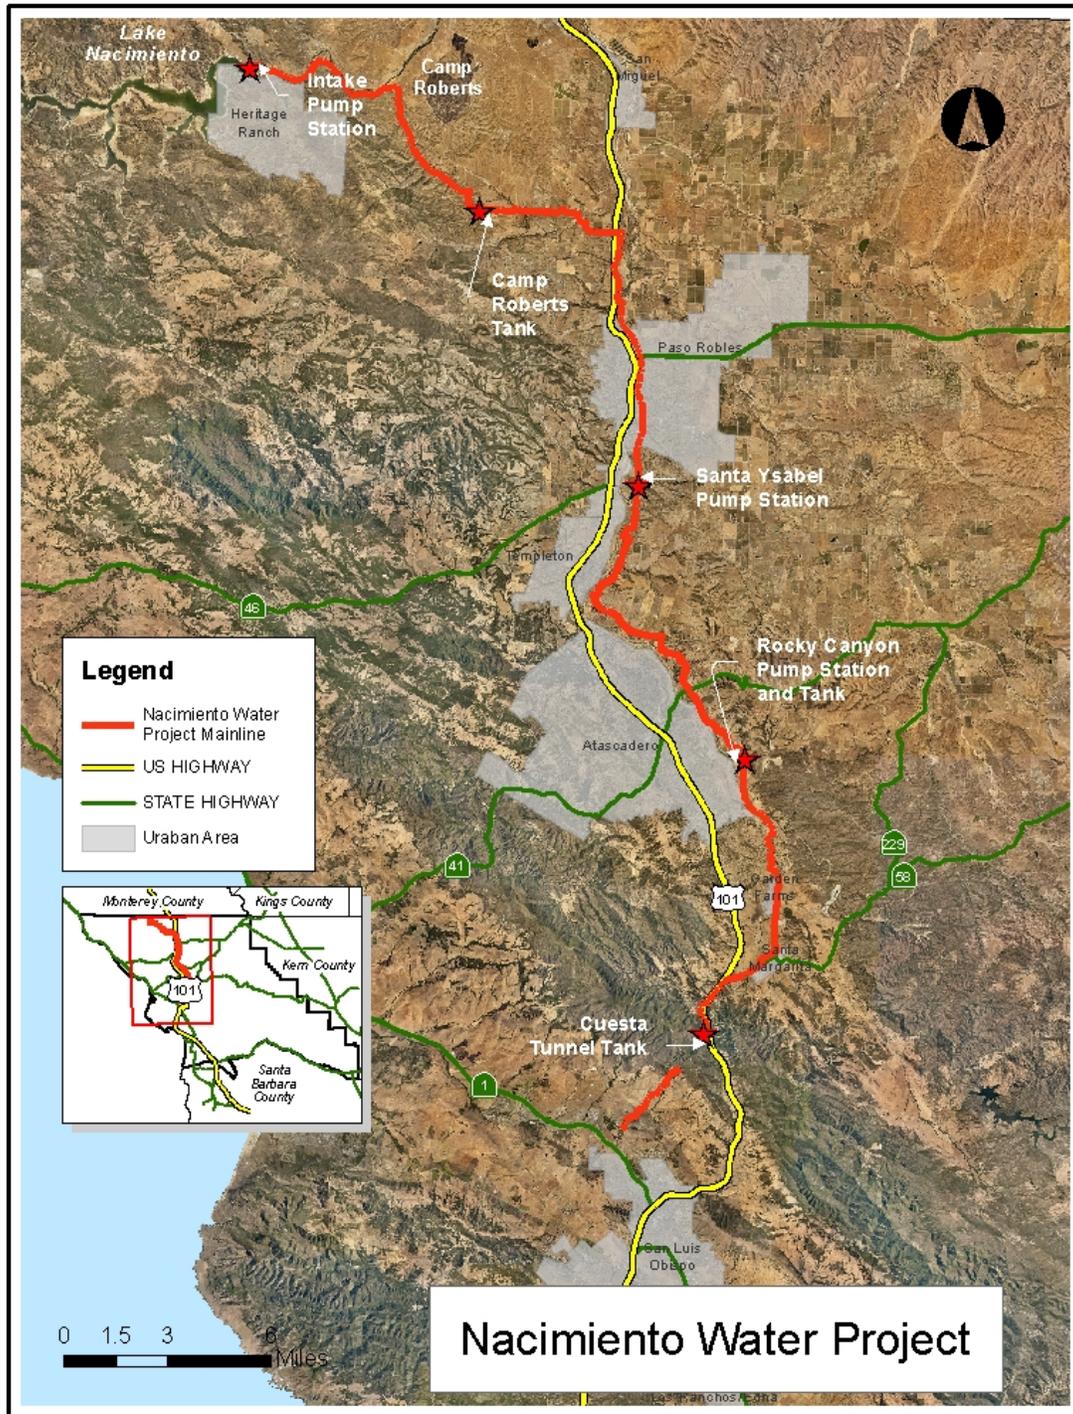
Figure 2: Facilities Aerial Map

Tank construction work included: excavation, foundation preparation, and slope protection; reinforced concrete tank foundation; site improvements, drainage facilities, and access road paving; construction of inlet and outlet piping, valves, and appurtenances; welded steel tank design, fabrication, and field erection; application and curing of tank coatings; and installation of cathodic protection and instrumentation and control systems.

- **Supervisory Control and Data Acquisition (SCADA):** A SCADA system and Project controls electronically control the completed Project. This work included the installation of SCADA equipment, software, electrical conduit, cable, and system configuration services.
- **Chemical Treatment:** No chemical treatment is provided at any point along the transmission main.

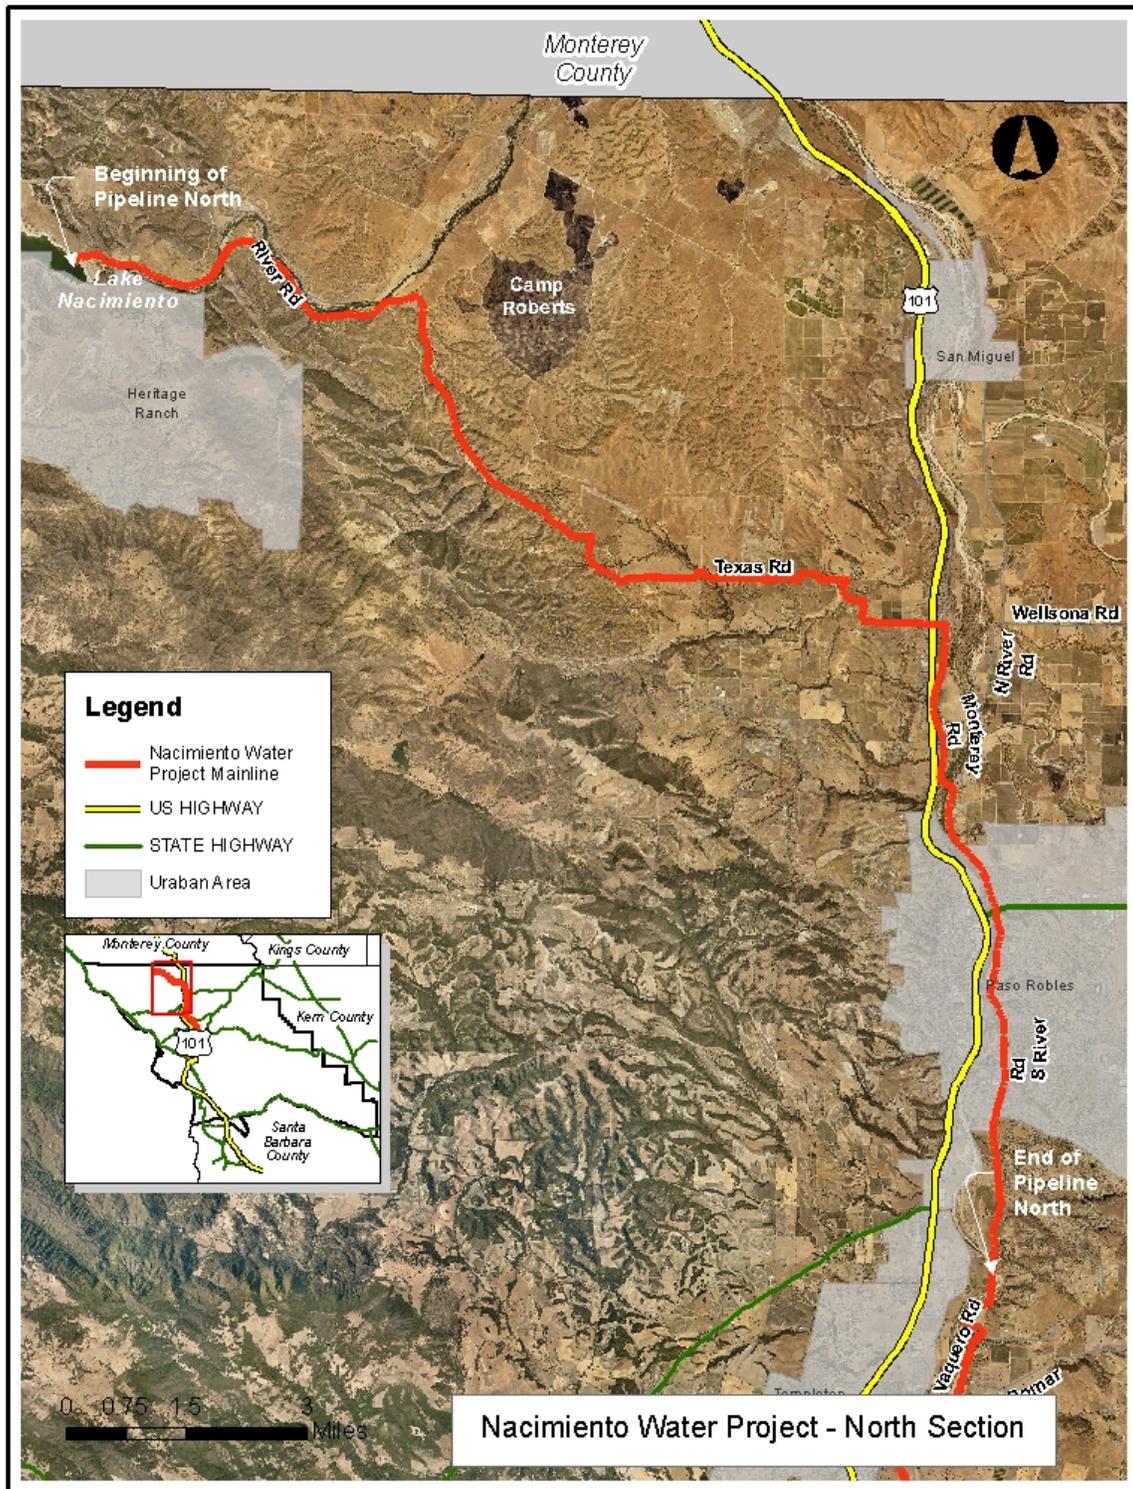
Figure 3: Pipeline North Section Aerial Map

- **Pipeline:** Approximately 22 miles of 36-inch to 30-inch diameter steel pipeline was installed as the northern portion of the Project’s pipeline. Pipeline work included trenching, pipeline installation, and backfilling; sheeting, shoring, and bracing; performance of trenchless construction at road and highway crossings; application of pipeline linings and coatings; installation of appurtenances and corrosion monitoring stations; pavement restoration; traffic and pedestrian control; protection and location of existing utilities; performance of pipeline pressure and leakage testing; unexploded ordnance (UXO) detection and avoidance on Camp Roberts; hazardous materials removal and disposal; and site restoration.

- **Fiber Optic Cable:** A fiber optic communication line aids in Project operations and control. The contractor installed pull boxes and installed and tested fiber optic conduit and cable.

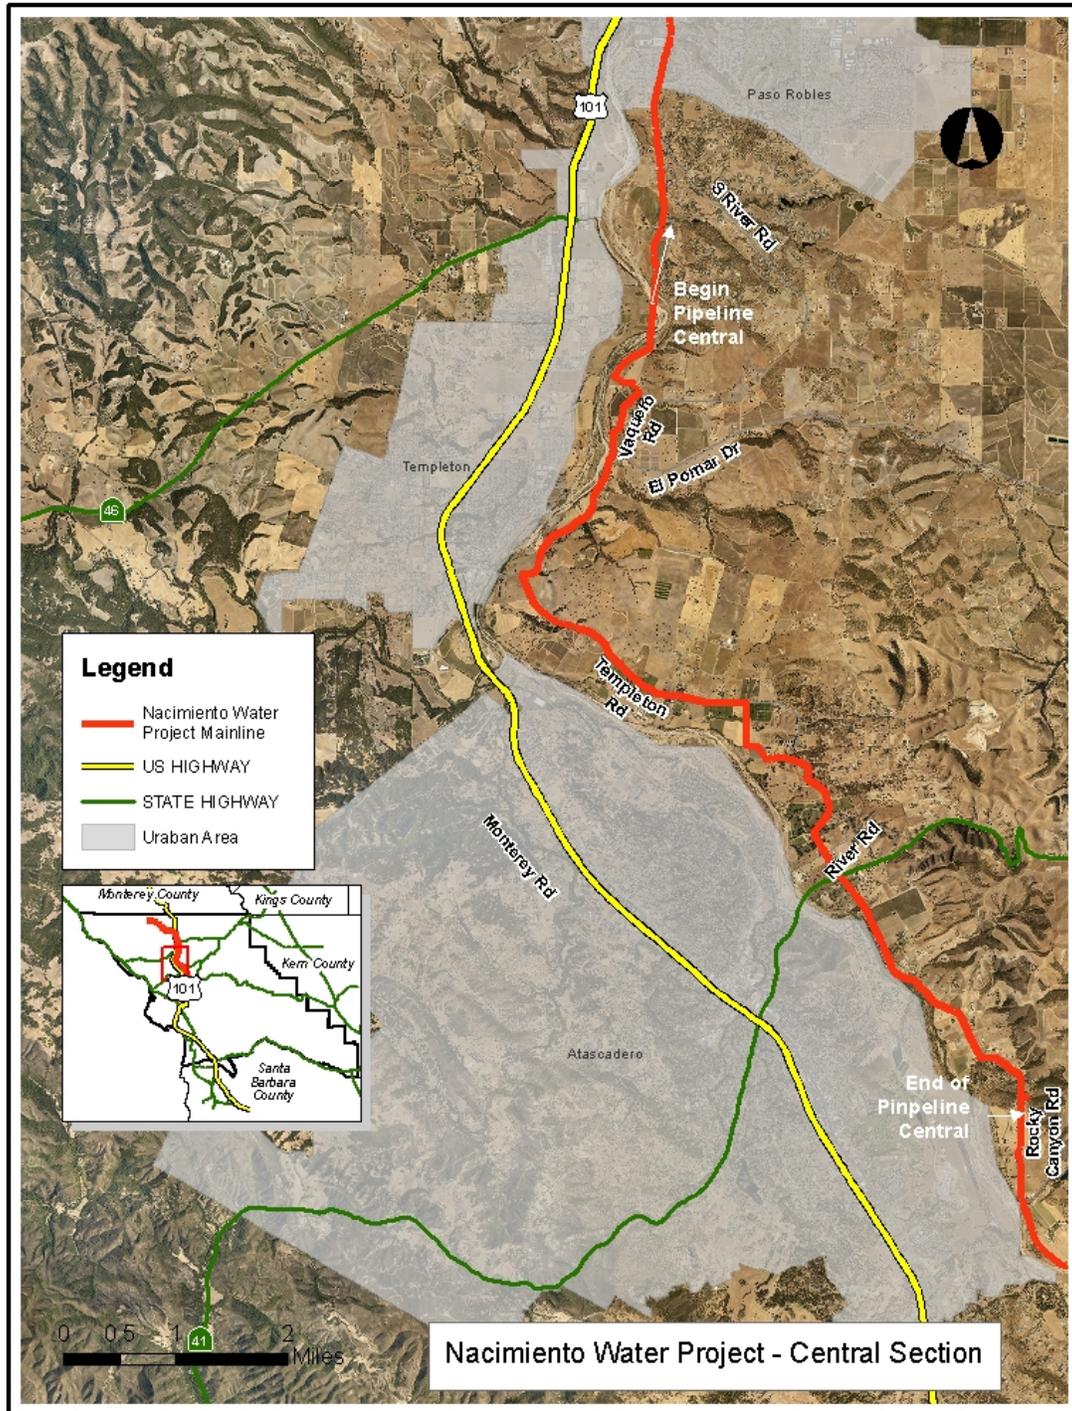
Figure 4: Pipeline Central Aerial Map

- **Pipeline:** Approximately 11 miles of 24-inch to 18-inch diameter ductile iron pipeline was installed as the central portion of the Project's pipeline. Pipeline work included trenching, pipeline installation, and backfilling; sheeting, shoring, and bracing; performance of trenchless construction at road and highway crossings; application of pipeline linings and coatings; installation of appurtenances and corrosion monitoring stations; pavement restoration; traffic and pedestrian control; protection and location of existing utilities; hazardous materials removal and disposal; and site restoration.

- **Templeton Road Realignment:** An approximate half-mile stretch of the northern portion of Templeton Road was realigned to improve traffic safety. This work included demolition, grading, paving, and utility relocation.

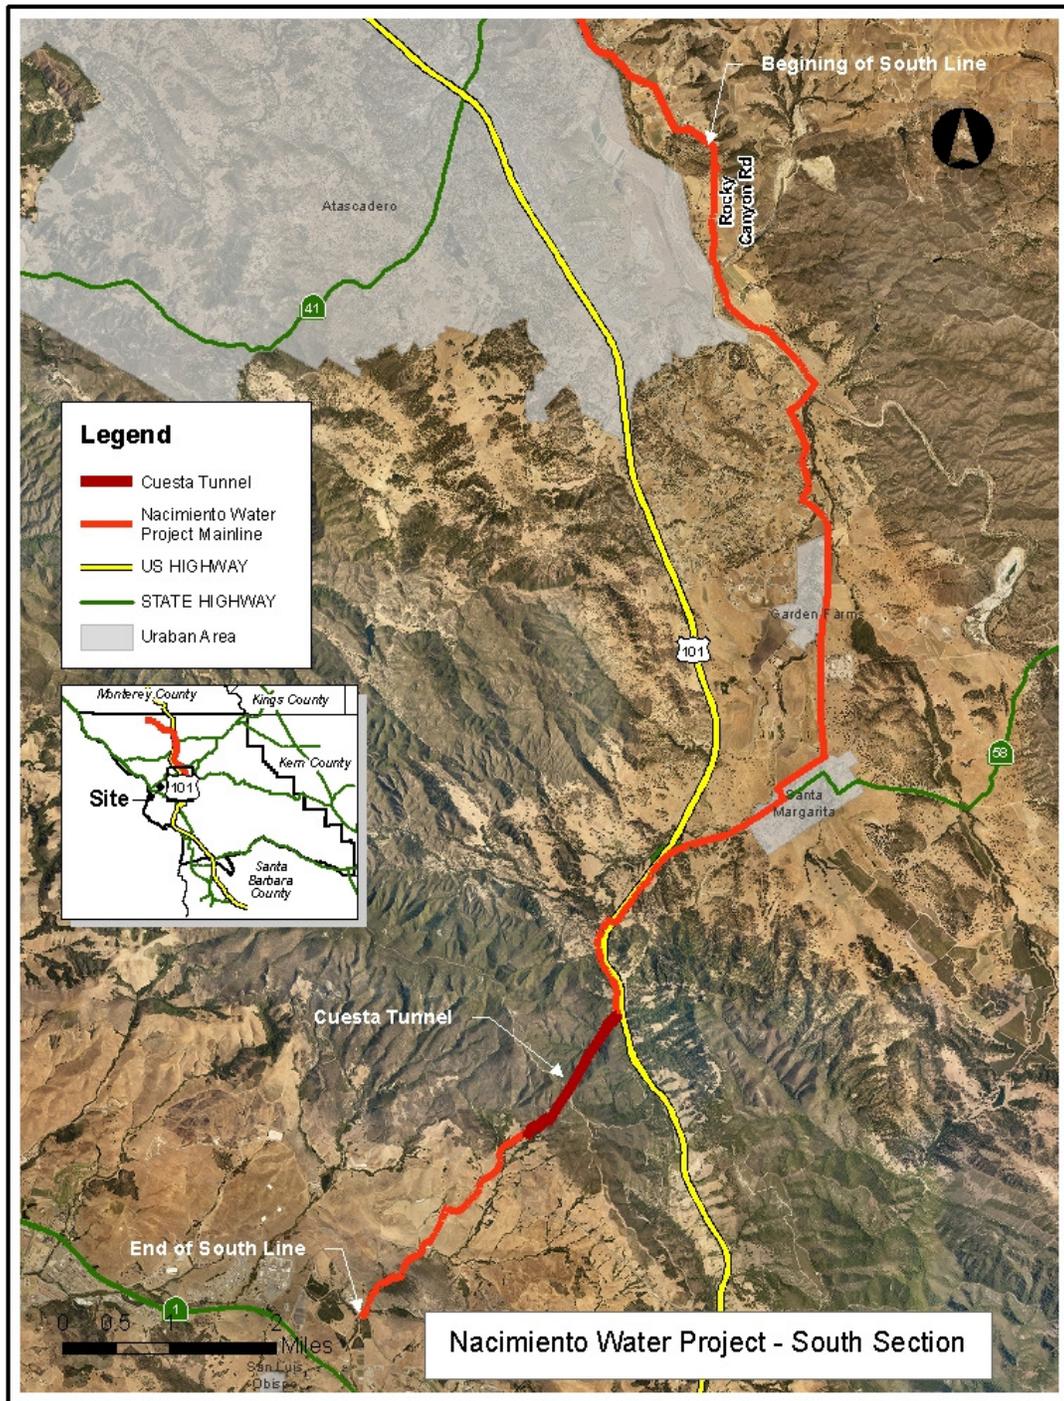
Figure 5: Pipeline South Aerial Map

- **Pipeline:** Approximately 12 miles of 18-inch to 12-inch diameter ductile iron pipeline were installed as the southern portion of the Project’s pipeline. Pipeline work included trenching, pipeline installation, and backfilling; sheeting, shoring, and bracing; performance of trenchless construction at road and highway crossings; application of pipeline linings and coatings; installation of appurtenances and corrosion monitoring stations; pavement restoration; traffic and pedestrian control; protection and location of existing utilities; hazardous materials removal and disposal; and site restoration.

- **Fiber Optic Cable:** A fiber optic communication line aids in Project operations and control. The contractor installed pull boxes and installed and tested of fiber optic conduit and cable.

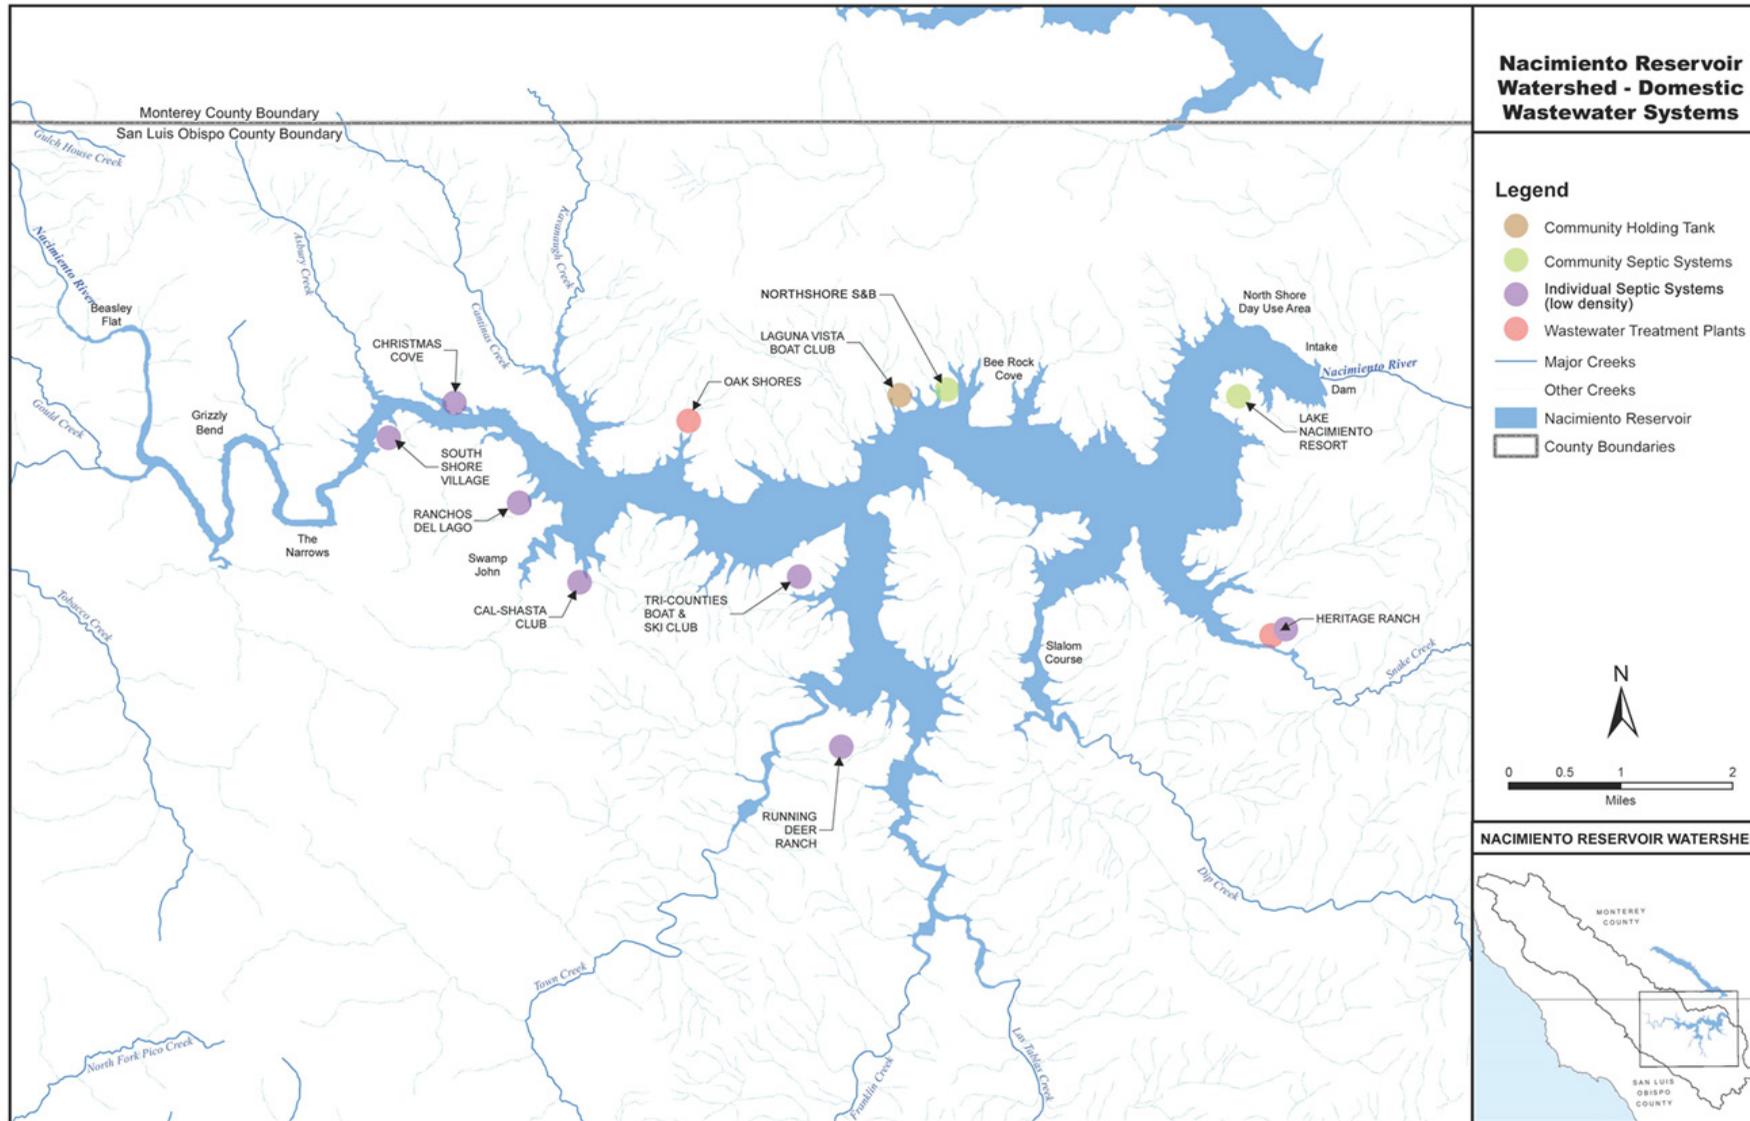
Figure 8: Nacimiento Reservoir Lower Watershed Wastewater Systems Overview

There were eleven incidents of Sanitary Sewer Overflows (SSO) from the Oak Shores collection system during 2016 – 2020 that required notification to the Regional Water Quality Control Board. Two of the spills were designated Category 2 SSOs (Spills greater than or equal to 1,000 gallons that do not reach surface water) and 9 were designated Category 3 SSOs (spills less than 1,000 gallons that do not reach surface water). The primary cause of the SSOs was debris in private laterals and the mainline. The spill discharges were all discharged directly to land or a storm drain system. None of the spills entered the Nacimiento Reservoir.

The Oak Shores Wastewater Treatment Facility provides secondary treatment via two aeration ponds and two settling lagoons. The treatment plant is located approximately 1,000 ft horizontally away from and more than 100 ft above the High Water Level (HWL). It has a design capacity of 0.100 MGD; actual average flows from 2016 to 2020 varied from 0.0110 MGD in the winter to 0.1242 MGD during peak periods of summer. Disposal is to an evaporation/percolation pond and disposal area. Effluent is pumped nearly two miles from the treatment plant to a spray field that is located within the reservoir watershed, over 2,000 ft horizontally away from the HWL.

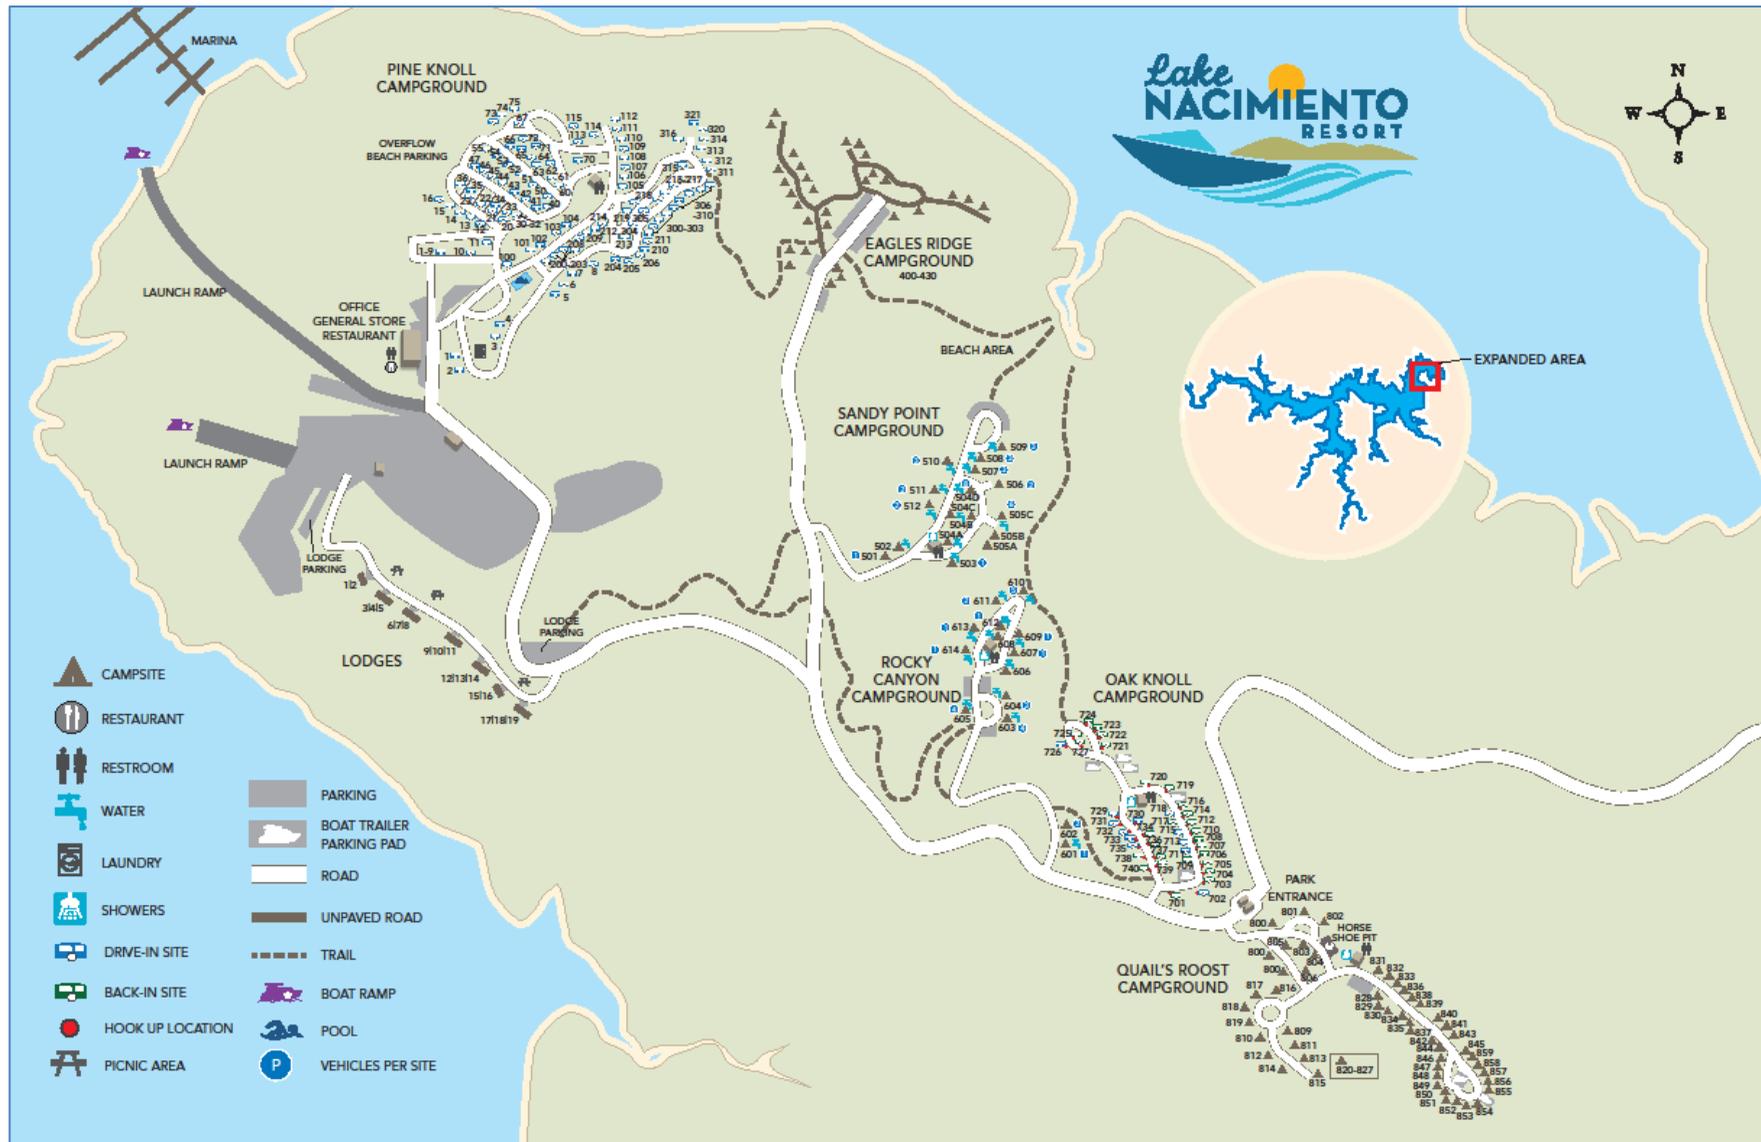
Figure 9: Lake Nacimiento Campgrounds

Located less than one mile away from the NWP intake structure, lies the Lake Nacimiento Resort. This public recreation area is served by a community septic system that is operated by Monterey County Parks Department staff under the provisions of Central Coast RWQCB Order No. 96-26. The Resort has seven campgrounds. The total number of camp sites and amenities available at each campground varies throughout the year depending on the season and visitor demand. During the peak season in Summer, there are over 300 camp sites available, 33 flush toilets, and 8 chemical toilets. (See [Table 2](#) and [Figure 9](#) below)

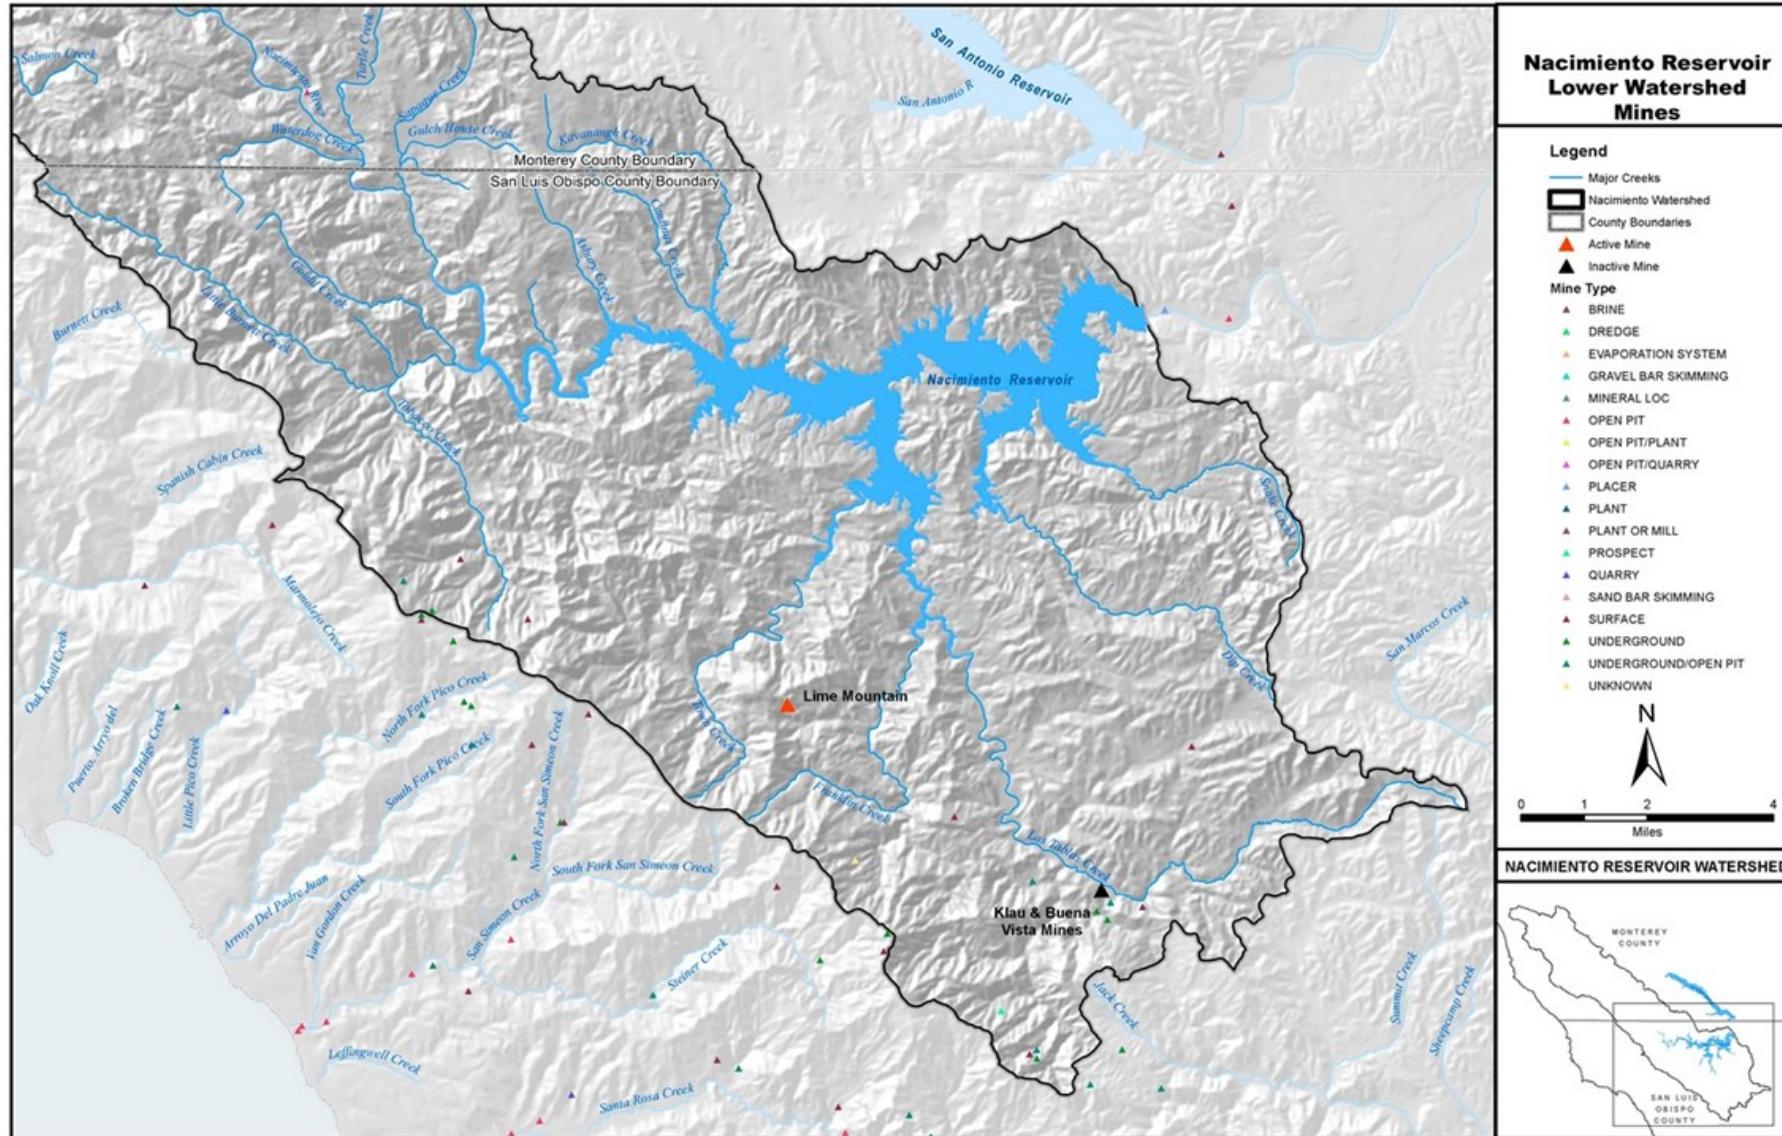
Figure 10: Lower Watershed Mines

The Lime Mountain Company is an open pit calcium carbonate mine located in the lower watershed, at Lime Mountain, approximately 4 miles south of Nacimiento Reservoir. The mine continues to operate. No updated information could be found on the mine. The Initial Watershed Survey stated: “The mine is inspected annually by the SLO County Department of Planning and Building acting as an agent of the California Department of Conservation, Office of Mine Reclamation. Inspection reports from 2010 and 2011 indicate that all runoff is contained on site and no drainage concerns were identified.” (See [Figure 10](#))

Because of the health hazards that mercury presents the San Luis Obispo County Health Department in 2009 issued a revised health advisory warning people to limit their consumption of fish from Lake Nacimiento. The advisory is still in effect. ([Figure 10: Lower Watershed Mines](#))

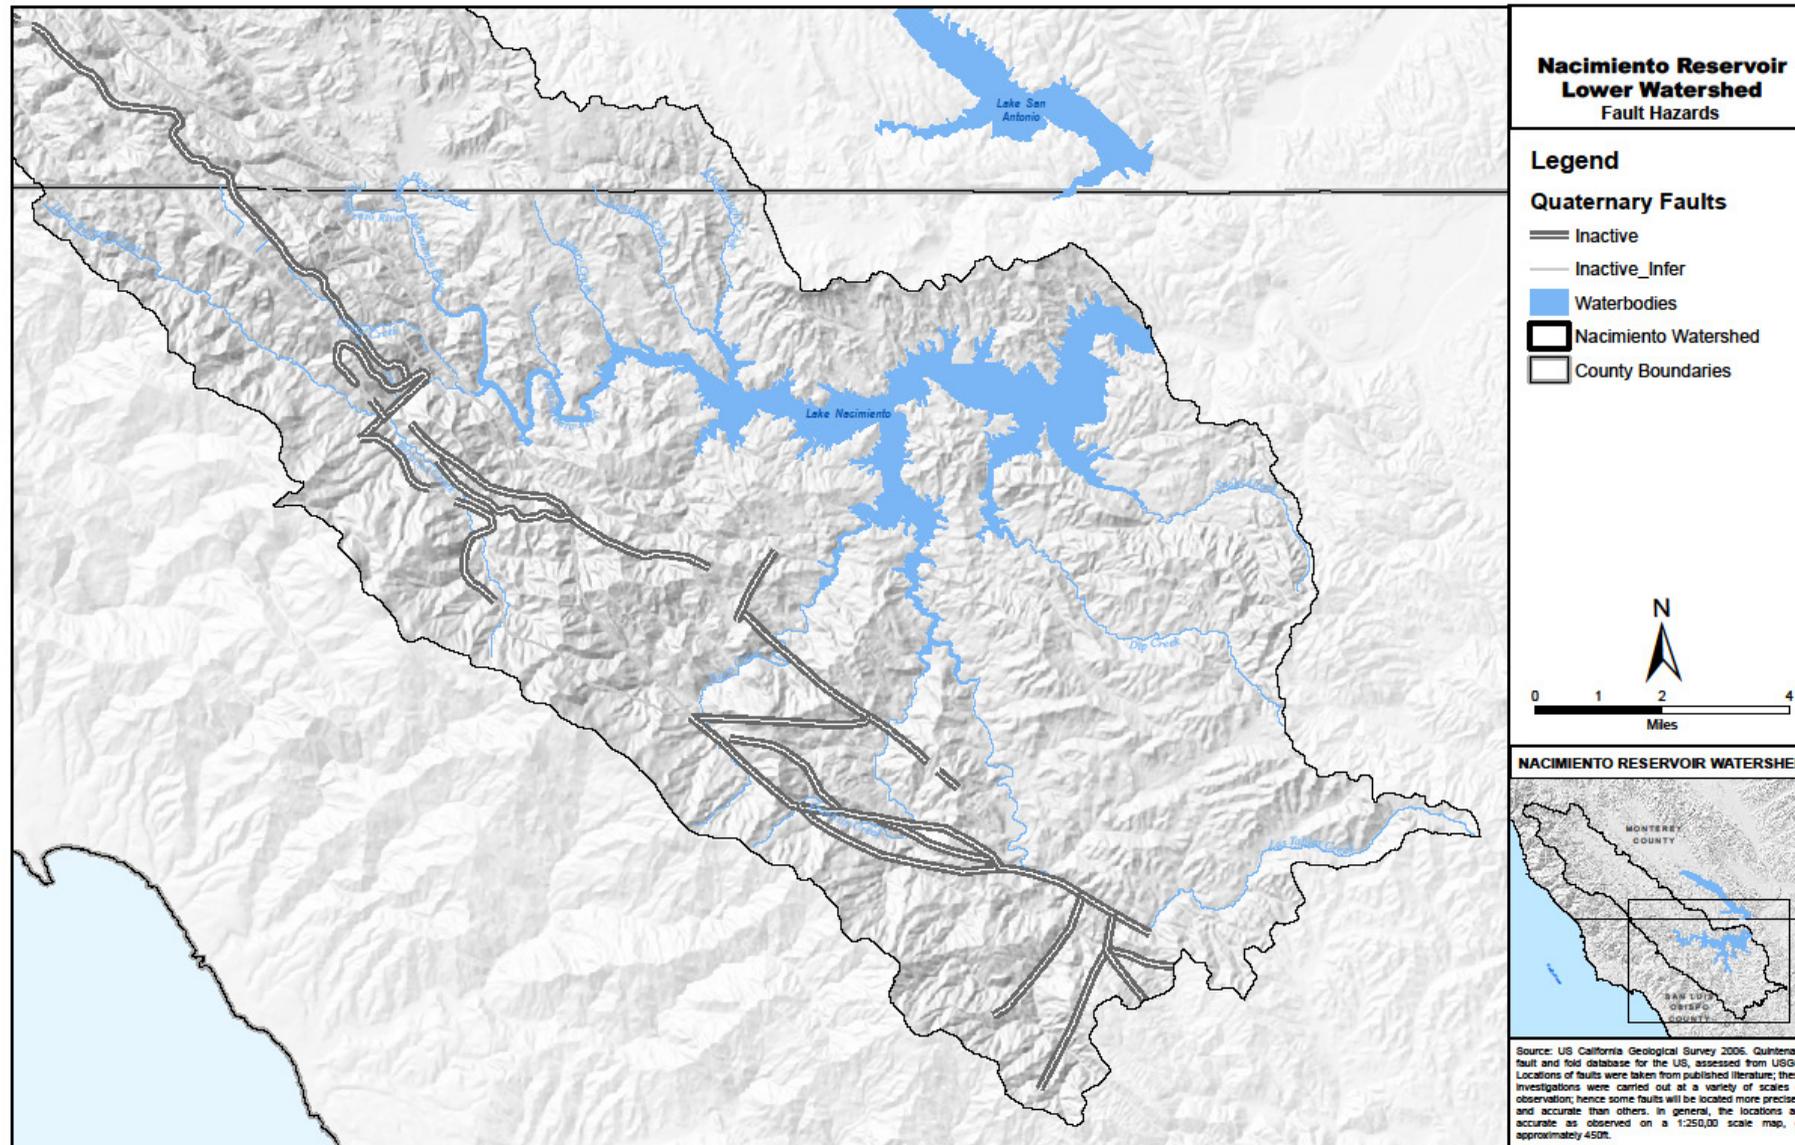
Figure 13: Fault Hazards

Several earthquake faults run along the west side of the entire watershed. Lake Nacimiento, CA has a very high earthquake risk, with a total of 3,930 earthquakes since 1931. The USGS database shows that there is a 96.30% chance of a major earthquake within 50km of Lake Nacimiento, CA within the next 50 years. The largest earthquake within 30 miles of Lake Nacimiento, CA was a 6.5 Magnitude in 2003. Earthquakes can disrupt sewage collection lines and treatment facilities and can cause ruptures in hazardous material storage tanks, leading to spills of untreated sewage and hazardous material into the reservoir and watershed. (See [Figure 13: Fault Hazards](#))

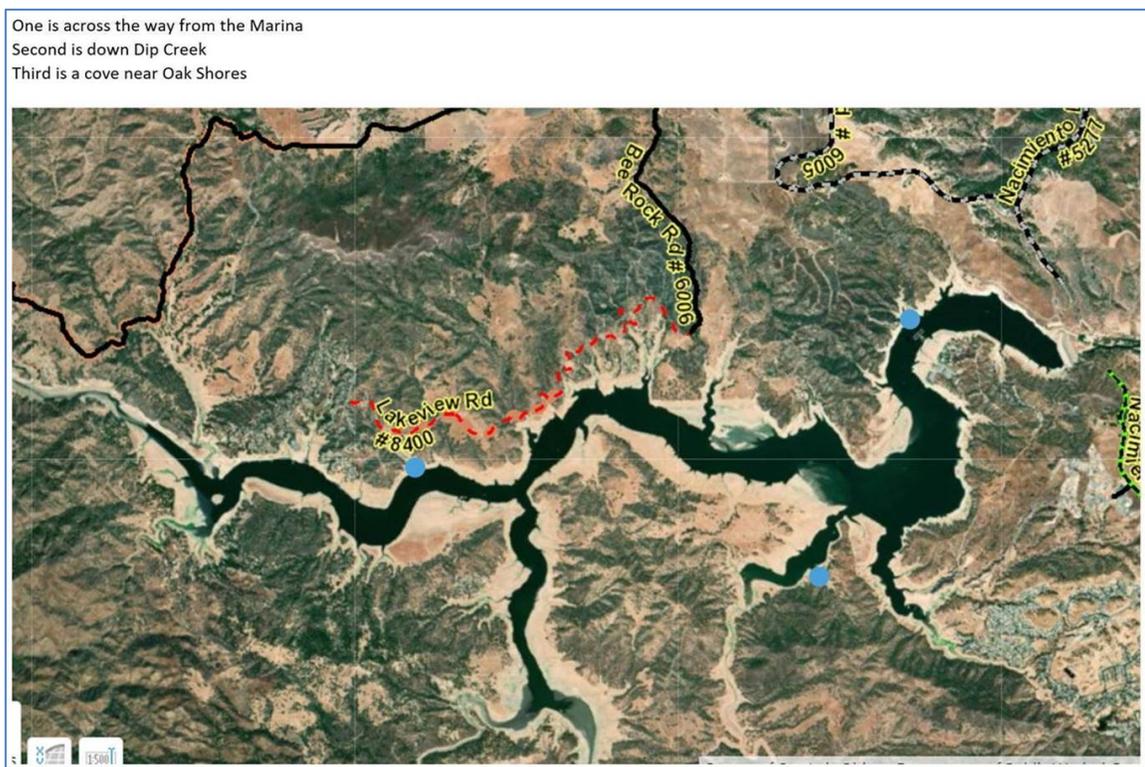
**Figure 14: Floating Toilet Locations**

Floating toilets (FT) continue to be a concern in the Watershed. The FTs are located at different sites on the reservoir (See Figure 14 ). These are located at the Marina, Oak Shores, and Dip Creek. The number of sites vary and the number of FTs at each site vary (typically 0 to 6) due to season, lake levels, and demand. (See Figure 15 and Figure 16) They are cleaned at least twice a week during peak season and holding tank levels are checked upon each cleaning. Pump outs occur on an as needed basis.

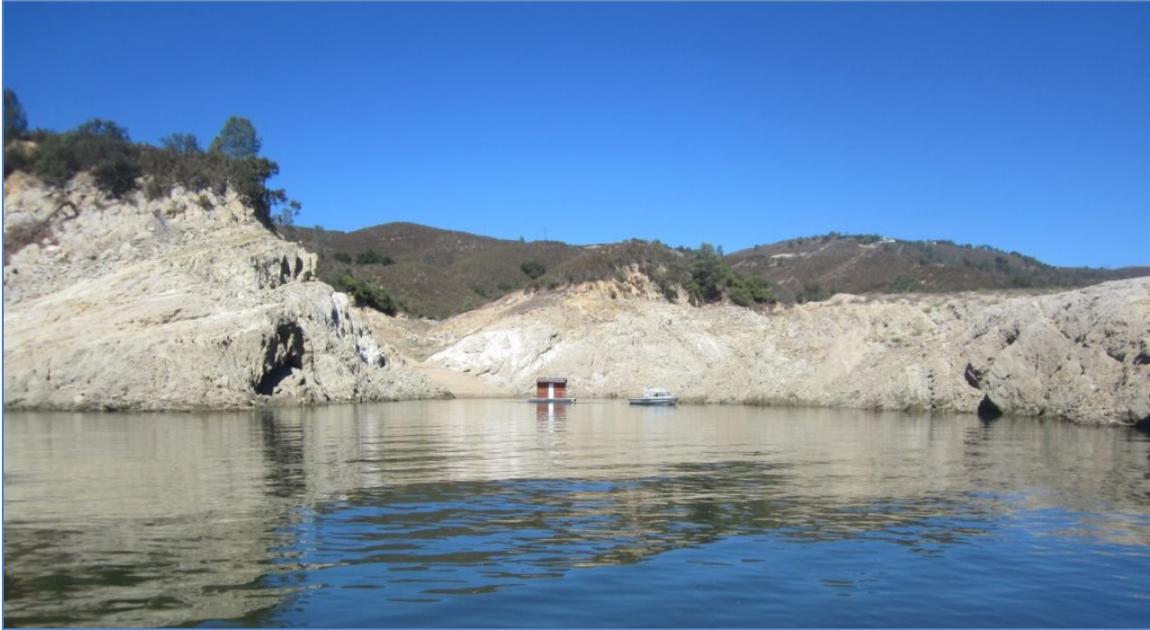
**Figure 15: Floating Toilets Across from Lake Nacimiento Resort**

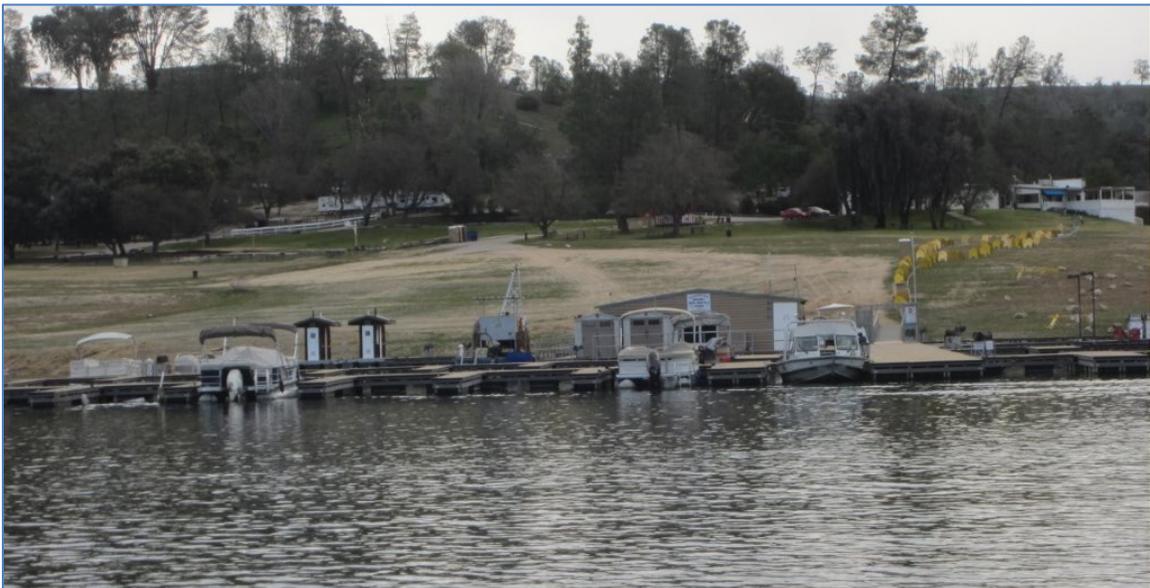
**Figure 16: Floating Toilets at Lake Nacimiento Resort Boat Dock**

Despite efforts by Monterey County and their management partner Basecamp Hospitality to keep the FTs clean and sanitary, SLO County staff have reported the FTs to be in “Fair” to “Poor” condition in approximately 75% of their inspections. Conditions found include feces in the toilet bowl, FT floors, and on the FT deck; bad odors; and FTs non-flushable and/or overflowing. (See [Figure 17](#))

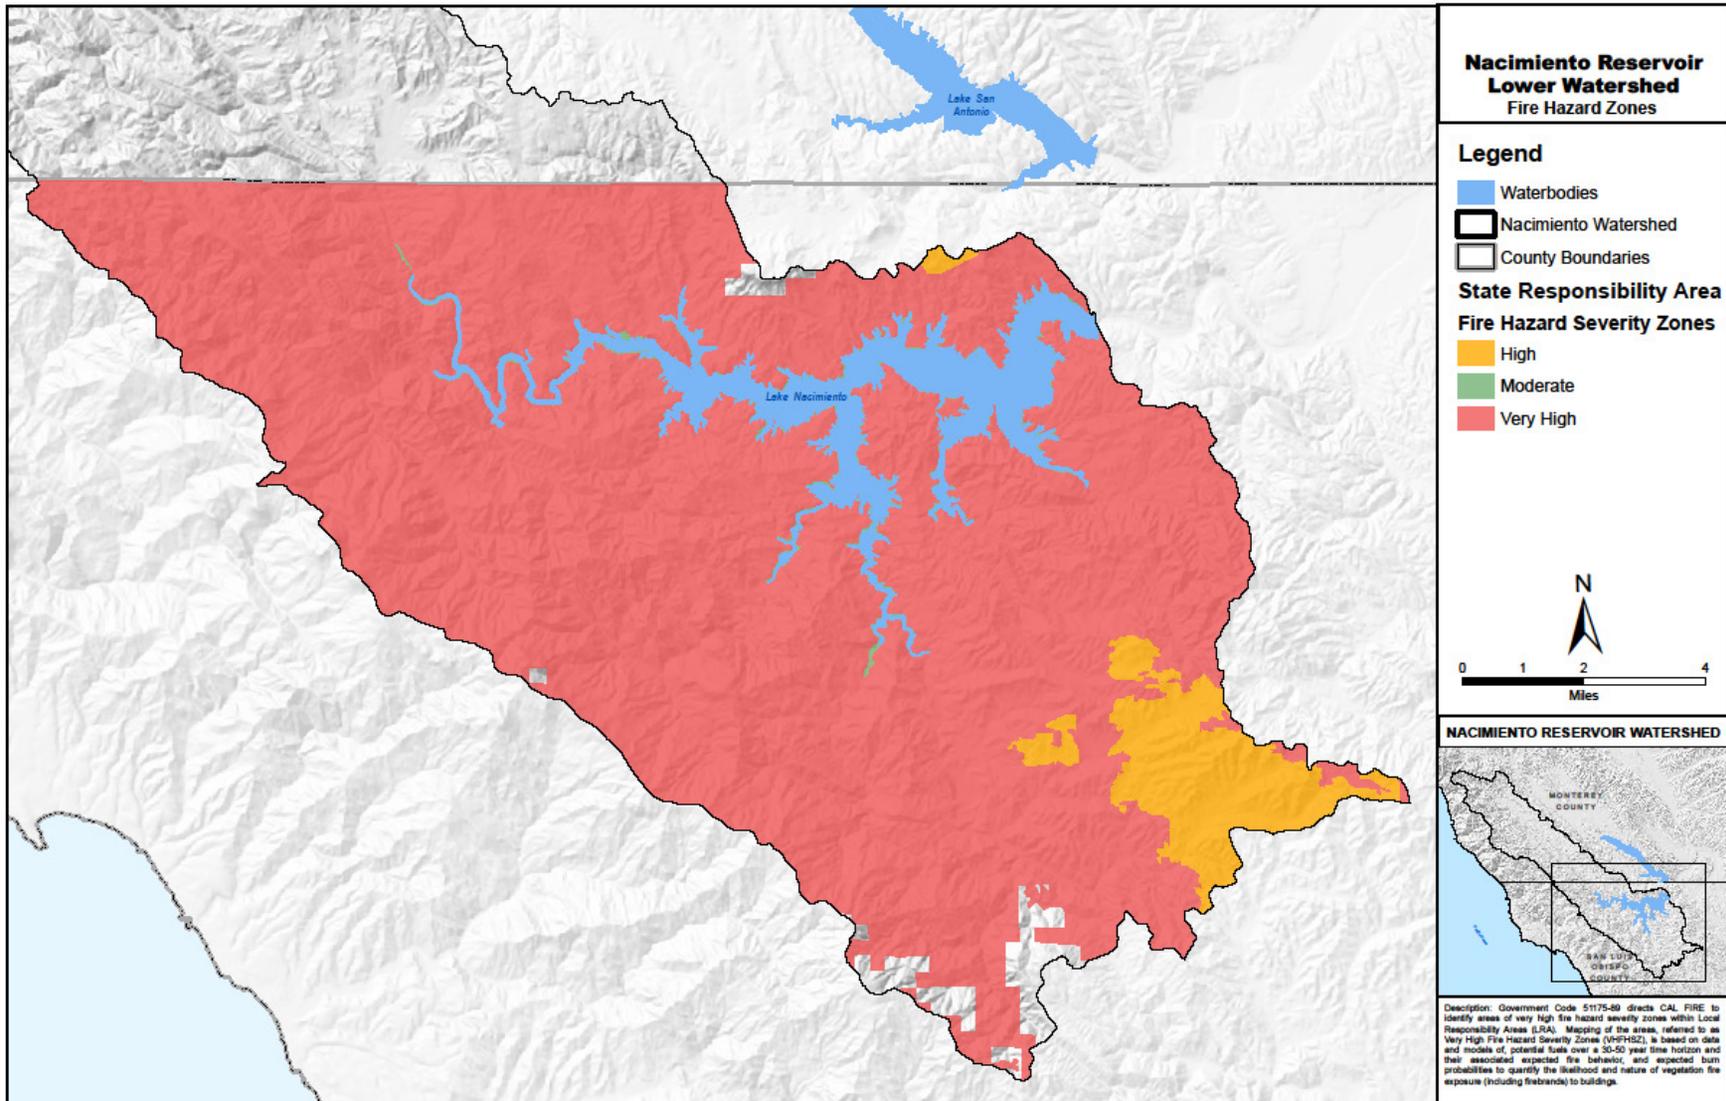
Figure 18: Fire Hazard Zone Watershed Data Evaluation

The Nacimiento Reservoir Lower Watershed is at very high risk for fire (See [Figure 18: Fire Hazard Zone Watershed Data Evaluation](#) ). As witnessed by the August 2016 Chimney Fire, the threat of fire is significant. The fire lasted 25 days and burned a total of 64,344 acres. 94% of the fire was within the Nacimiento Watershed and the fire burned 47% of the watershed tributary to Nacimiento Lake. See the “Watershed Events” section for more information.
