# **Nacimiento Water Project Watershed Sanitary Survey Five-Year Update (2016 – 2020)**

# Nacimiento Water Project, San Luis Obispo County

## 2020 Watershed Sanitary Survey Five-Year Update

<b>SWRCB-DDW System No.:</b>	4010080
<b>System Name:</b>	San Luis Obispo County – Nacimiento Water Project
<b>Survey Period:</b>	January 1, 2016 through December 31, 2020
<b>Initial Survey Completed:</b>	2011
<b>Updates Completed:</b>	2016, 2021

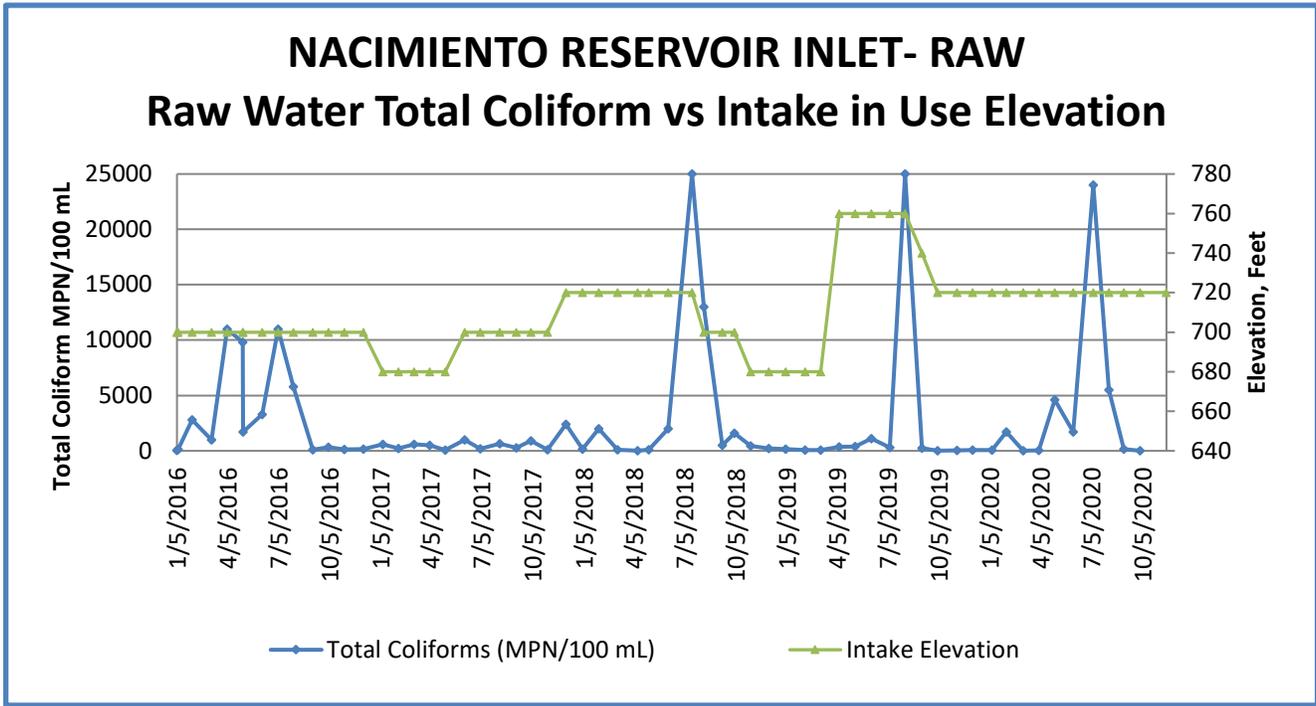
Figure 19: Raw Water Total Coliform MPN

A total of 62 bacteriological samples were collected from the raw water (intake in use) during January 2016 and December 2020. There were no water deliveries to participating agencies from 09/11/2019 through 04/20/2020 due to a significant leak in the pipeline. The average raw water total coliform was 2700 MPN/100mL and ranged from 11 to >24,000 MPN/100mL. The average raw water *E. coli* was 3 MPN/100mL and ranged from <1 to 34. Higher total coliforms were seen in the summer months (June – September) when typically, the reservoir levels are lower and temperatures higher. Overall, coliform MPNs are acceptable and do not pose a significant impact to water treatment by NWP participants.

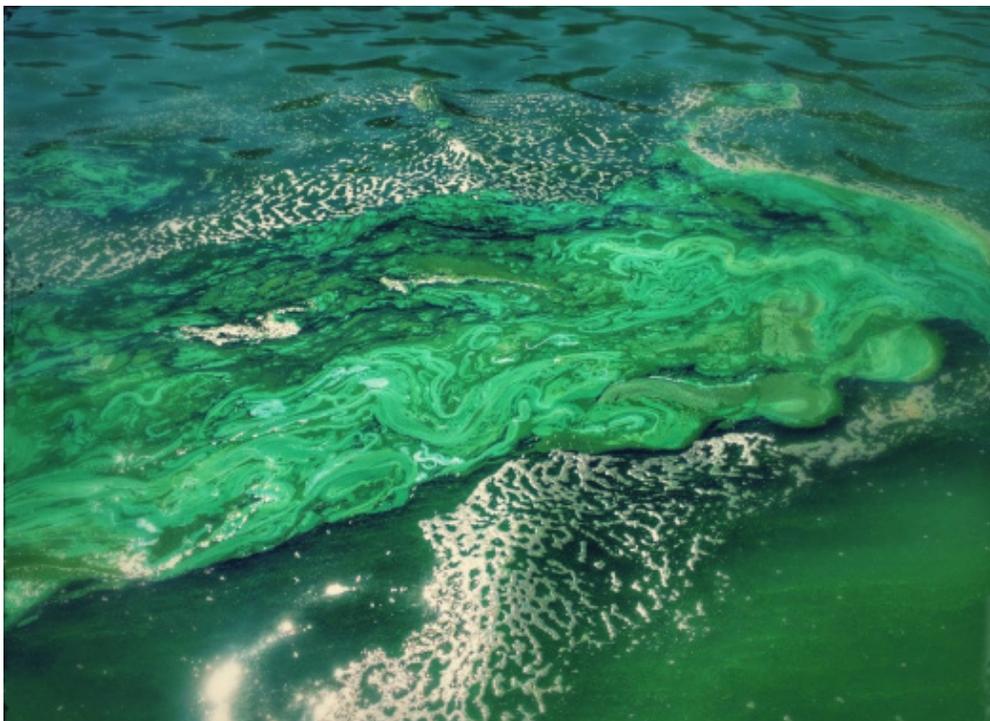
Cyanotoxins are some of the most powerful natural poisons known, including poisons that can cause rapid death by respiratory failure. The toxins include potent neurotoxins, hepatotoxins, cytotoxins, and endotoxins. symptoms or pruritic skin rashes. Algae that have been known to produce algal toxins have been found at County Reservoirs during warmer times of the year. The most common bloom-forming blue-green algae is *Microcystis*. It produces the cyanotoxin, Microcystin. *Microcystis* blooms resemble a greenish, thick, paint-like (sometimes granular) material that accumulates along shores (See [Figure 22](#)). Cylindrospermopsin is an alkaloid cyanotoxin produced by several freshwater genera, including *Cylindrospermopsis*, *Aphanizomenon*, *Anabaena*, and *Lyngbya*.

**Figure 22: Example of Blue-Green Algal Bloom**

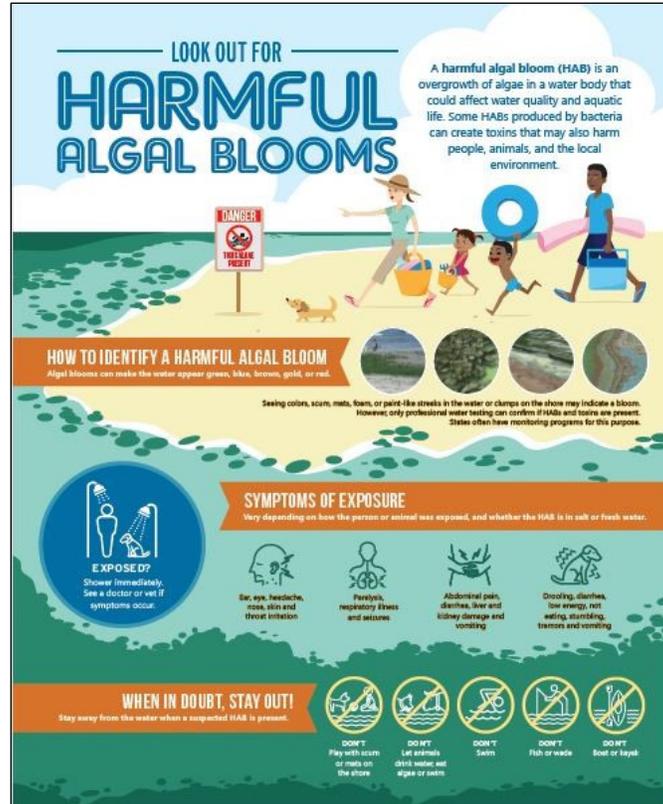
WARNING, or DANGER, when HAB or confirmation testing trigger a notice. See sample signs in Figure 23 and Figure 24.

Figure 23: General Information Algal Toxin Signage

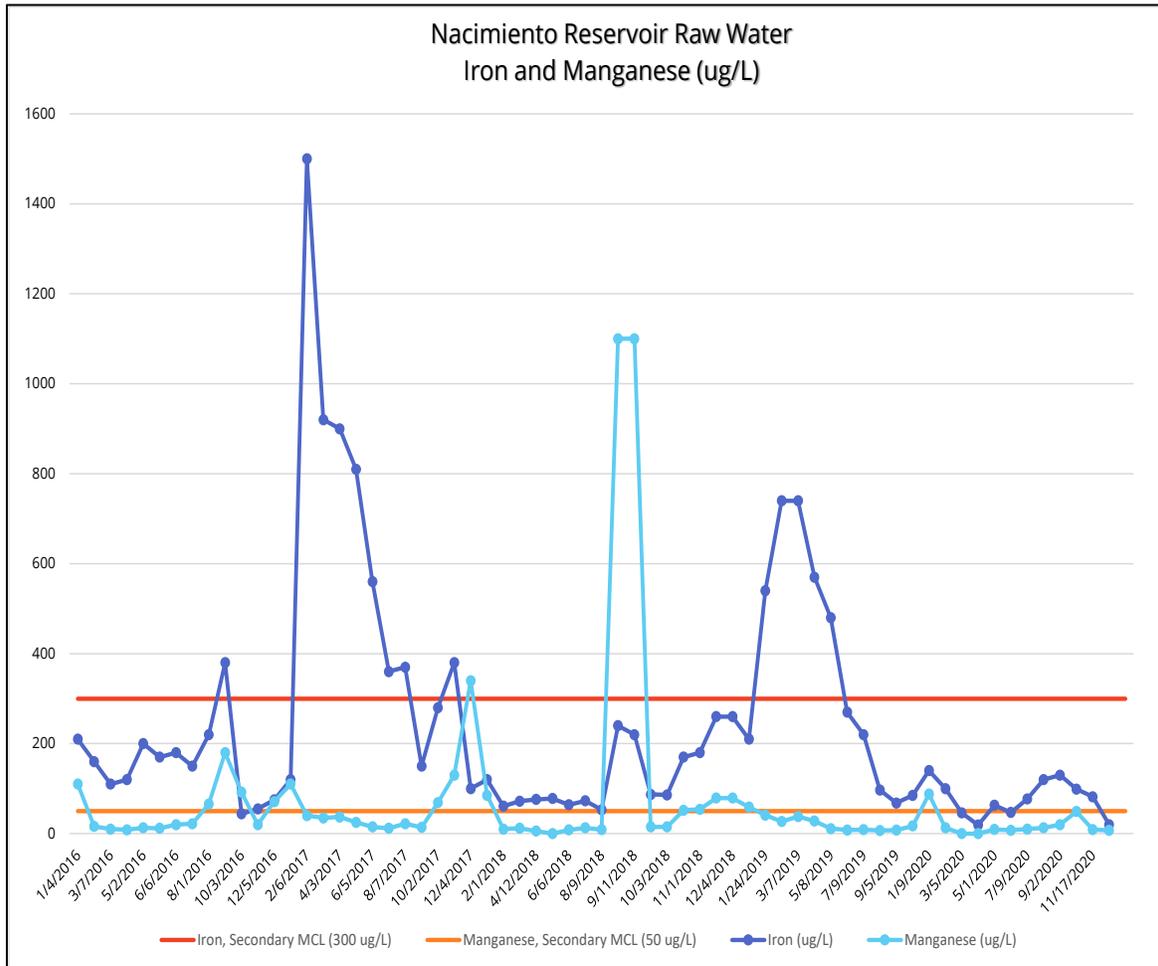
**Figure 25: Nacimiento Raw Water Iron and Manganese**

in Table 12 and all iron and manganese data in Appendix E: Raw Water (Intake in Use): Aluminum, Iron, Manganese, Mercury Data.

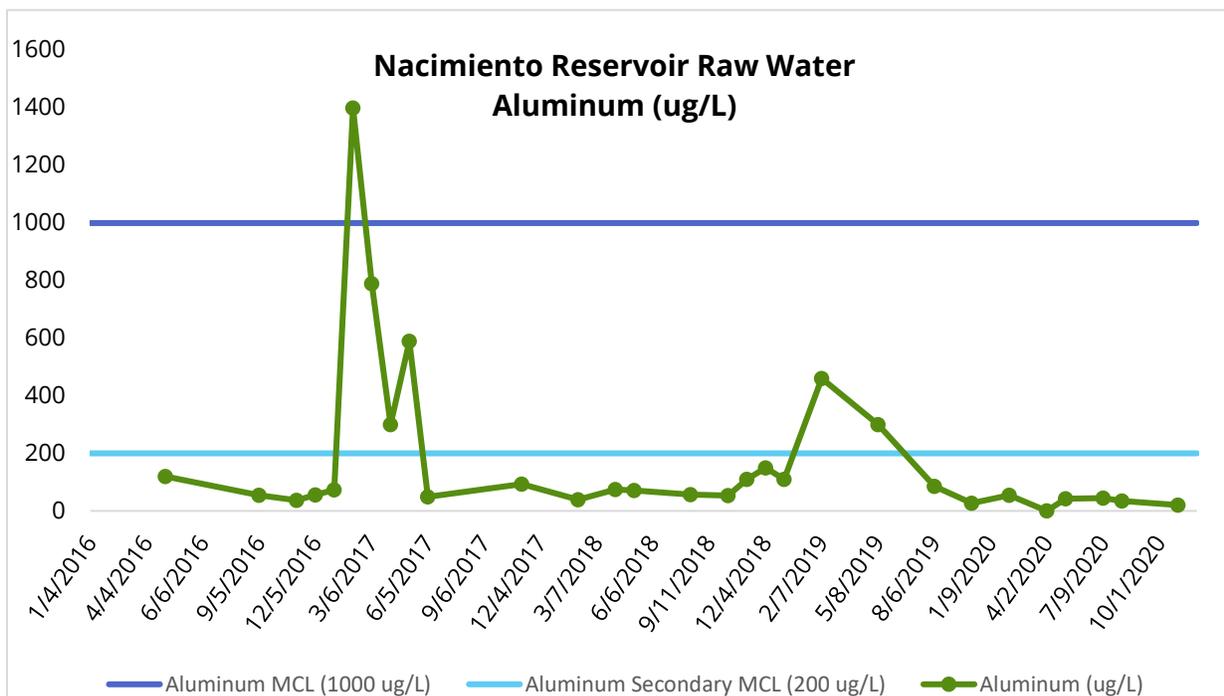
**Figure 26: Nacimiento Raw Water Aluminum**

Over 160 samples were collected for aluminum from 2016 thru 2020. Samples were collected from the intake depths in the upper and lower levels of the water column as well as the raw water intake in use. Aluminum is found throughout the water column. Results vary widely, ranging from not detected to 1400 µg/L in the raw water intake. Samples are collected quarterly and have in general shown higher levels in the winter months and at lower depths. However, high values were seen at various times and elevations throughout the year. (See [Figure 26](#) and [Appendix E: Raw Water \(Intake in Use\): Aluminum, Iron, Manganese, Mercury Data](#).)

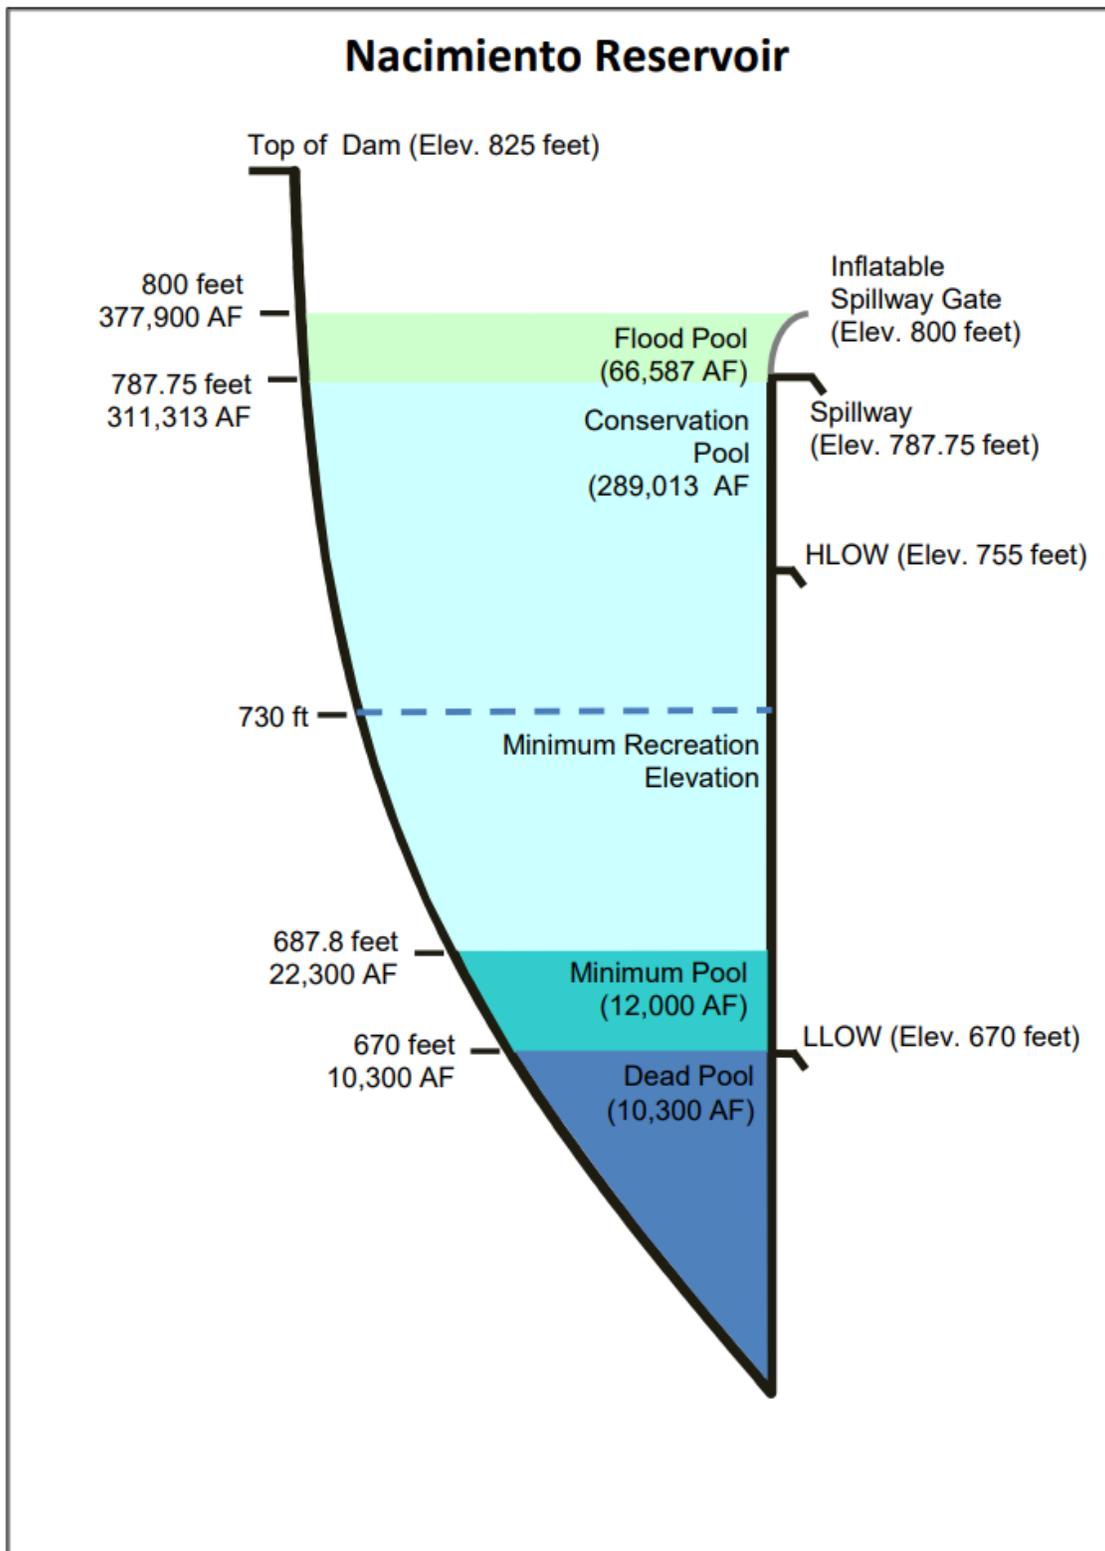
Figure 28: Key Elevations of Nacimiento Reservoir

<b>687.8</b>	22,300	Minimum pool, lowest Lake elevation at which water is available to MCWRA for release
<b>670.0</b>	10,300	Minimum elevation (at which) water can be released from the Low-Level Outlet Works; physical minimum pool; lowest possible Lake elevation (at which) water can flow from outlet works by gravity.
<b>Source: Monterey County Water Resources Agency, provided to Nacimiento and San Antonio Watershed Committee, September 2008</b>

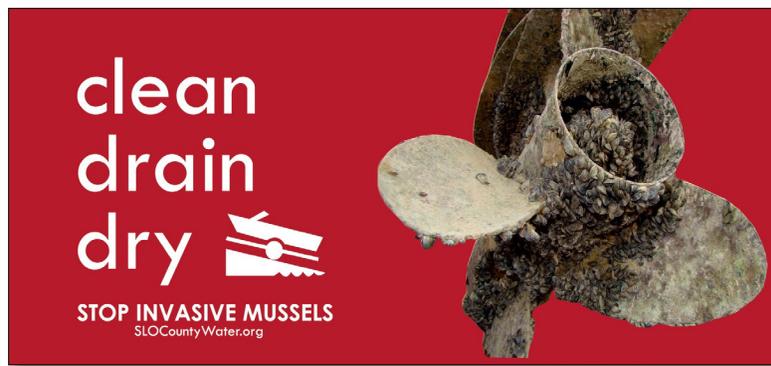
**Figure 29: Boat Propeller Infested with Mussels**

The County appreciates boaters' assistance in protecting local water resources. The public can assist in educating others about the importance of responsible boating by remembering to **CLEAN, DRAIN, and DRY** all boats and equipment before visiting local lakes and being prepared to have boats inspected. See Figure 29 below of a mussel-infested boat propeller.
