October 6, 2015
Revised: April 3, 2020
File No.: 20210004.001A

**SUBJECT: Foundation Report (95% Submittal)
El Camino Real Bridge Replacement
Santa Margarita Creek and El Camino Real
Bridge No.
San Luis Obispo County, California**

**FOUNDATION REPORT (95% Submittal)
EL CAMINO REAL BRIDGE REPLACEMENT
SANTA MARGARITA CREEK AND EL CAMINO REAL
BRIDGE NO. 48C-0029
SAN LUIS OBISPO COUNTY, CALIFORNIA**

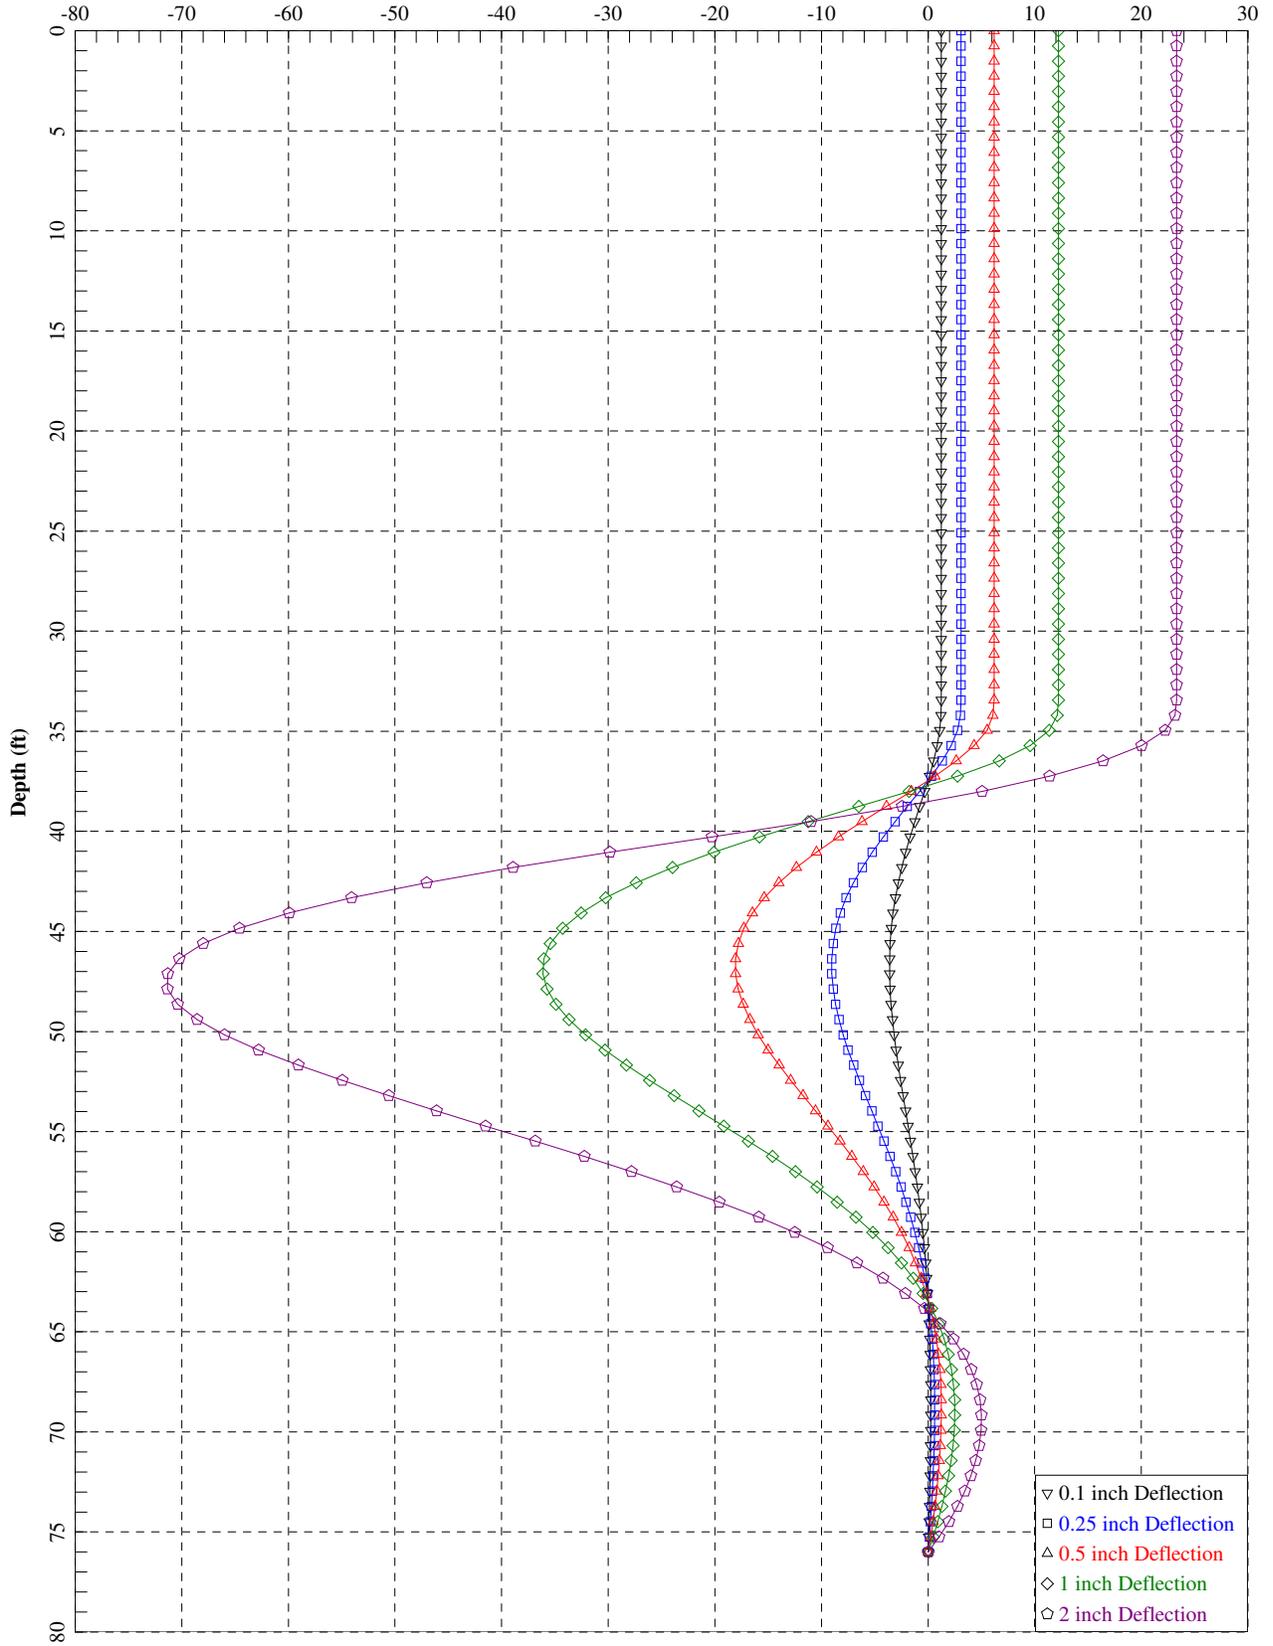
Bents 2 and 3 Free Head Shear
Shear Force (kips)
