Natural Environment Study

El Camino Real at Santa Margarita Creek Bridge Replacement, San Luis Obispo County, California

El Camino Real between Santa Margarita Road and Asuncion Road
Existing Bridge No. 49C0310

February 2018

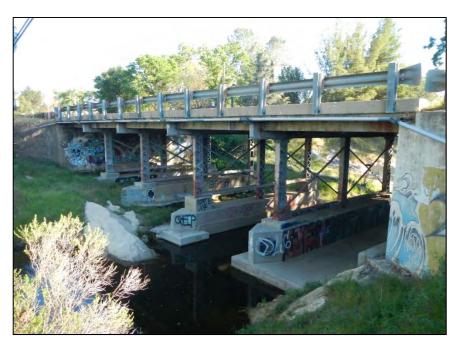
PHOTO 1:

View north of the existing El Camino Real Bridge. Note perennial pool in foreground.

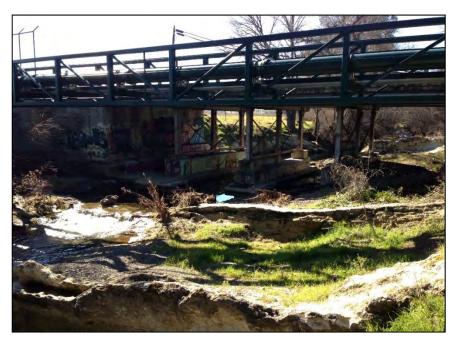
PHOTO 2:

View southwest of El Camino Real Bridge and the Nacimiento waterline span.

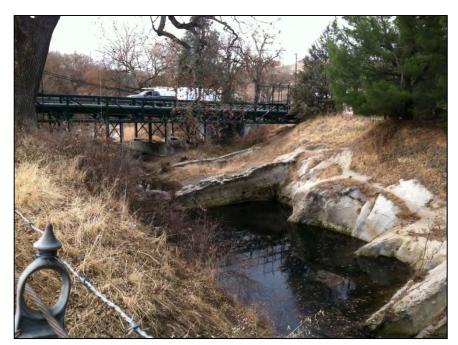
PHOTO 3:

View northwest of existing EI Camino Real Bridge. Note parallel utility bridge spanning across Santa Margarita Creek.

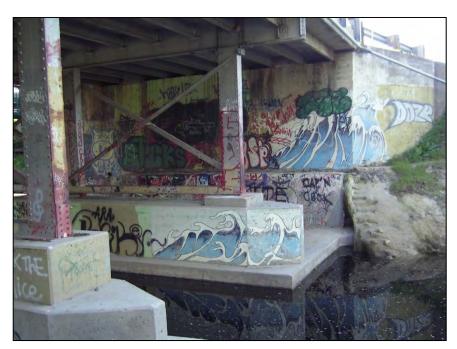
PHOTO 7:

View south of existing El Camino Real Bridge. Note large amount of concrete to be removed from the Santa Margarita Creek Channel.

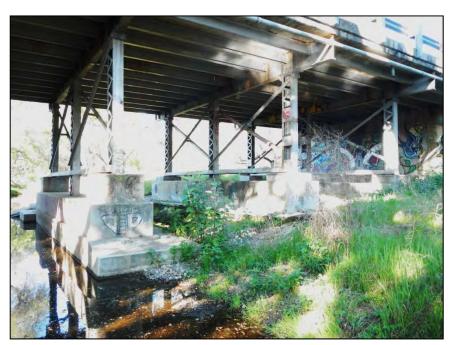
PHOTO 8:

View west of the underlying sandstone geology on the east bank adjacent to the BSA downstream of the bridge.

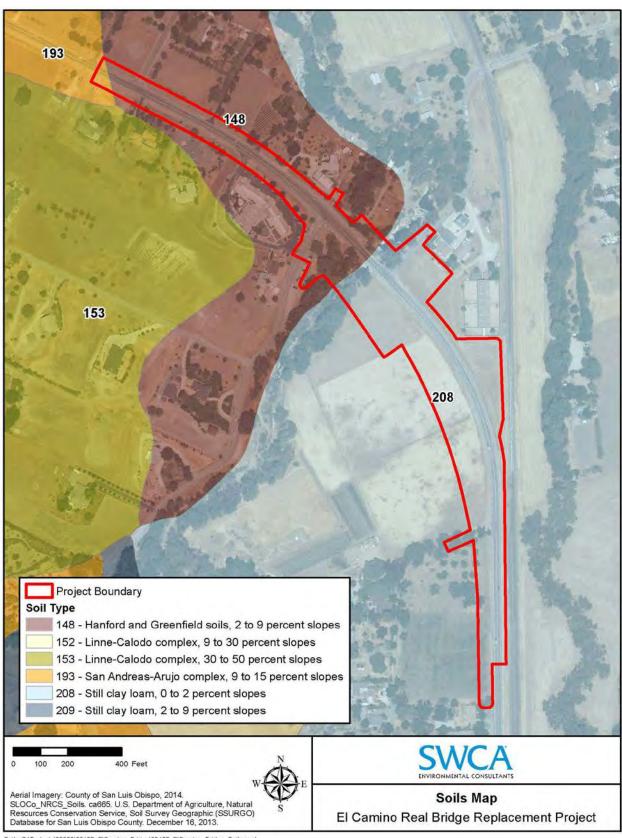
Figure 3. Soils Map

- Still clay loam (#208) is shown to occur on the terrace to the southeast of the creek. Still clay loam is a very deep, nearly level soil that is considered to be well drained. Still clay loam is formed in alluvium derived from sedimentary rocks. The soil has moderate erodibility and moderate shrink-swell characteristics.

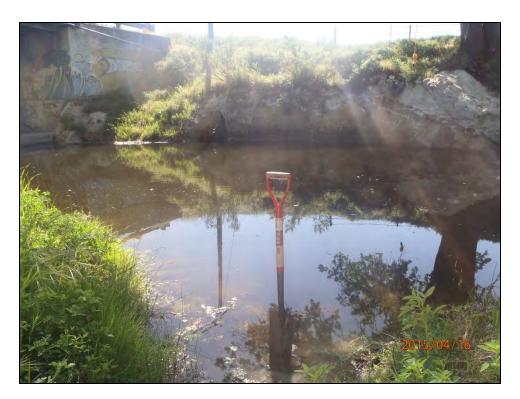
PHOTO 3:

View of the center point of Sample Plot 1 located upstream of the bridge and at the water's edge.

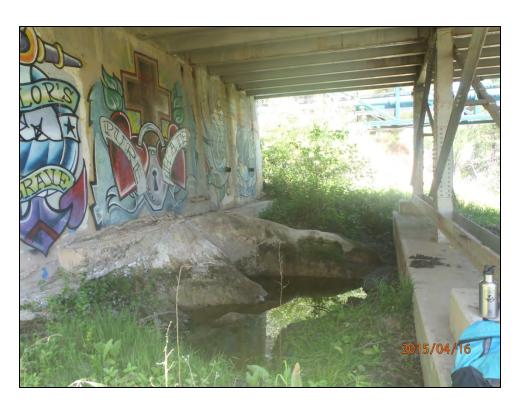
PHOTO 5:

View of the pooled area located under the bridge.
