Bridge Maintenance Updates – Villa Creek Road, Cayucos and Pippin Lane, See Canyon

Villa Creek Bridge

Pippin Lane Bridge

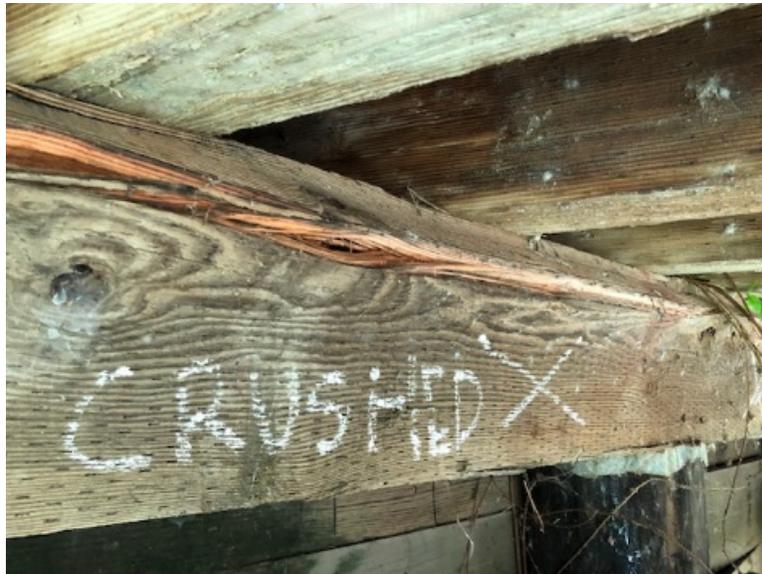
Villa Creek Bridge is located about 5 miles north of Cayucos along Hwy 1. During the bridge's bi-annual inspection it was determined by a Caltrans inspector that the easterly half of the southerly cap beam was crushed. Being a two-lane bridge, Caltrans required that the east lane of the bridge be closed to traffic to prevent further loading to the damaged beam.

Damaged Timber Cap Beam on Villa Creek Bridge

County staff developed a traffic control plan within a day and the County road crew had the signs and delineators in place by Friday morning May 1. The delineators will remain in place, allowing the bridge to be used with a single lane, until permits can be obtained, and the necessary repair made to the timber cap. This repair does not qualify for emergency permitting because the road can remain open with one lane of the bridge still in use.

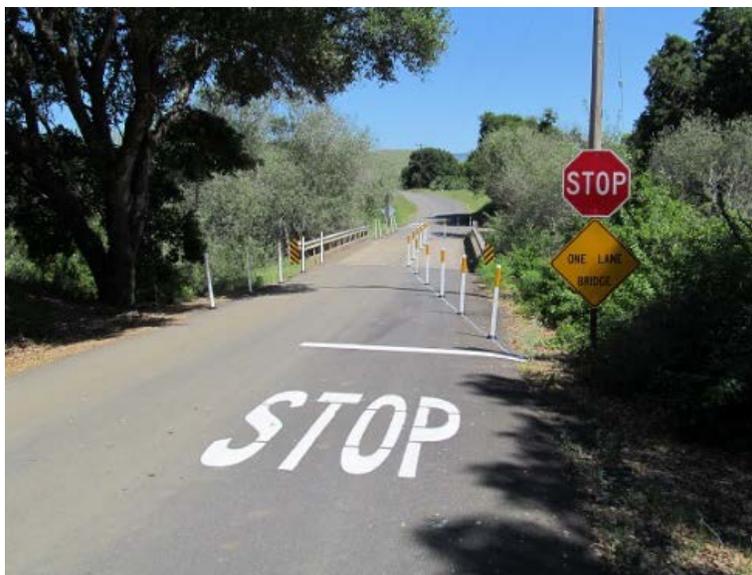
Delineated One-Lane at Villa Creek Bridge

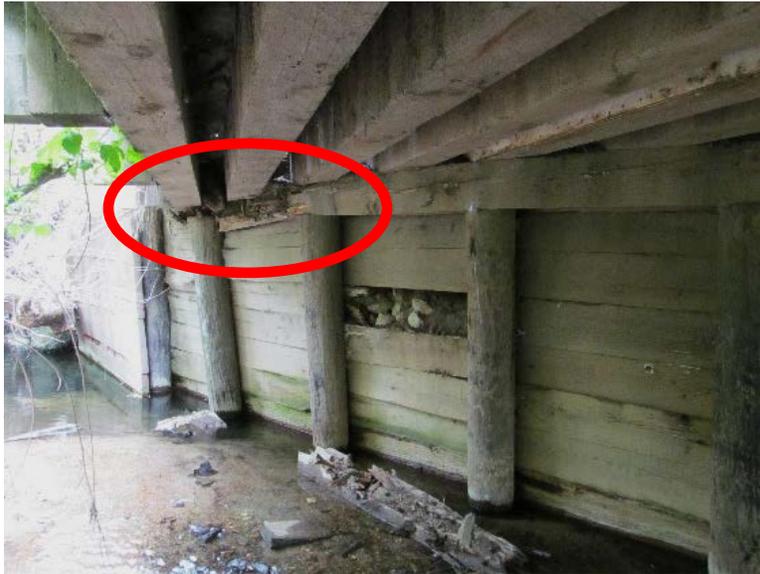
The Pippin Lane bridge is located about 1 mile north of San Luis Bay Drive off of See Canyon Road. After the bridge damage was reported by CalFire the bridge was inspected by Caltrans and County staff. Unlike the damage on Villa Creek, the cap beam was completely crushed. The Pippin Lane Bridge was more complex because it is a single lane bridge. Caltrans and County staff determined on Thursday April 30 that traffic could not be diverted around the damaged portion of the timber cap beam and that the bridge was unsafe for continued vehicle traffic.

Crushed Timber Cap Beam on Pippin Lane Bridge – Before Repair

The situation required County staff to develop a repair plan and obtain emergency permits to repair the damaged timber cap beam as soon as possible and restore access for the residents. The bridge is in an environmentally sensitive area that is habitat to red legged frogs and steelhead trout, requiring environmental staff to conduct a nighttime survey and develop a plan that would protect the habitat.

With the emergency permits and plan developed, the County road crew was able to start work on Tuesday May 5 and have the repair work complete and bridge re-opened to vehicle traffic by the end of the day on Thursday May 7.

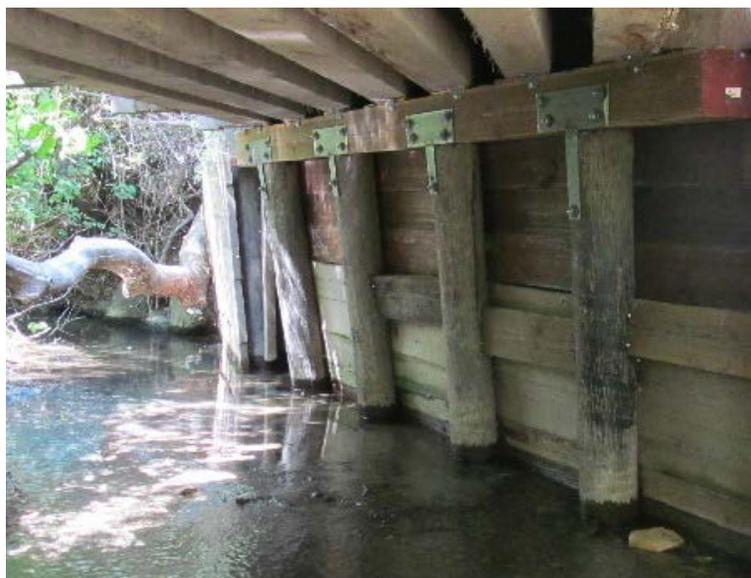
Repaired Timber Cap Beam on Pippin Lane Bridge
