**SAN LUIS OBISPO COUNTY
DEPARTMENT OF PLANNING AND BUILDING
NOTICE OF PREPARATION**

SUBJECT: Notice of Preparation of an Environmental Impact Report for the *Plains Exploration and Production Phase IV Development Plan (D010386D)*.

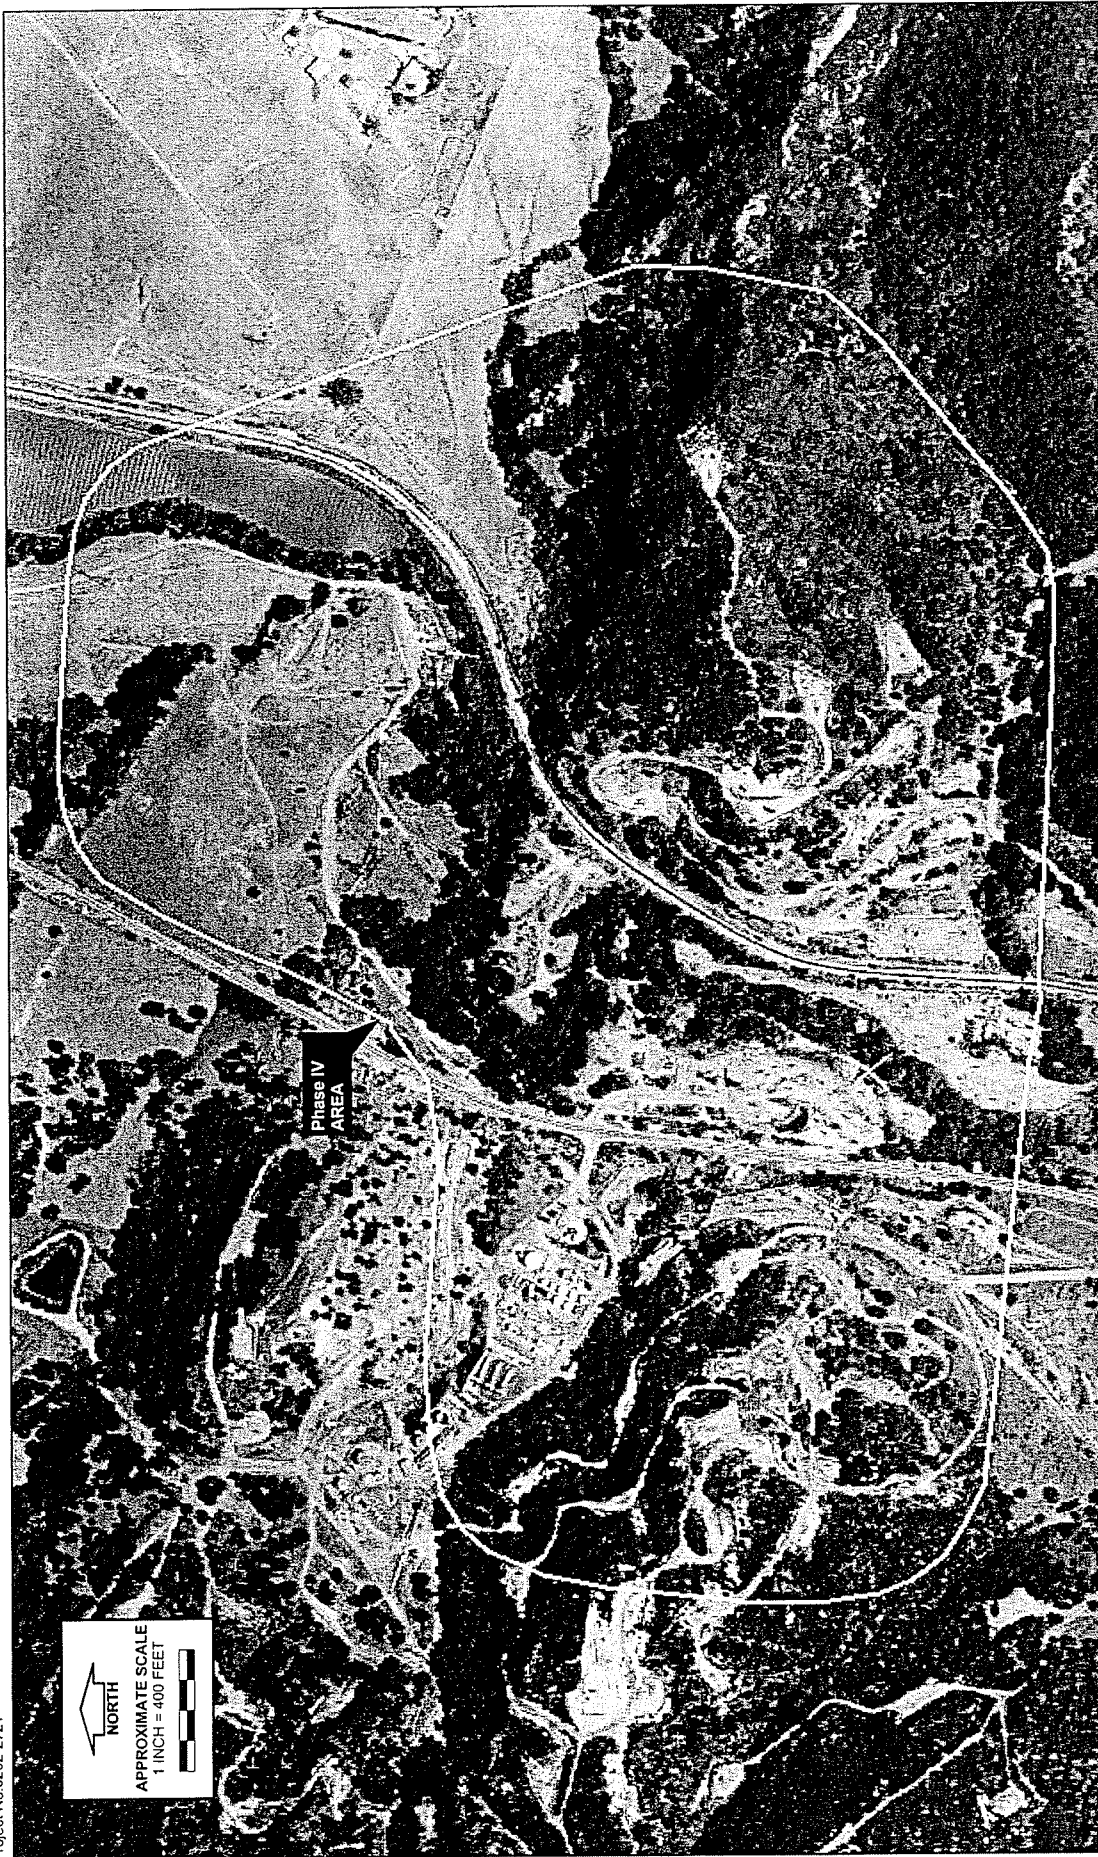
Phase IV
AREA

The project would consist of two phases: (1) Construction Phase, and (2) Operational Phase. Construction would include 95 new producer wells and 30 steam injector wells (which are needed to enhance recovery of the heavy crude oil found at the site). Existing ancillary equipment, such as heater treaters, storage tanks and pollution control equipment is adequate to support the proposed project expansion. All of the producing wells will occur within the 264-acre Phase III boundary. The project would include the construction of three steam generators originally approved during the Phase III expansion, but never constructed. The remaining existing pads will require from minimal to moderate grading. The new pads that are required would be accessible from the existing roads; therefore, no new roads are proposed. About seven previously undisturbed acres will be disturbed, to varying degrees, by the proposed expansion. Figure 3.4 shows the Phase IV Development Area.
