**Habitat Assessment  
for the  
Arroyo Grande Creek Flood Control Project**

**Prepared for:  
San Luis Obispo County**

**July 26, 2000**

**Prepared by:  
Essex Environmental  
890 Osos Street, Suite B  
San Luis Obispo, CA 93401  
(805) 5461860**

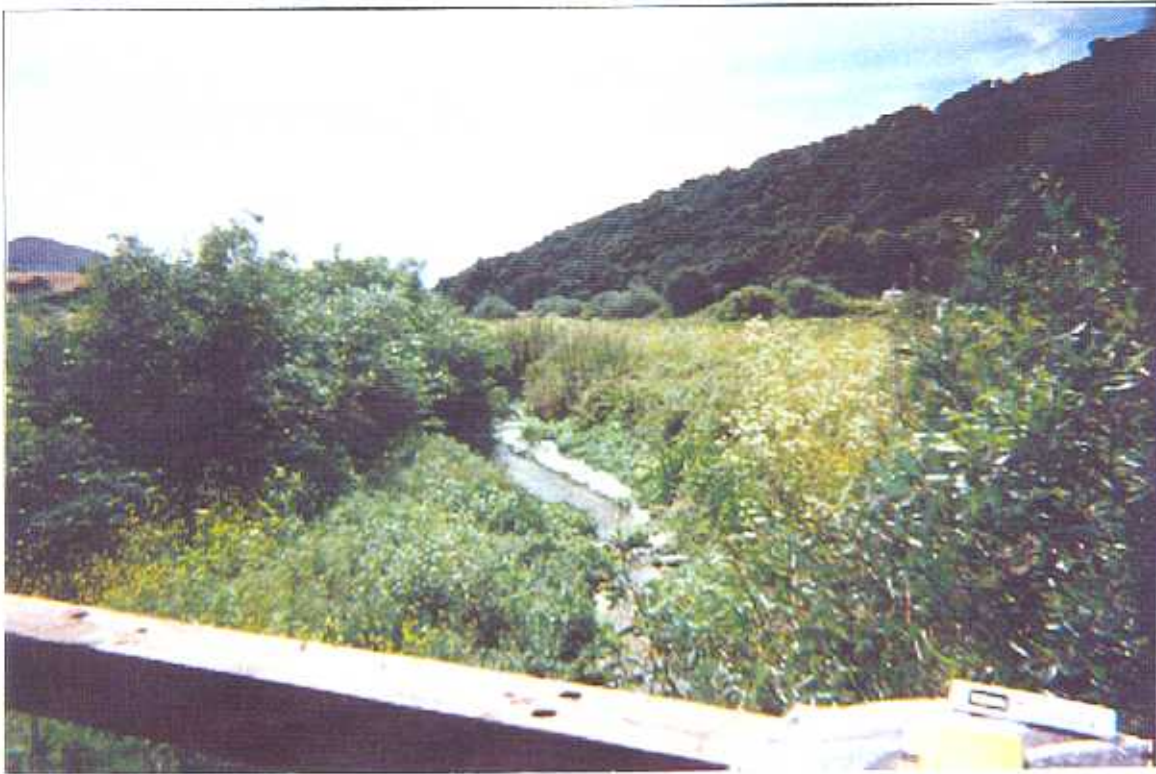
**Photo 1:** Segment 1. Upstream view of Los Berros Creek overflow channel from Century Lane bridge crossing. Sediment with riparian/ruderal scrub in left and center of photo is proposed to be removed from work area 1.

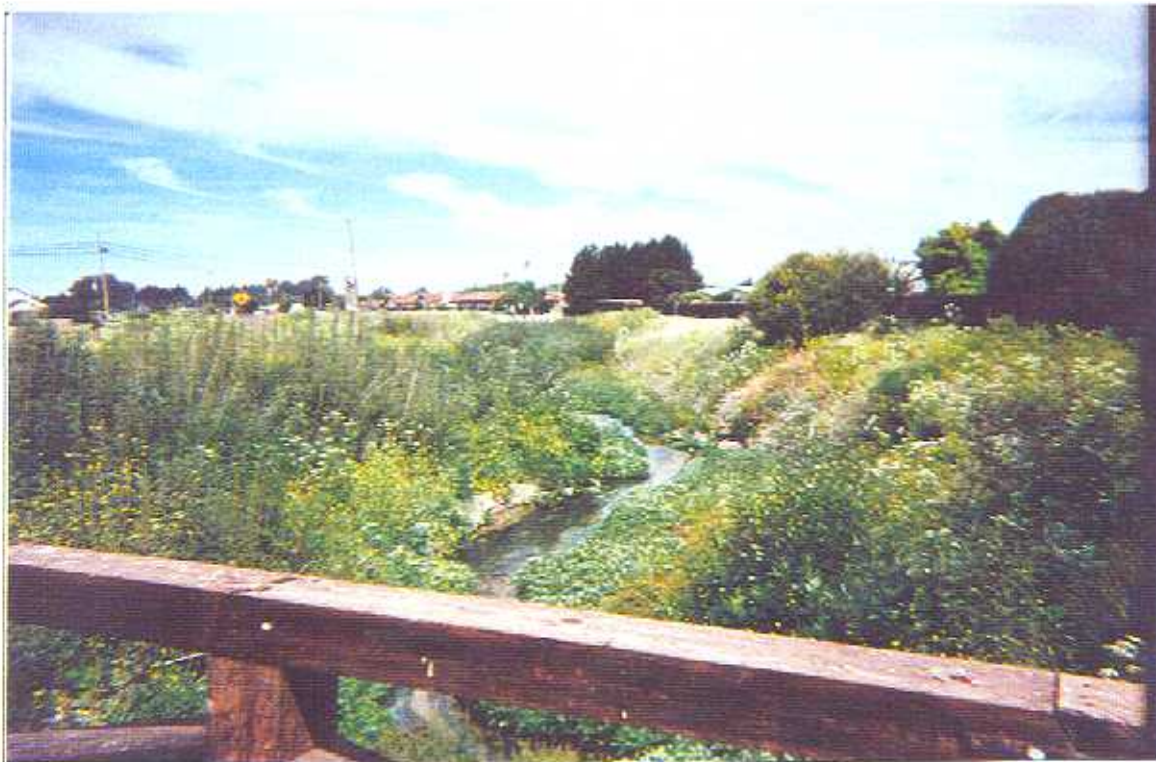
**Photo 2:** Segment 1. Downstream view of Los Berros Creek overflow channel from Century Lane bridge crossing. Sediment with riparian/ruderal scrub on both sides of the upper bank of levee are proposed to be removed from work areas 2 left and 3 left.

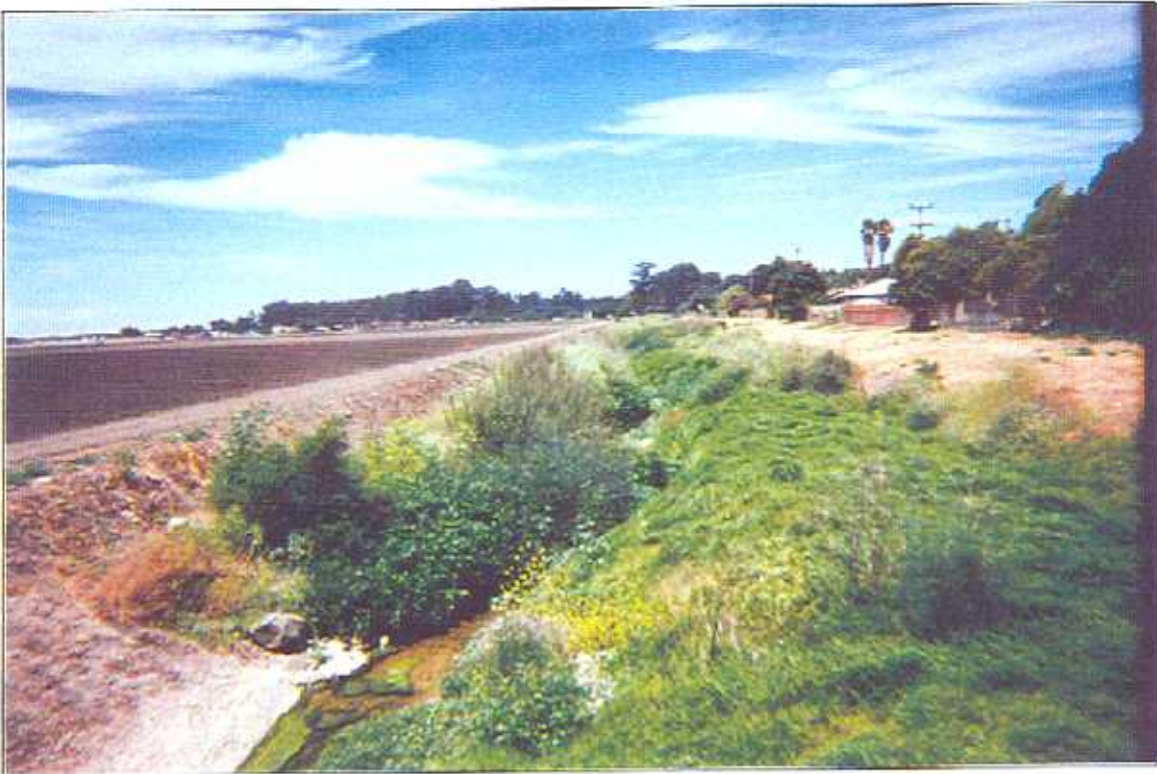
**Photo 3:** Segment 2. Downstream view of Los Barros Creek overflow channel from Valley Road bridge crossing. Sediment with riparian/ruderal scrub on right side of photograph is proposed for removal in work area 6.

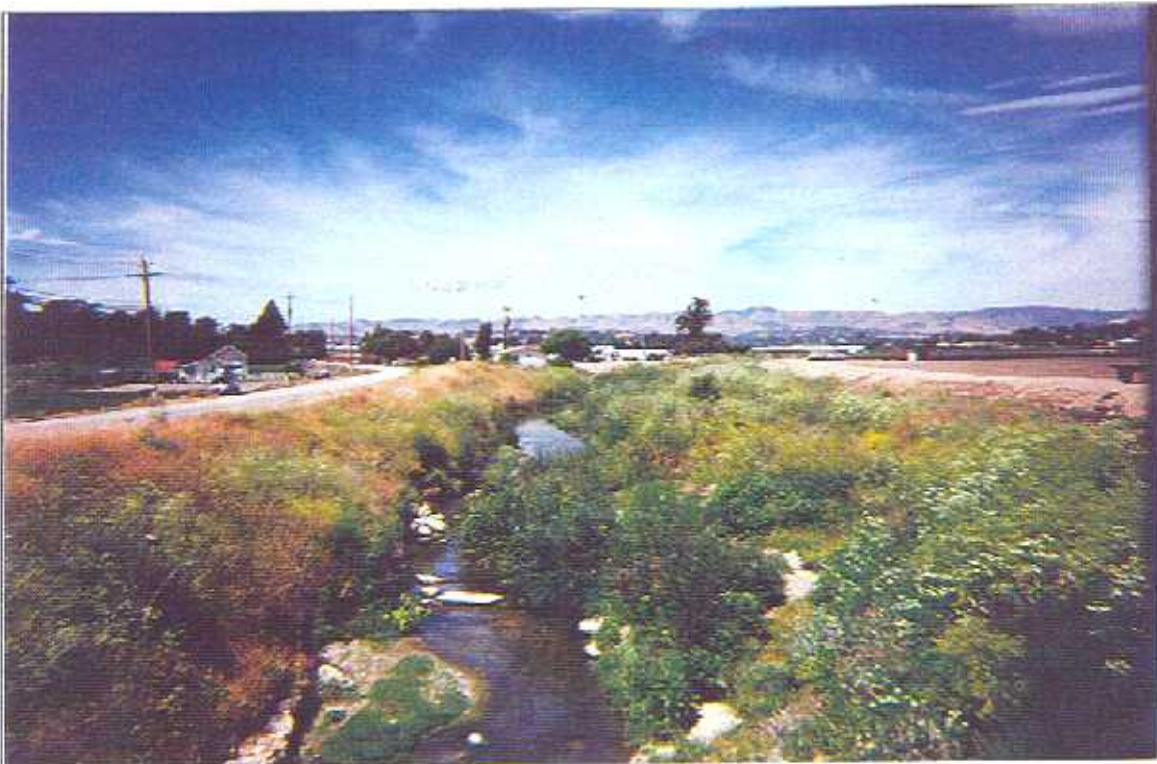
**Photo 4:** Segment 3. Upstream view of Arroyo Grande Creek flood control channel from Highway 1 crossing. Sediment with riparian/ruderal/channel bank scrub along right side to center of photo is proposed for removal from work area 11. Steelhead observed along boulders in center of photo.

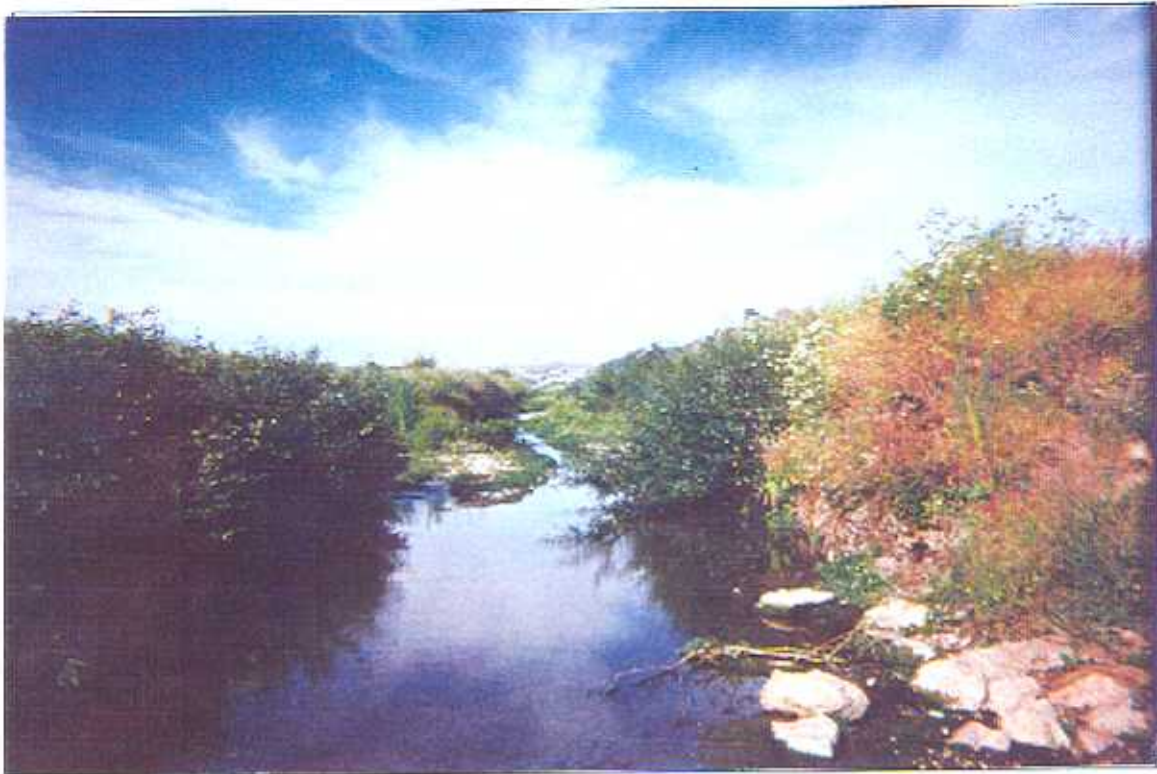
**Photo 5:** Segment 4. Upstream view of Arroyo Grande Creek flood control channel from access road crossing #3. Sediment with riparian/ruderal scrub in left of photo is proposed for removal from work area #14. Steelhead observed in stream, under willow clump on left side of photo.

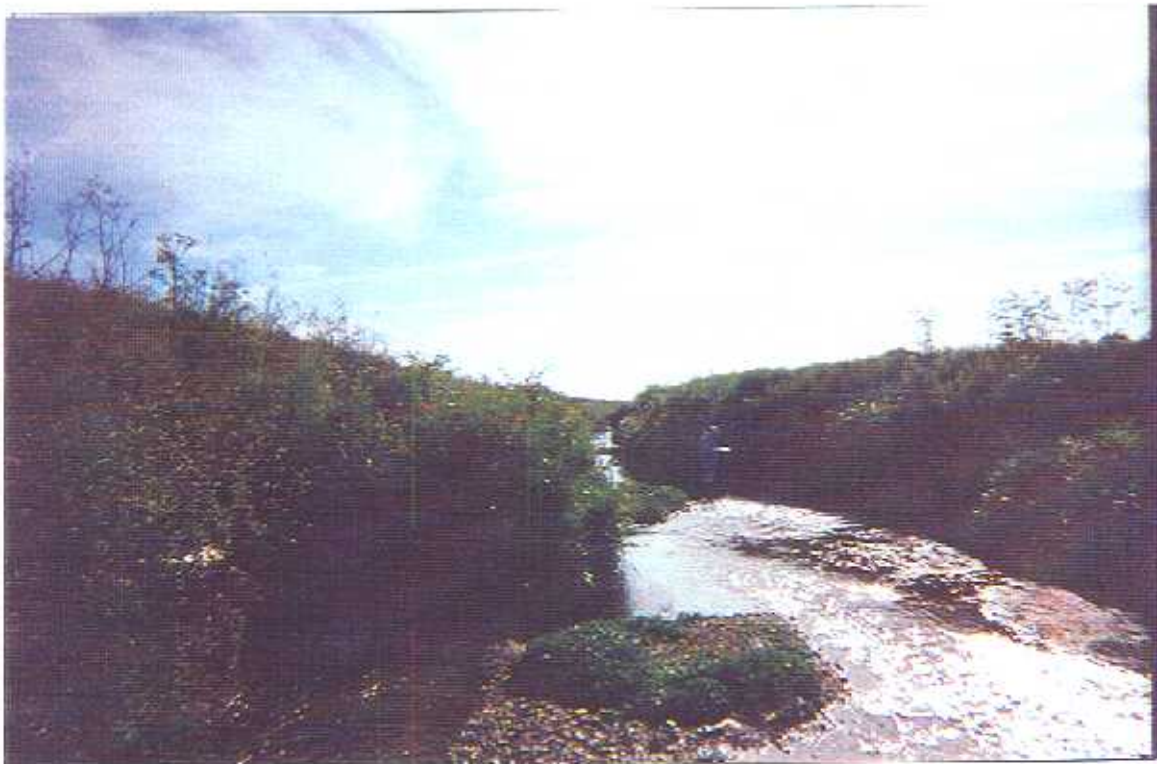
**Photo 6:** Segment 5. Downstream view of Arroyo Grande Creek flood control channel from access road crossing #3. Sediment with riparian/ruderal scrub along right bank in photo is proposed for removal from work area #15.

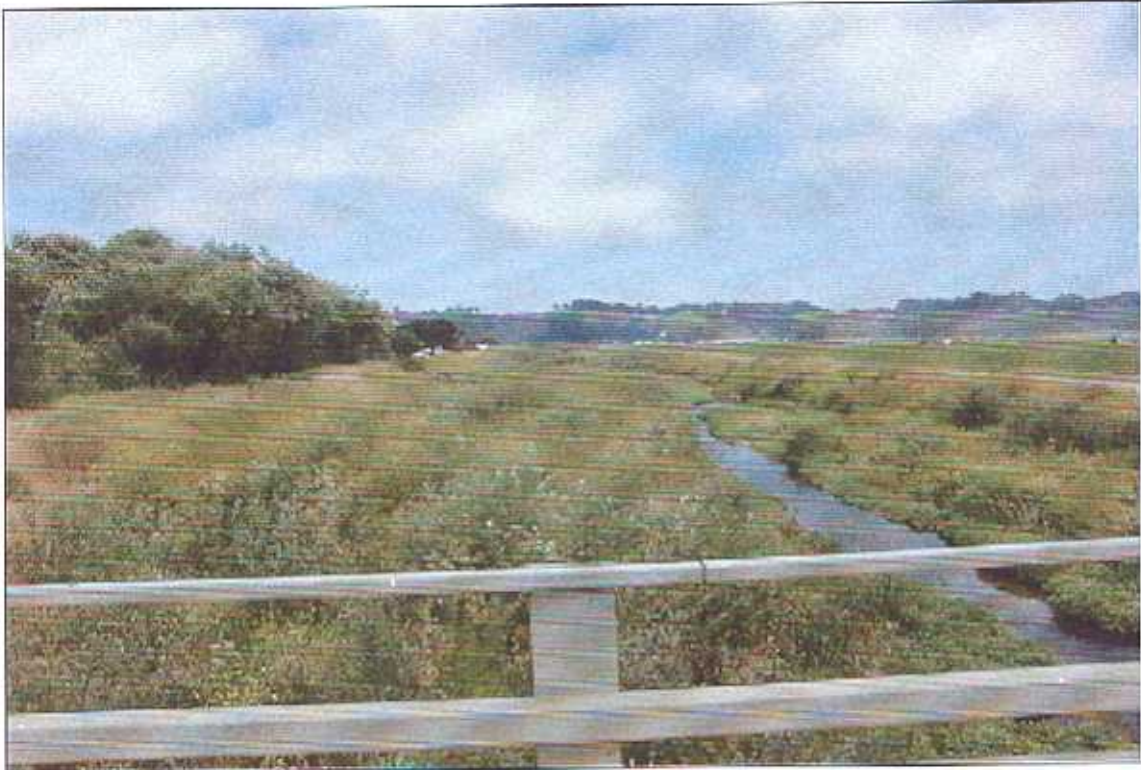
**Photo 7** Segment 5. Upstream view of Arroyo Grande Creek flood control channel from 22<sup>nd</sup> Avenue Bridge. Sediment with riparian/ruderal scrub along left bank in photo is proposed for removal from work area #18.

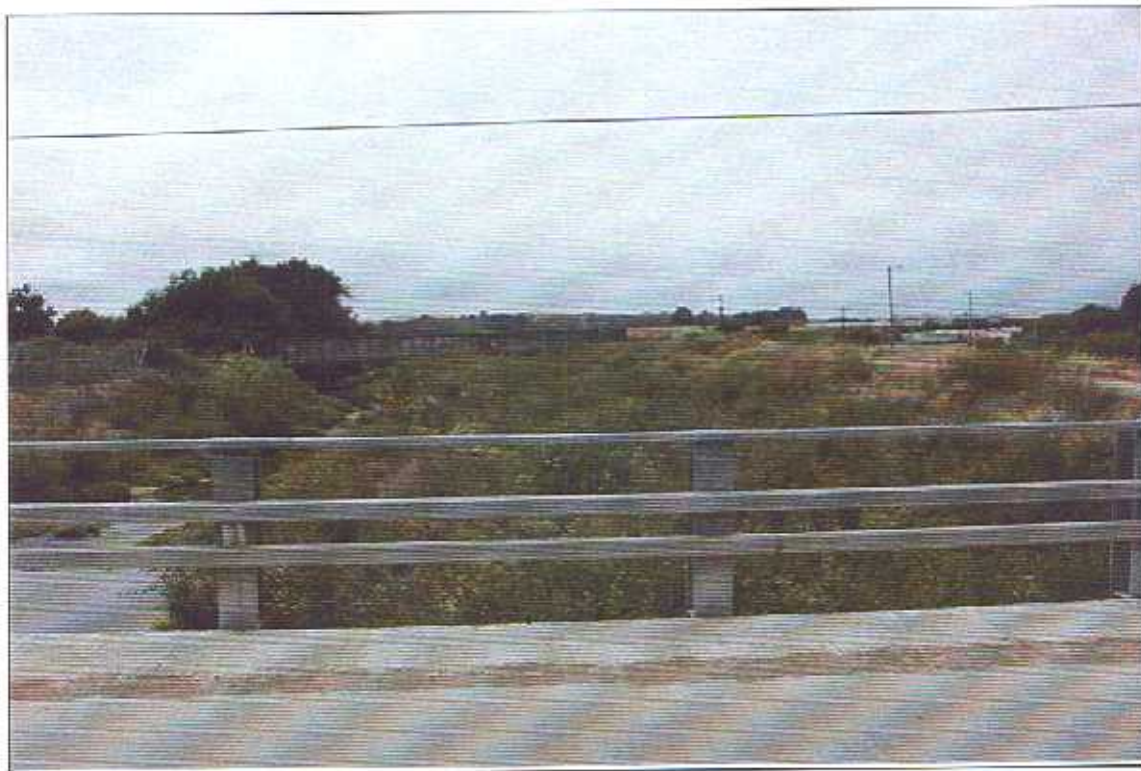
**Photo 8** Segment 5. Downstream view of Arroyo Grande Creek flood control channel and railroad crossing from 22<sup>nd</sup> Avenue Bridge. Sediment with riparian/ruderal scrub on right in photo is proposed for removal from work area #19.

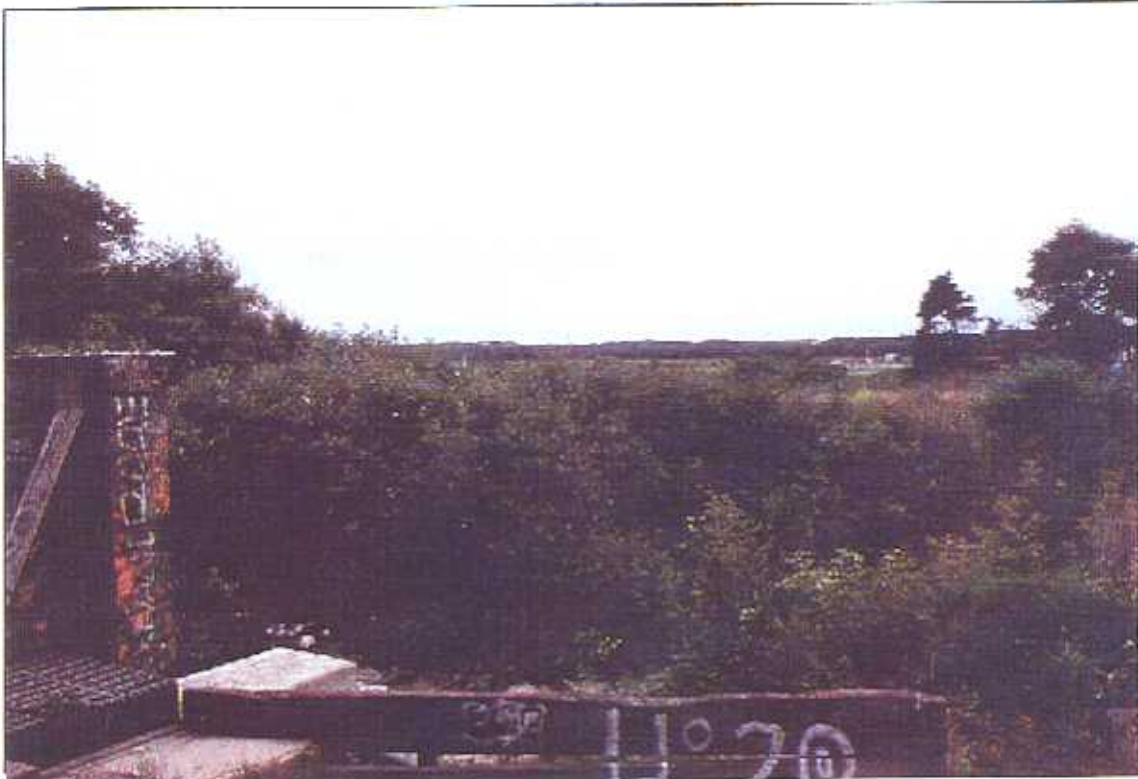
**Photo 9:** Segment 6. Downstream view of Arroyo Grande Creek flood control channel from railroad crossing. Sediment with riparian/ruderal/channel bank scrub in foreground of photo is proposed for removal from work area #20.

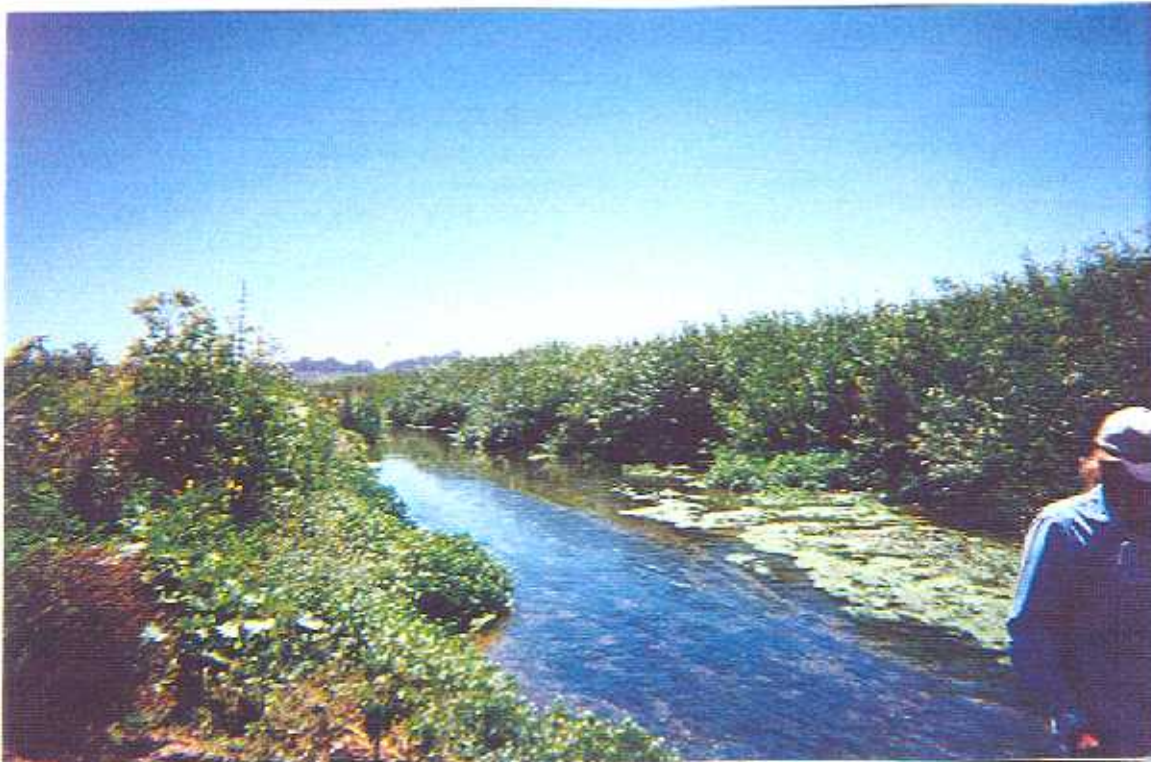
**Photo 10:** Segment 6. Upstream view of Arroyo Grande Creek flood control channel from access road crossing #4. Sediment with riparian/ruderal scrub along left bank of channel is proposed for removal from work area #24.

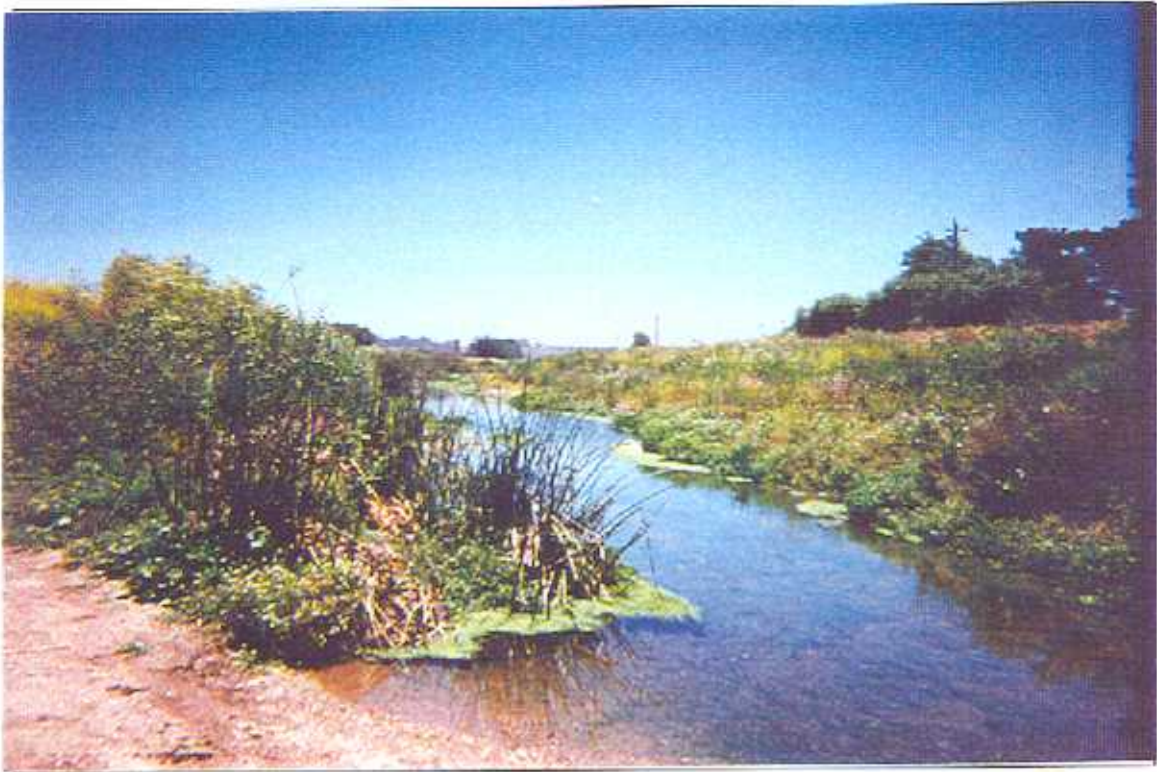
**Photo 11:** Segment 7. Upstream view of Arroyo Grande Creek flood control channel from access road crossing #5. Sediment with riparian/ruderal scrub on left bank is proposed for removal from work area #28.

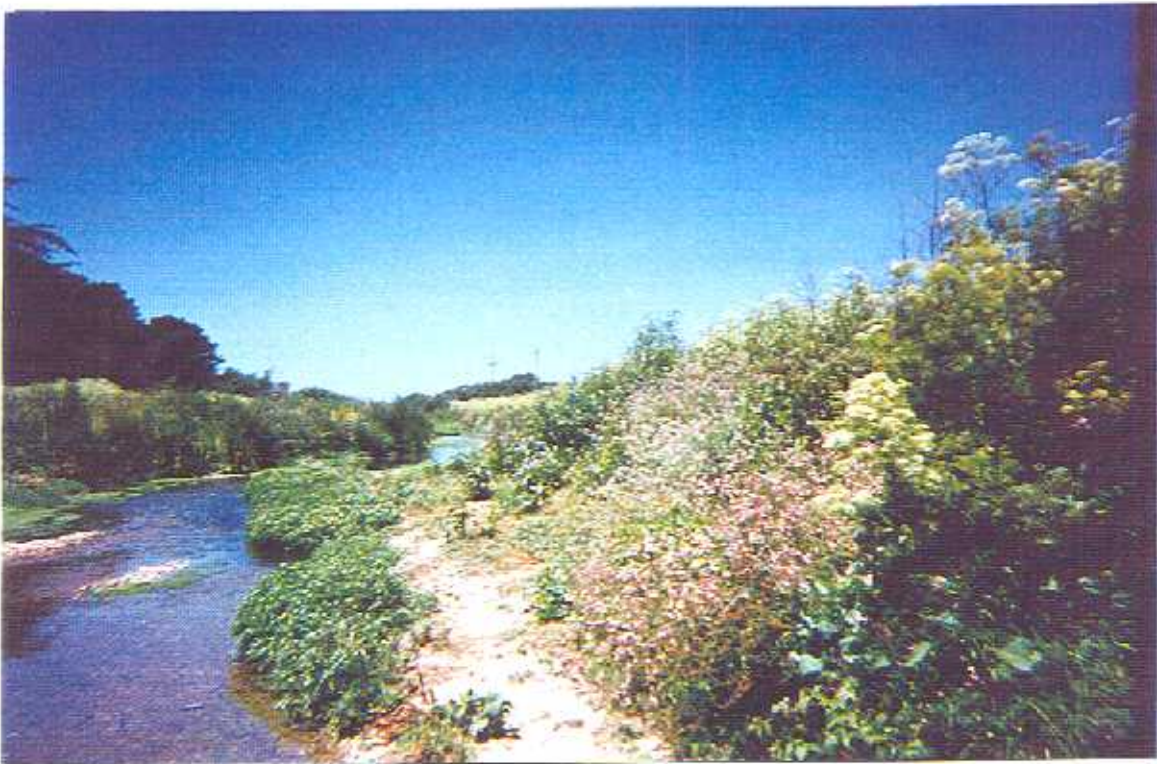
**Photo 12:** Segment 8. Downstream view of Arroyo Grande Creek flood control channel from access road crossing #5. Sediment with riparian/ruderal scrub on right bank in photo is proposed for removal from work area #29.

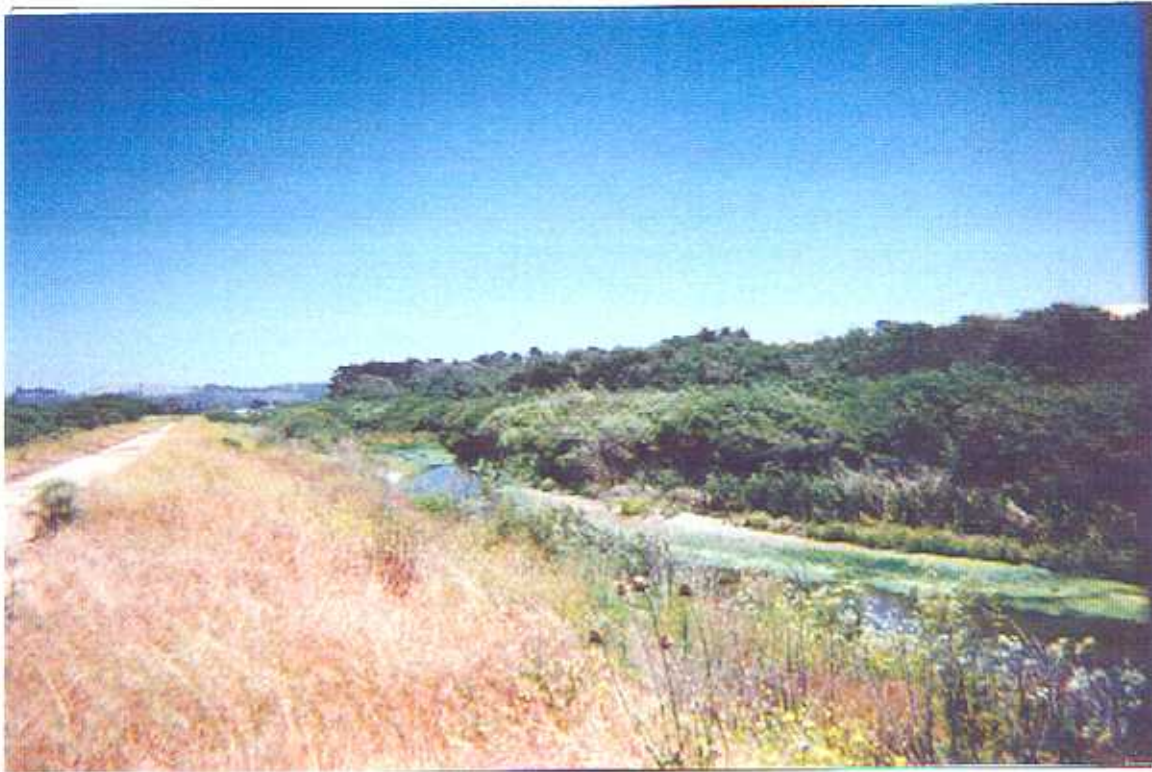
**Photo 13:** Segment 8. Upstream view of Arroyo Grande Creek flood control channel from north bank of levee. Sediment with ruderal scrub patch on left bank, on center of photo is proposed for removal from work area #32.

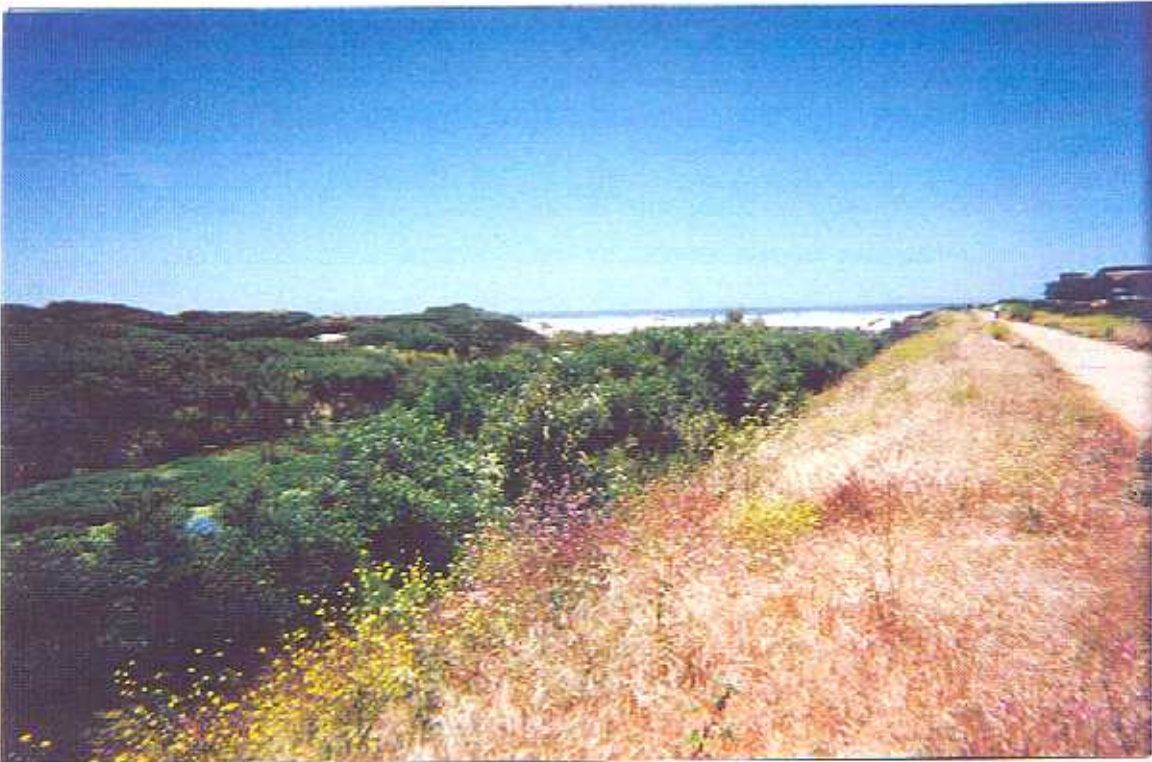
**Photo 14:** Segment 8. Downstream view of Arroyo Grande Creek flood control channel from north levee bank. This area is not proposed to be removed.
