ZONE 3 OF THE FLOOD CONTROL AND WATER CONSERVATION DISTRICT OF SAN LUIS OBISPO COUNTY

LOPEZ WATER TREATMENT PLANT AUDIT

FINAL REPORT

**B&V Project 97260.400
B&V File A
June 2002**

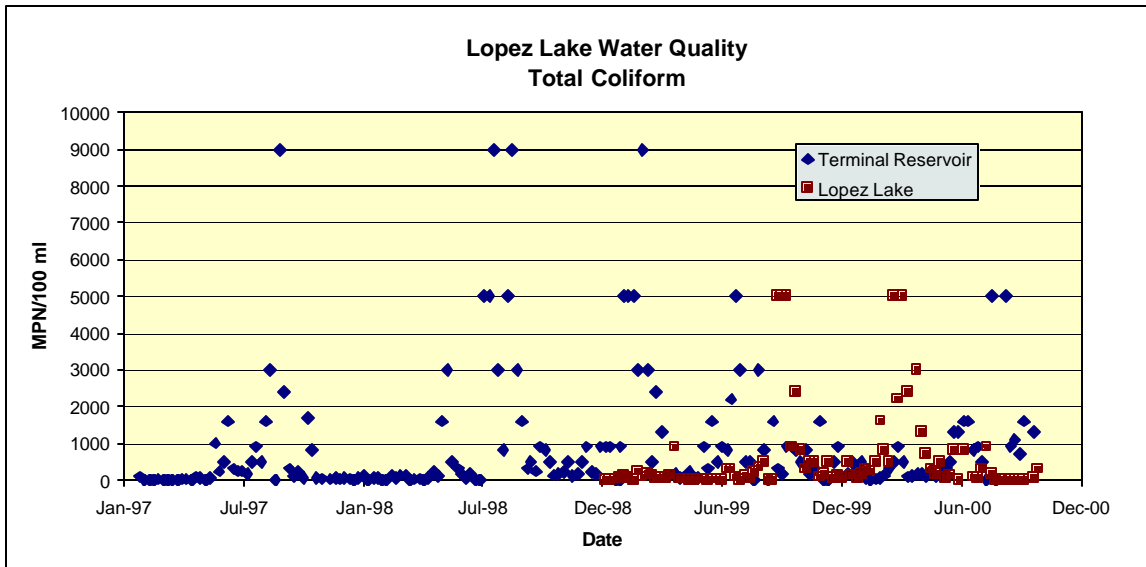
Figure 3.1: Total Coliform Concentrations in the Terminal Reservoir and Lake Lopez

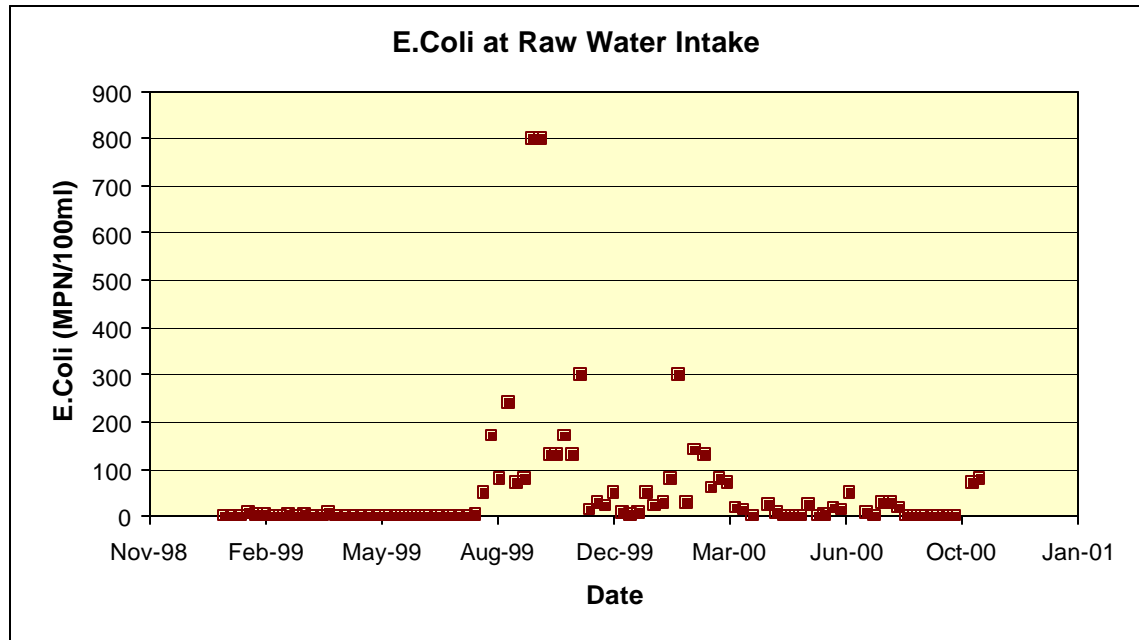
Figure 3.2: E. Coli in Raw Water Entering the WTP

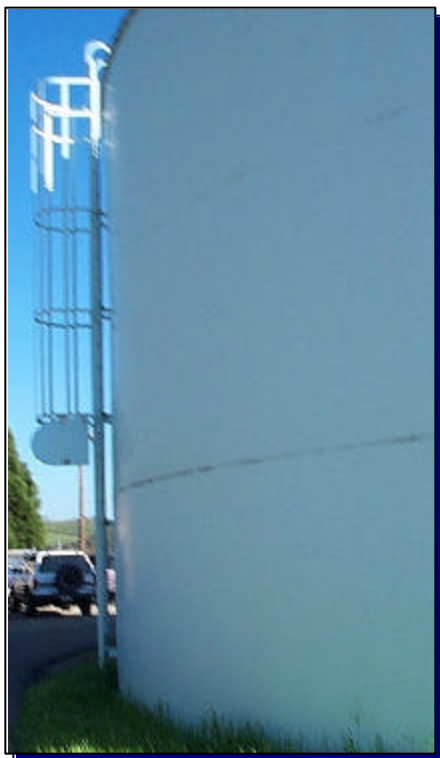
As-built drawings indicate that there is one 18-inch common inlet/outlet pipe, one 6-inch overflow pipe, and one 6-inch drainpipe. Drawings do not indicate flexible expansion joints for the piping.

No assessment of tank corrosion was made during the inspection, however the roof's coating system is peeling.

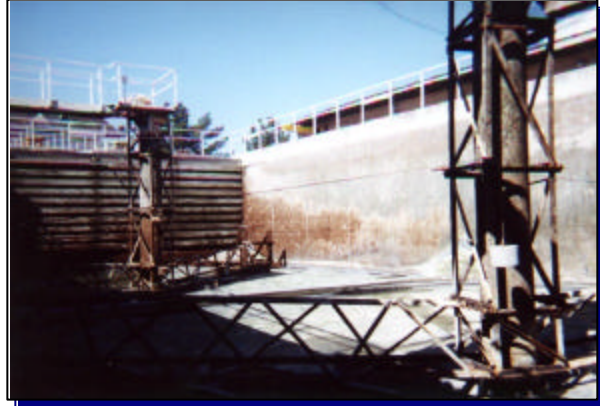
The baffles in the flocculation basin are timber members, anchored with bolts and square washer plates that are exhibiting initial to moderate stages of corrosion. Some of the baffles displayed signs of wood splitting and deterioration. The coating on the baffles is also failing.

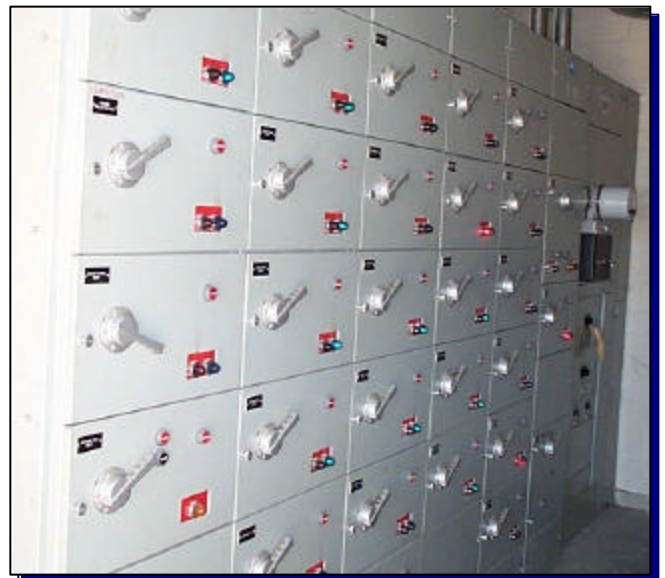
1. Administration building's main panelboard is Panel "LA," manufactured by ITE Imperial Corporation, 120/208V, 3 phase, 225 amps, 4 wire, and 42-circuit panel. The panel is dated back to the 1970's and the breakers are old and most likely irreplaceable.
2. The short circuit ampere rating (SCA) of breakers was not readable, but breaker ratings are probably rated at 10,000 amperes and they may be rated as low as 7,500 amperes. The upstream 112.5KVA transformer feeding this panel (along with panels "LC," "LF," "LR," and "LS") did not have an impedance value on the nameplate. The transformer impedance determines the amount of short circuit current that the transformer will allow

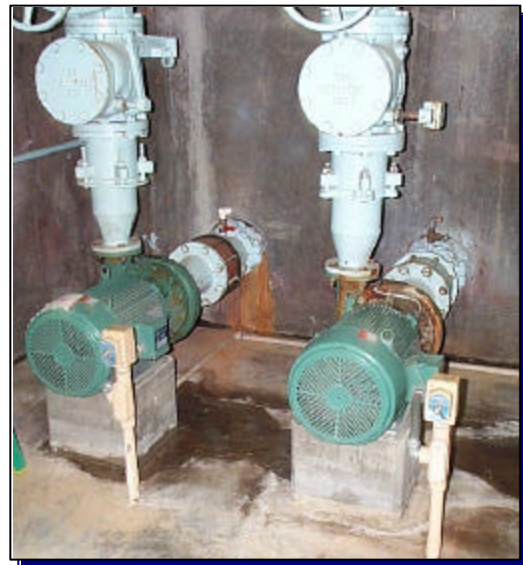
1. Two wash water pumps are made by U.S. Electric. They are 15 horsepower, 208-230/460V, 3 phase motors that seem to be in fair condition. Control stations and conduits stubbing out of floor are rusty.
2. Motor operated valves (MOV) seem to be in fair condition but may need replacement in near future. Some MOV’s are missing electrical terminal board covers.
3. HACH, model 1720C turbidimeters seem to be fairly new and can be reused with an upgraded PLC control system.
4. Several conduit runs have more than the total of 360 degrees (allowed by code) of bending radius between pull points.

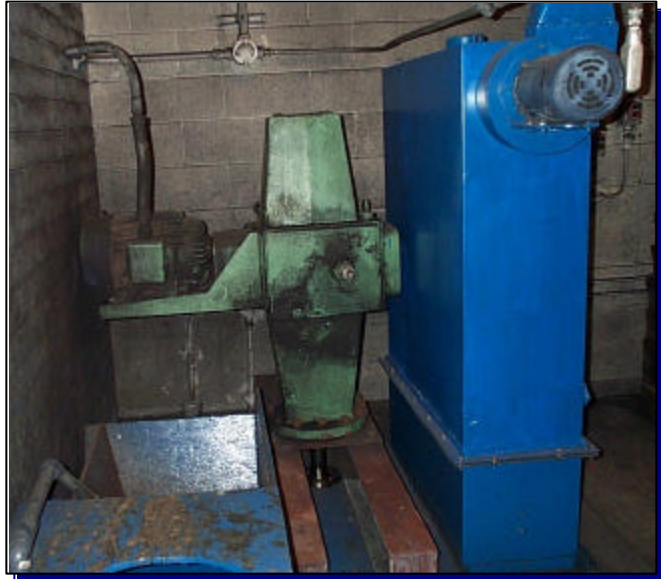
5. Disconnect switch for rotodip motor on north wall seems old and in poor condition. A receptacle has been installed on the top of the disconnect switch.

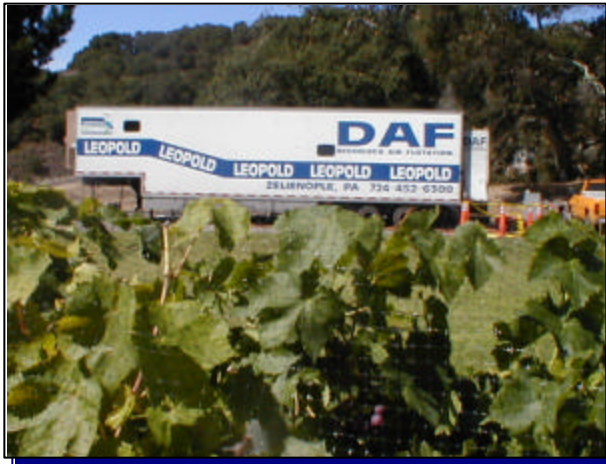
and a chlorine dioxide generator rented from CDG Technology Inc. (CDG). The Leopold DAF pilot plant was contained in a trailer, complete with three chemical feeders, two static mixers, a two-stage flocculation unit, a DAF clarifier system, two pilot filters, a sludge holding tank and sludge pump, and on-line monitoring equipment including pH and conductivity meters, temperature gauges, turbidimeters, and particle counters. The CDG chlorine generator used a solid sodium chlorite

cartridge to react with chlorine to generate chlorine dioxide. The major pilot equipment systems are described in more detail in Appendix M. Pictures of the pilot plant on location are displayed below.

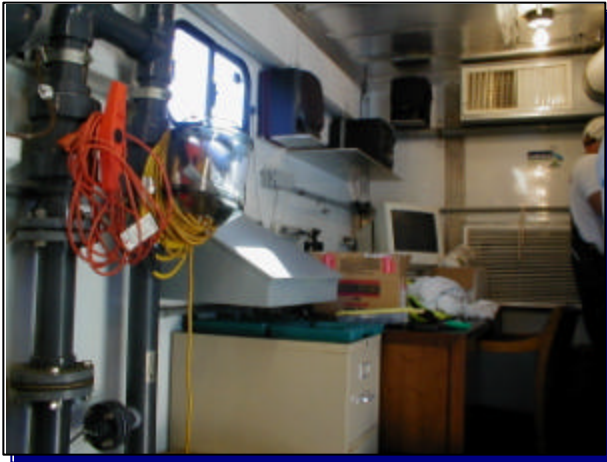
Head loss versus effluent turbidity, for both pilot filters over the entire testing period, are shown in Figures 31 and 32 in Appendix N. During the first week of

continuous testing, the pilot filter effluent turbidity ranged from 0.2 to 0.3 NTU. At the same time, the WTP was experiencing high filter effluent turbidity. Apparently, there was an algae bloom in the Terminal Reservoir during this period, and the District treated the reservoir with copper sulfate and acid. After the first week, the pilot filter effluent turbidity began to decrease, but it was still higher than 0.1 NTU until September 24 when the raw water turbidity decreased to less than

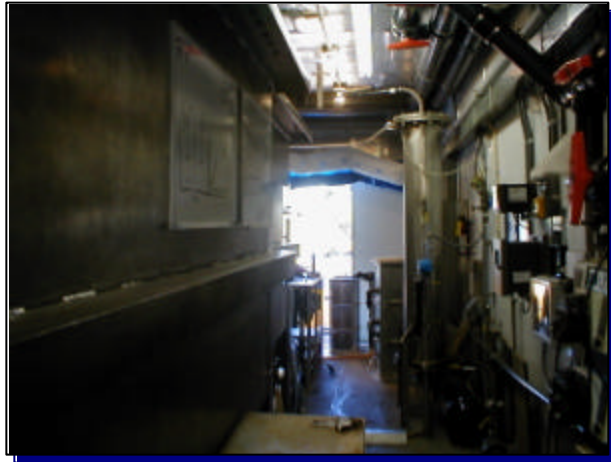
Attempts to improve the filter performance in turbidity reduction including lowering filter loading rate (3 gpm/ft² versus 4 gpm/ft²), pH adjustment (acid feed), coagulant aid, and filter aid feed were not effective in significantly improving filter effluent turbidity reduction. District laboratory staff conducted a bench-scale test by filtering a pilot filter effluent sample through a 0.45-micron filter. The turbidity decreased from 0.25 NTU to 0.08 NTU, indicating that there were fine particles (both larger and smaller than 0.45 micron in size) in the filter effluent.

The particle count data provided a different perspective on filter performance. The average raw water particle count (2-20 micron) was approximately 10,000/mL. The average DAF effluent particle count was approximately 800/mL and was as low as 100/mL with 1.5 mg/L of chlorine dioxide as pre-oxidant. This represents 92 to 99% particle removal. The filter effluent particle count averaged 50/mL and was as low as 10-12/mL with 1.5 mg/L of chlorine dioxide feed as pre-oxidant. The pilot filter performance in particles >2 micron was excellent. The log removal (DAF with filter) for total particles >2 micron was above 2.8 during the 'best' period and averaged 2.2-2.3 during the 'worst' period. This easily met the 2-log *Cryptosporidium* removal requirements of the IESWTR. Runs of the pilot filters were at least 48 hours in length at a surface loading rate of 4 gpm/ft². This is equivalent to a unit filter run volume (UFRV) of larger than 11,200 gal/ft²-run, which is excellent and indicates that DAF is a good pretreatment alternative.

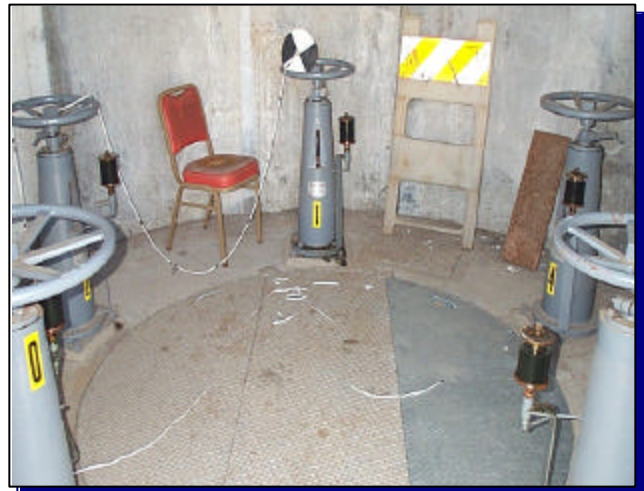
The following are recommended for the Terminal Reservoir:

- Upgrade the flow control valve to provide remote control capability.
- Remove aquatic weeds in the Terminal Reservoir.
- If the District were to require water quality improvements to the Terminal Reservoir in the future, Black & Veatch recommends consideration of capping of bottom sediments or aeration.

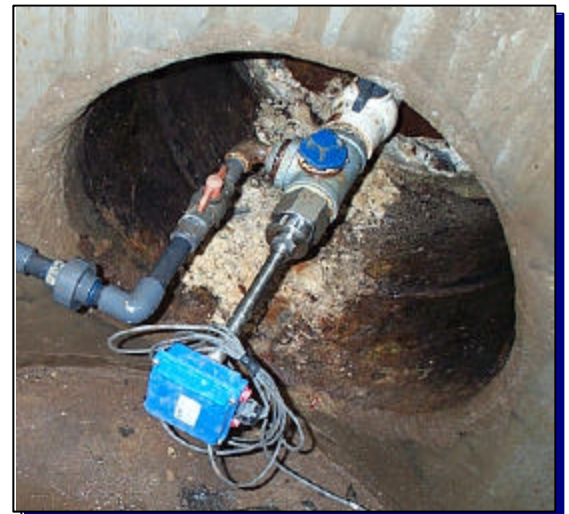
7.12 Finished Water Meter Vault

Since this vault is located in the Lopez Drive roadway, a second manhole, inside property fencing, should be provided. Additionally, the meter should be replaced with a venturi meter or a buried magnetic flowmeter.

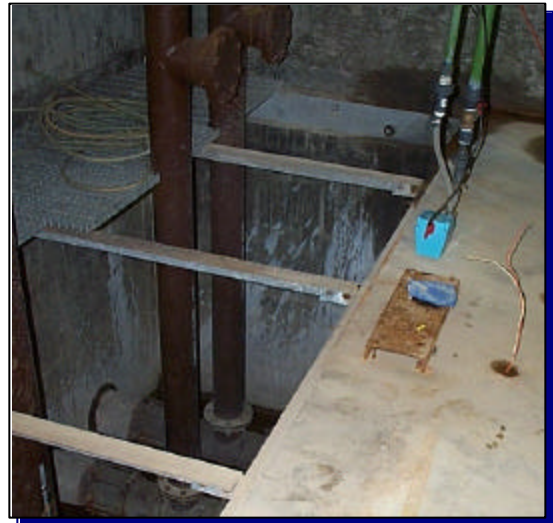
Electrical Recommendations:

- Replace panel with newer panel. A new panel will simplify maintenance and breaker replacement.
- Replace the panelboard “LS” and lighting fixture supports.
- Provide covers for the open terminal cabinets in order to prevent the risk of human contact with live wires.
- Identify (tag) and group wires inside the terminal cabinet to facilitate troubleshooting and wire tracing.
- Splice/connect wires in accordance with electrical codes.

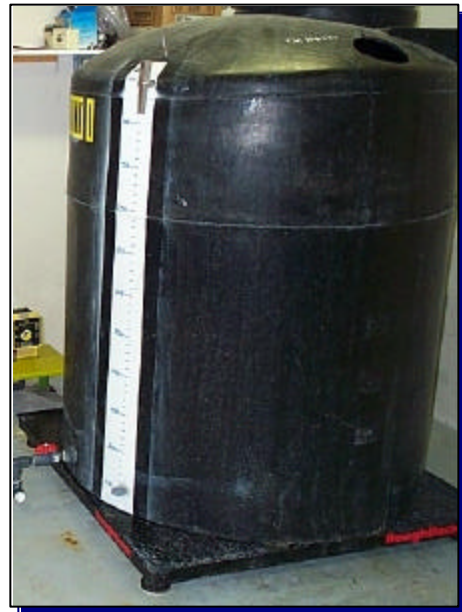
Structural Recommendations:

- Clean exterior surfaces of walls and slab removing corrosion and apply Sika Top Seal 107 as a sealant and preservative.
- Inject epoxy grout into cracks or repair concrete cracks by chipping out damaged areas and then applying a polymer-modified mortar.
- Provide lateral restraints for the piping, tanks, and electrical gear.
- If possible, provide flexible expansion joints on the chemical tanks.
- Provide anchors for metering pumps.
- Provide containment for various chemicals.
