**Hydrology and Geology Assessment  
of the Pismo Creek Watershed,  
San Luis Obispo County, California**

Balance Hydrologics, Inc.

August 2008

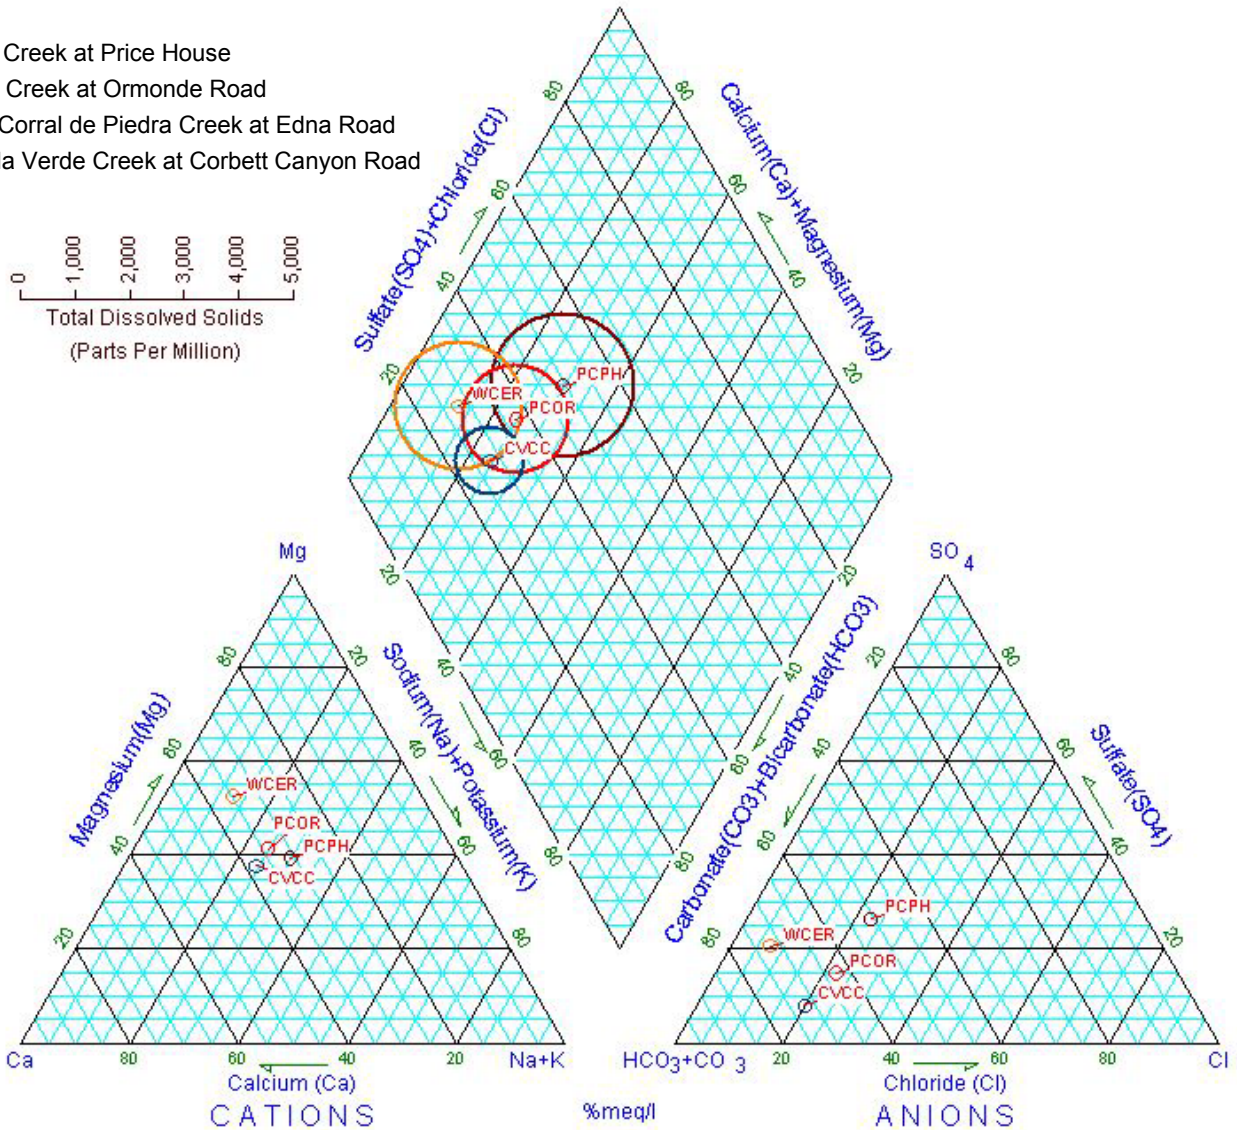
**Figure 12. Piper Plot of baseflow waters in the Pismo Creek Watershed, San Luis Obispo County, California**

The Piper plot is a useful interpretative tool in illustrating differences and similarities among waters. Total dissolved solids and specific conductance were found to be lower in Canada Verde at Corbett Canyon Road. Pismo Creek at the Price House was found to be slightly higher in relative sulfate concentrations, perhaps due to upstream contact with bituminous sandstones and the related shales, either through natural seepage or indirectly as inflow from oil-production areas.

Table 4 presents the results of general minerals sampling and Figure 12 is a trilinear ('Piper') plot of the general mineral data. The Piper plot is a useful interpretative tool in illustrating differences and similarities among waters. Total dissolved solids and specific conductance were found to be lower in Canada Verde at Corbett Canyon Road. Pismo Creek at the Price House was found to be slightly higher in relative sulfate concentrations, perhaps due to upstream contact with bituminous sandstones and the related shales, either through natural seepage or indirectly as inflow from oil-production areas. Data reported by Entrix (2006) did not indicate an increase in sulfur concentrations upstream of Cuevitas Creek, and relationships shown in Figure 10 and discussed above imply the salinity increases are associated with areas upstream and downstream of the Entrix sampling stations. Therefore, if further investigations are to take place to evaluate a potential source of elevated sulfates, we recommend directing the investigation in the downstream portion of Price Canyon or in areas immediately downstream of Edna.

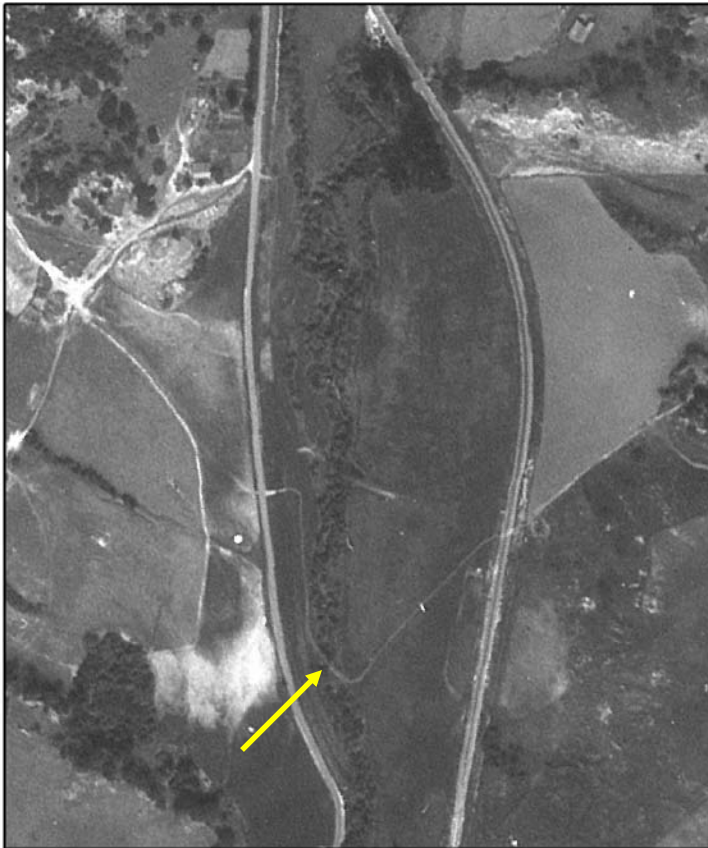
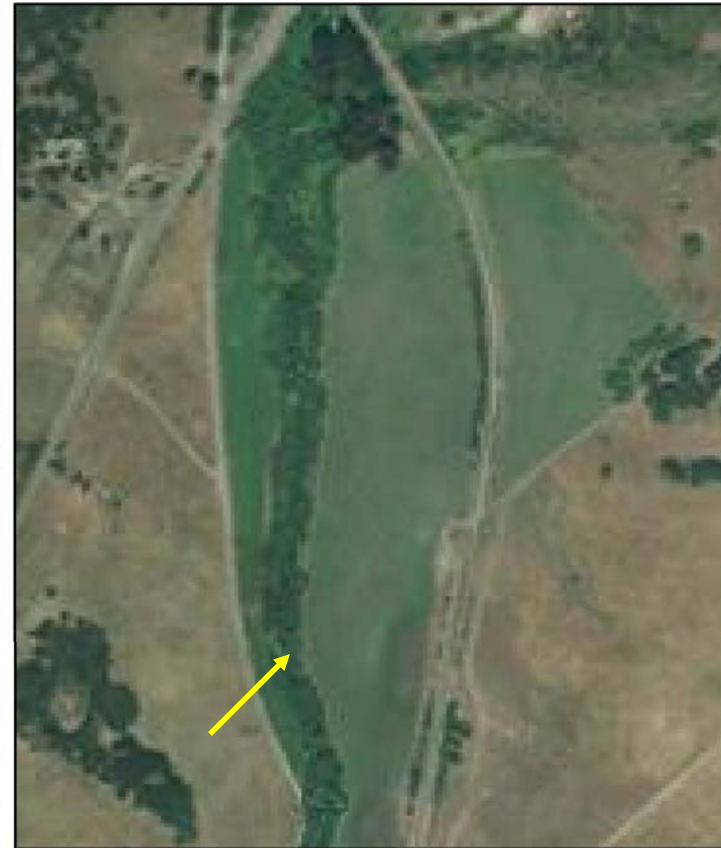
**Figure 15. Pismo Creek above Price Canyon in 1947 and 2005, Pismo Creek Watershed, San Luis Obispo County, California**

Stereo-viewing and the presence of a road crossing indicate that the channel was not substantially incised in 1947, while recent field investigations imply it to be significantly (20 feet or more) incised under present-day conditions.

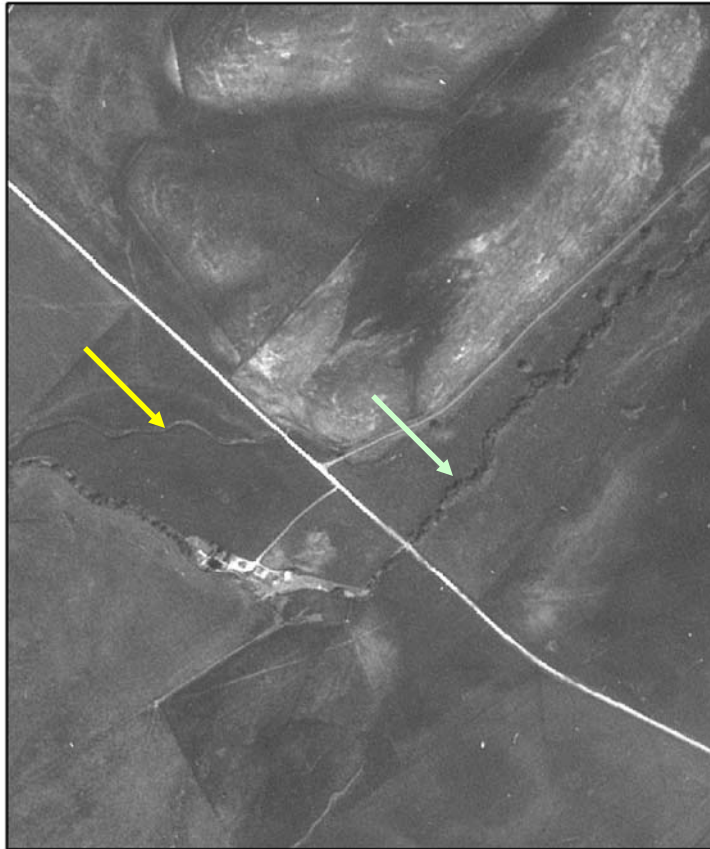
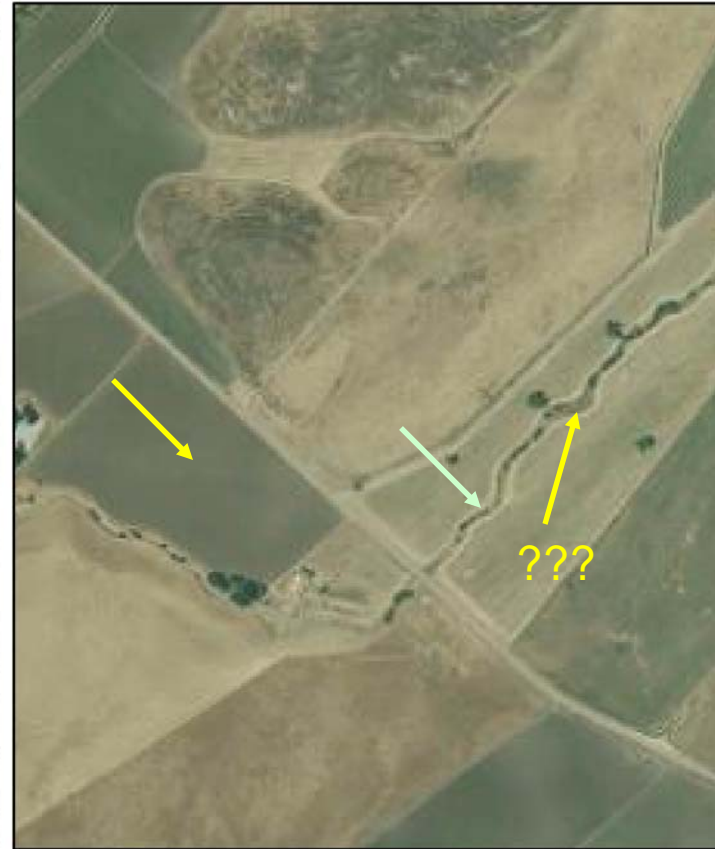
**Figure 16. East Corral de Piedra Creek in 1947 and 2005, Pismo Creek Watershed, San Luis Obispo County, California,**

Throughout Edna Valley, channels are typically incised and appear to be hydrologically disconnected from the surrounding valley flat, and in many cases are straight with a limited riparian vegetated buffer. Figure 16 shows channel conditions on East Corral de Piedra near where it exits the mountainous upper watershed. Historical aerial photos show the presence of an alternate channel that does not exist today, suggesting that historically, the stream frequently overtopped its banks and occupied alternate channels. The channel has become disconnected from the floodplain in relatively recent times, perhaps with the development of intensive viticulture in this reach, or simply because a local farmer chose to fill in the alternate channel. In either case, today's channel is incised significantly and floodplain processes do not appear to be present.
