**Salinas Reservoir**  
**Water Quality Monitoring Report**  
**Water Year 2023 (October 2022 – September 2023)**

San Luis Obispo County  
Flood Control and  
Water Conservation District

Prepared by:  
County of San Luis Obispo  
Department of Public Works  
Water Quality Laboratory

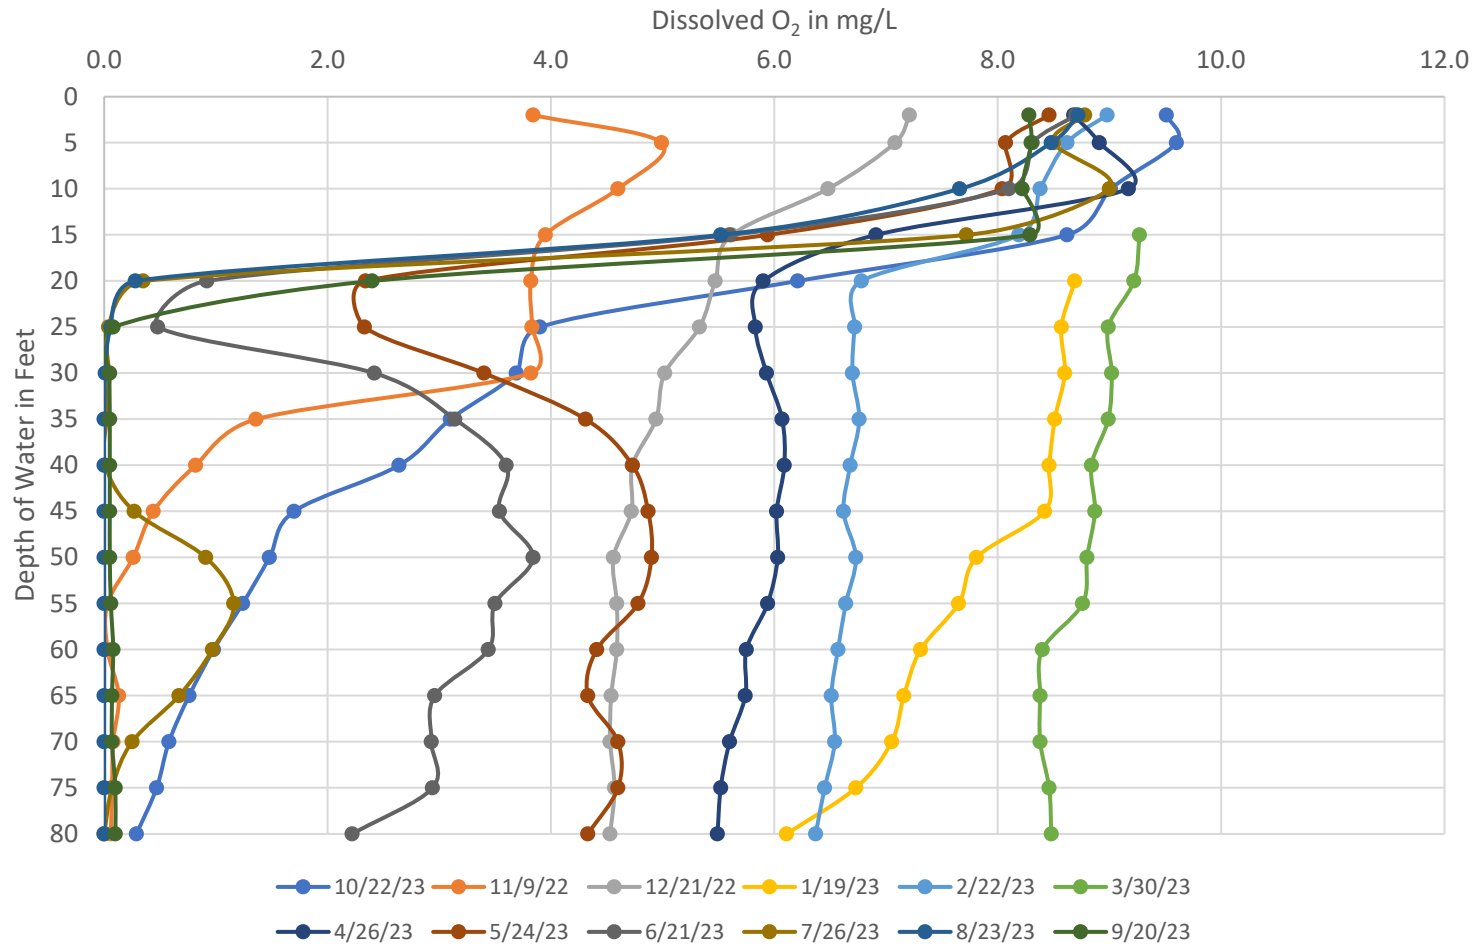
### 8.1.3 Oxygen Profile at Intake

## Salinas Reservoir Dissolved Oxygen Profile for Water Year 2023

Thermal stratification develops in the reservoir when the surface waters warm and decreases in density during the spring and summer months. During stratification, the water separates into a warmer oxygen-rich layer, the epilimnion, found at the top of the reservoir, and a colder oxygen deficient layer, the hypolimnion, found at the lower depths of the reservoir. The layer of water that separates these two zones is called the thermocline. The thermocline at SALR was between 15 and 30 feet below the surface. Thermocline shows a rapid to moderate decrease in temperature, dissolved oxygen, and pH.
