# *County of San Luis Obispo*

## *2014 Bridge Maintenance Program*

*Department of Public Works  
Transportation Division*

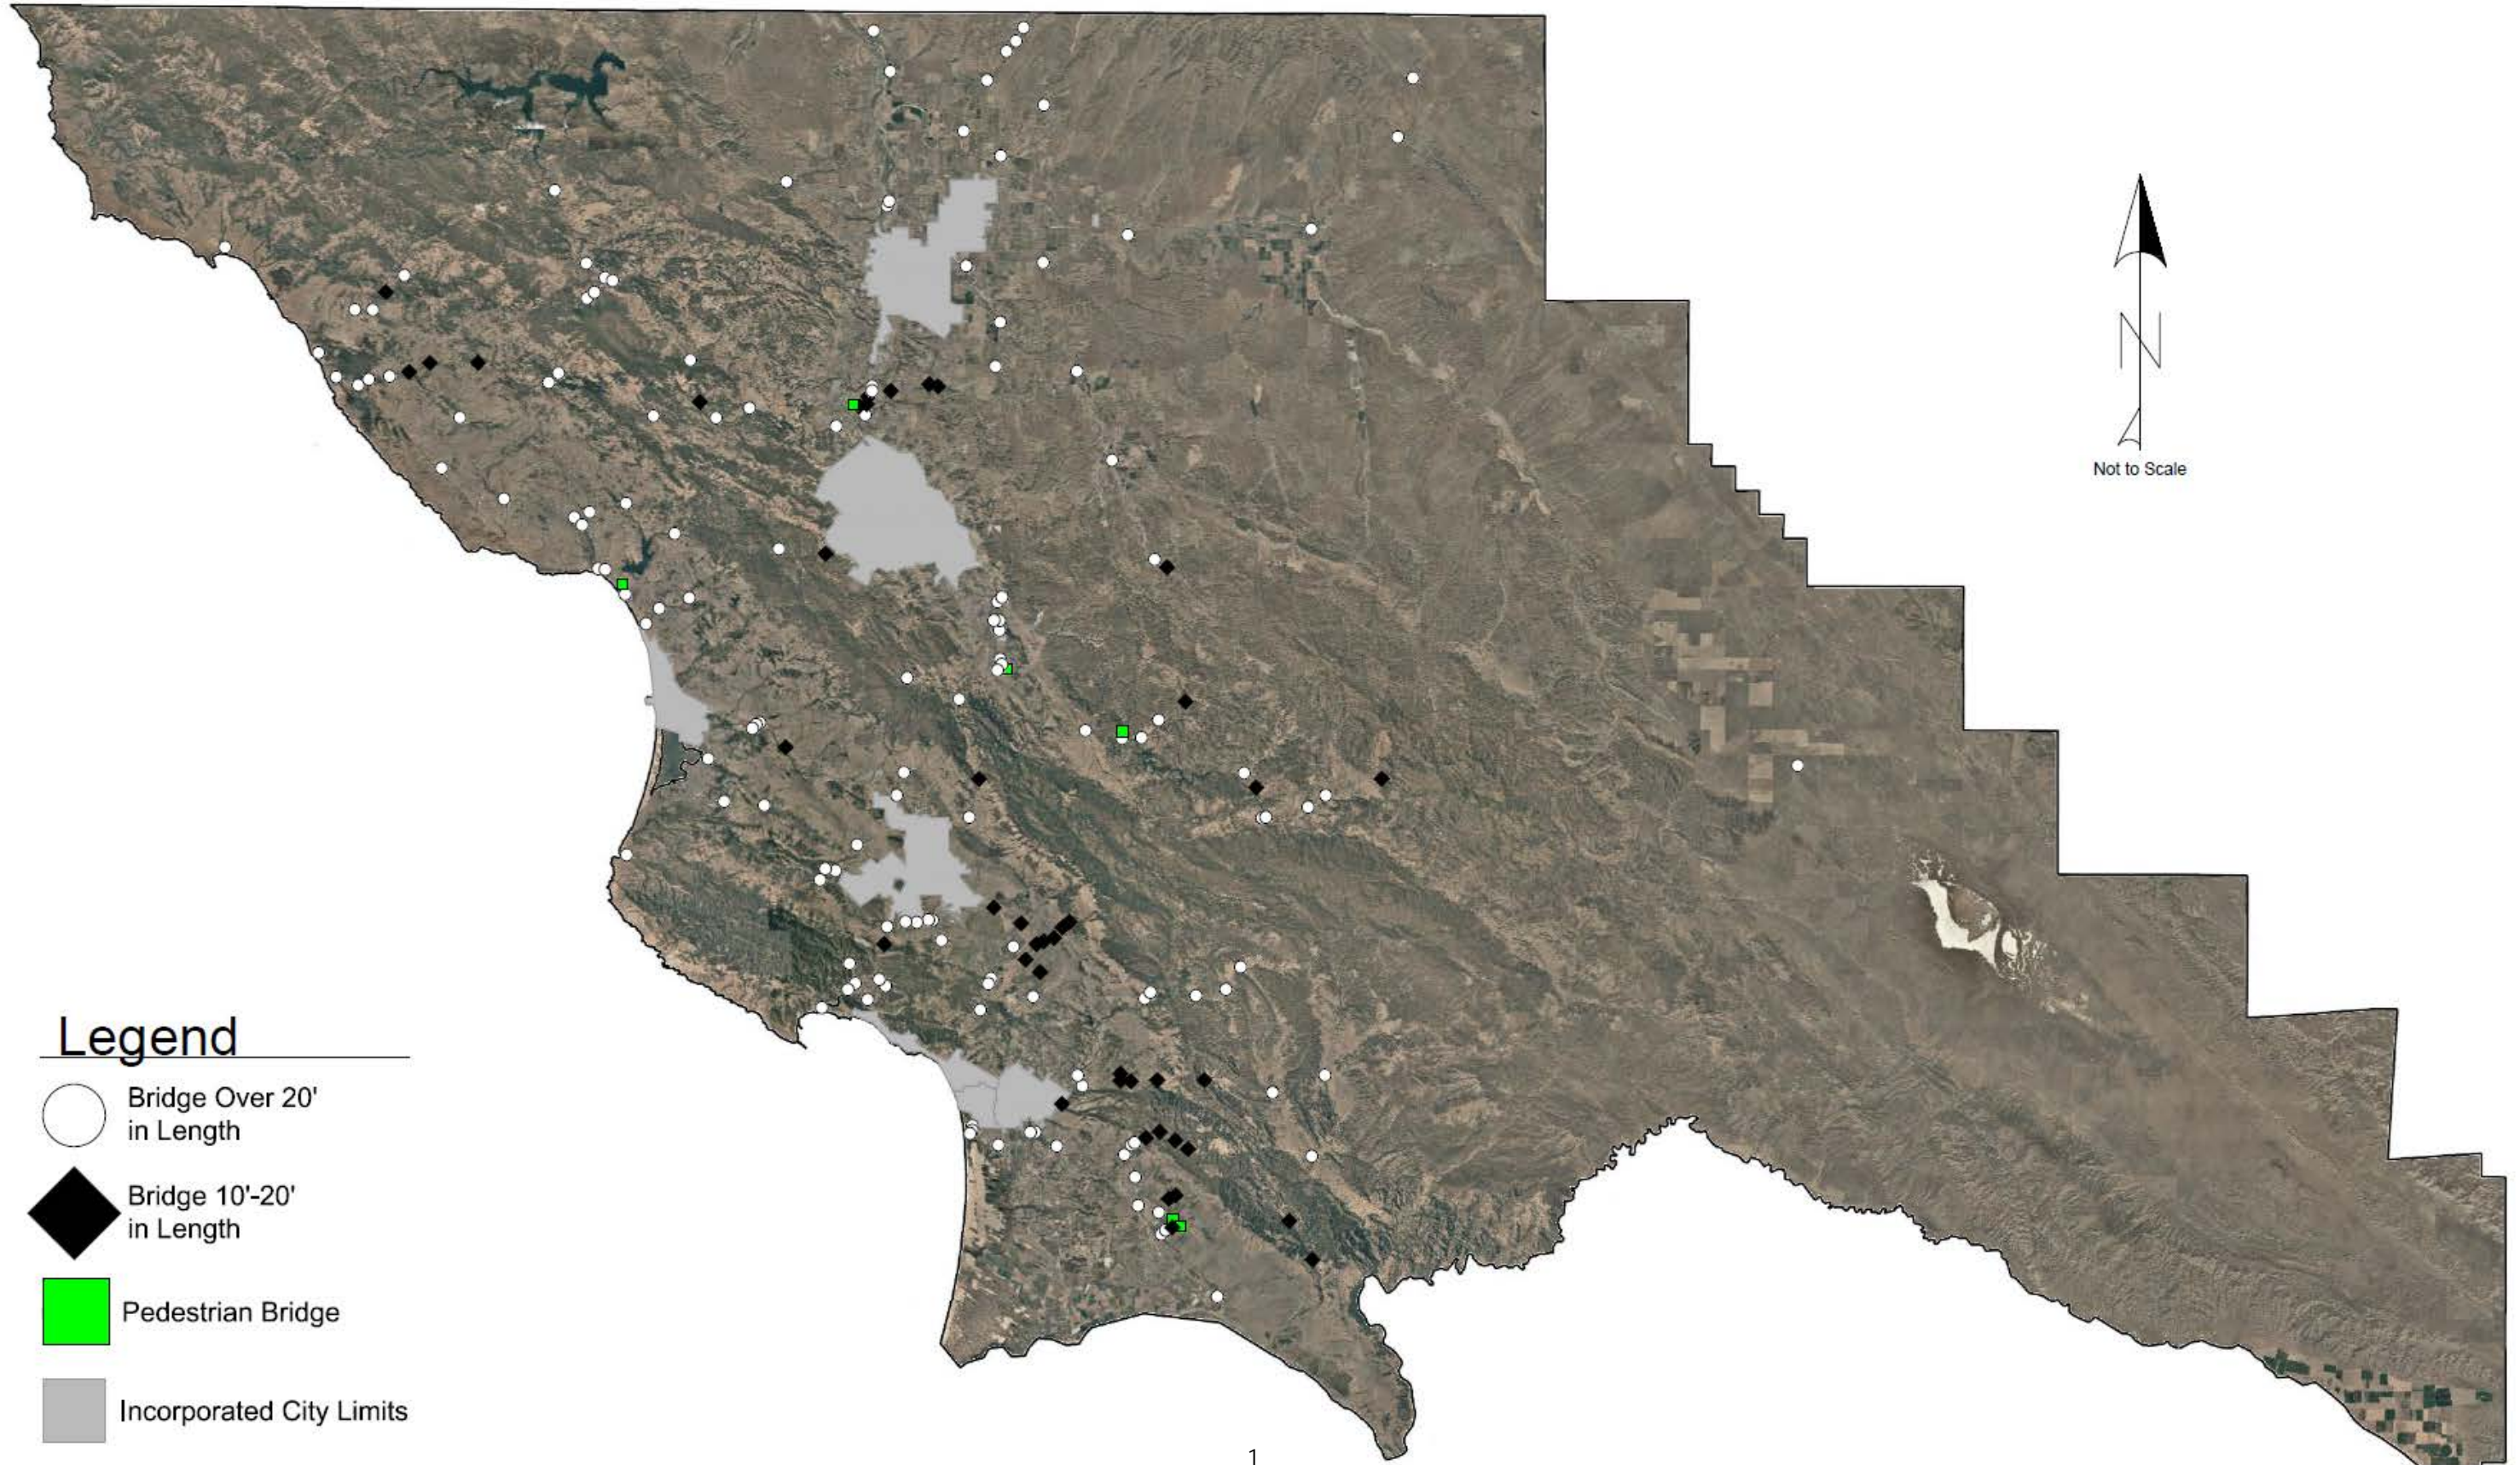
# Locations of County-Maintained Bridges - 2014

NBI bridges are typically identified by the bridge name followed by the bridge number, e.g., Adobe Way, 49C456. Some older bridges that are less than 20 feet also have a 49C designation, but are not listed on NBI and will lose that number upon replacement. A complete bridge inventory spreadsheet is provided in Appendix A. The map on the following page illustrates the distribution of maintained bridges throughout the County.

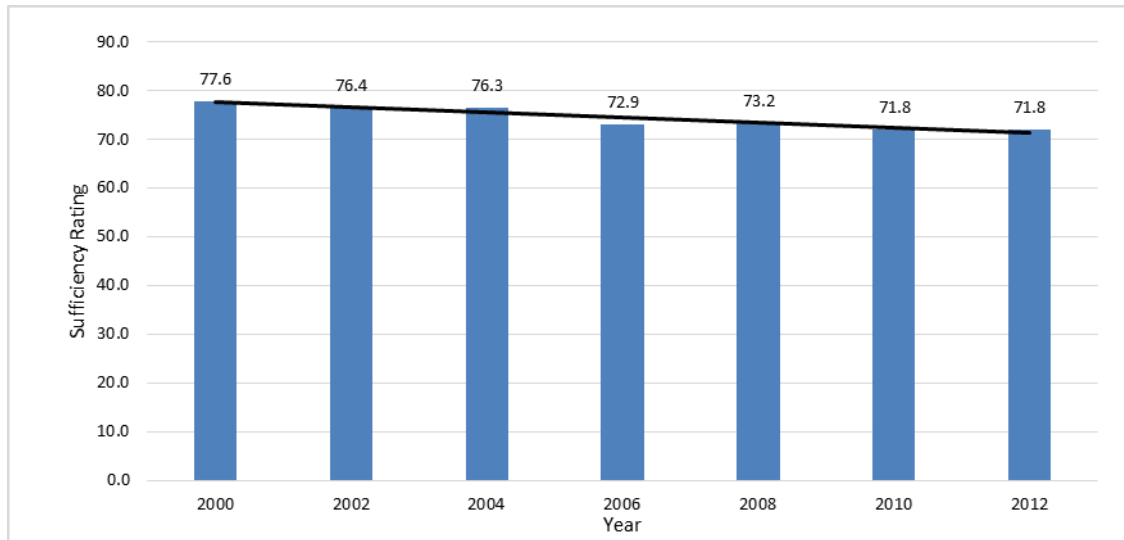
**Figure 2: Average Annual Sufficiency Rating (SR) of San Luis Obispo County Bridges**

Overall, the SR for the County bridge inventory has varied little over the past years. This is due to the large number of bridges in the inventory, which prevents the benefit of each year’s new bridges and new repairs from significantly increasing or decreasing the SR average. Considering the inventory continues to age, maintaining the current average SR is a significant accomplishment, which represents the County’s investment in replacing the most deficient bridges while the remainder of the inventory is kept in a state of good repair. In addition to using the SR as a measure of the condition of a bridge, the NBI defines two types of deficient bridges – structurally deficient (SD) and functionally obsolete (FO).
