Damaged Lines in Morro Bay's Wastewater Collection System

Causes and Effects

August, 2007

Condition of the Morro Bay Wastewater Collection System

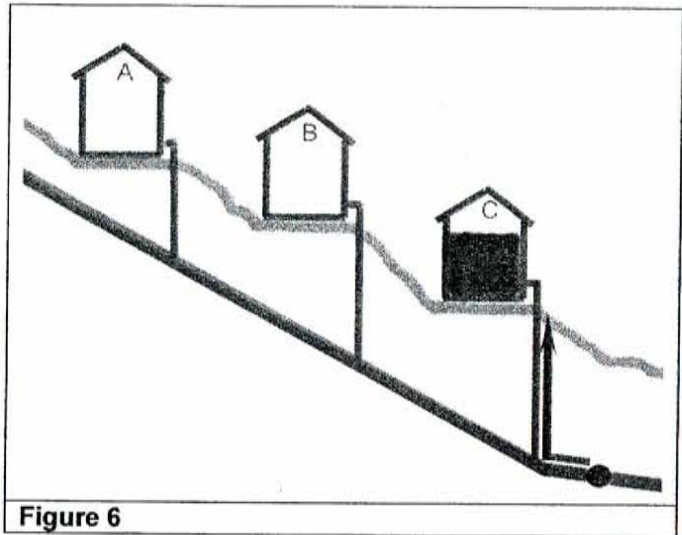
Figure 6 represents an actual incident that occurred on St. Mary Avenue in Cayucos, during the summer of 2003.. In this side view, we see houses on the hillside street, with an obstruction in the sewer line, at the bottom of the hill, just below house C.

Given the large number of hillside homes in Morro Bay, this scenario could definitely be repeated here. Because the City is responsible for maintaining its lines in good condition, there is significant liability.

Residents of Morro Bay report regularly-occurring problems with sewage backups in their neighborhoods, and are frequently told that they are caused by tree roots. This could happen here.
