GEOTECHNICAL REPORT

Arroyo Grande Creek Channel Waterway Management Program

San Luis Obispo County, California

Yeh Project No.: 218-169

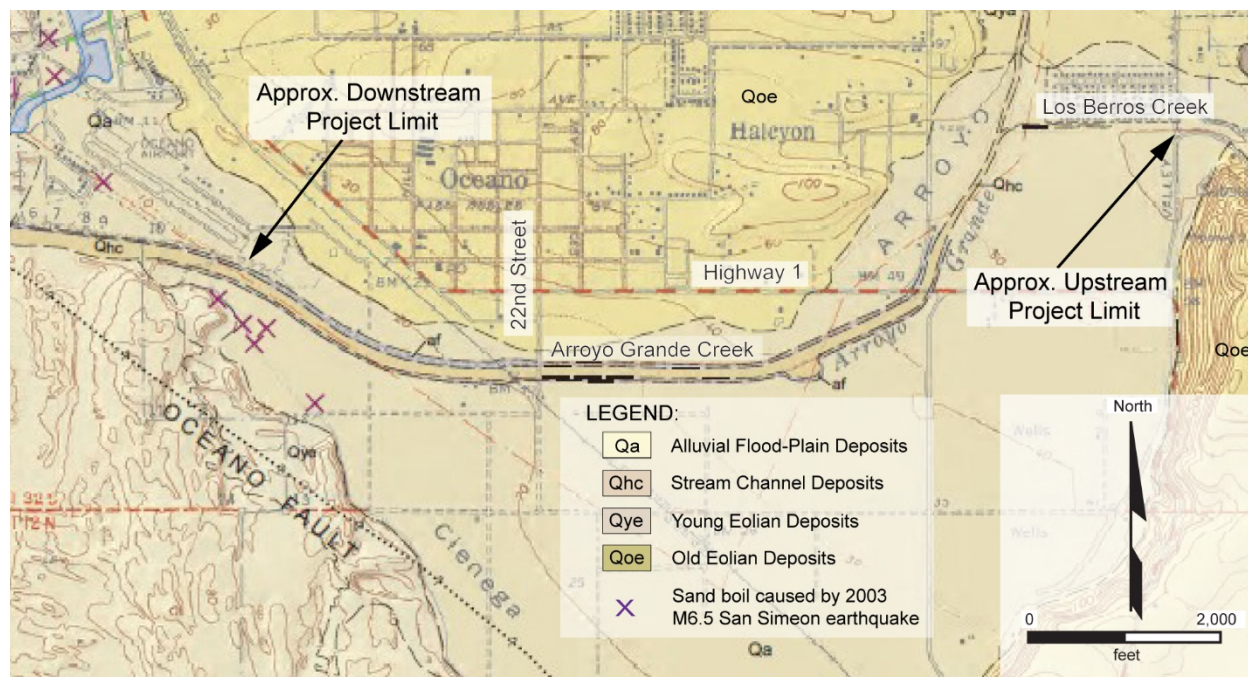
Figure 2: Geologic Map

rocks that overlie older rock formations. The surficial geology as mapped by Holland (2013) is shown on Figure 2.

Figure 2 also shows the location of sand boils caused by liquefaction during the 2003 M6.5 San Simeon earthquake and mapped by the USGS (Holzer et al. 2004), The sand boils were mapped north and south of Arroyo Grande Creek near the downstream project limits, where the USGS also observed evidence of instability on the south levee slope.

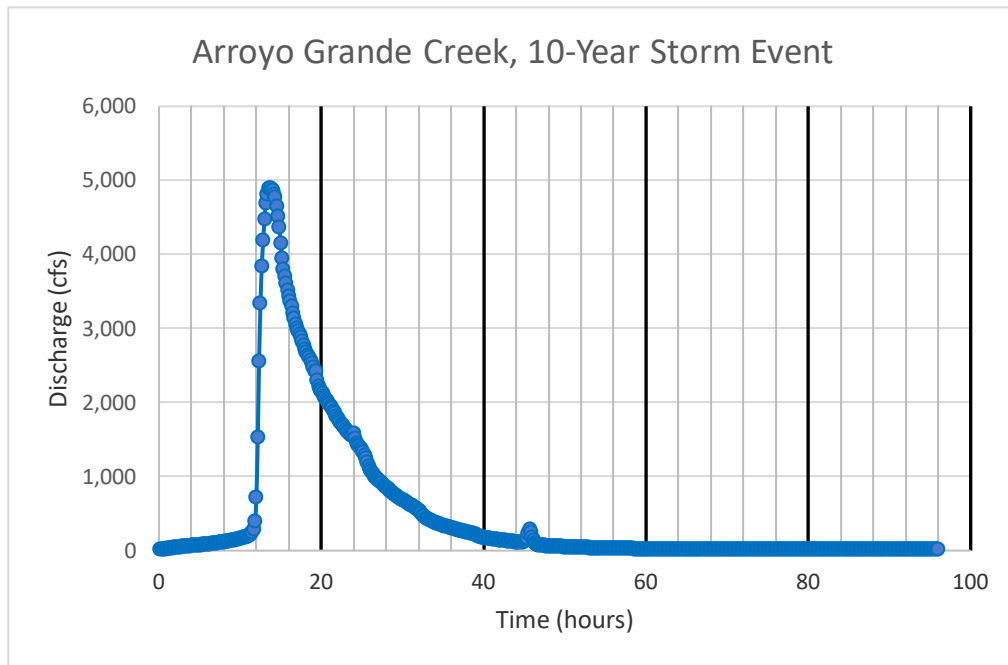
Figure 4: Hydrograph for 10-year flood event

for steady-state seepage conditions to develop during the 10-year storm event. Waterways (2020) provided the hydrograph for the 10-year storm event depicted in Figure 4. The peak discharge for the 10-year storm event occurs over approximately 3 hours, and the full duration of the storm is approximately 24 hours.

Input parameters applied to the transient seepage models were the same as those applied to the steady-state models, except the hydraulic head boundary conditions. Initial hydraulic head boundary conditions estimated for the transient seepage analyses included the creek water surface elevations based on our field observations and groundwater level estimates based on data collected for this study. Time-dependent water surface elevations for the transient analyses were based on the change in discharge shown in Figure 4.

Pore pressure contours estimated by the transient seepage analyses are presented in Appendix C for time periods of 0.1 hours, 1.1 hours, 3 hours, 8 hours, and 24 hours after the start of the 10-year storm event. The hydraulic boundary condition corresponding to the peak water surface elevation of the 10-year storm event was applied at 0.1 hours. Subsequent hydraulic boundary conditions are time-dependent and correspond to water surface elevation estimates based on the Waterways (2020) hydrograph depicted in Figure 4. The subsurface materials

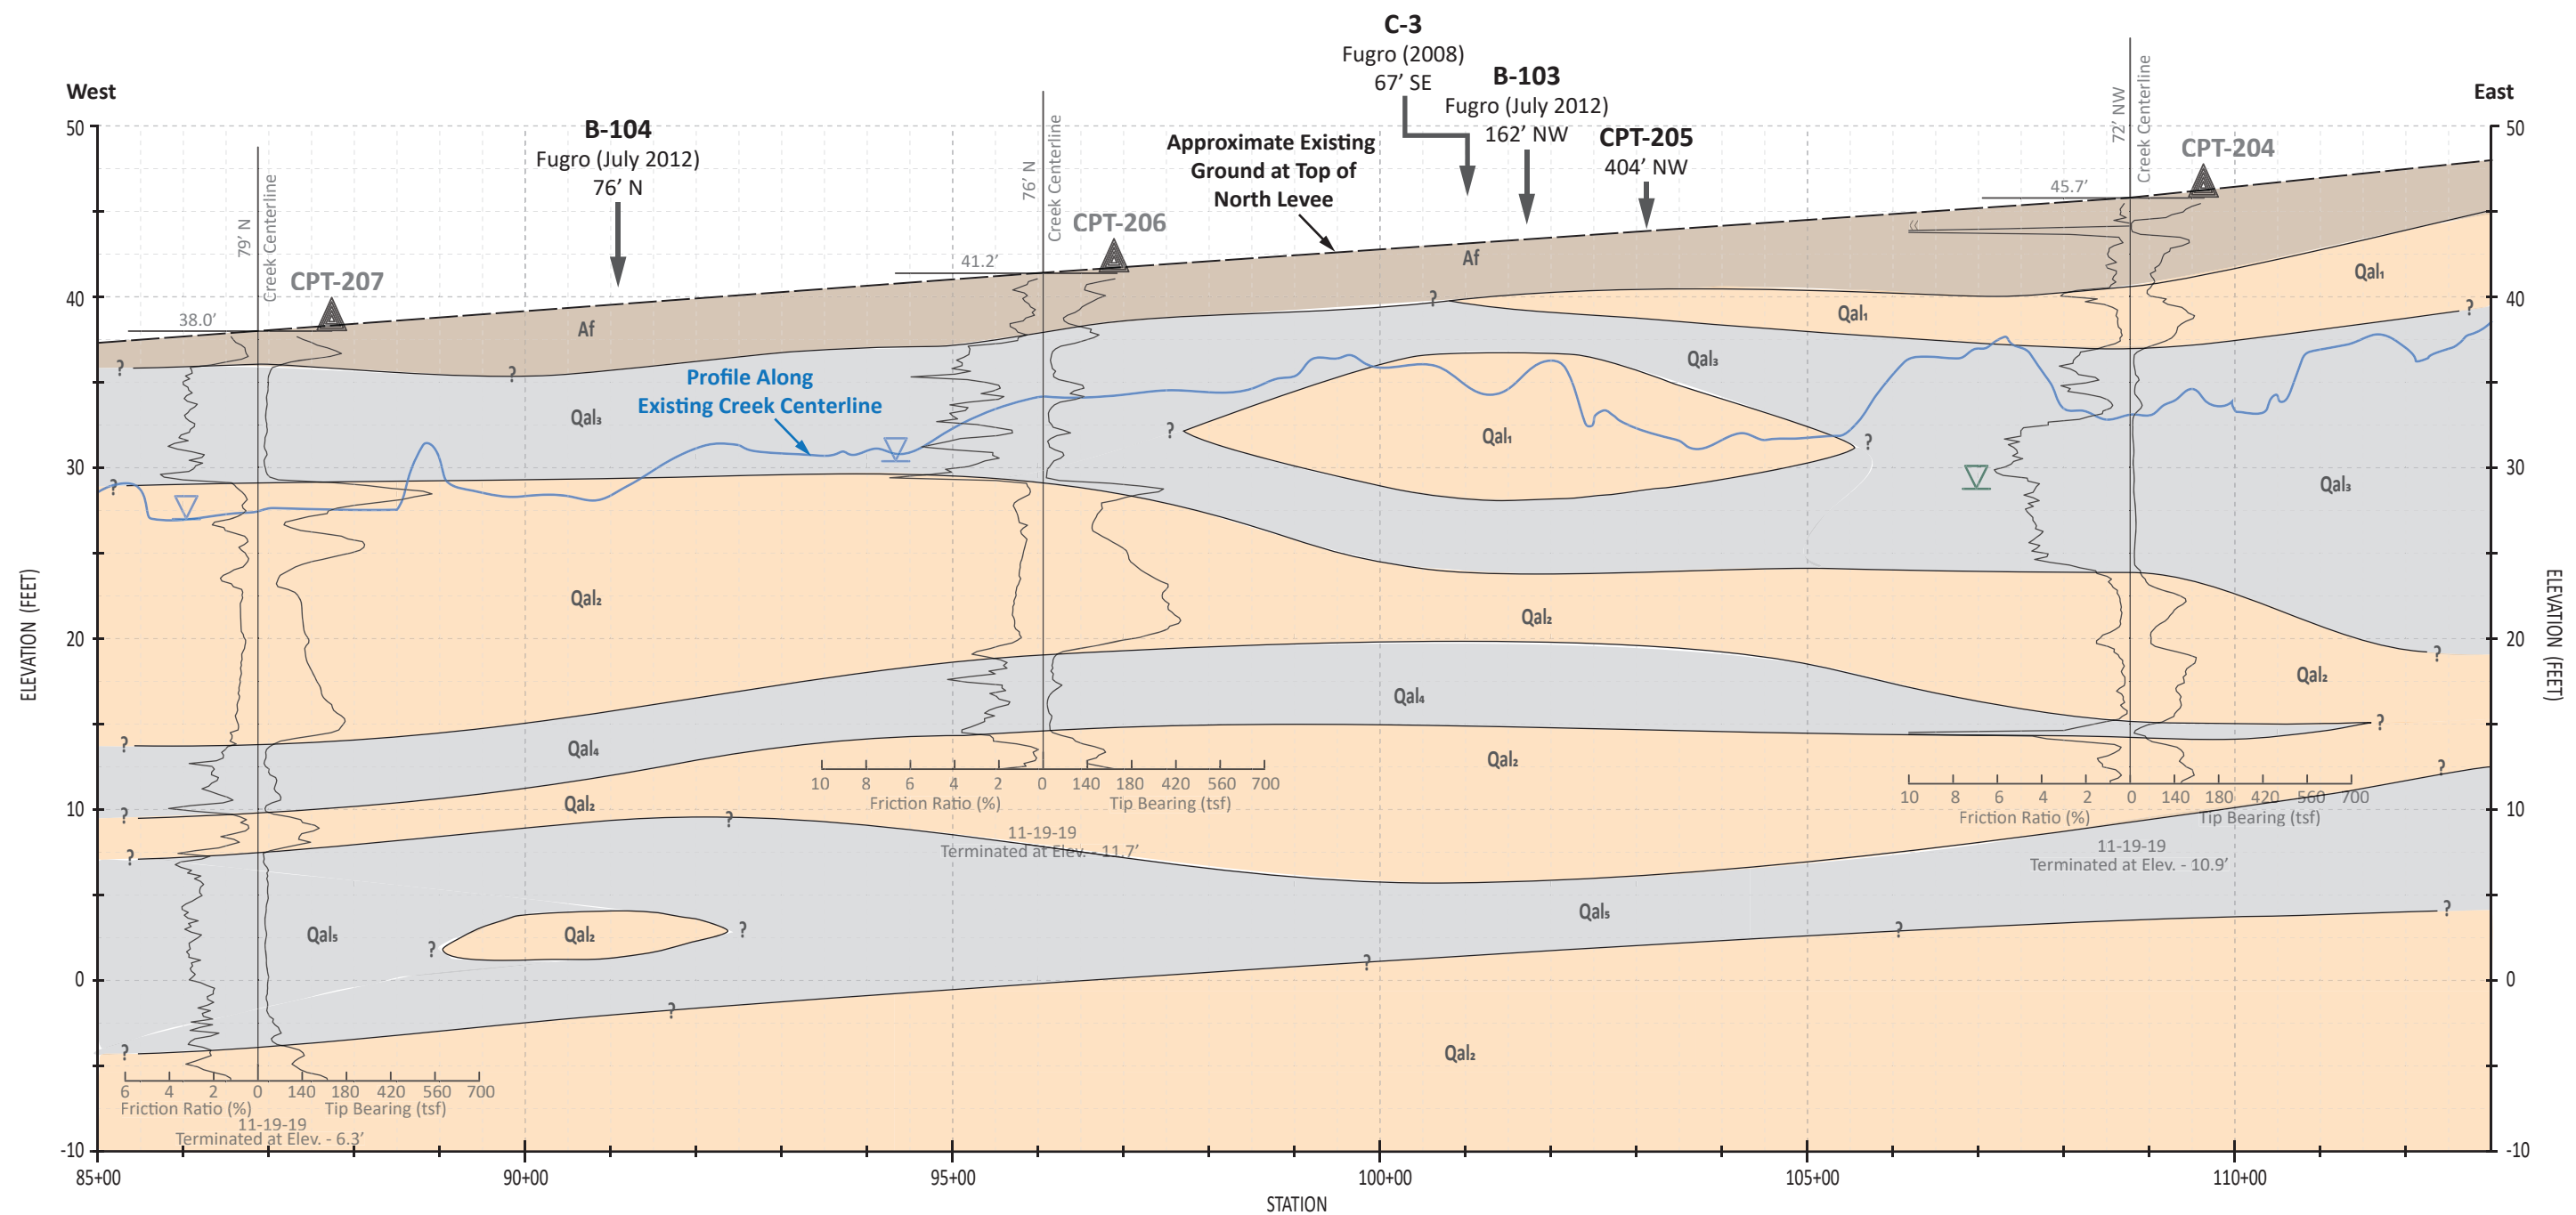
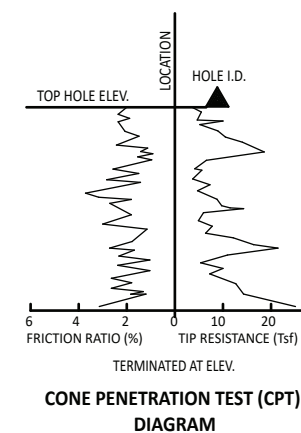
Yeh and Associates, Inc. Geotechnical • Geological • Construction Services	
NORTH LEVEE - INTERPRETED SUBSURFACE PROFILE	
PROJECT NAME: ARROYO GRANDE CREEK CHANNEL WATERWAY MANAGEMENT Arroyo Grande, CA	PLATE 2a
PROJECT NUMBER: 218-169	REVISION DATE: 1/30/2020

interpretation of subsurface conditions encountered below the north levee between approximately Station 85+00 and 140+00 are shown on Plates 2a and 2b. Our interpretation of subsurface conditions is based on the CPT correlations developed by Robertson and Campanella (1986) and is generally supplemented by logs of previous explorations (Fugro 2009, 2012a, 2012b; USGS 2004; Caltrans 1956, 1984; San Luis Obispo County, 1984).

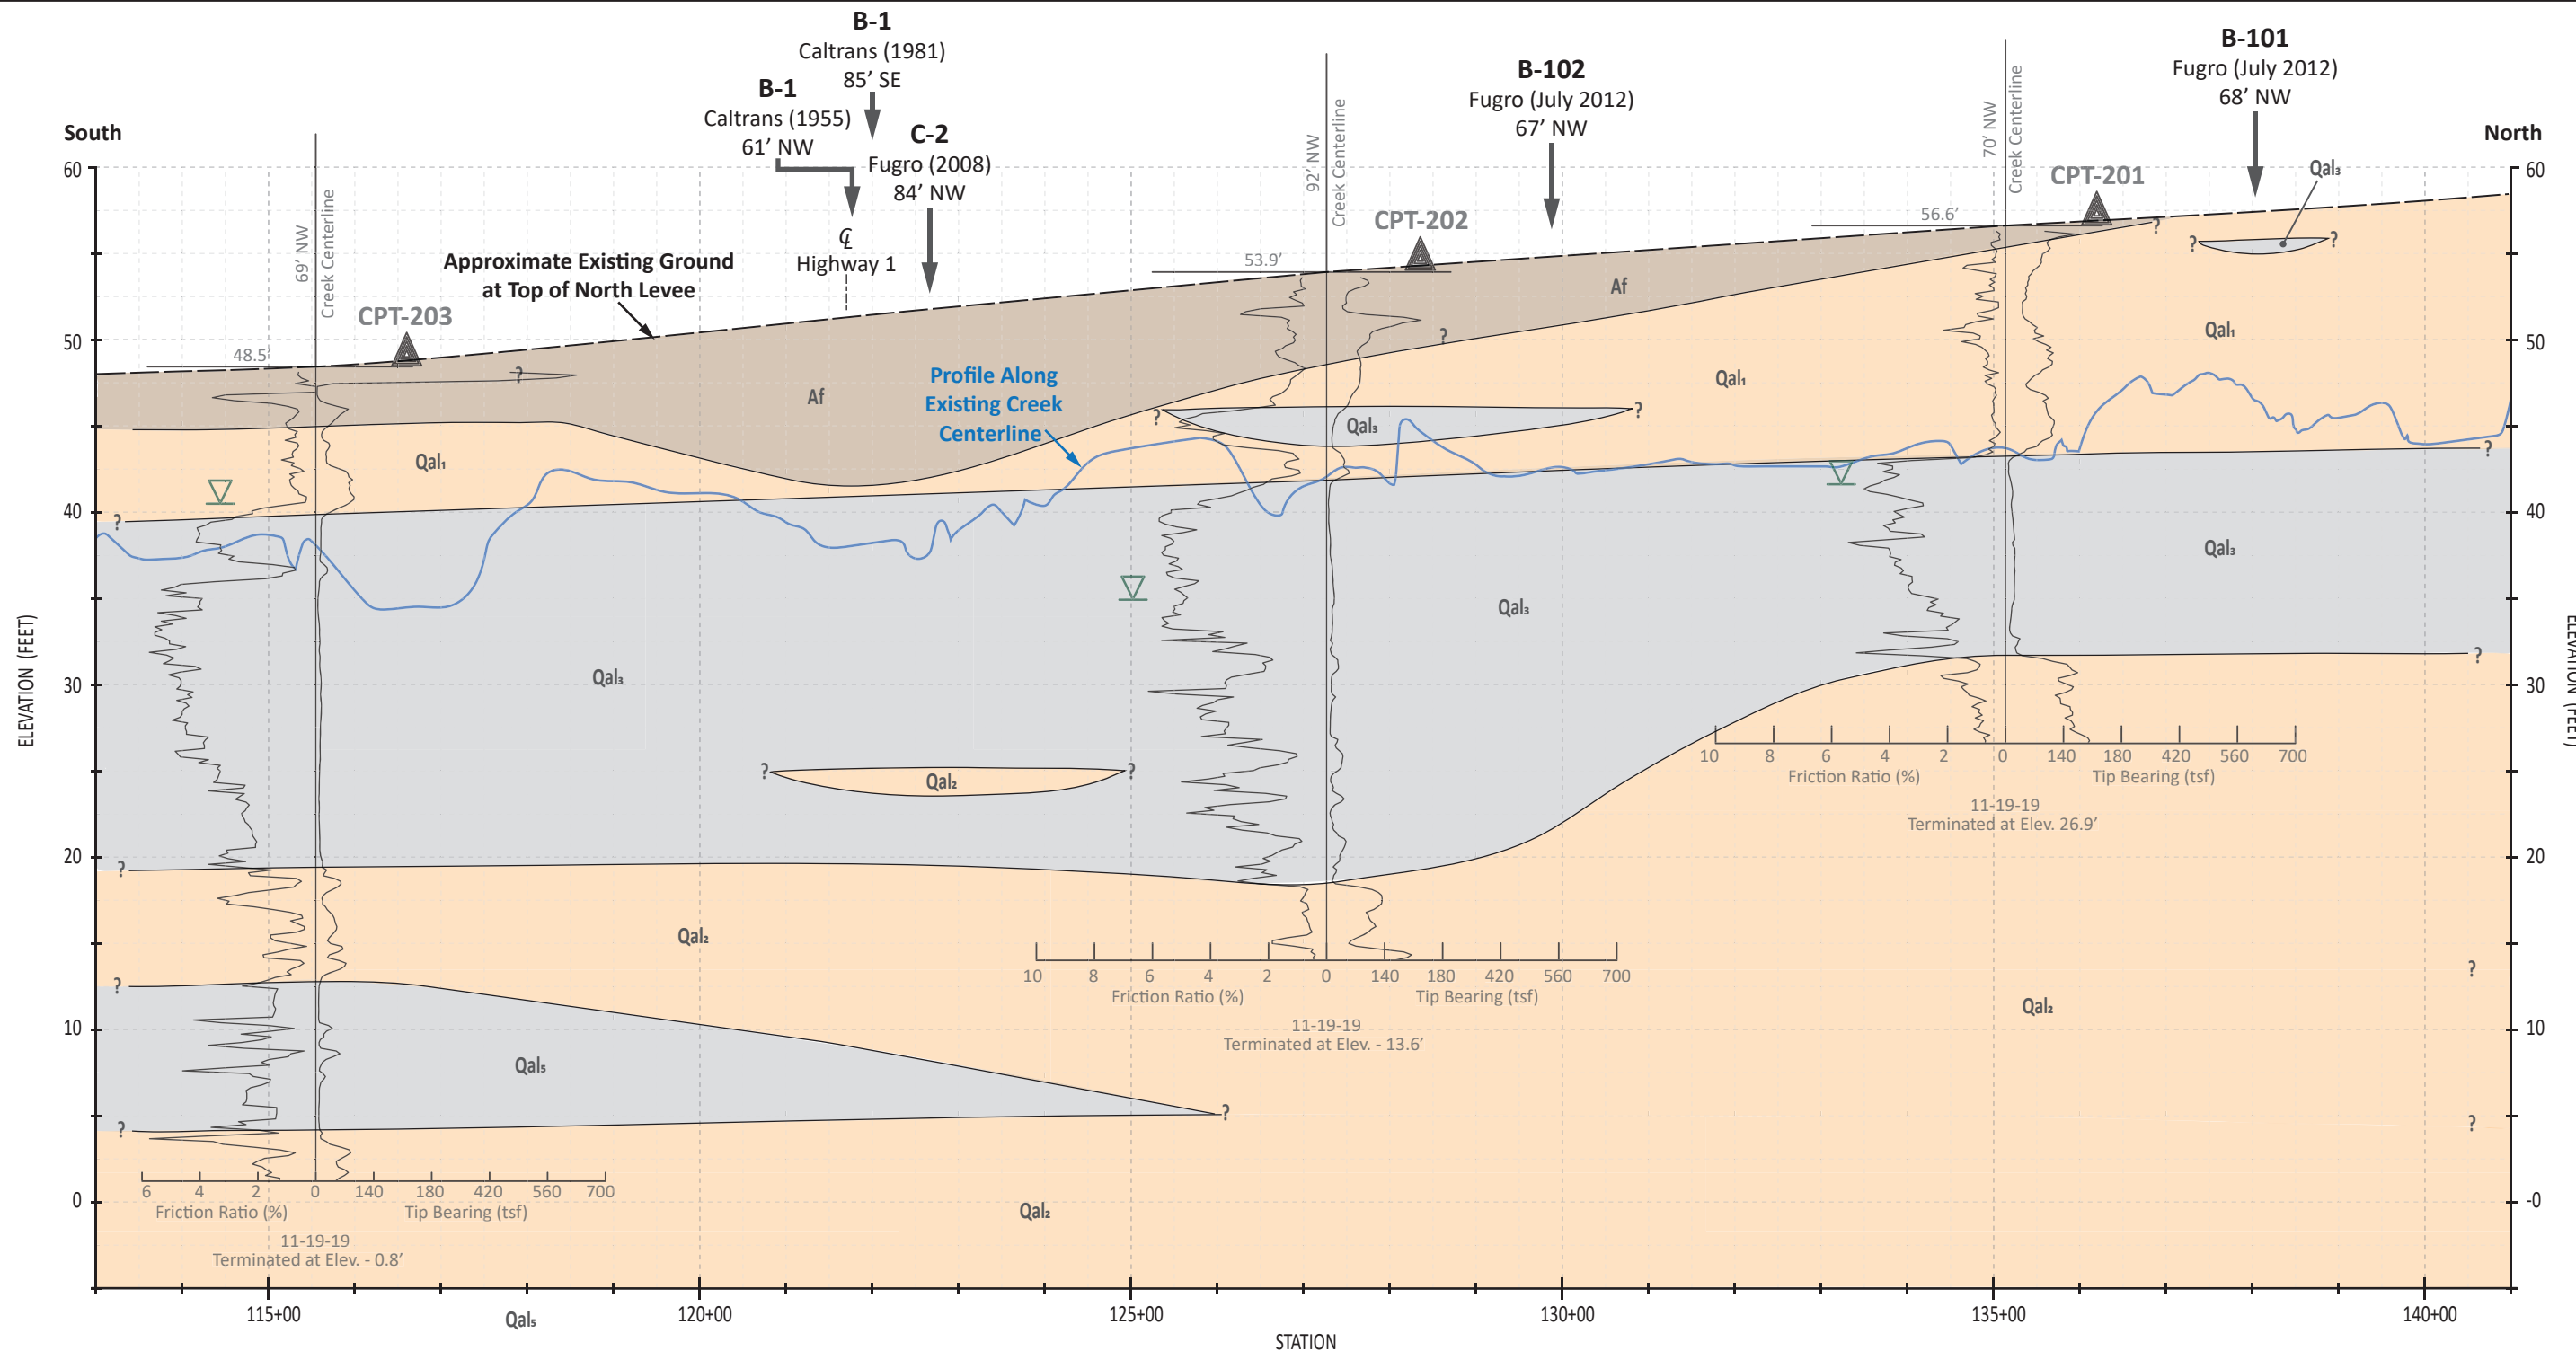
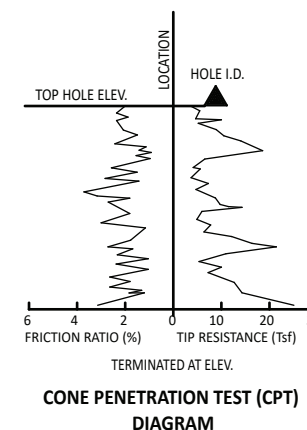
PROJECT NAME: ARROYO GRANDE CREEK CHANNEL WATERWAY MANAGEMENT Arroyo Grande, CA		PLATE 2b
PROJECT NUMBER: 218-169	REVISION DATE: 1/30/2020

Fine-grained alluvium (unit Qa13) encountered at a shallow depth below the levee provides a blanket layer of relatively impervious material that limits underseepage through the foundation soil. The Qa13 unit was not encountered at a shallow depth below the proposed flood wall location or below the levee between approximately Stations 103+00 and 135+00, as shown on Plates 2a and 2b. DWR (2015) states that levees and flood walls without a blanket layer do not meet typical performance criteria for underseepage. As discussed by Fugro (2012b), the potential susceptibility of the north levee to adverse underseepage during a 50-year flood event is potentially influenced by the depth to the relatively impervious Qa13 unit (i.e., blanket layer). Exit gradients estimated by Fugro (2012b) based on steady-state conditions for the 50-year storm event did not meet performance criteria where the Qa13 unit was not present directly below the levee fill. Those analyses results show the potential vulnerability of the levee to underseepage during storm events with longer recurrence intervals than the design 10-year storm event.
