# MEADOW CREEK LAGOON HABITAT RESTORATION

**PRELIMINARY GEOTECHNICAL AND  
GEOLOGIC HAZARDS REPORT**

**Meadow Creek Lagoon Habitat Restoration  
San Luis Obispo County, California**

Yeh Project No.: 220-331

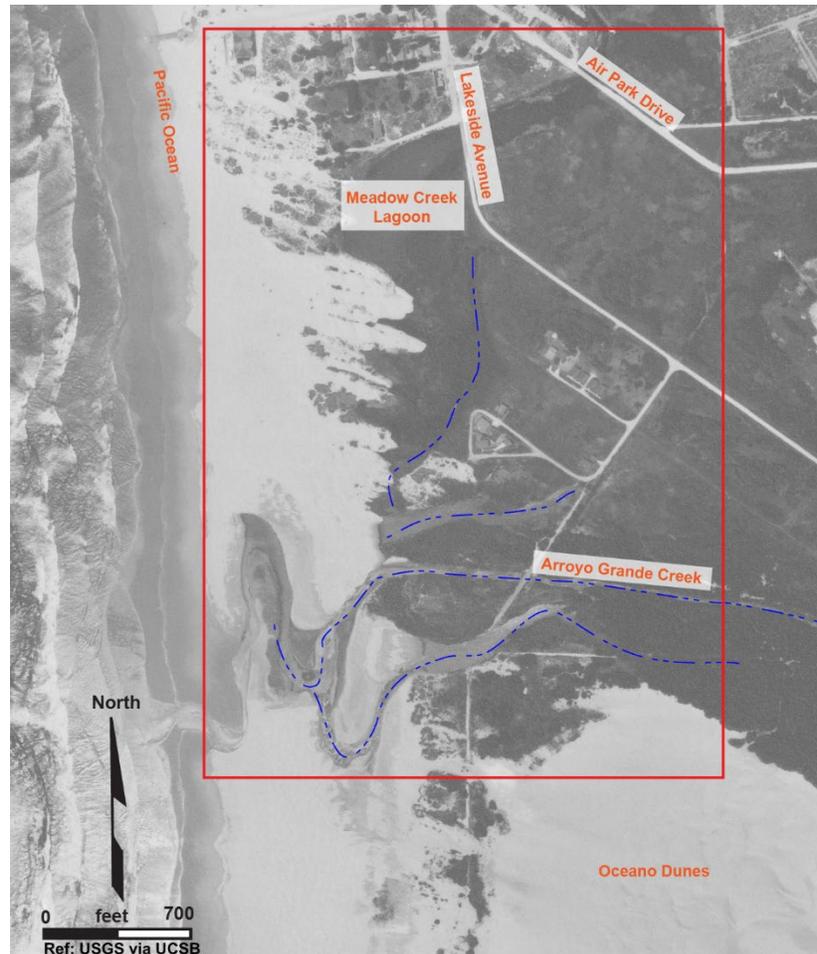
Figure 2: 1940 Aerial Photo

The EDR (2021) Decade Package provided historic aerial photographs of the site. Figure 2 shows the site relative to a 1940 aerial photo (from UCSB 2021) and historic drainages of the Meadow Creek and Arroyo Grande Creek watersheds. The drainages flow west into coastal beach and dune sand deposits and toward the Pacific Ocean near the southern end of the approximate study area (shown as a red rectangle).

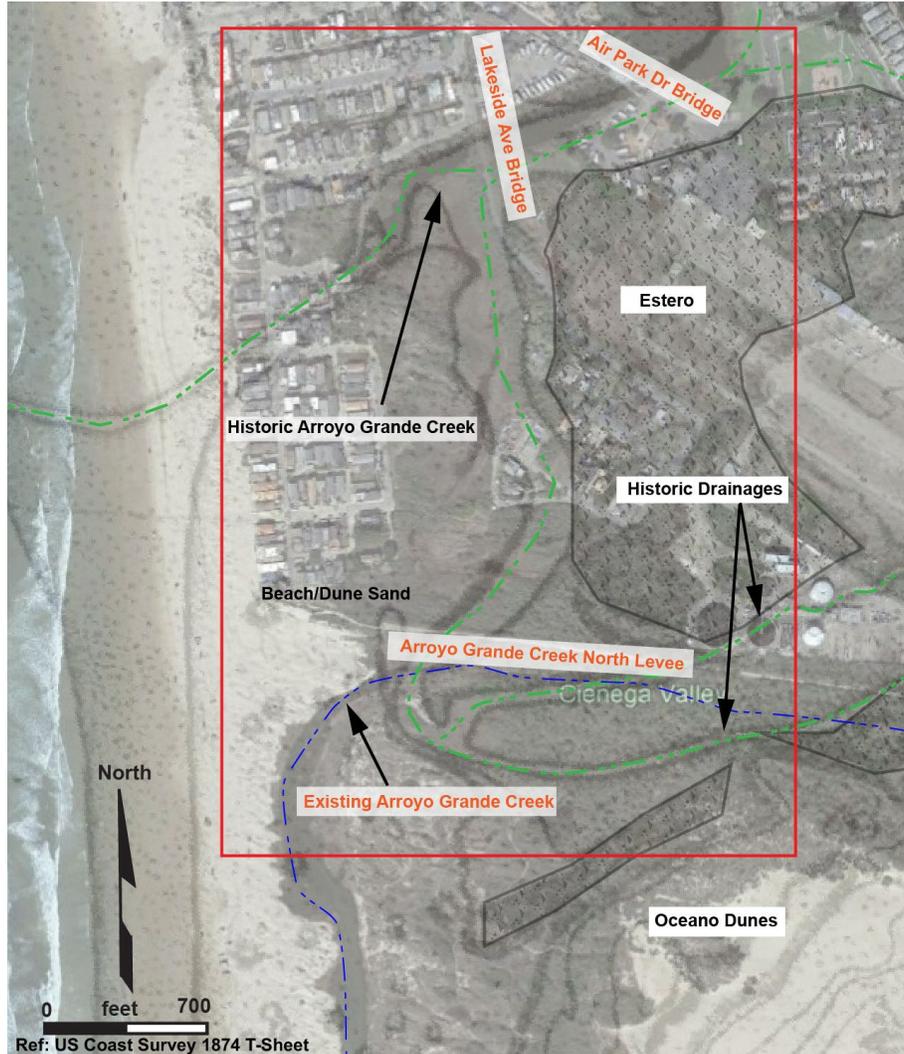
Figure 3: Historic 1874 Survey Overlay

Figure 3 presents an overlay of a recent aerial image and a historic map consisting of T-sheet number 1393 from a mapping project performed in 1874 by the U.S. Coast Survey (NOAA 2021). The figure shows the approximate locations of a historic estero (aka estuary) and historic drainages of Arroyo Grande Creek, the approximate thalweg of the existing creek, and the locations of existing roads and the north levee of Arroyo Grande Creek. The estero was eventually drained and the creeks were channelized to reduce flooding. The historic estero was filled over the last century for the development of surrounding properties, and

Meadow Creek Lagoon is the only remaining trace of the estuary. In addition to the landscape modification by extensive filling, comparison of the 1874 survey and existing Arroyo Grande Creek channel in Figure 3 indicates that much of the original channel was filled and the active channel was relocated southwestward to an excavated channel at its present position (Holzer et. al 2004).

**Artificial Fill (af).** The historic estero shown in Figure 3 was filled to develop the properties surrounding Meadow Creek Lagoon, and the fill likely consisted of levelled dune and beach sands placed on estuarine and alluvial flood-plain deposits. A hybrid designation (Qye/af or Qa/af) is shown on Plate 2 where the surficial contact between young eolian deposits (Qye) or alluvial flood-plain deposits (Qa) and artificial fill (af) could not be distinguished. The fill is anticipated to consist of relatively loose, predominantly coarse-grained soil typical of dune and beach sand deposits.

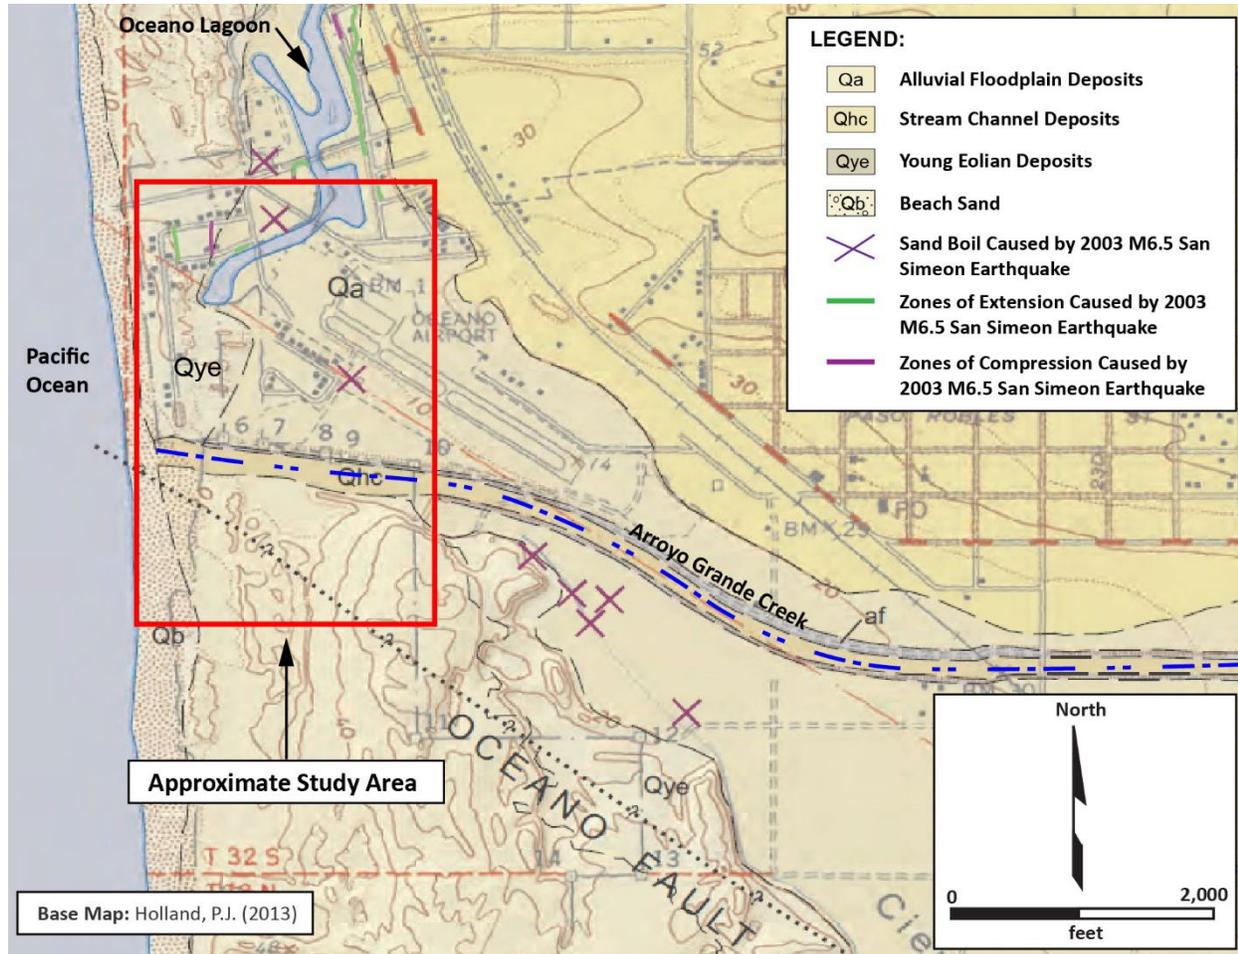
Figure 4: Geologic Map (Holland 2013)

As noted in Holzer et. al (2004), the geology within the study area consists of a complex sequence of interbedded unconsolidated sediments resulting from the interaction of multiple geologic environments that are active in the area, including the floodplains of Meadow and Arroyo Grande Creeks, eolian (windblown) sand dunes, shallow bay, estuary, and marshes, and sandy beaches.

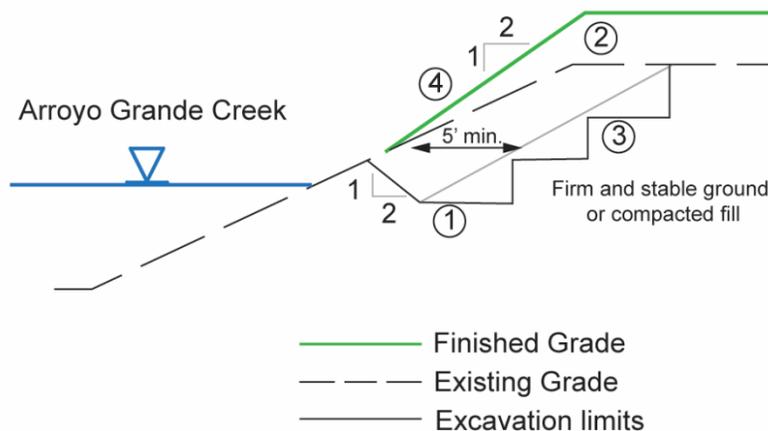
Figure 5: Typical Levee Grading Detail

1. Excavate base key into firm and competent material at the toe of the proposed fill.
2. Place compacted fill per recommendations of the report.
3. Key and bench into existing embankment slope such that the outer 5 feet of the existing embankment is removed. Existing fill and excavated soil can be incorporated into the new fill.
4. Overbuild slope and cut back to expose compacted fill at finished grade.

Where the existing levee embankment will be raised by constructing against an existing slope, the fill materials should be keyed and benched into the existing slope. Typical grading recommendations for improvements to existing levee embankments is summarized in Figure 5.

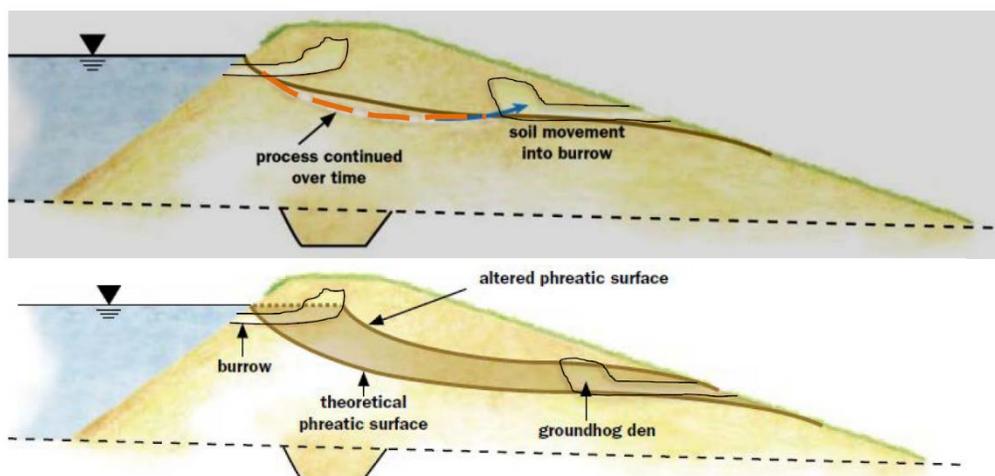
Figure 6: Seepage-related levee failure mechanism due to burrowing animals (FEMA, 2005)

We observed rodent burrows on the interior and exterior slopes and Fugro (2012b) reported probing the levee slopes by hand to depths of up to 4 feet. Burrowing animals and large buried roots of vegetation such as trees that have been removed as part of a vegetation management program can cause extensive void systems within the levees. Subsurface voids generally shorten flow paths through the levee and increase the potential for seepage-related hazards and slope instability. Figure 6 illustrates the potential for seepage-related levee failure mechanism due to burrowing animals. The potential for instability of loose surficial soil and seepage-related hazards during relatively long-duration storm events would be reduced by removal and replacement of the outer 5 feet of the existing levee embankment if the selected project alternative involves modifying the existing north levee of Arroyo Grande Creek.

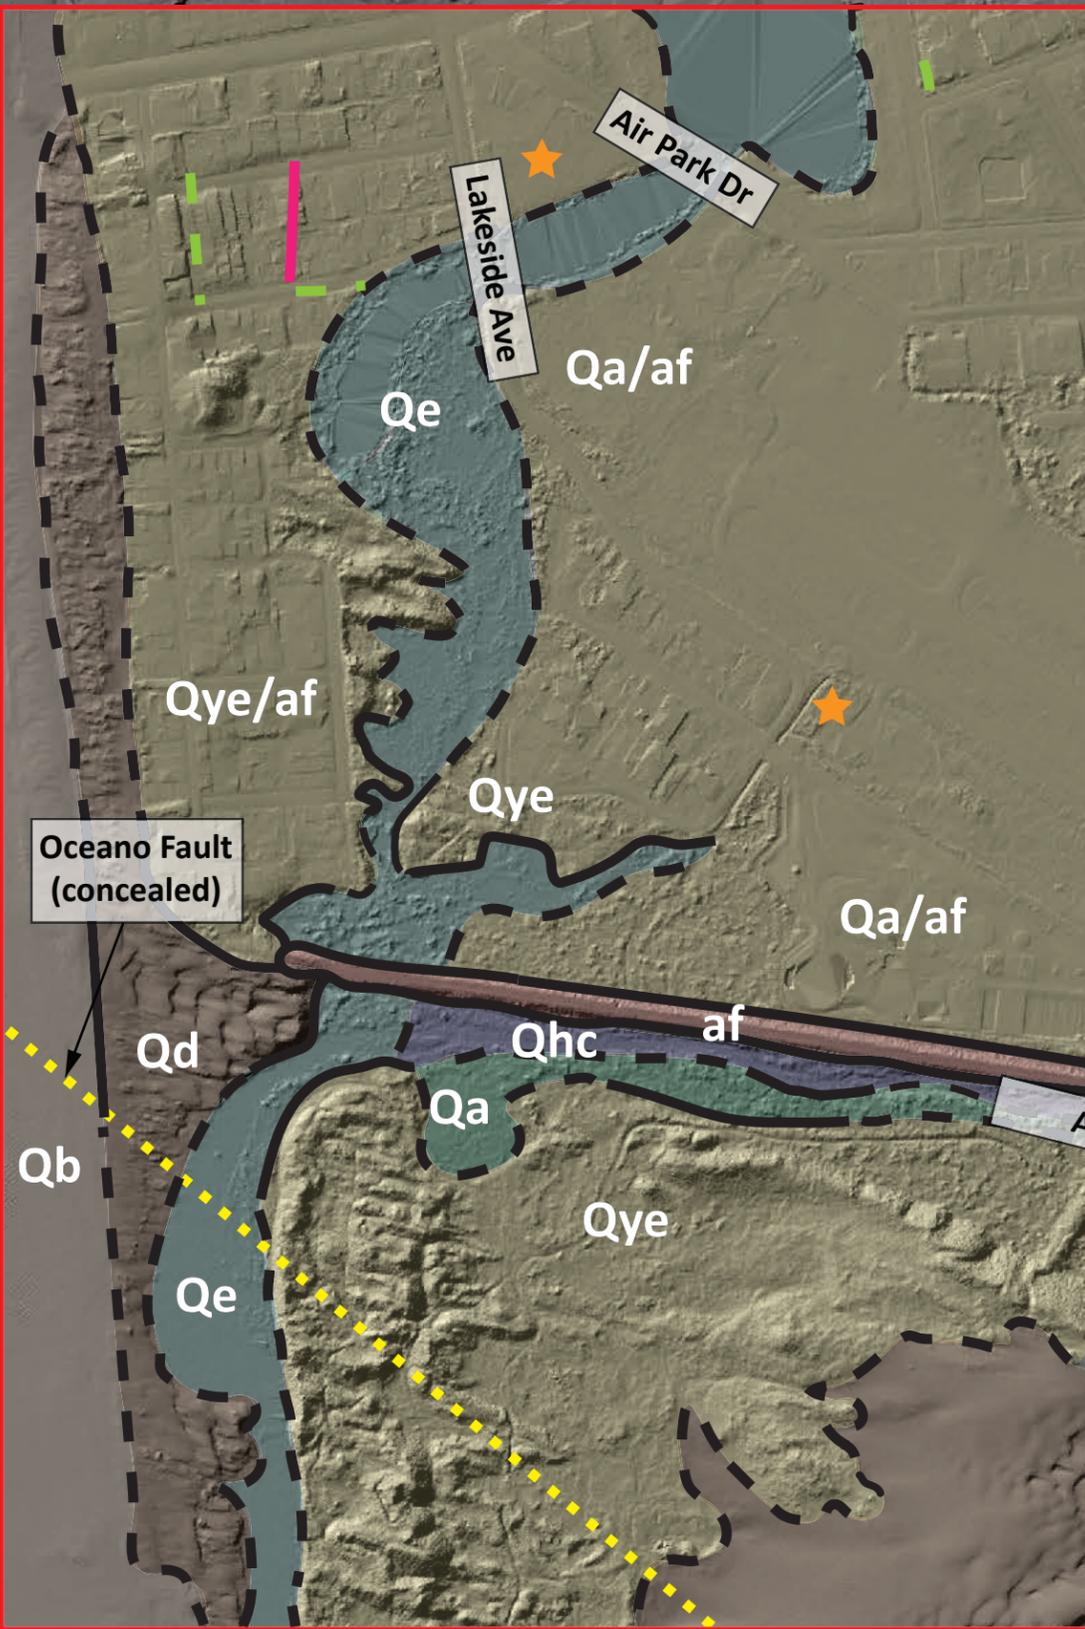
**SITE GEOLOGIC MAP**

- Known Contact Between Map Units
- Approximate Contact Between Map
- Zones of Compression Caused by 2003 M6.5 San Simeon Earthquake
- Zones of Extension Caused by 2003 M6.5 San Simeon Earthquake
- Sand Boil Areas Caused by 2003 M6.5 San Simeon Earthquake

Yeh's mapped interpretation of surficial geology within the study area is shown on Plate 2 – Site Geologic Map and is based on surface conditions observed during our site reconnaissance on September 30, 2021, review of aerial photographs and historical U.S. Coast Survey T-sheets (NOAA 2018), and subsurface information presented in previous studies (Jenks & Harrison 1979; Kleinfelder 2014; Holzer et. al 2004; Fugro 2009, 2012a; Yeh 2019, 2020).

Subsurface conditions within the study area are anticipated to consist of artificial fill (af), estuarine deposits (Qe), stream channel deposits (Qhc), alluvial flood-plain deposits (Qa), beach sand (Qb), dune sand (Qd), and young eolian deposits (Qye), as shown on Plate 2. Descriptions of the units are provided below and based on surface conditions observed during our site reconnaissance and on subsurface information presented in previous studies (Jenks & Harrison 1979; Holzer et. al 2004; Fugro 2009, 2012a; Kleinfelder 2014; Yeh 2019, 2020). The locations of explorations performed by previous studies are shown on Plate 1.

Liquefaction analyses performed by previous studies (Holzer et. al 2004; Fugro 2009, 2012a; Kleinfelder 2014; Yeh 2019, 2020) indicated that the alluvial and eolian deposits consisting of predominantly loose to medium dense sandy soil encountered by those studies was potentially liquefiable. Holzer et. al (2004) mapped evidence of liquefaction that occurred in the study area in response to the 2003 M6.5 San Simeon Earthquake (see Figure 4 and Plate 2). Evidence of liquefaction in the site vicinity consisted of lateral spreading and damage to homes in Oceano, sand boils and seismic settlement at the Oceano Airport, and failure of the south levee on Arroyo Grande Creek approximately 1,800 feet east of the study area (see Plate 2).

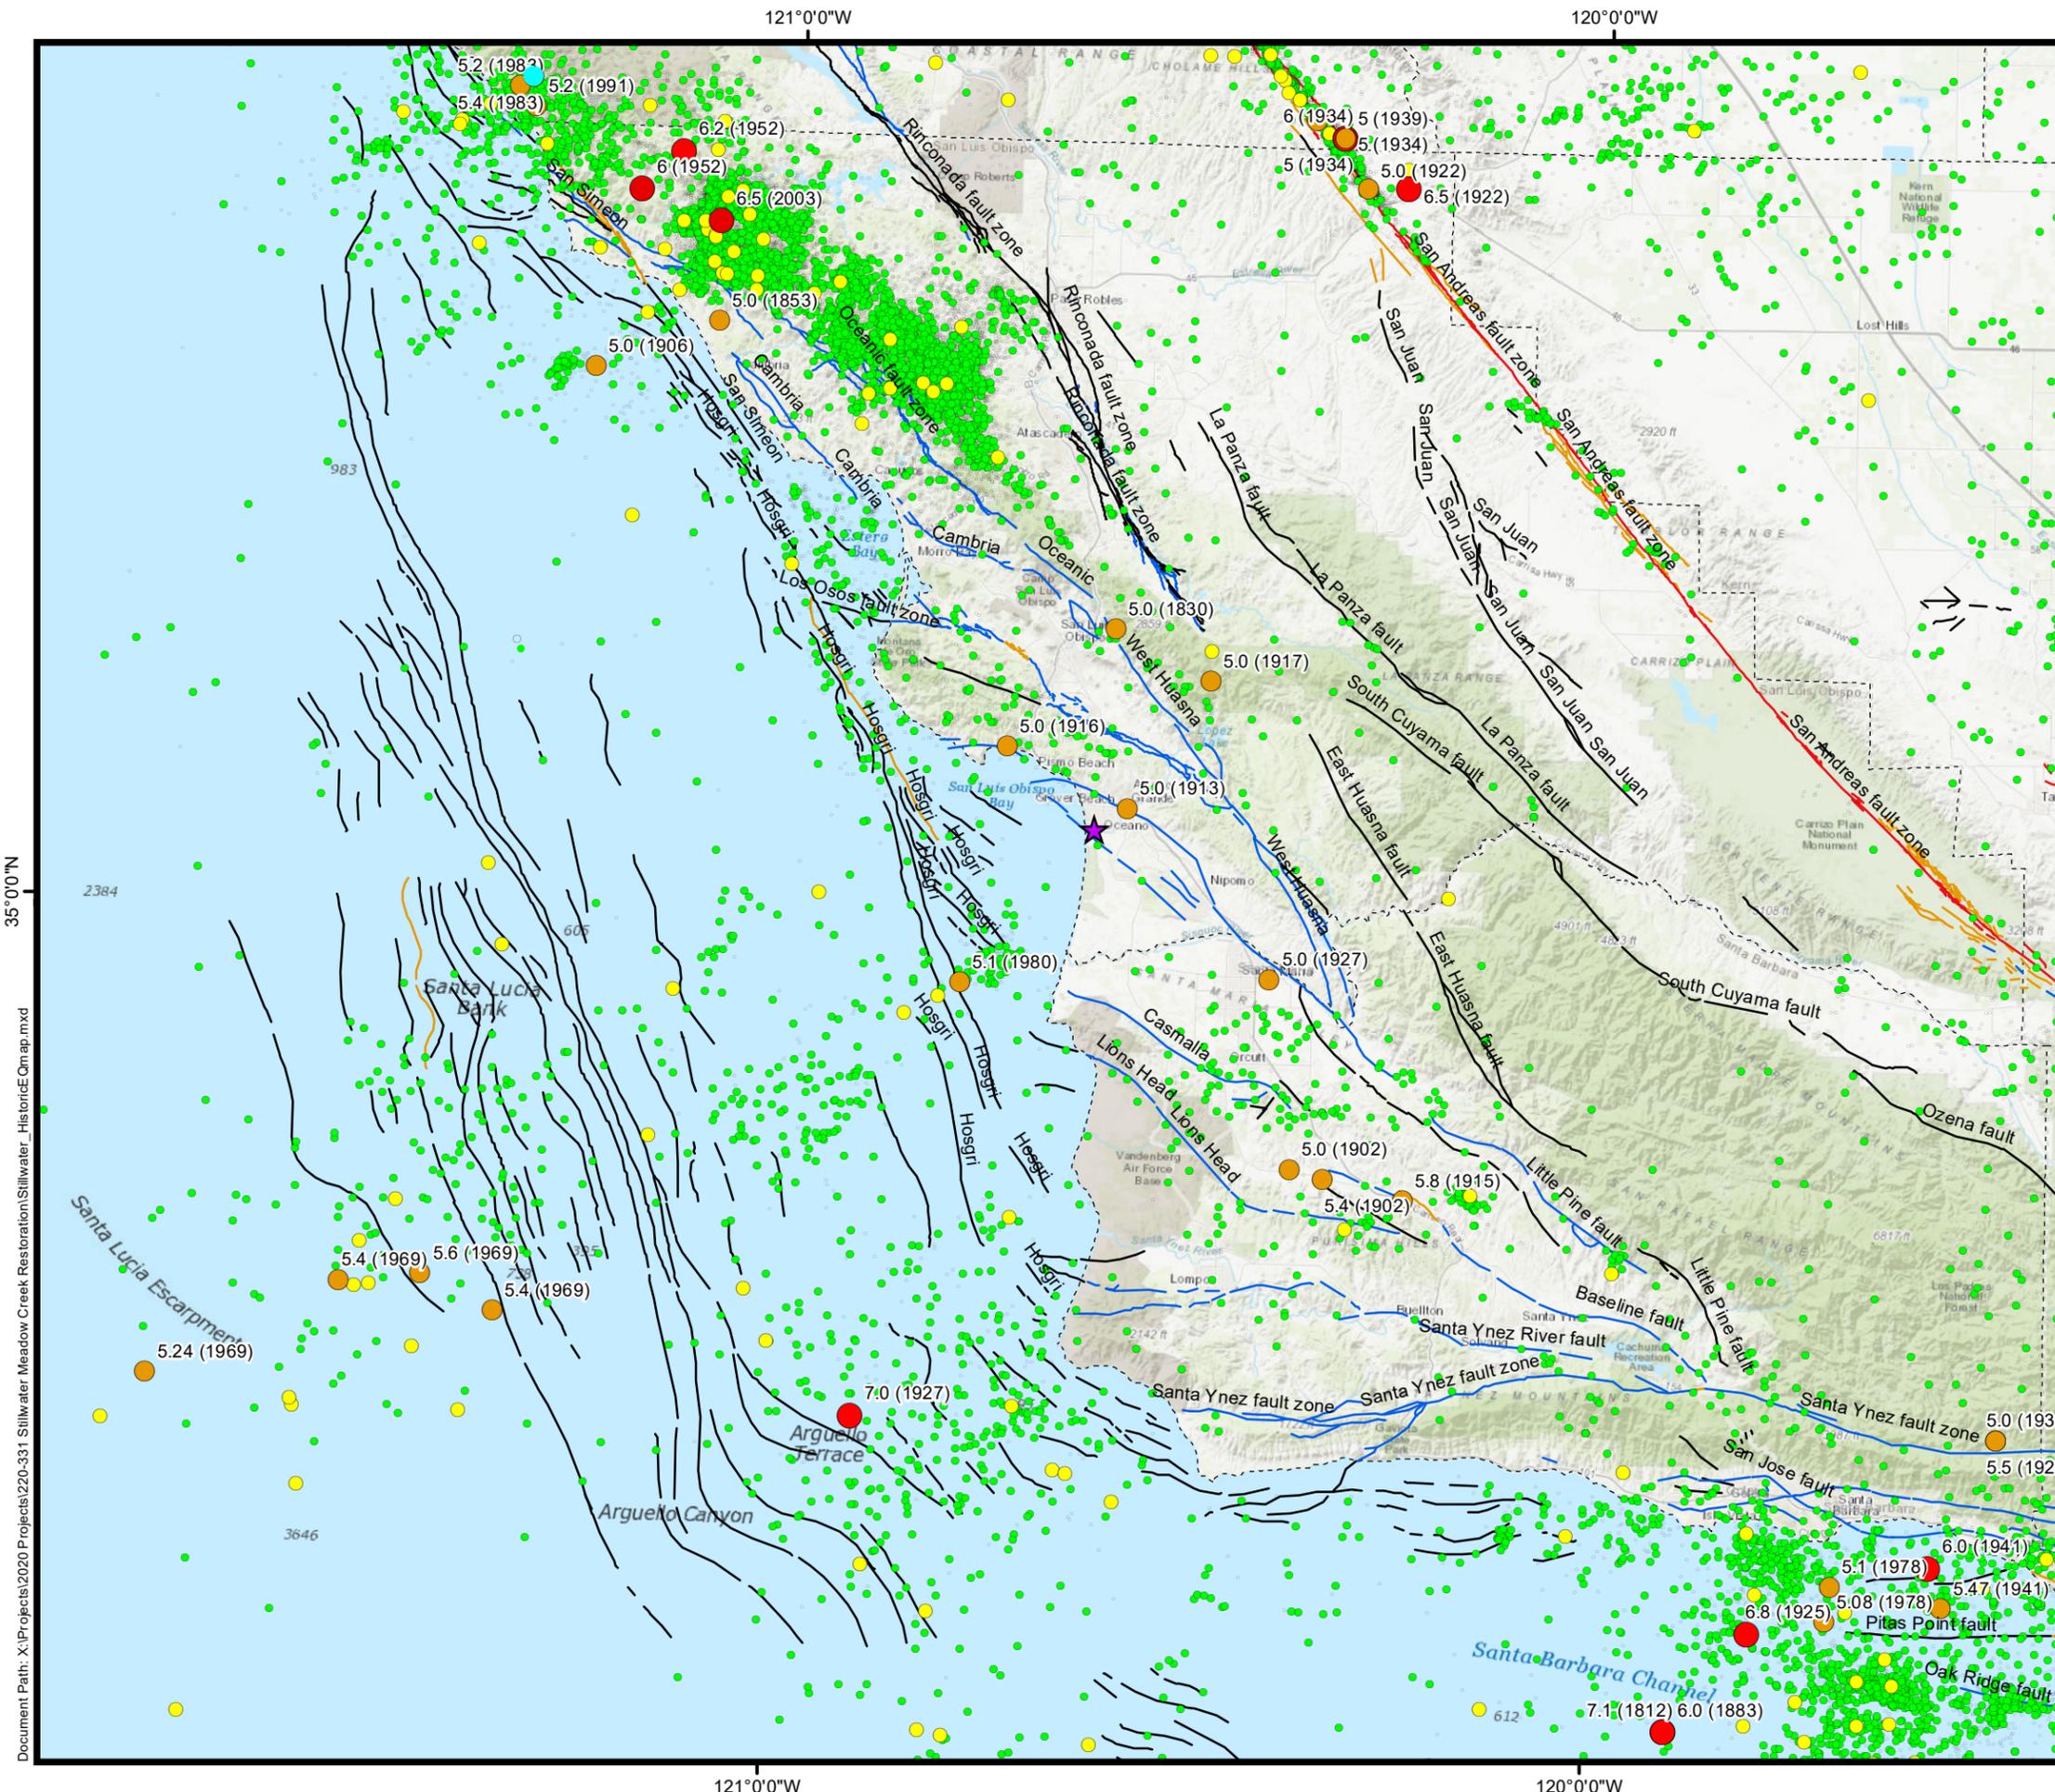
**HISTORIC SEISMICITY AND REGIONAL FAULT MAP**

1) Earthquake Data:  
 Earthquake epicenters from:  
 a) ANSS Composite Catalog Search, 1931 to 2021  
 <www.ncedc.org/anss/> (Downloaded October 2021)  
 b) "Seismotectonic framework, coastal central California",  
 Seismotectonics of the Central California Coast Range,  
 Special Paper 292, Geological Society of America, 1994.

2) Faults:  
 Bryant, W.A. (compiler), 2005, Digital Database of Quaternary  
 and Younger Faults from the Fault Activity Map of California,  
 version 2.0:  
 California Geological Survey Web Page,  
 <http://www.consrv.ca.gov  
 /CGS/information/publications/QuaternaryFaults\_ver2.htm>  
 (Downloaded June 2016)

The faults shown on Plate 3 are classified as Historic, Holocene, Late Quaternary, or Quaternary. CGS defines these terms based on the age of a fault as follows:

The Hosgri Fault Zone is mapped trending northwest approximately 11.2 miles northwest of the study area (see Plate 3). An approximate 19.3-mile-long length of the Hosgri Fault Zone is classified by CGS (Bryant, 2005) as an active (Holocene) fault. A concealed trace of the Oceano fault is mapped trending northwest within the southwestern limits of the study area (see Plate 2). The Oceano fault is considered a part of the San Luis Range fault system and is classified by CGS (Bryant, 2005) as a potentially active (late Quaternary) northwest trending fault. The County of San Luis Obispo (1999) noted that the Oceano fault “is conservatively considered to be potentially active by current state standards,” and the County’s (2021) Land Use View mapping tool classifies the fault as inactive.

record. A summary of magnitude 2.0 and greater seismic events recorded from 1931 through 2021 by the Advanced National Seismic System (ANSS 2021) and Clark et al. (1994) is shown on Plate 3 – Historic Seismicity and Regional Fault Map. The project has been impacted by historic earthquakes (such as the 2003 San Simeon Earthquake). The primary effects of strong ground motion will generally be those phenomena associated with seismic shaking and/or ground acceleration, which are discussed in subsequent sections of this report.

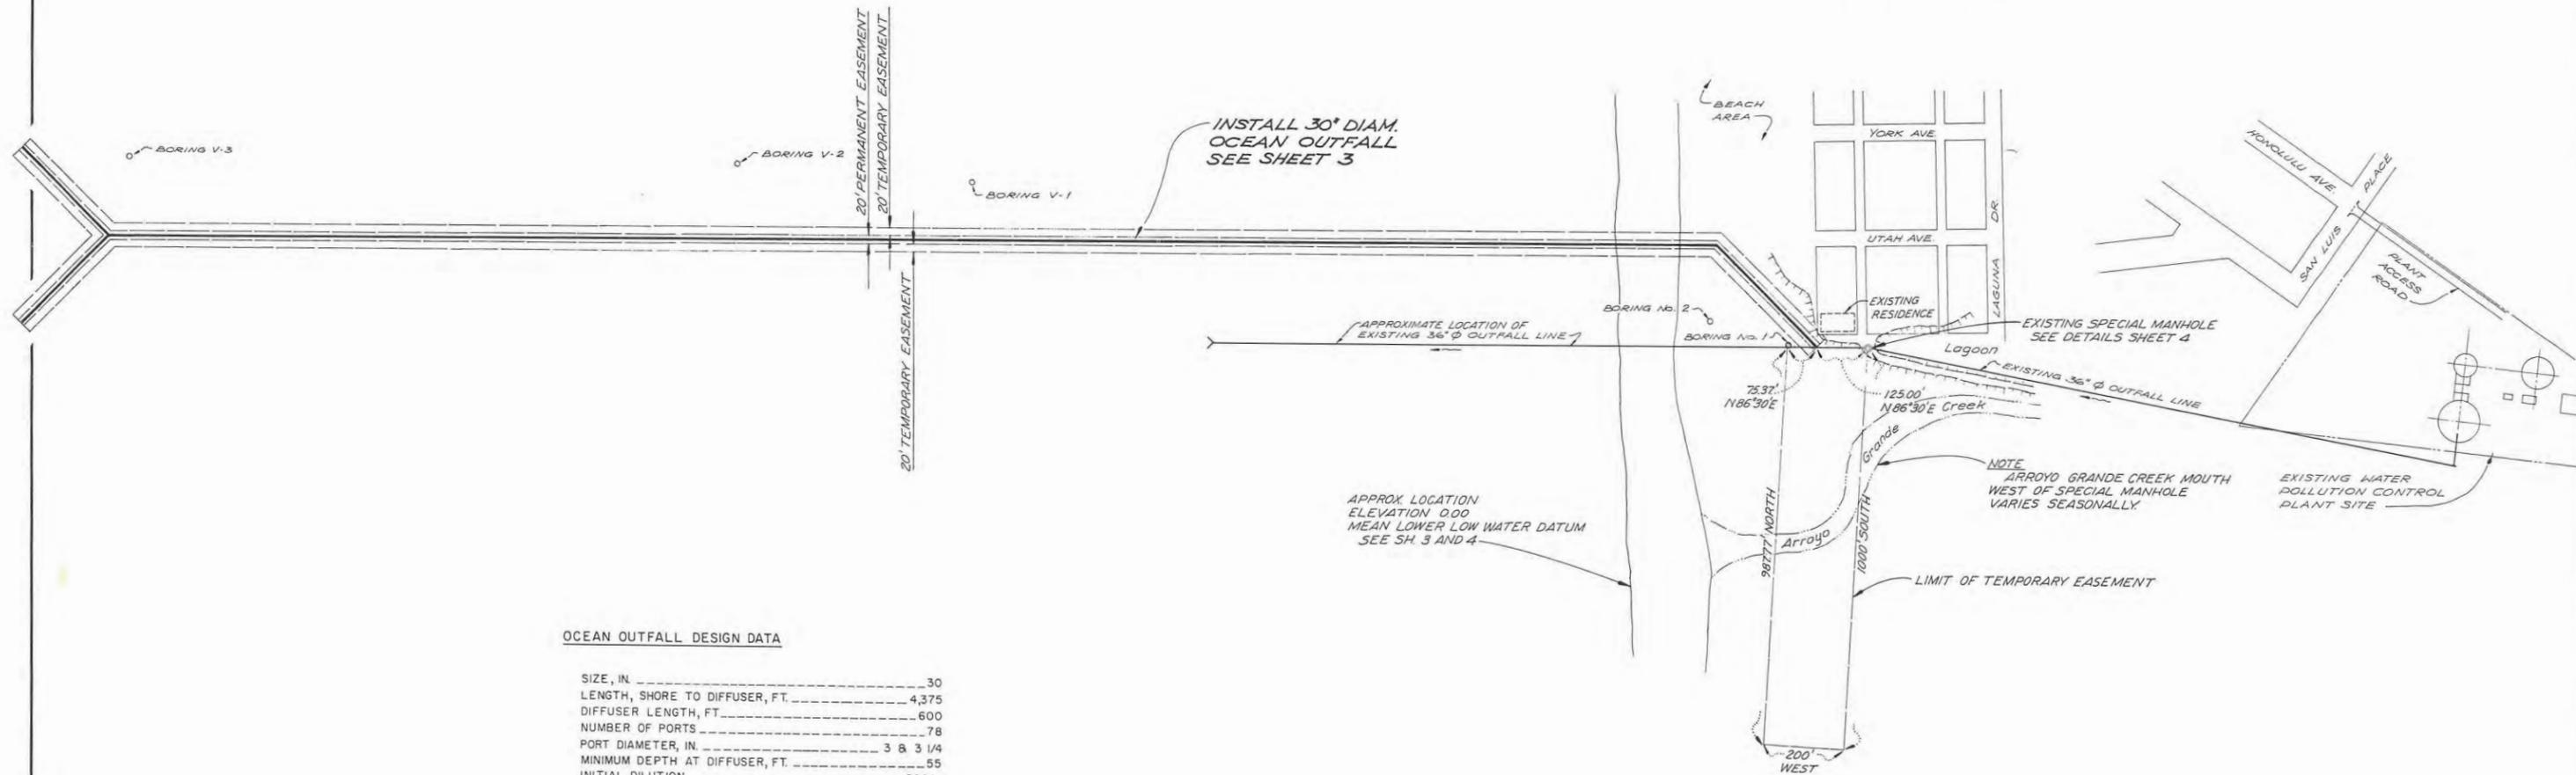
**OCEAN OUTFALL DESIGN DATA**

SIZE, IN	30
LENGTH, SHORE TO DIFFUSER, FT.	4,375
DIFFUSER LENGTH, FT.	600
NUMBER OF PORTS	78
PORT DIAMETER, IN.	3 & 3 1/4
MINIMUM DEPTH AT DIFFUSER, FT.	55
INITIAL DILUTION	200 : 1
CAPACITY AT MAX. TIDE, MGD	8.5

SO. SAN LUIS OBISPO CO. SANITATION DISTRICT SAN LUIS OBISPO COUNTY, CALIFORNIA	
WASTEWATER WORKS IMPROVEMENTS	
OCEAN OUTFALL	
SITE PLAN	
JENKS & HARRISON CONSULTING SANITARY & CIVIL ENGINEERS	
Drawn by: CS SLH	Scale: 1" = 200'
Des/Chd by: HLH DAB	Date: DEC. 1978

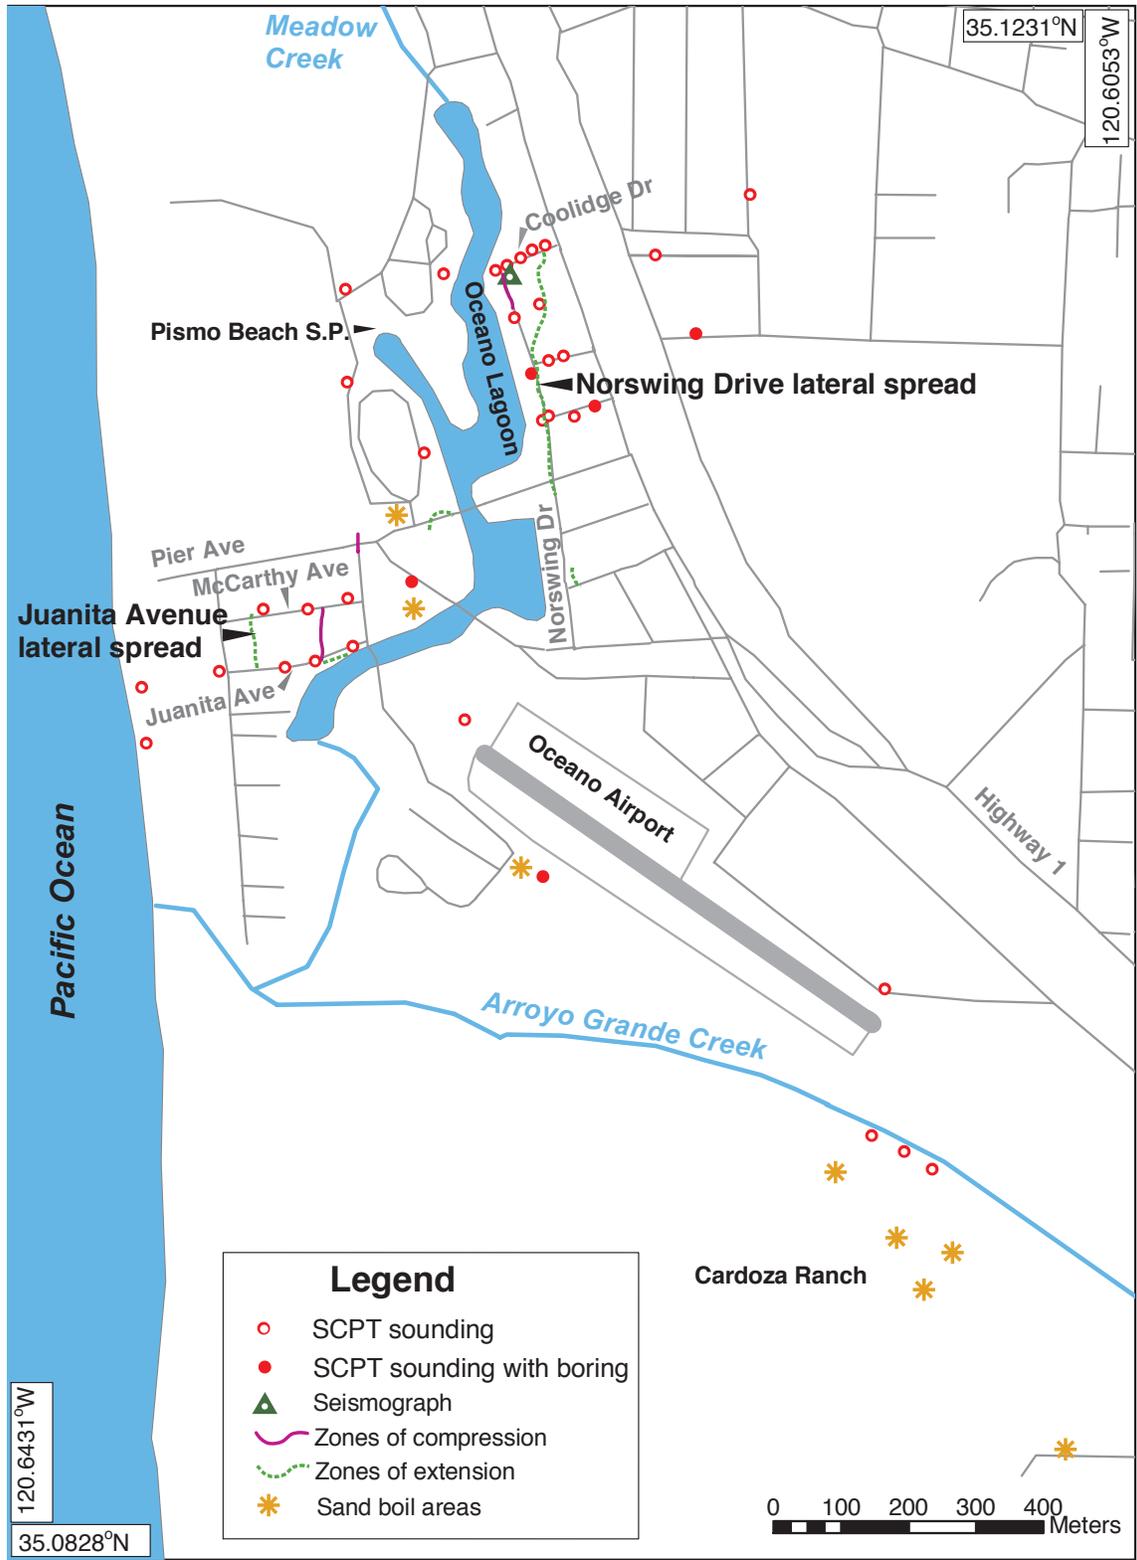
Figure 3. Map of Oceano, California, area with ground failure and liquefaction areas, USGS SCPT soundings and borings, and portable digital seismograph.

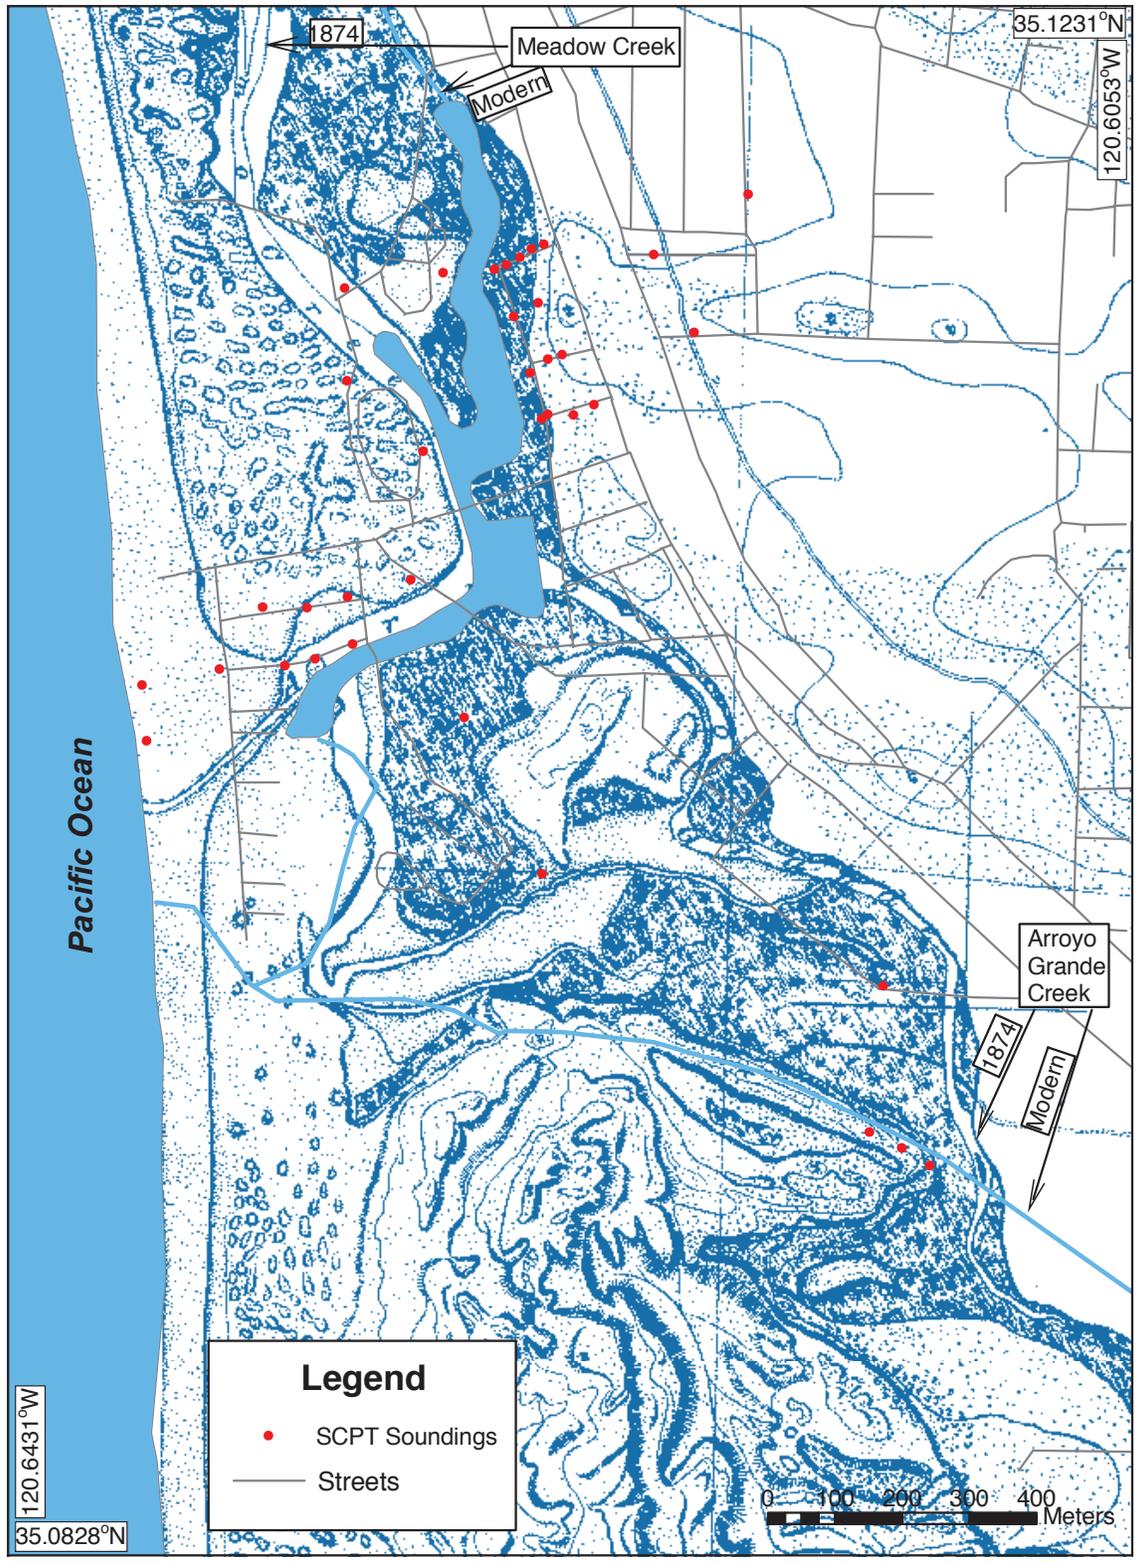
Figure 4. Oceano portion of 1873-1874 U.S. Coast Survey T-sheet 1393 with road network, modern hydrography (in light blue), and locations of USGS SCPT soundings superimposed. Stippled pattern denotes sandy areas including dune fields. Dark pattern denotes marshes along Meadow and Arroyo Grande Creeks.

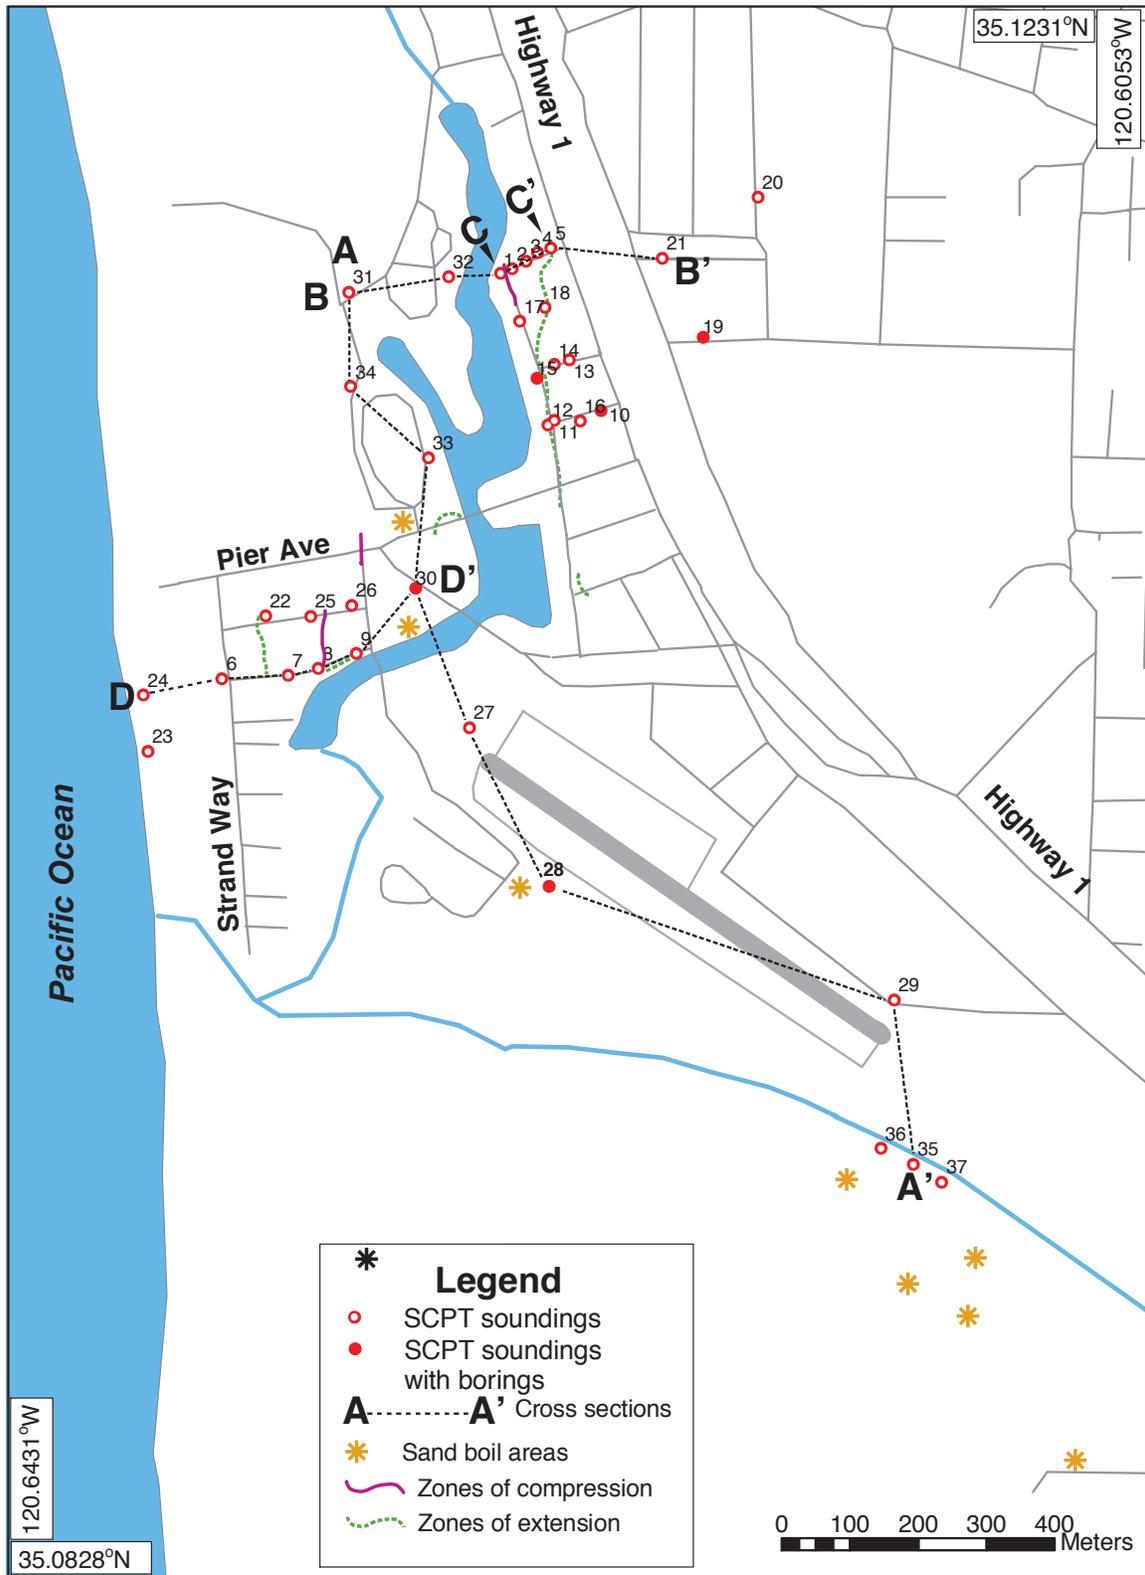
Figure 5. Locations of cross sections, Oceano.

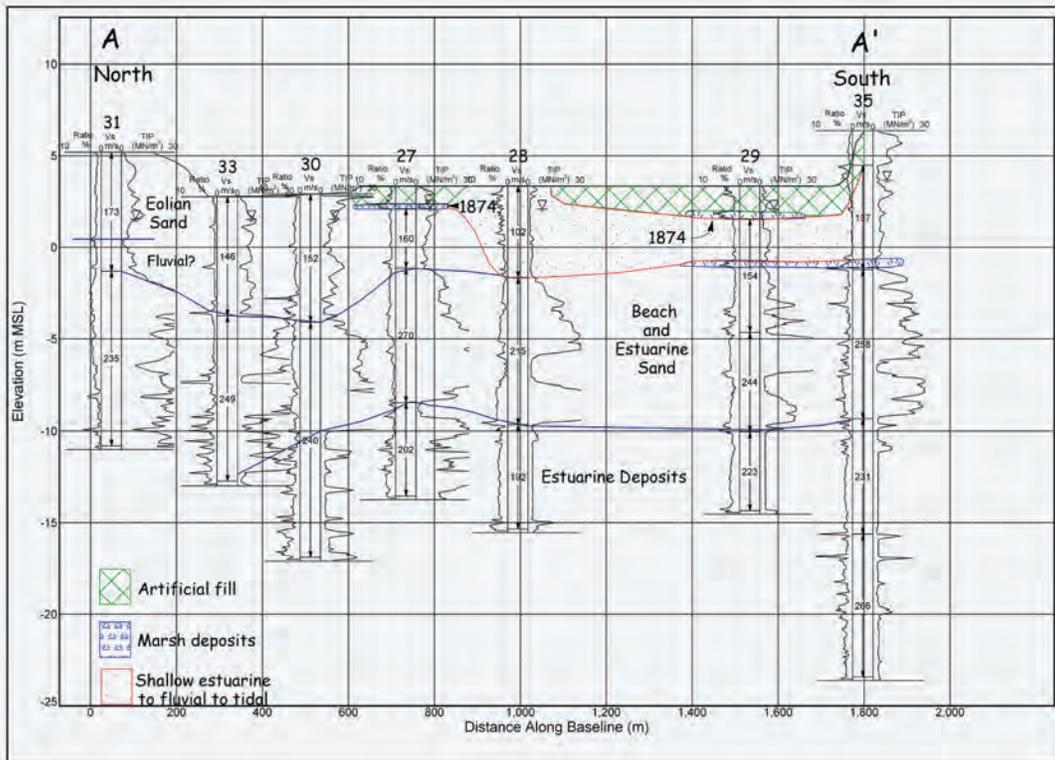
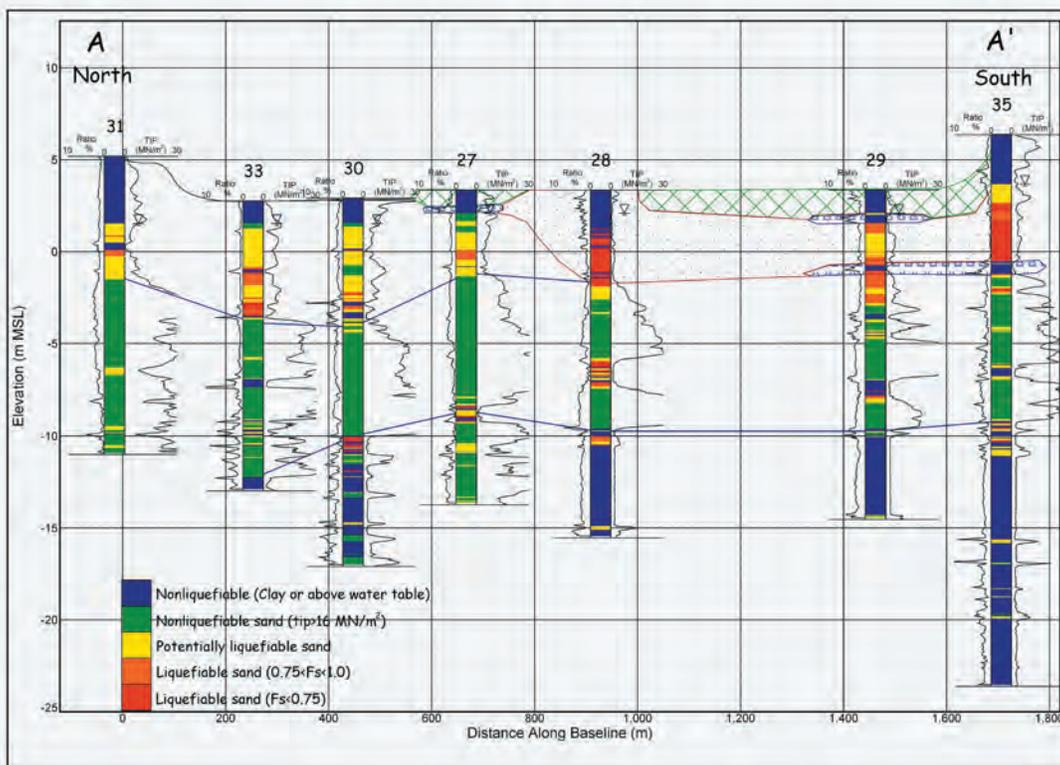
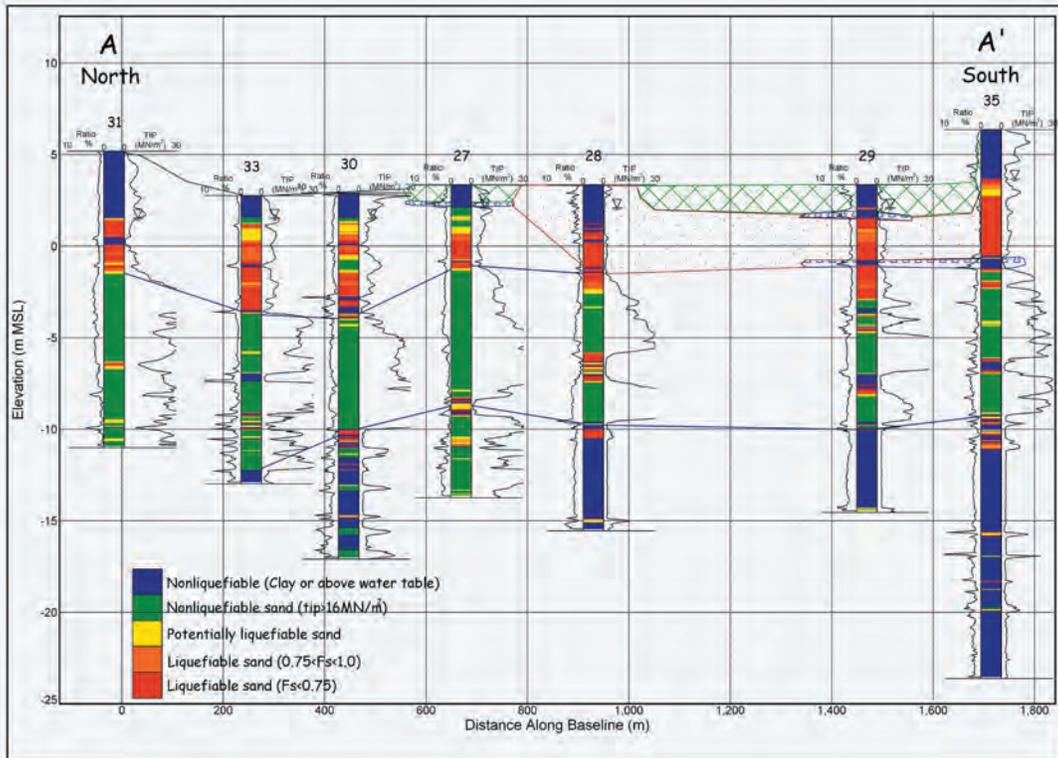
Figure 6. North-south cross section (A-A') at Oceano of generalized shallow subsurface conditions based on SCPT soundings. See Figure 5 for location of cross section. Cross section includes profiles of CPT tip and friction ratio, geologic units, and water table with (a) shear-wave velocity ( $V_s$ ), (b) liquefaction factors of safety for a M6.5 and PGA=0.25 g, and (c) liquefaction factors of safety for a M6.8 and PGA=0.4 g.
