# MEADOW CREEK LAGOON HABITAT RESTORATION

**PRELIMINARY GEOTECHNICAL AND  
GEOLOGIC HAZARDS REPORT**

**Meadow Creek Lagoon Habitat Restoration  
San Luis Obispo County, California**

Yeh Project No.: 220-331

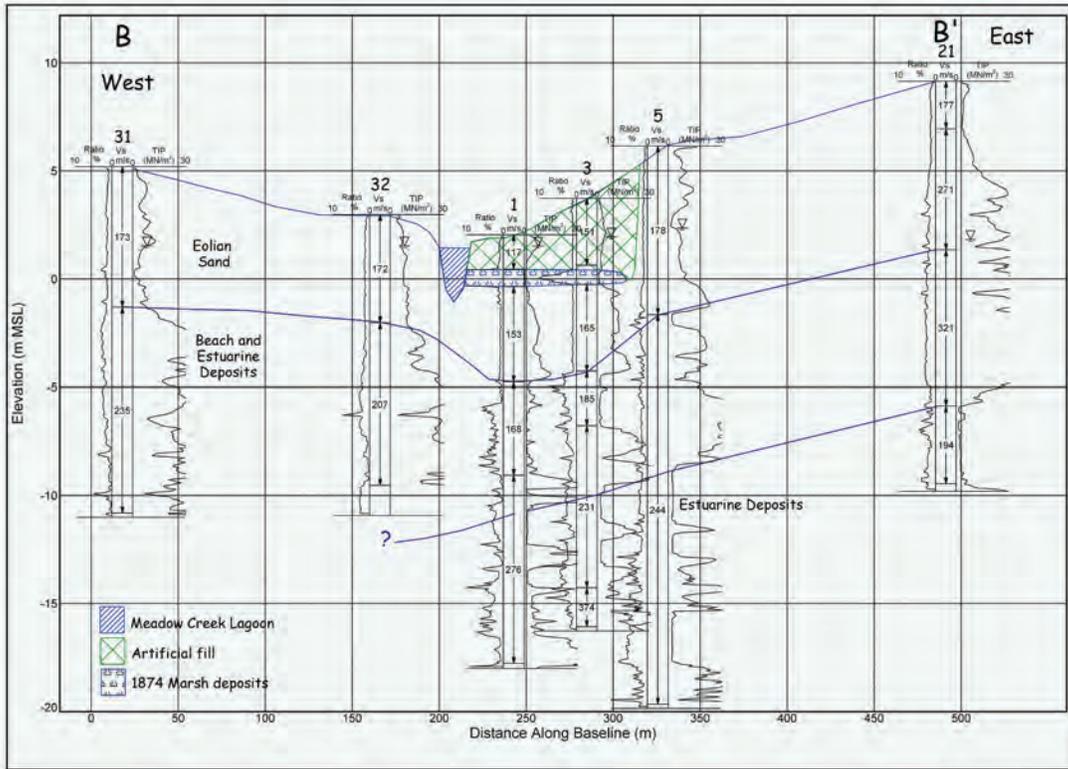
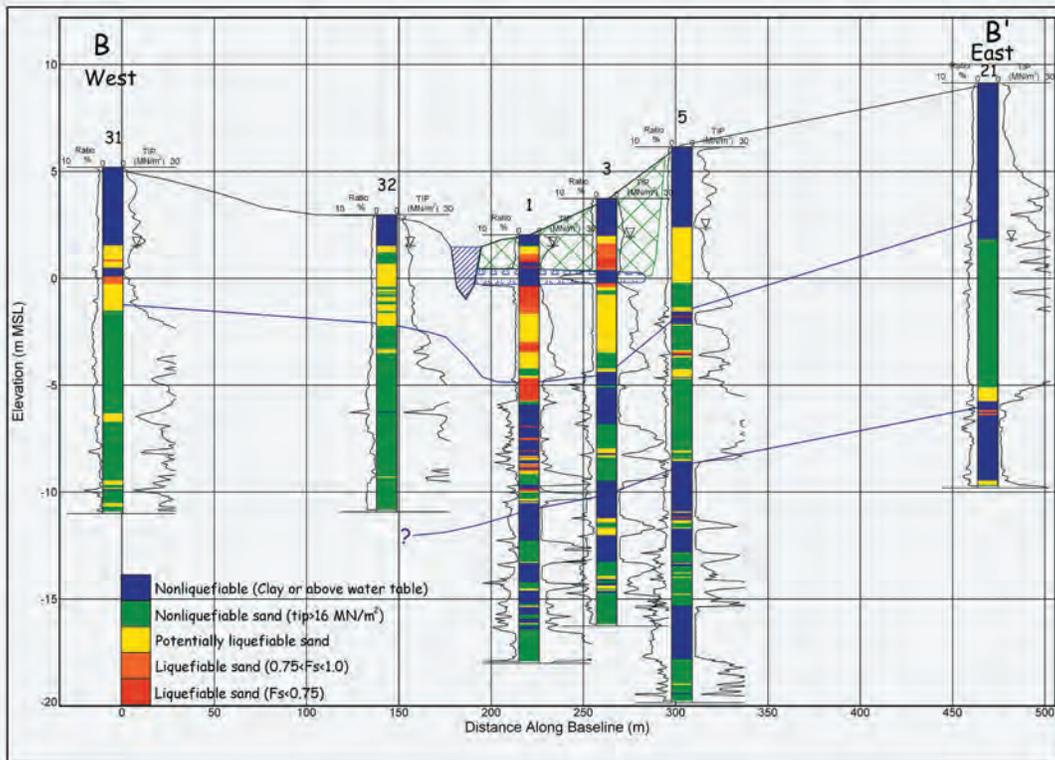
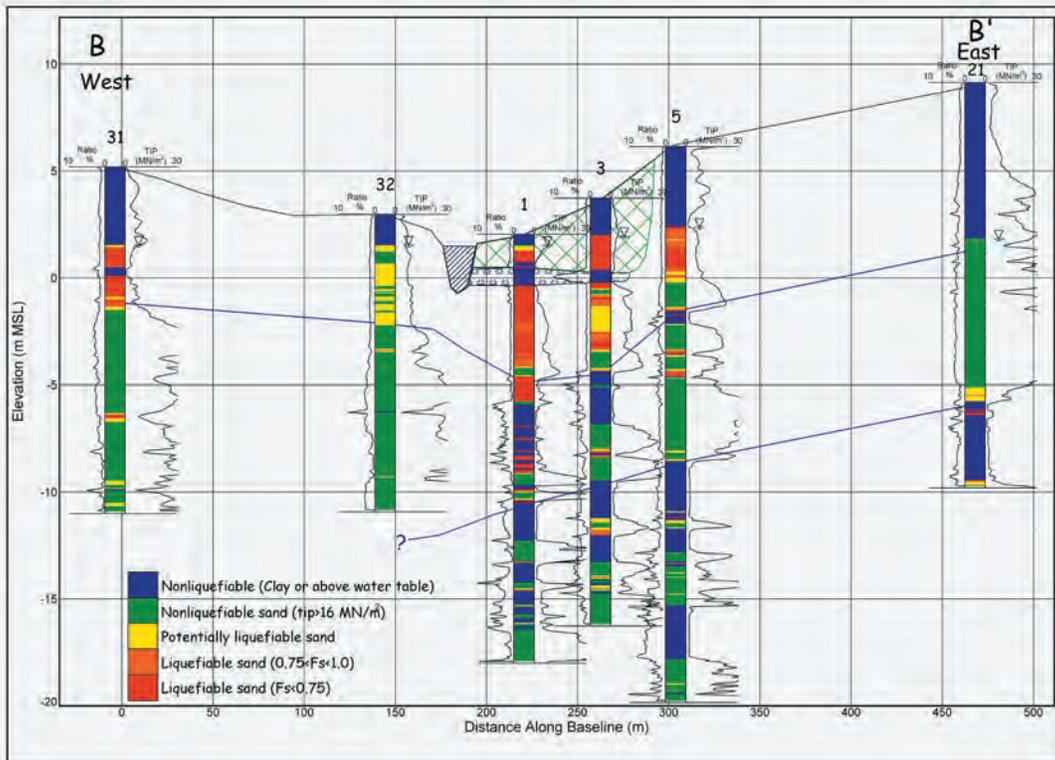
Figure 7. East-west cross section (B-B') at Oceano of generalized shallow subsurface conditions based on SCPT soundings. See Figure 5 for location of cross section. Cross section includes profiles of CPT tip and friction ratio, geologic units, and water table with (a) shear-wave velocity ( $V_s$ ), (b) liquefaction factors of safety for a M6.5 and PGA=0.25 g, and (c) liquefaction factors of safety for a M6.8 and PGA=0.4 g.

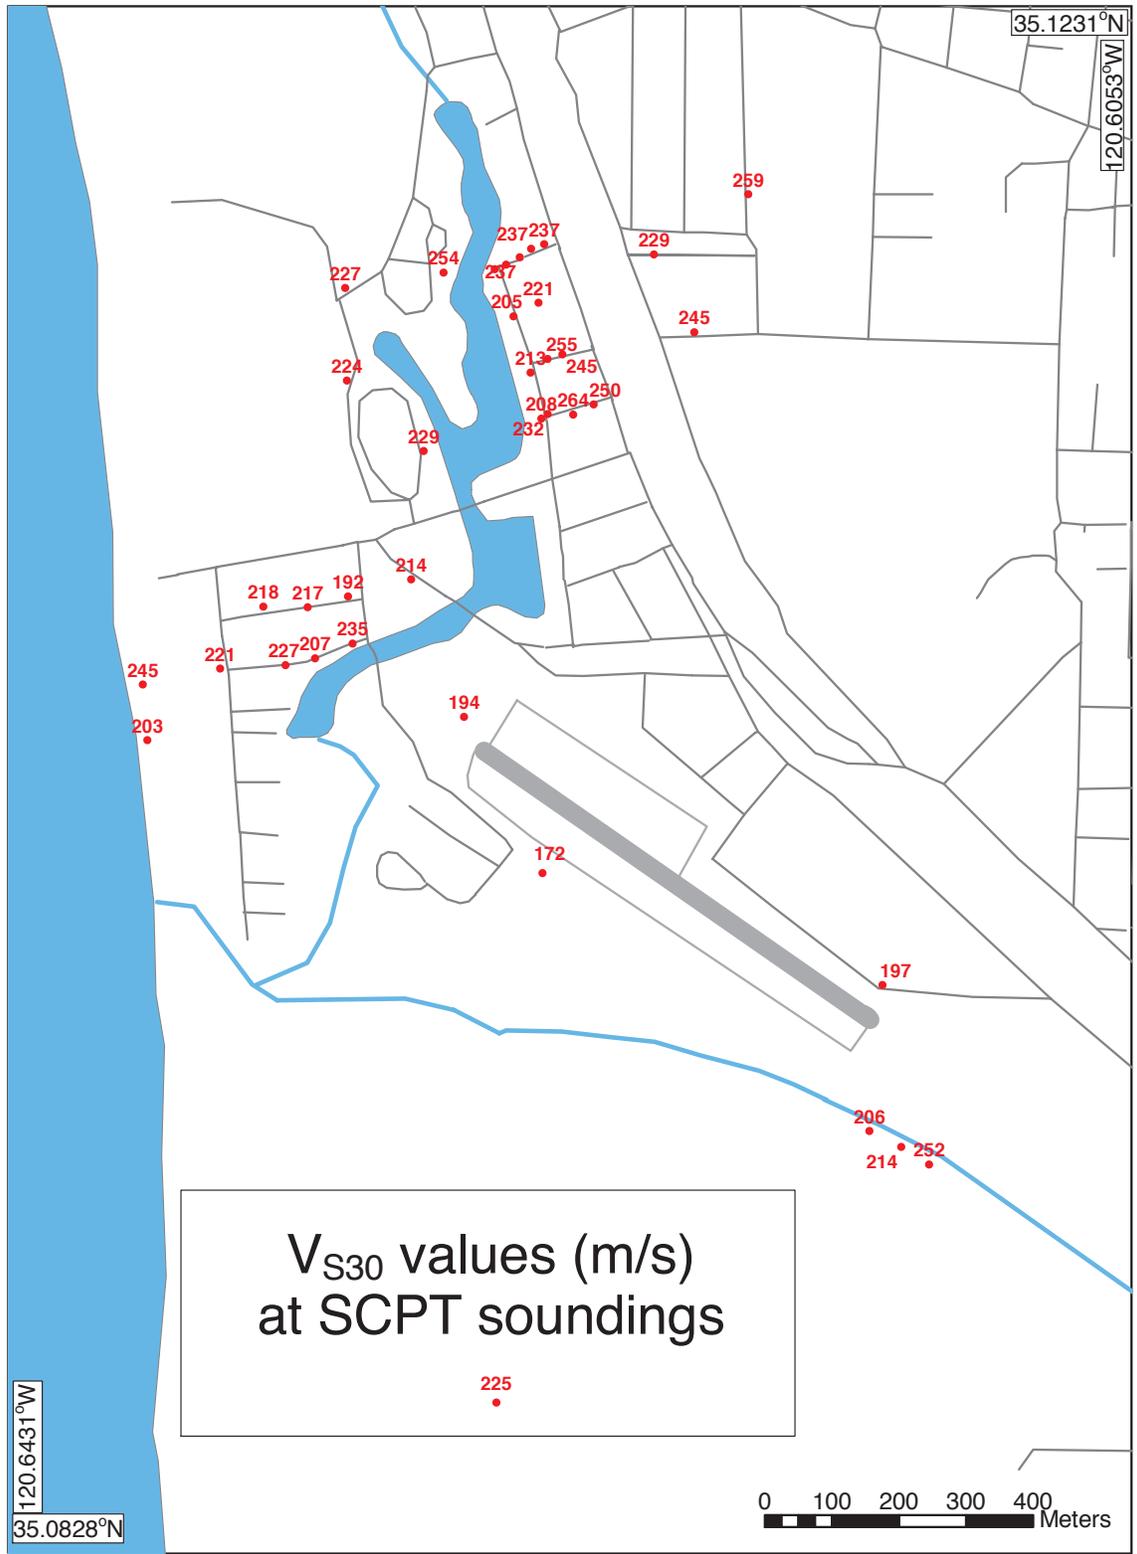
Figure 13. Map of  $V_{s30}$  values inferred from USGS SCPT soundings.

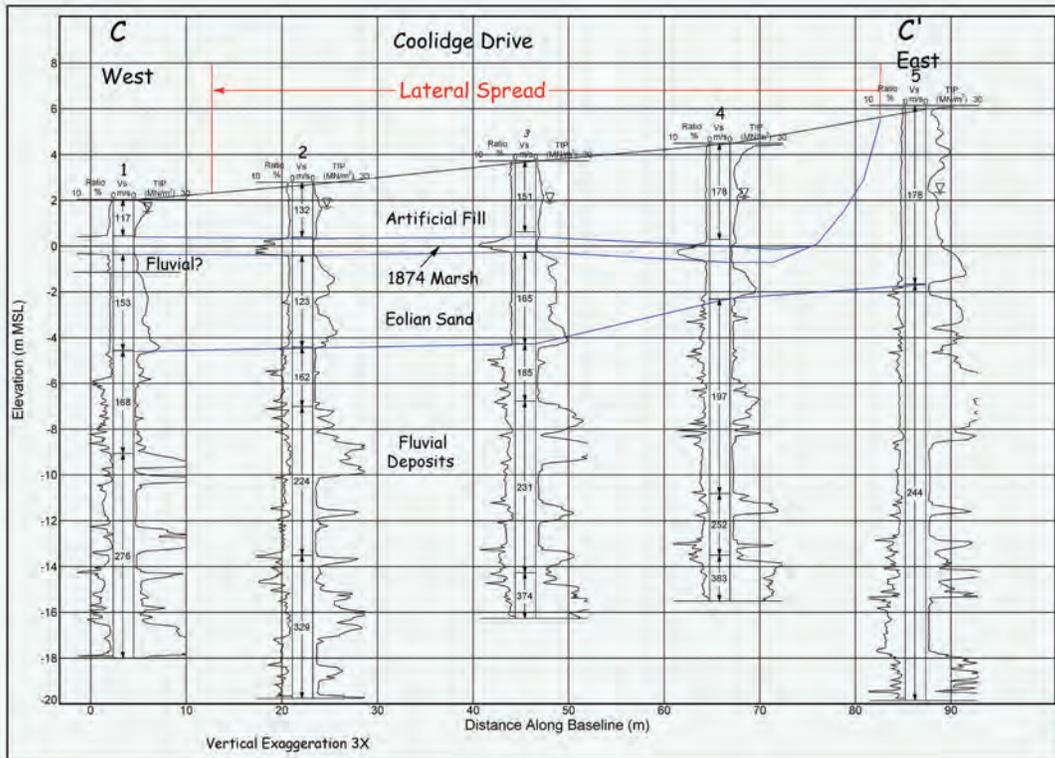
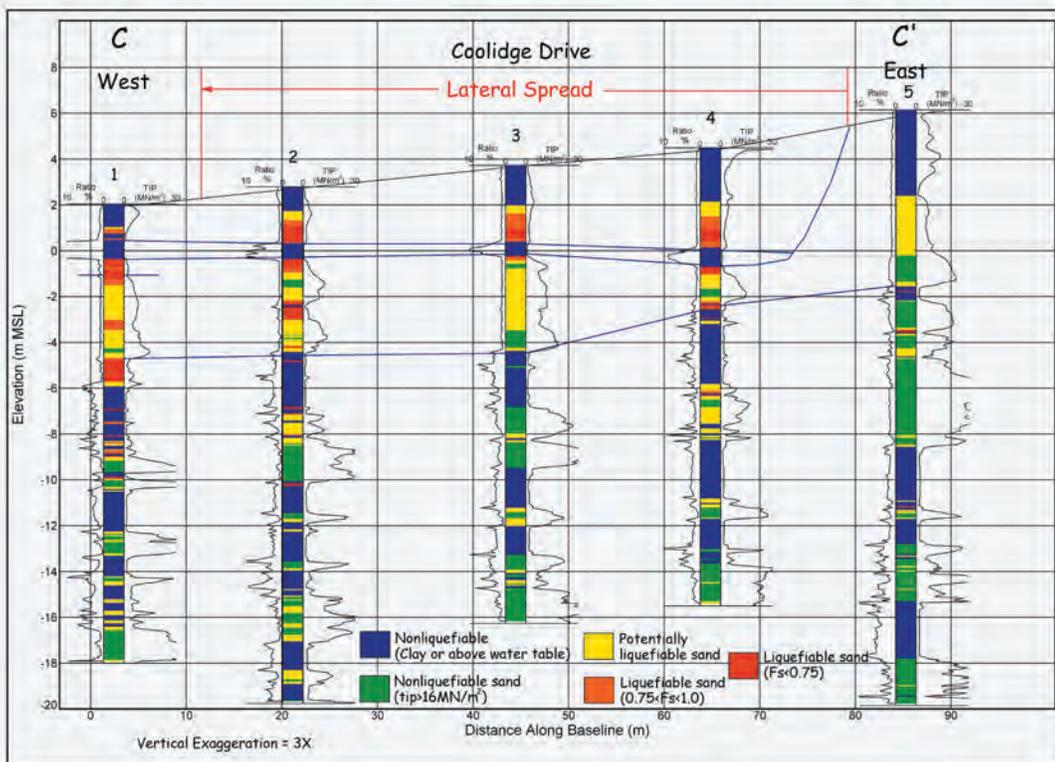
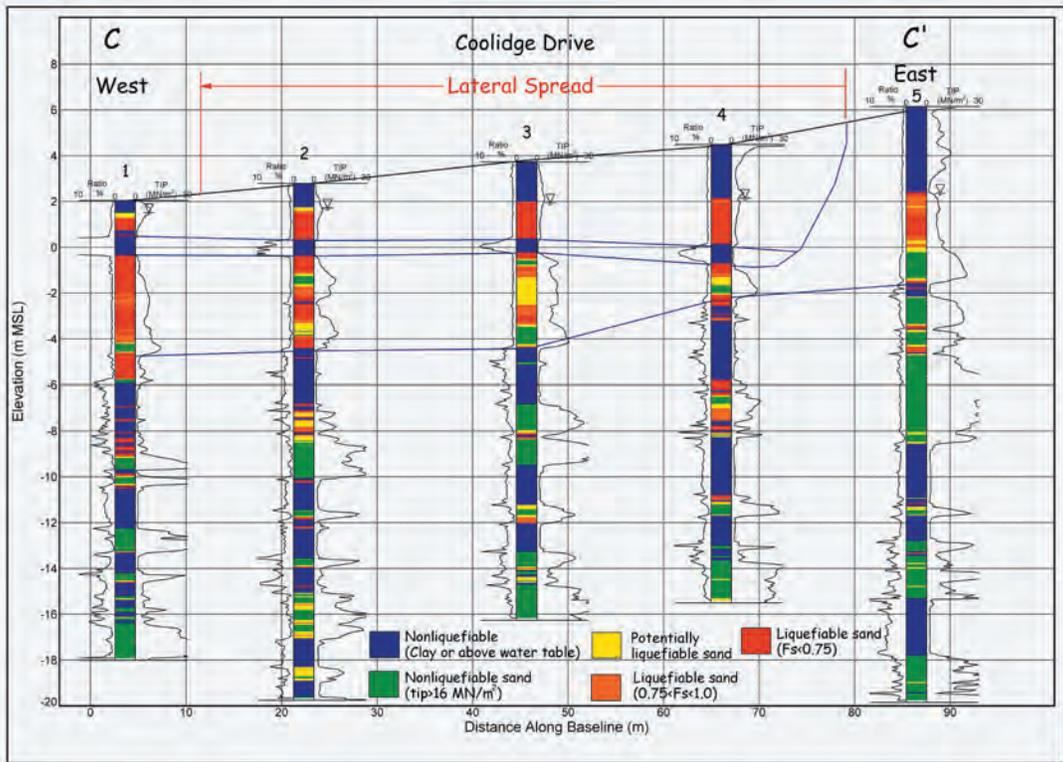
Figure 17. Cross section C-C' of Norswing Drive lateral spread along Coolidge Drive. See Figure 5 for location. Cross section includes profiles of CPT tip and friction ratio, geologic units, and water table with (a) shear-wave velocity ( $V_s$ ), (b) liquefaction factors of safety for a M6.5 and PGA=0.25 g, and (c) liquefaction factors of safety for a M6.8 and PGA=0.4 g.

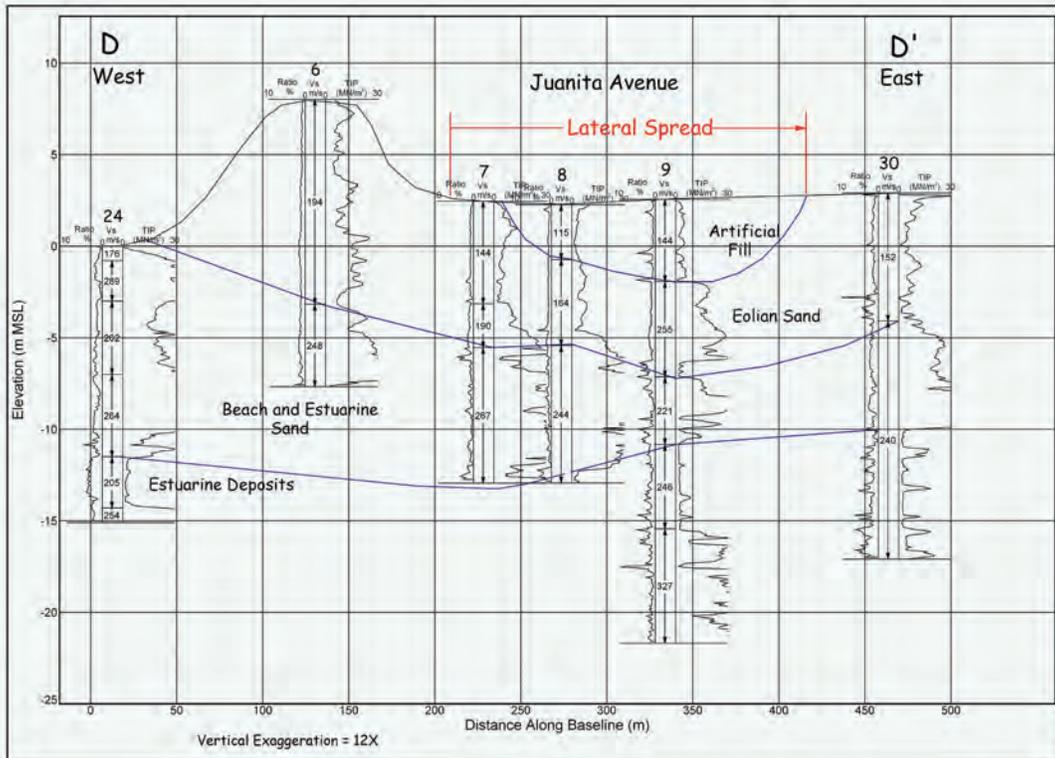
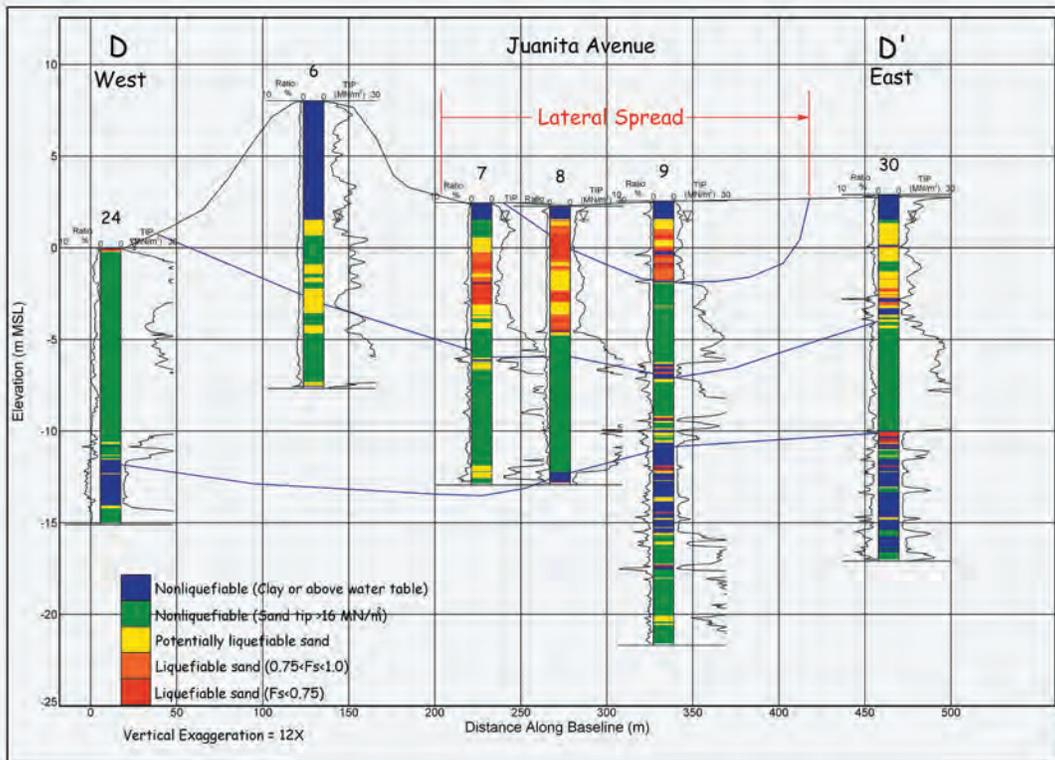
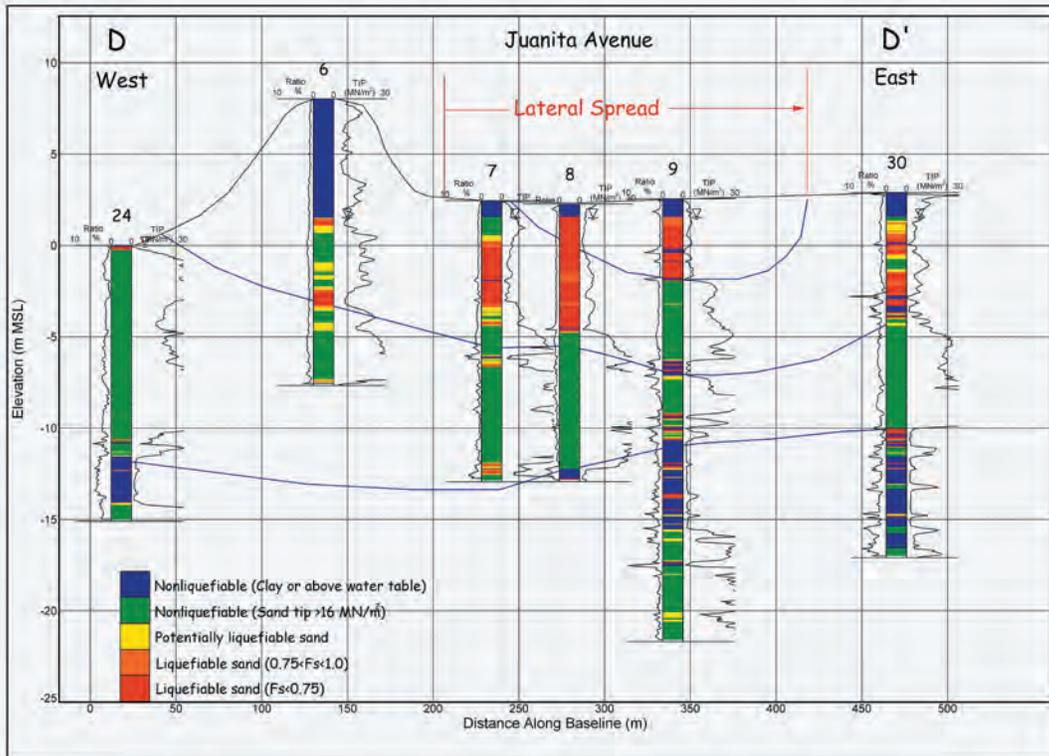
Figure 18. Cross section D-D' of Juanita Avenue lateral spread along Juanita Avenue. See Figure 5 for location. Cross section includes profiles of CPT tip and friction ratio, geologic units, and water table with (a) shear-wave velocity ( $V_s$ ), (b) liquefaction factors of safety for a M6.5 and  $PGA=0.25$  g, and (c) liquefaction factors of safety for a M6.8 and  $PGA=0.4$  g.

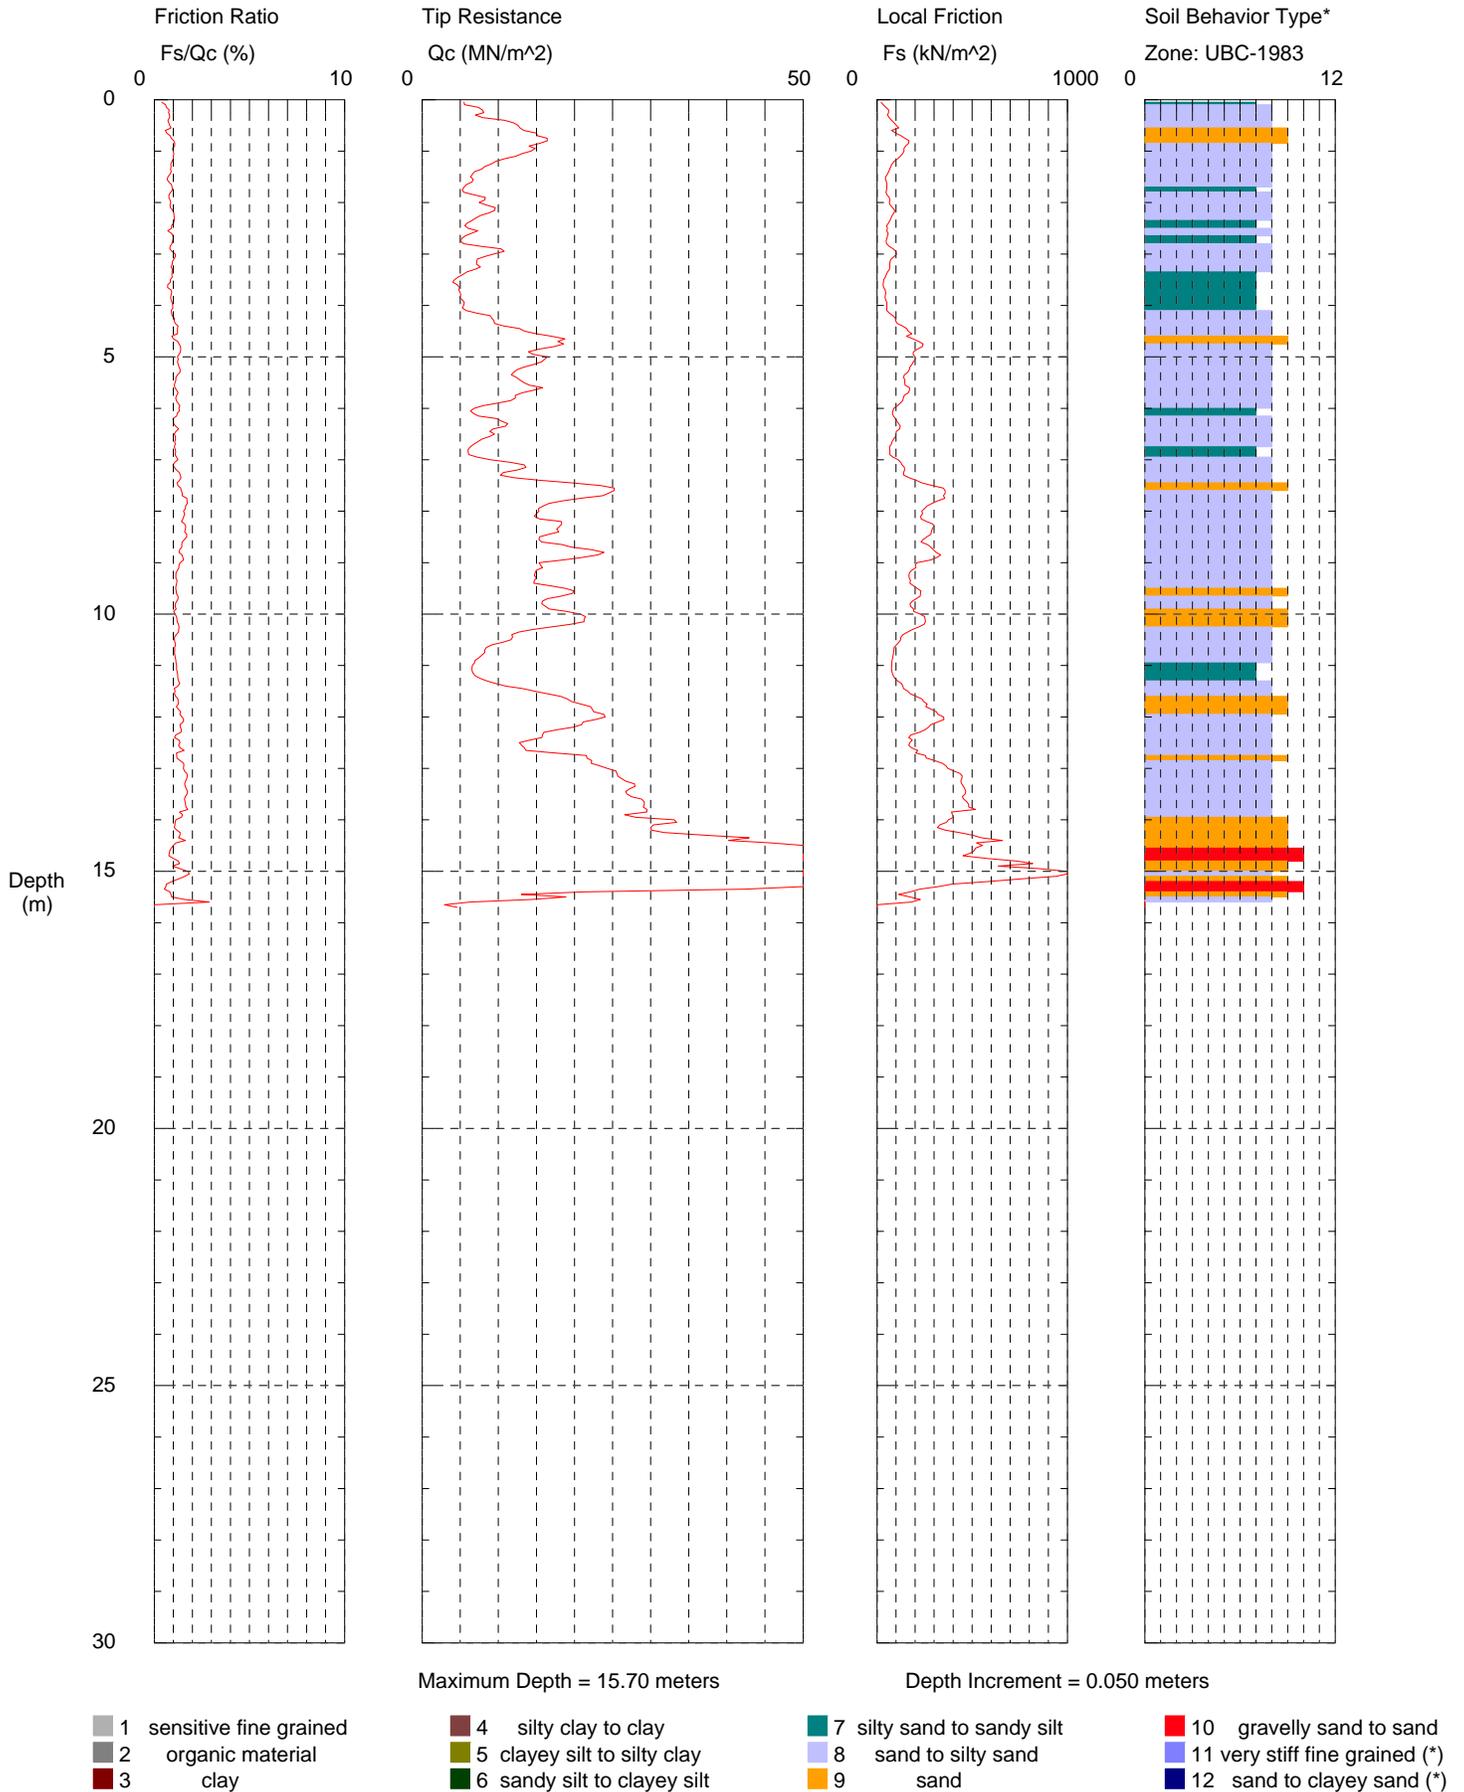
Operator: Tom Noce  
 Sounding: SOC006  
 Cone Used: 766tc

CPT Date/Time: 02-24-04 12:04  
 Location: Strand & Juanita  
 Job Number: Oceano

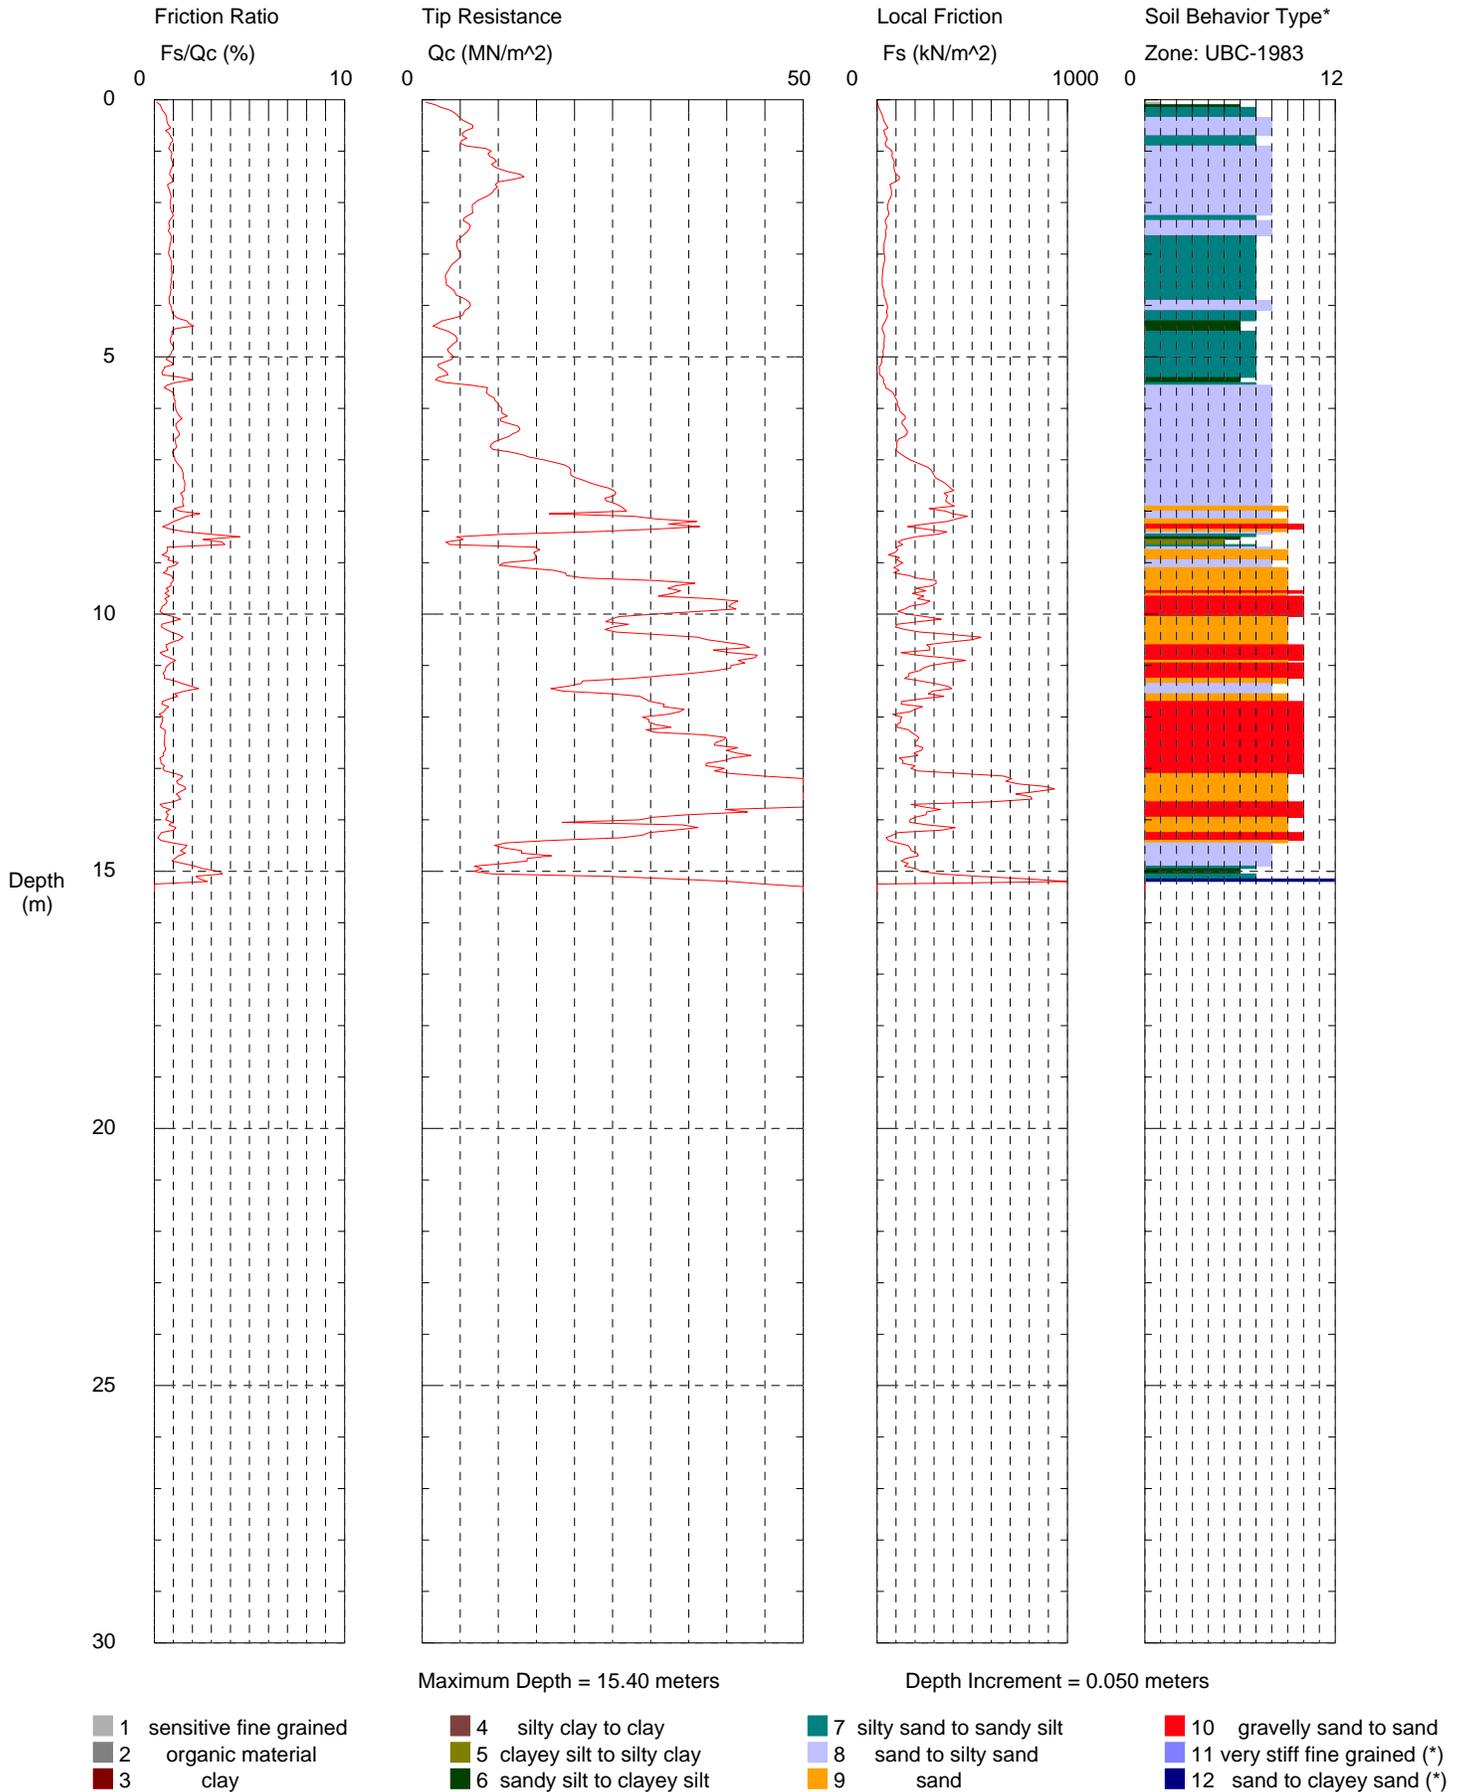
Operator: Tom Noce  
 Sounding: SOC007  
 Cone Used: 766tc

CPT Date/Time: 02-24-04 14:16  
 Location: 344 Juanita  
 Job Number: Oceano

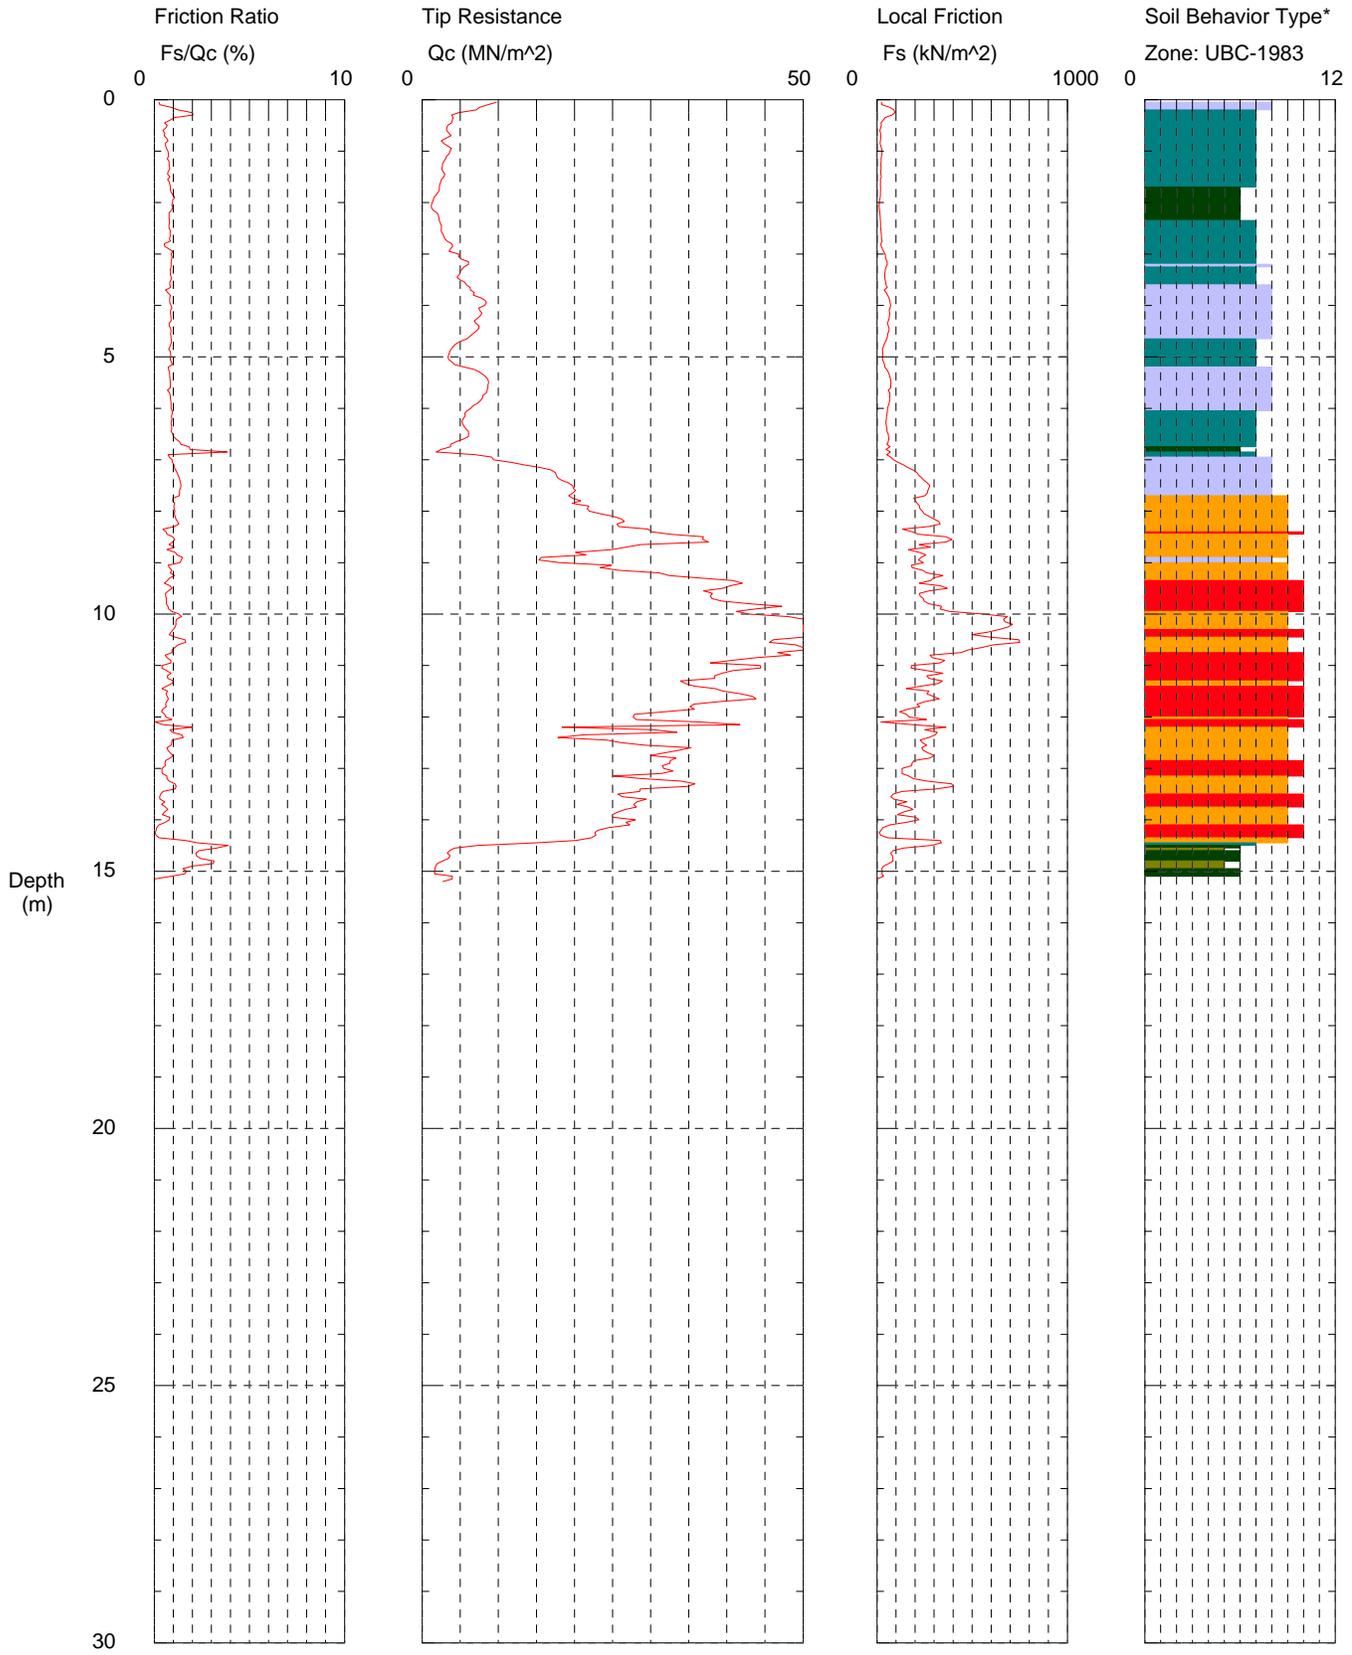
Operator: Tom Noce  
 Sounding: SOC008  
 Cone Used: 766tc

CPT Date/Time: 02-24-04 16:21  
 Location: 373 Juanita opp  
 Job Number: Oceano

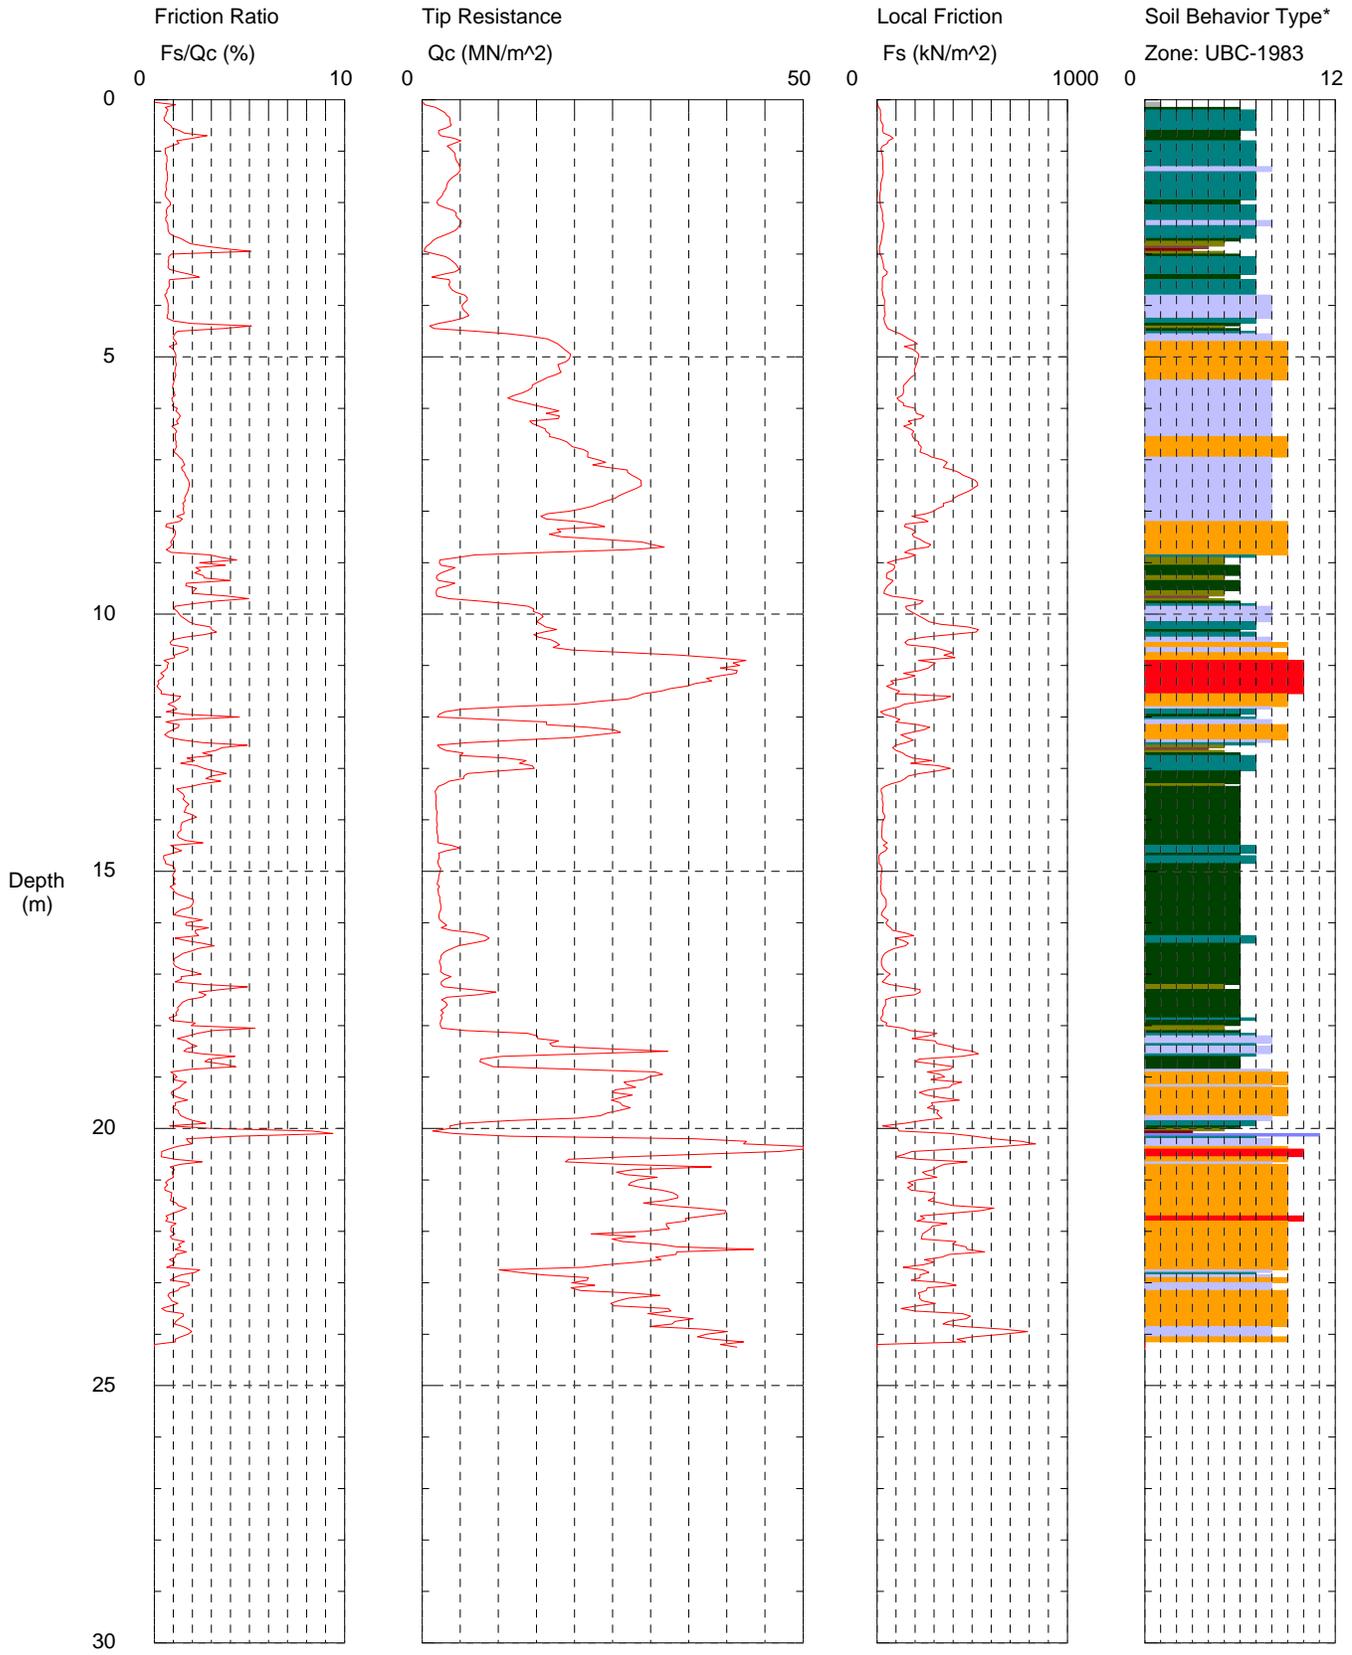
Operator: Tom Noce  
 Sounding: SOC009  
 Cone Used: 766tc

CPT Date/Time: 02-25-04 06:53  
 Location: Juanita Lakeside  
 Job Number: Oceano

Maximum Depth = 24.25 meters

Depth Increment = 0.050 meters

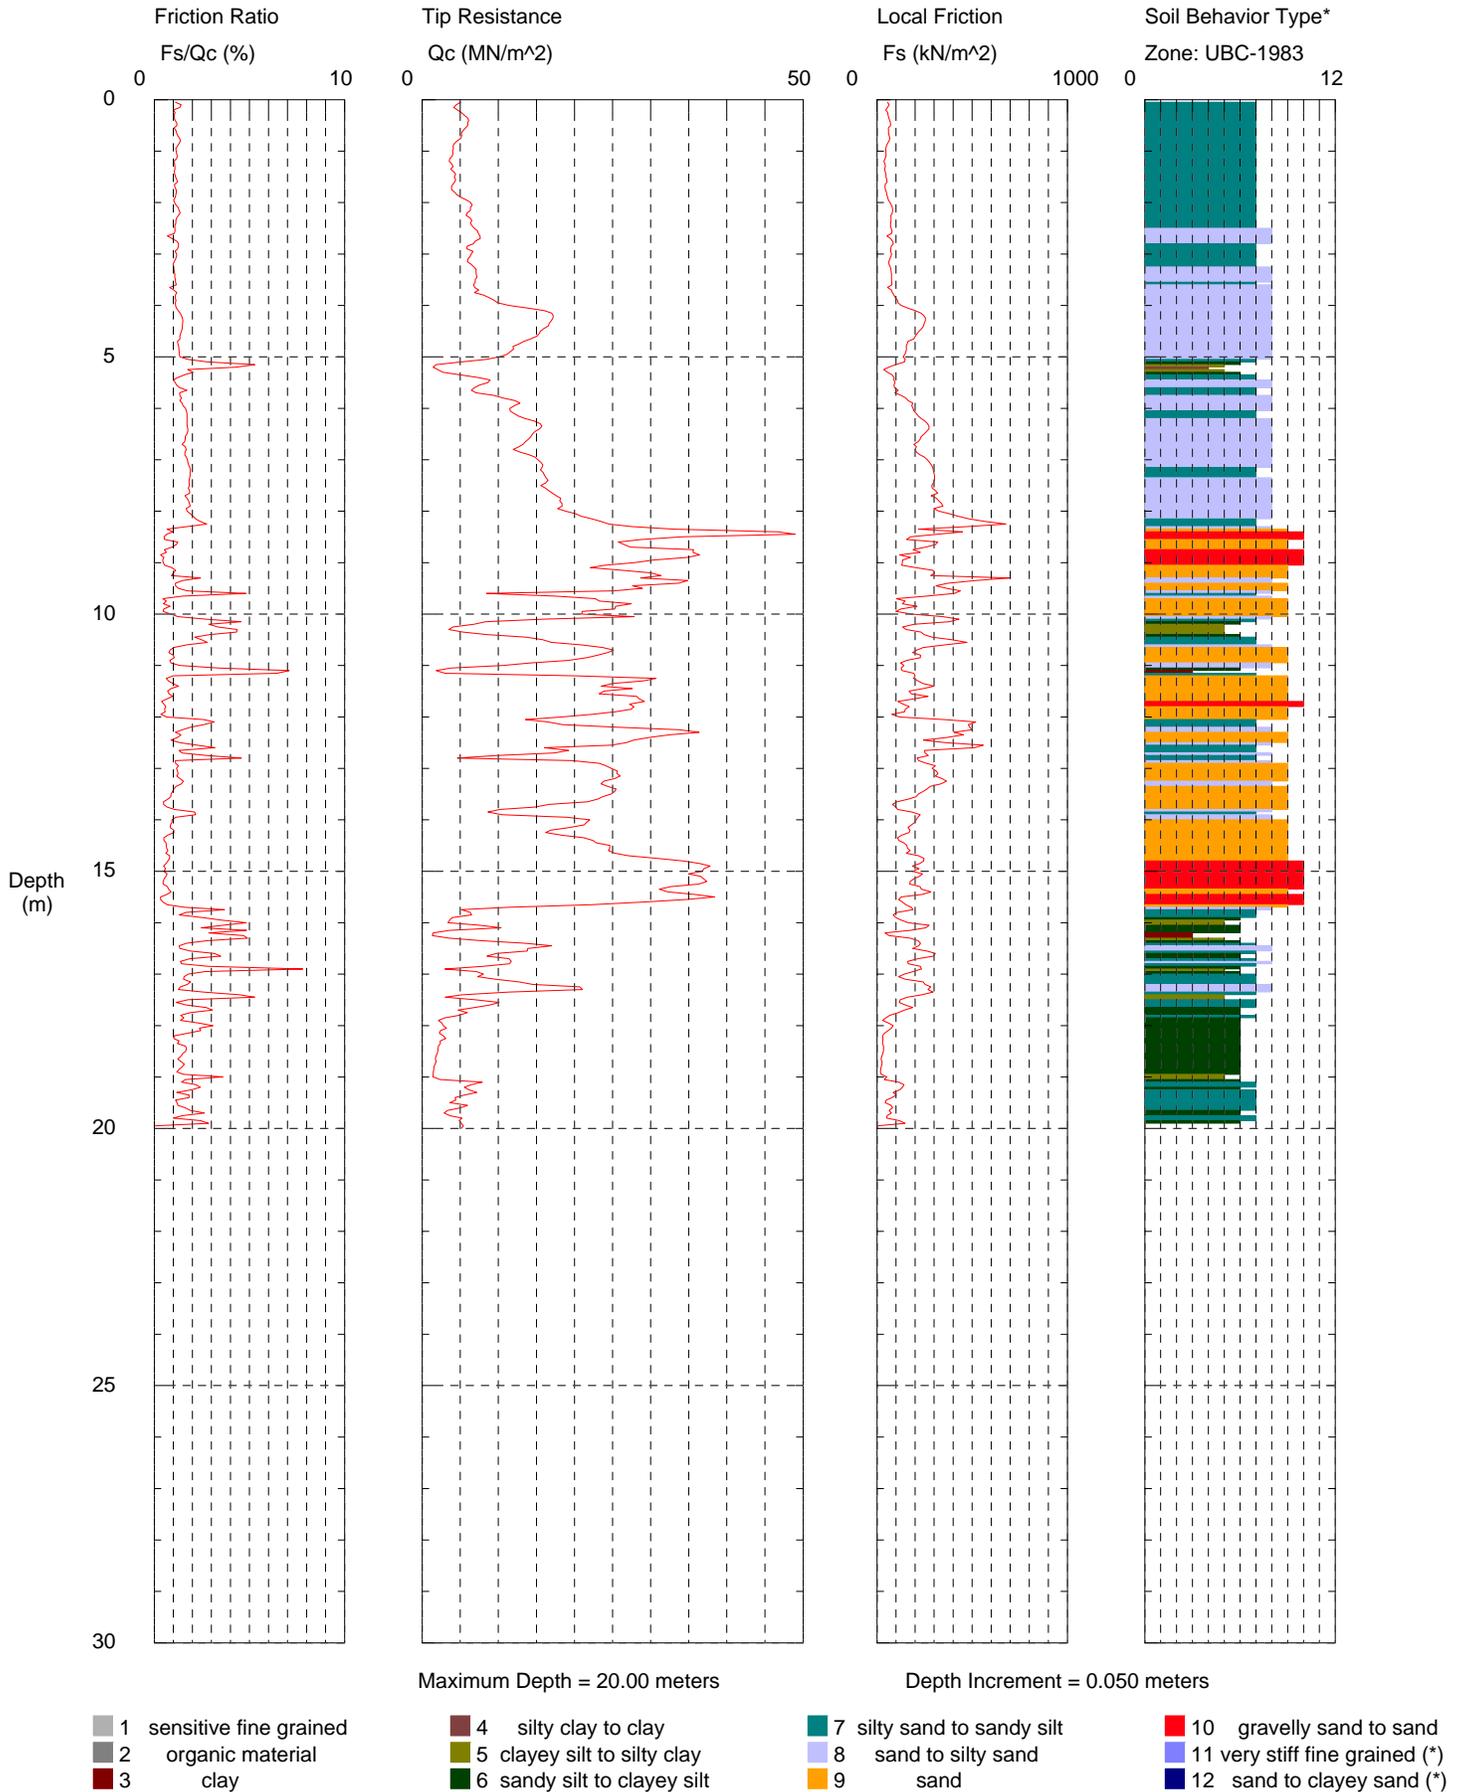
Operator: Tom Noce  
 Sounding: SOC022  
 Cone Used: 766tc

CPT Date/Time: 03-01-04 15:06  
 Location: 339 McCarthy  
 Job Number: Oceano
