# MEADOW CREEK LAGOON HABITAT RESTORATION

**PRELIMINARY GEOTECHNICAL AND  
GEOLOGIC HAZARDS REPORT**

**Meadow Creek Lagoon Habitat Restoration  
San Luis Obispo County, California**

Yeh Project No.: 220-331

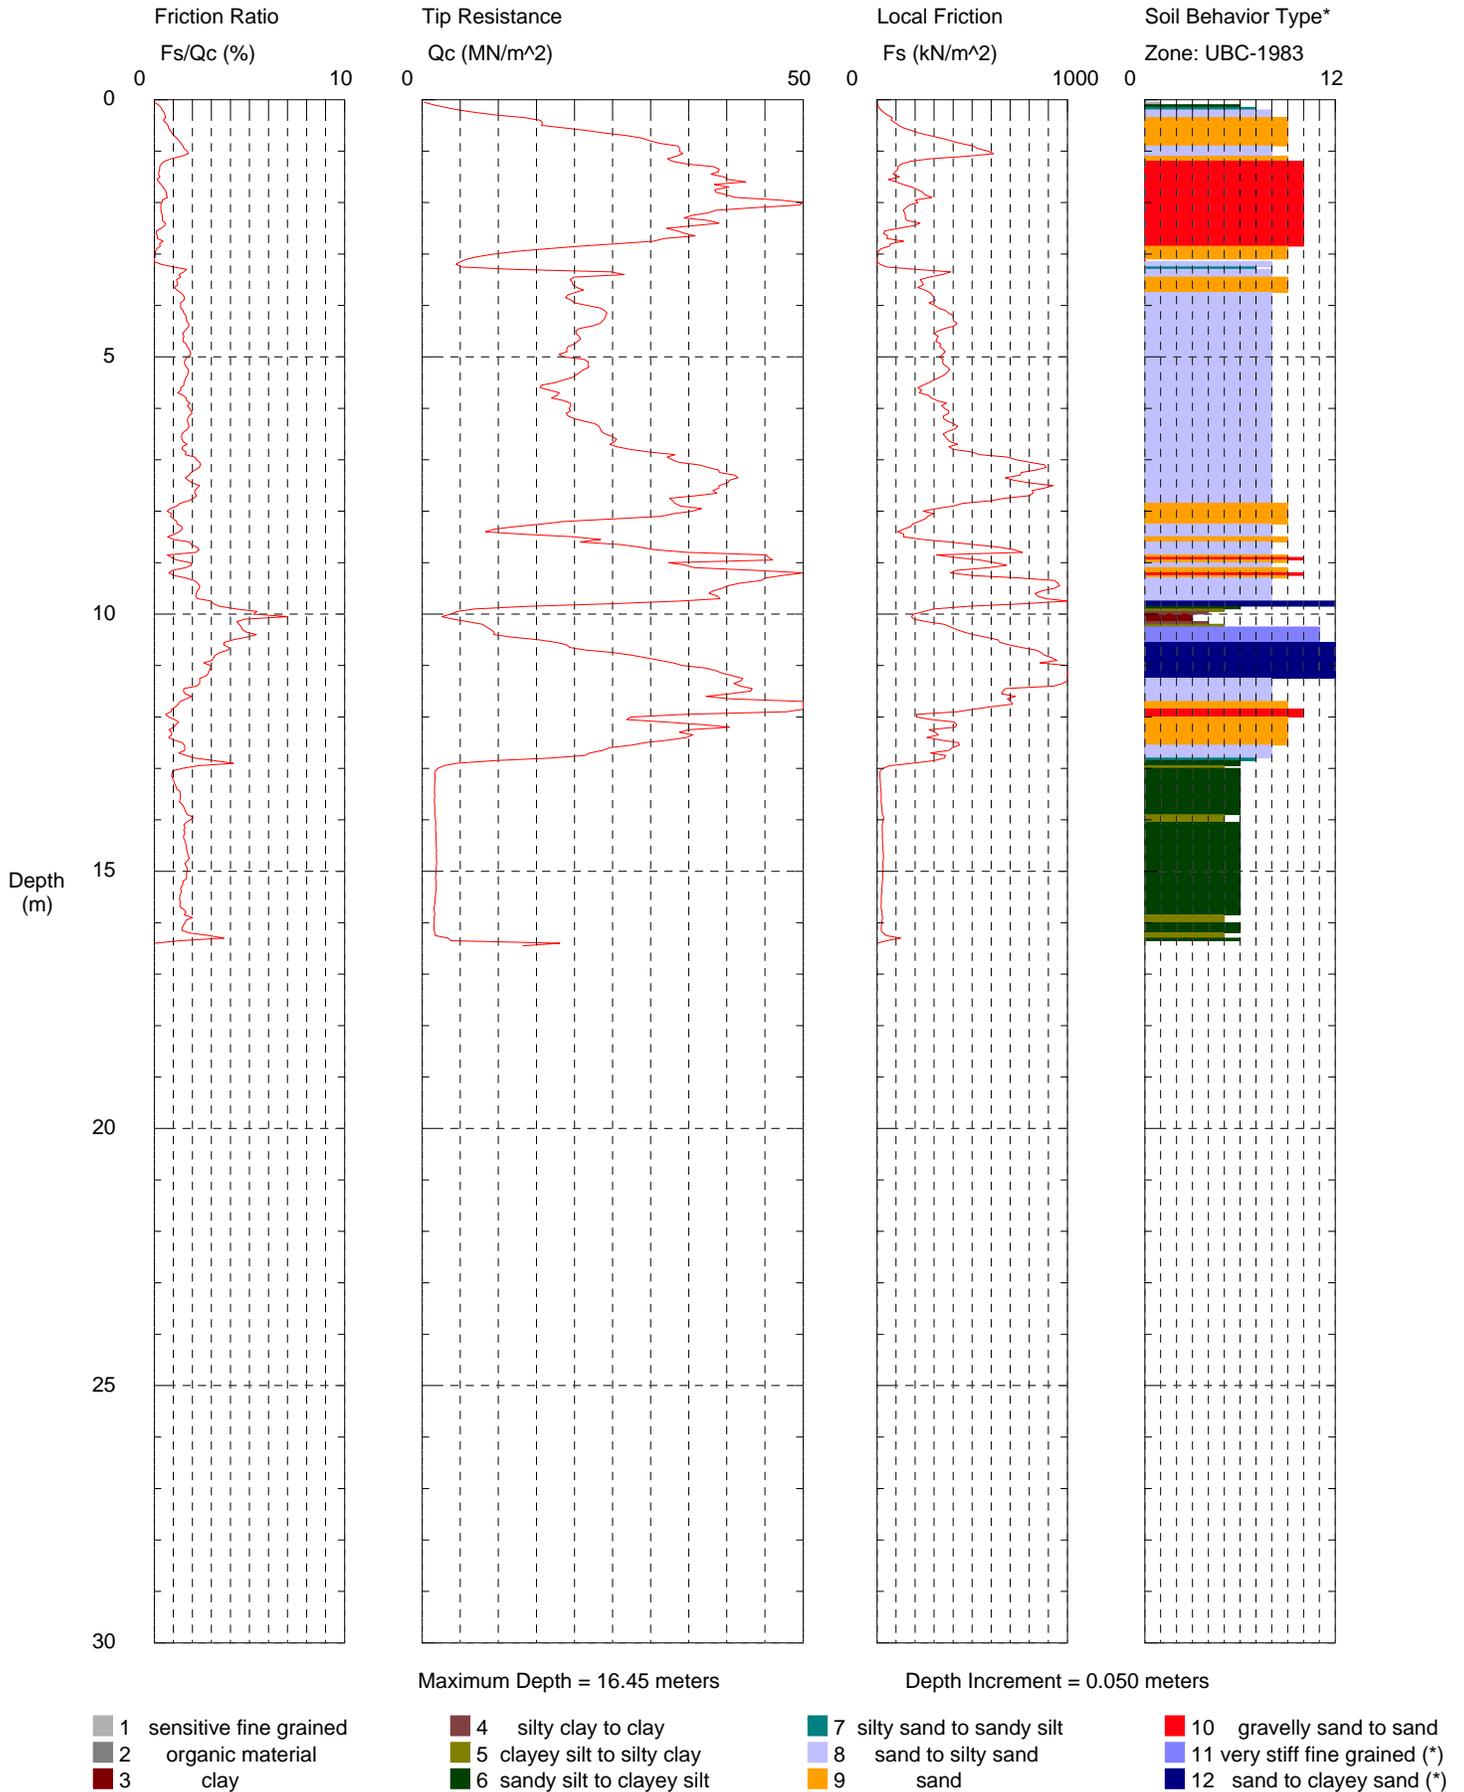
Operator: Tom Noce  
 Sounding: SOC023  
 Cone Used: 766tc

CPT Date/Time: 03-02-04 08:32  
 Location: Beach Juanita  
 Job Number: Oceano

\*Soil behavior type and SPT based on data from UBC-1983

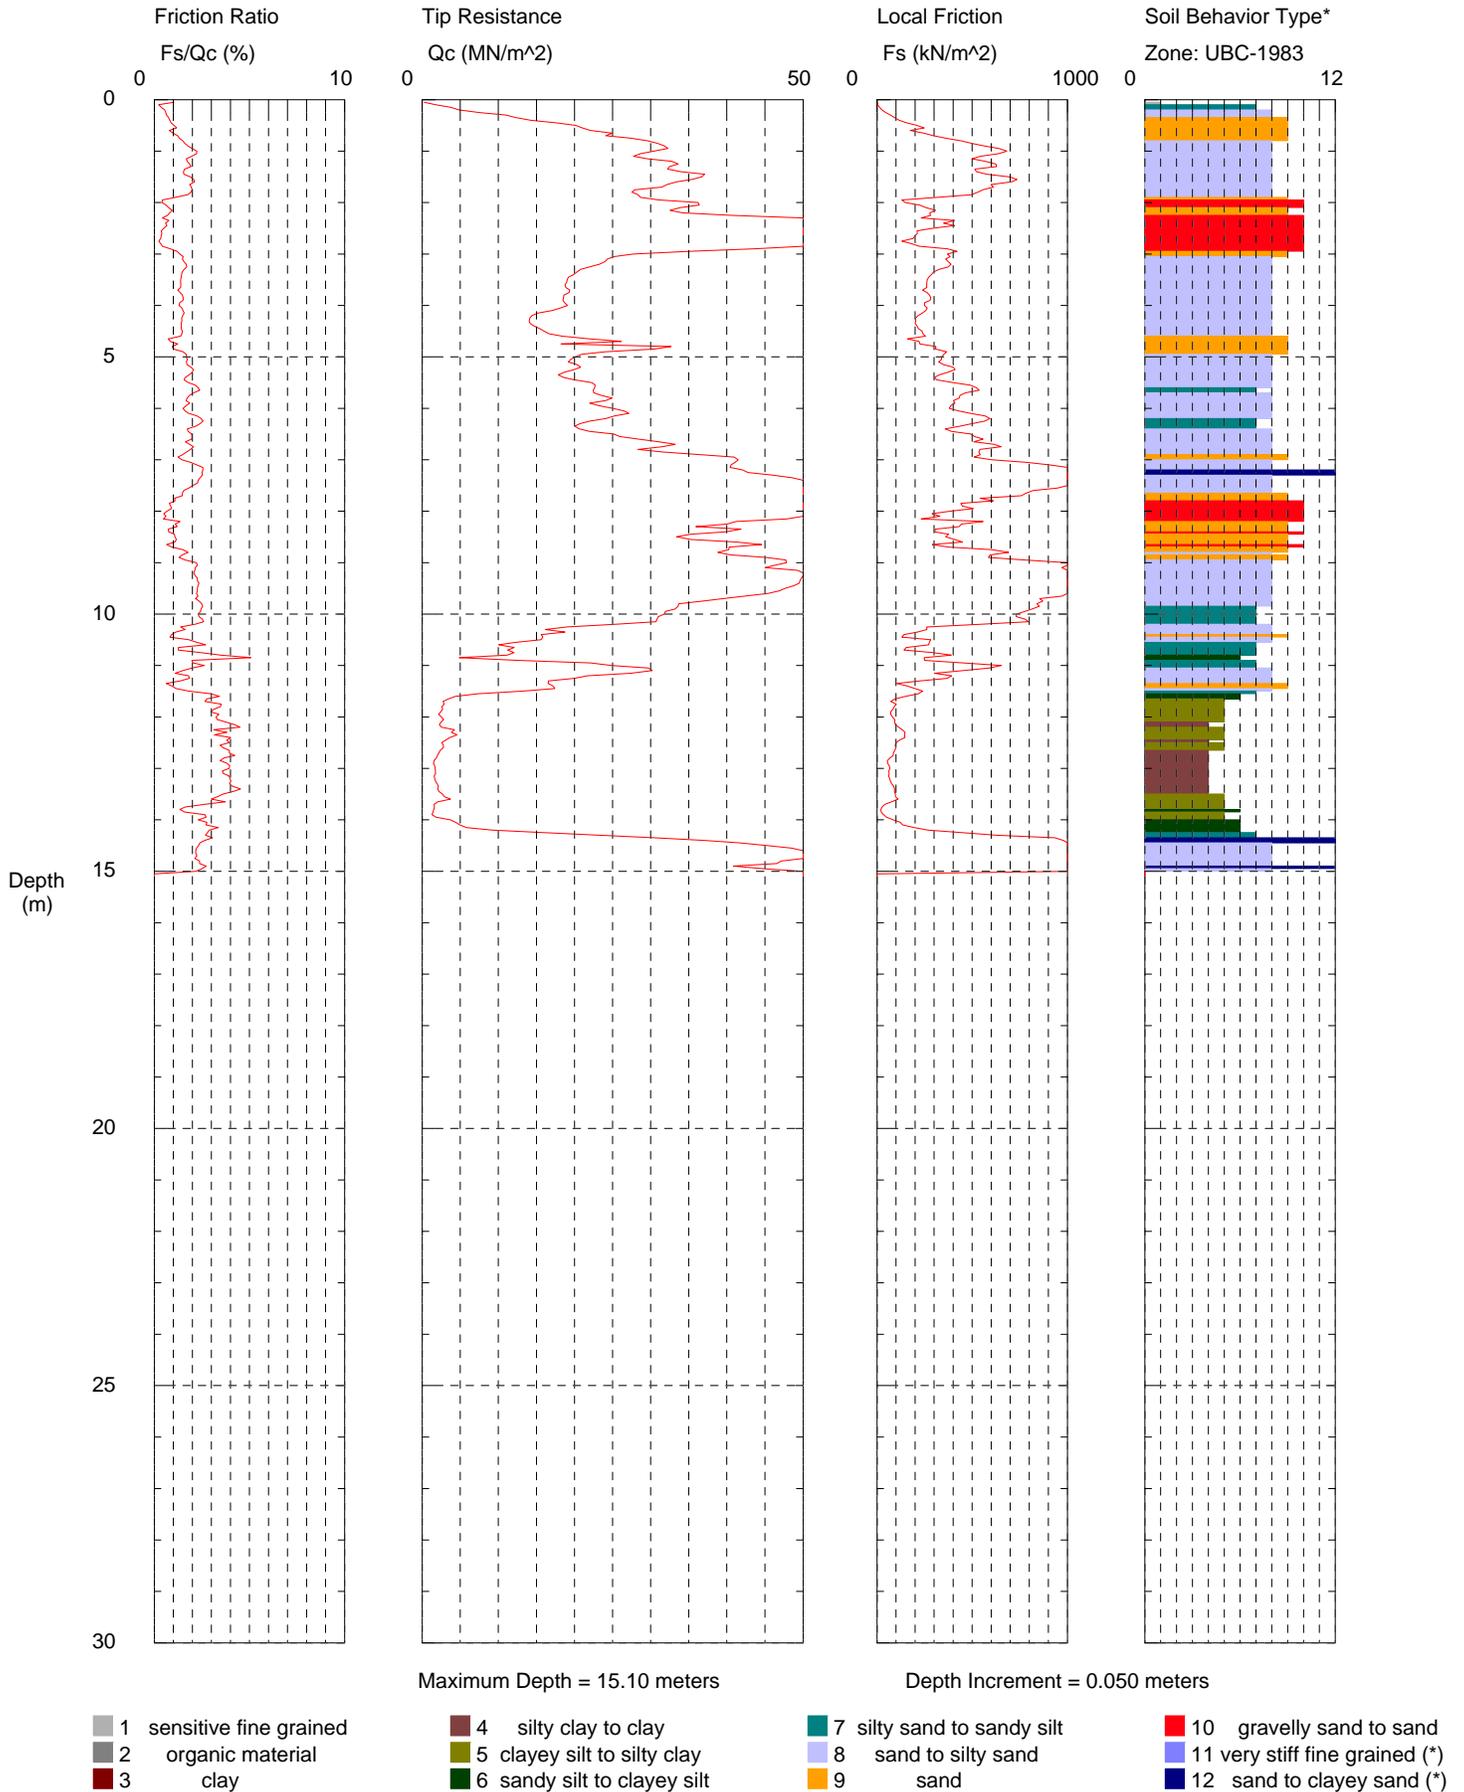
Operator: Tom Noce  
 Sounding: SOC024  
 Cone Used: 766tc

CPT Date/Time: 03-02-04 11:09  
 Location: Beach McCarthy  
 Job Number: Oceano

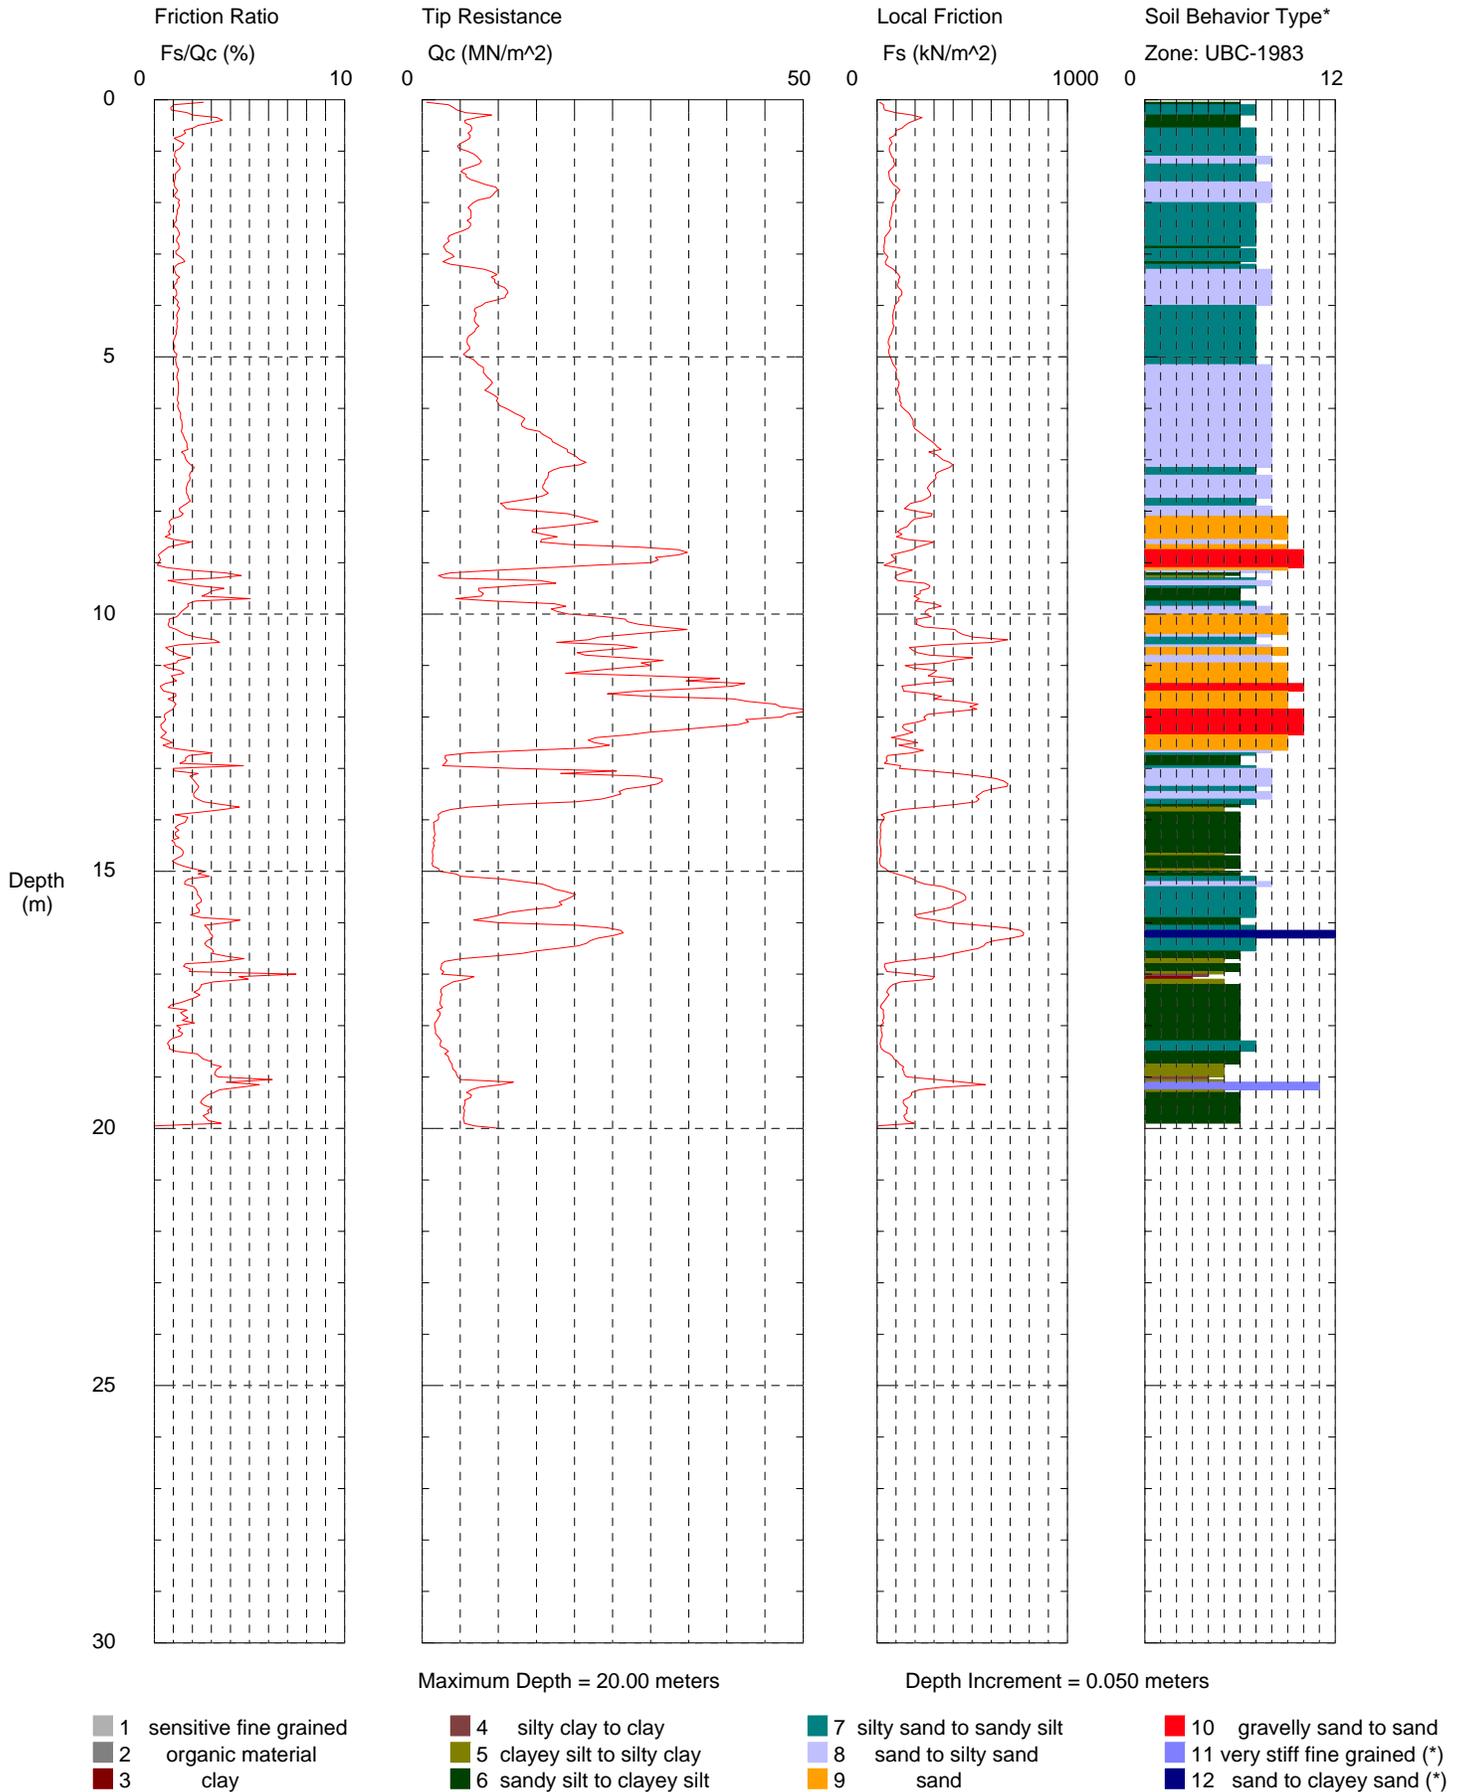
Operator: Tom Noce  
 Sounding: SOC025  
 Cone Used: 766tc

CPT Date/Time: 03-02-04 13:30  
 Location: 369 McCarthy opp  
 Job Number: Oceano

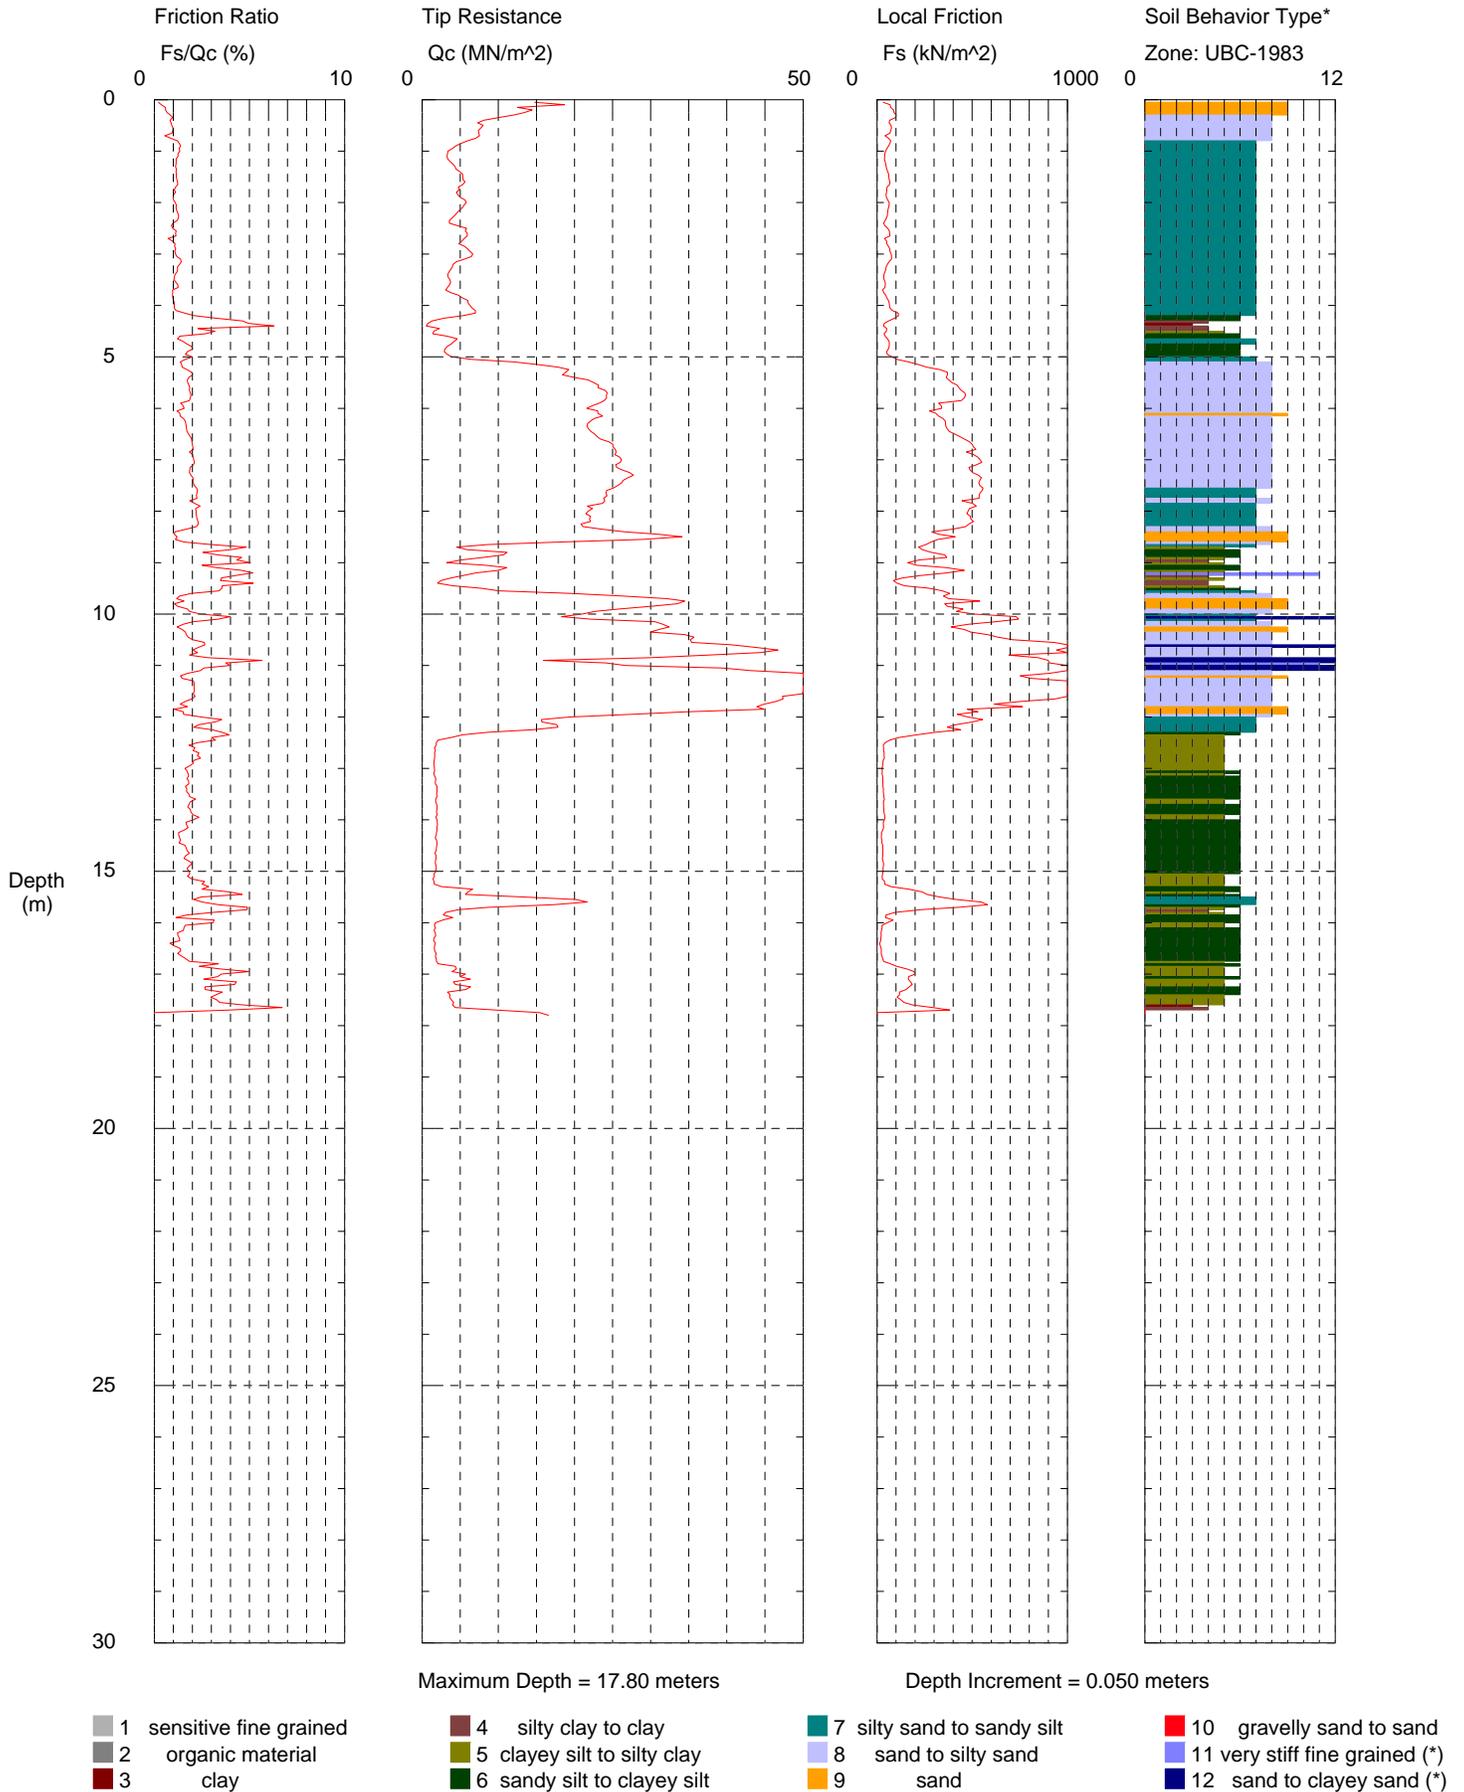
Operator: Tom Noce  
 Sounding: SOC026  
 Cone Used: 766tc

CPT Date/Time: 03-02-04 15:15  
 Location: McCarthyLakeside  
 Job Number: Oceano

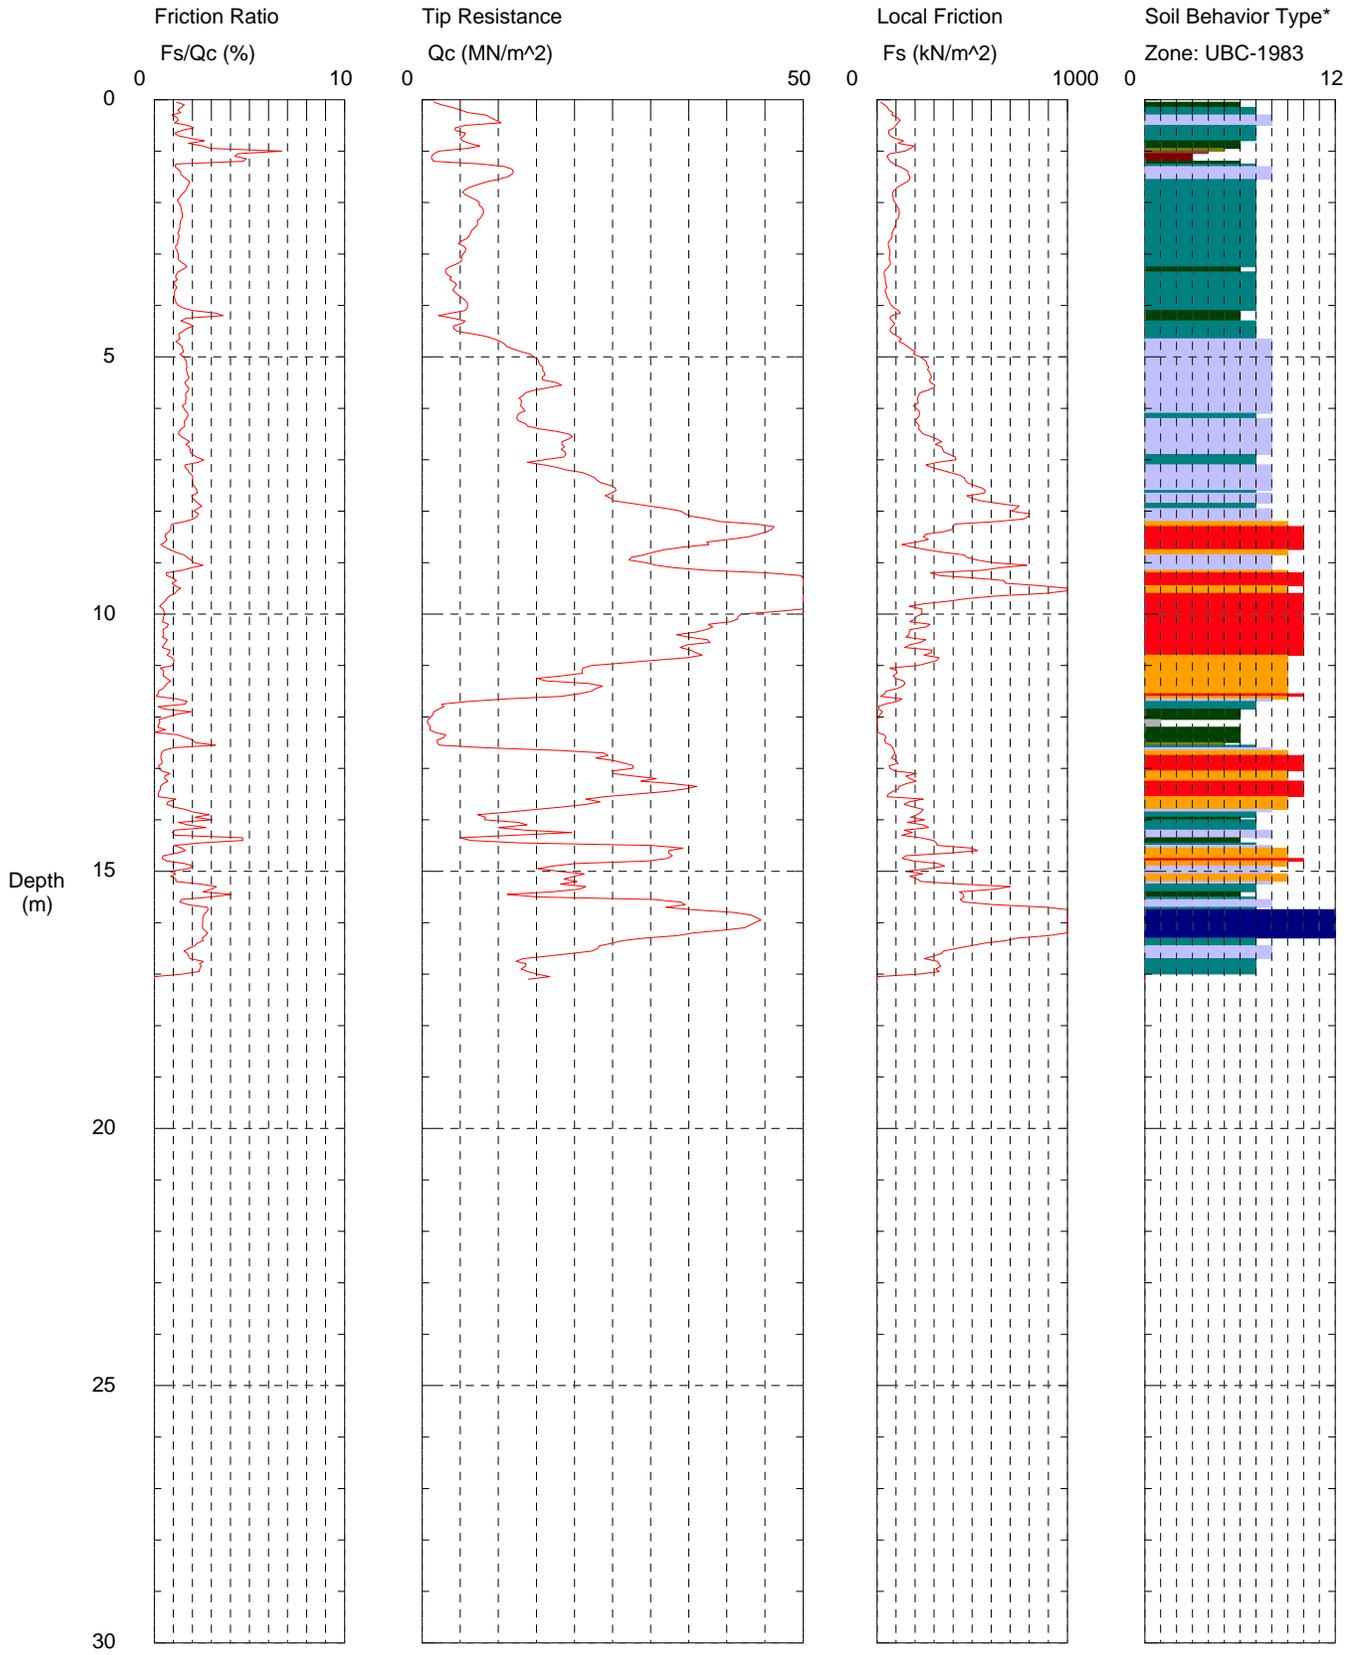
Operator: Tom Noce  
 Sounding: SOC027  
 Cone Used: 766tc

CPT Date/Time: 03-03-04 08:00  
 Location: Airport North  
 Job Number: Oceano

Maximum Depth = 17.10 meters

Depth Increment = 0.050 meters

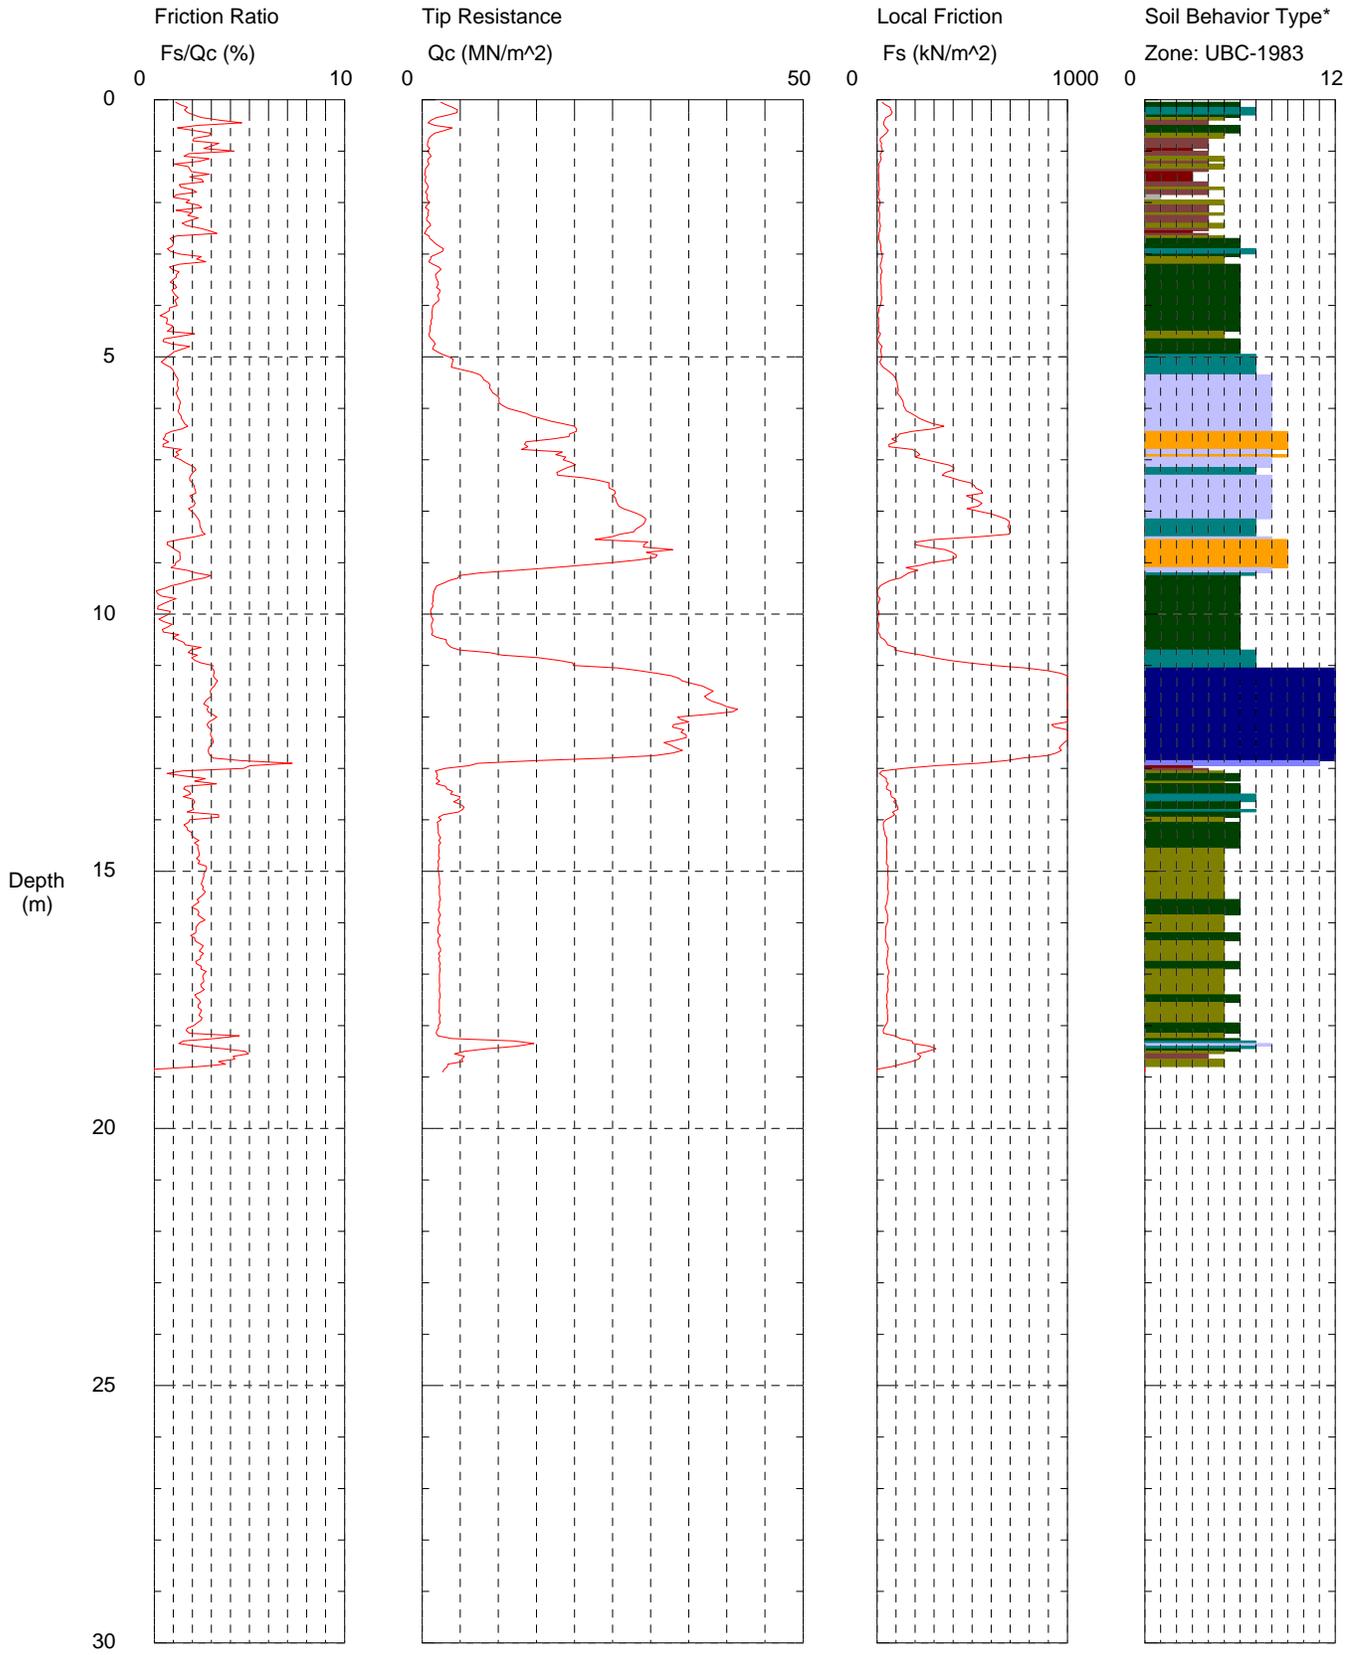
Operator: Tom Noce  
 Sounding: SOC028  
 Cone Used: 766tc

CPT Date/Time: 03-03-04 10:31  
 Location: Pirates Lair Air  
 Job Number: Oceano

Maximum Depth = 18.90 meters

Depth Increment = 0.050 meters

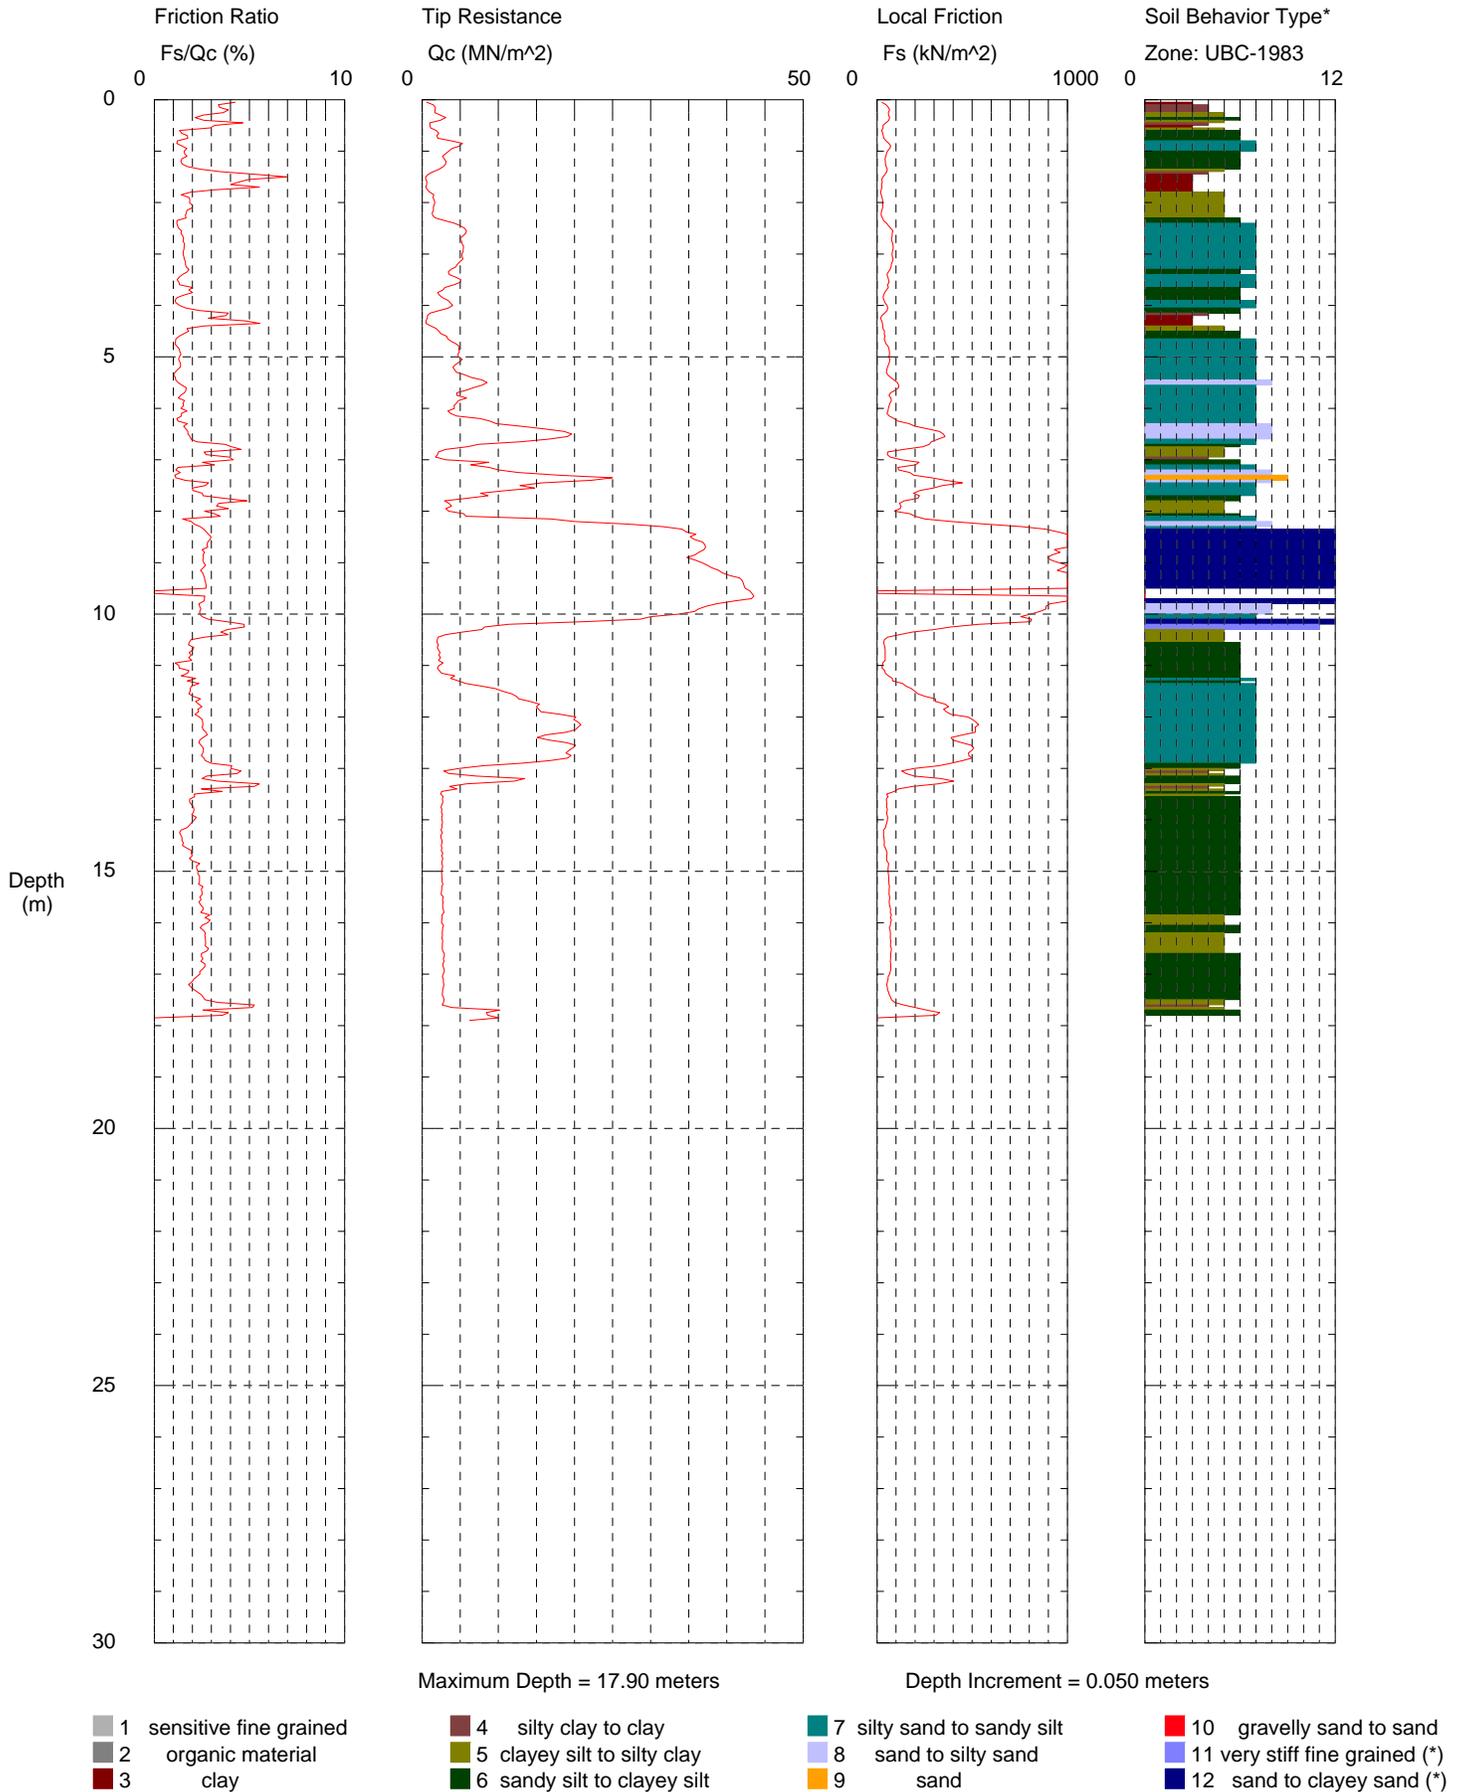
Operator: Tom Noce  
 Sounding: SOC029  
 Cone Used: 766tc

CPT Date/Time: 03-03-04 12:37  
 Location: Fountain Ave SPT  
 Job Number: Oceano

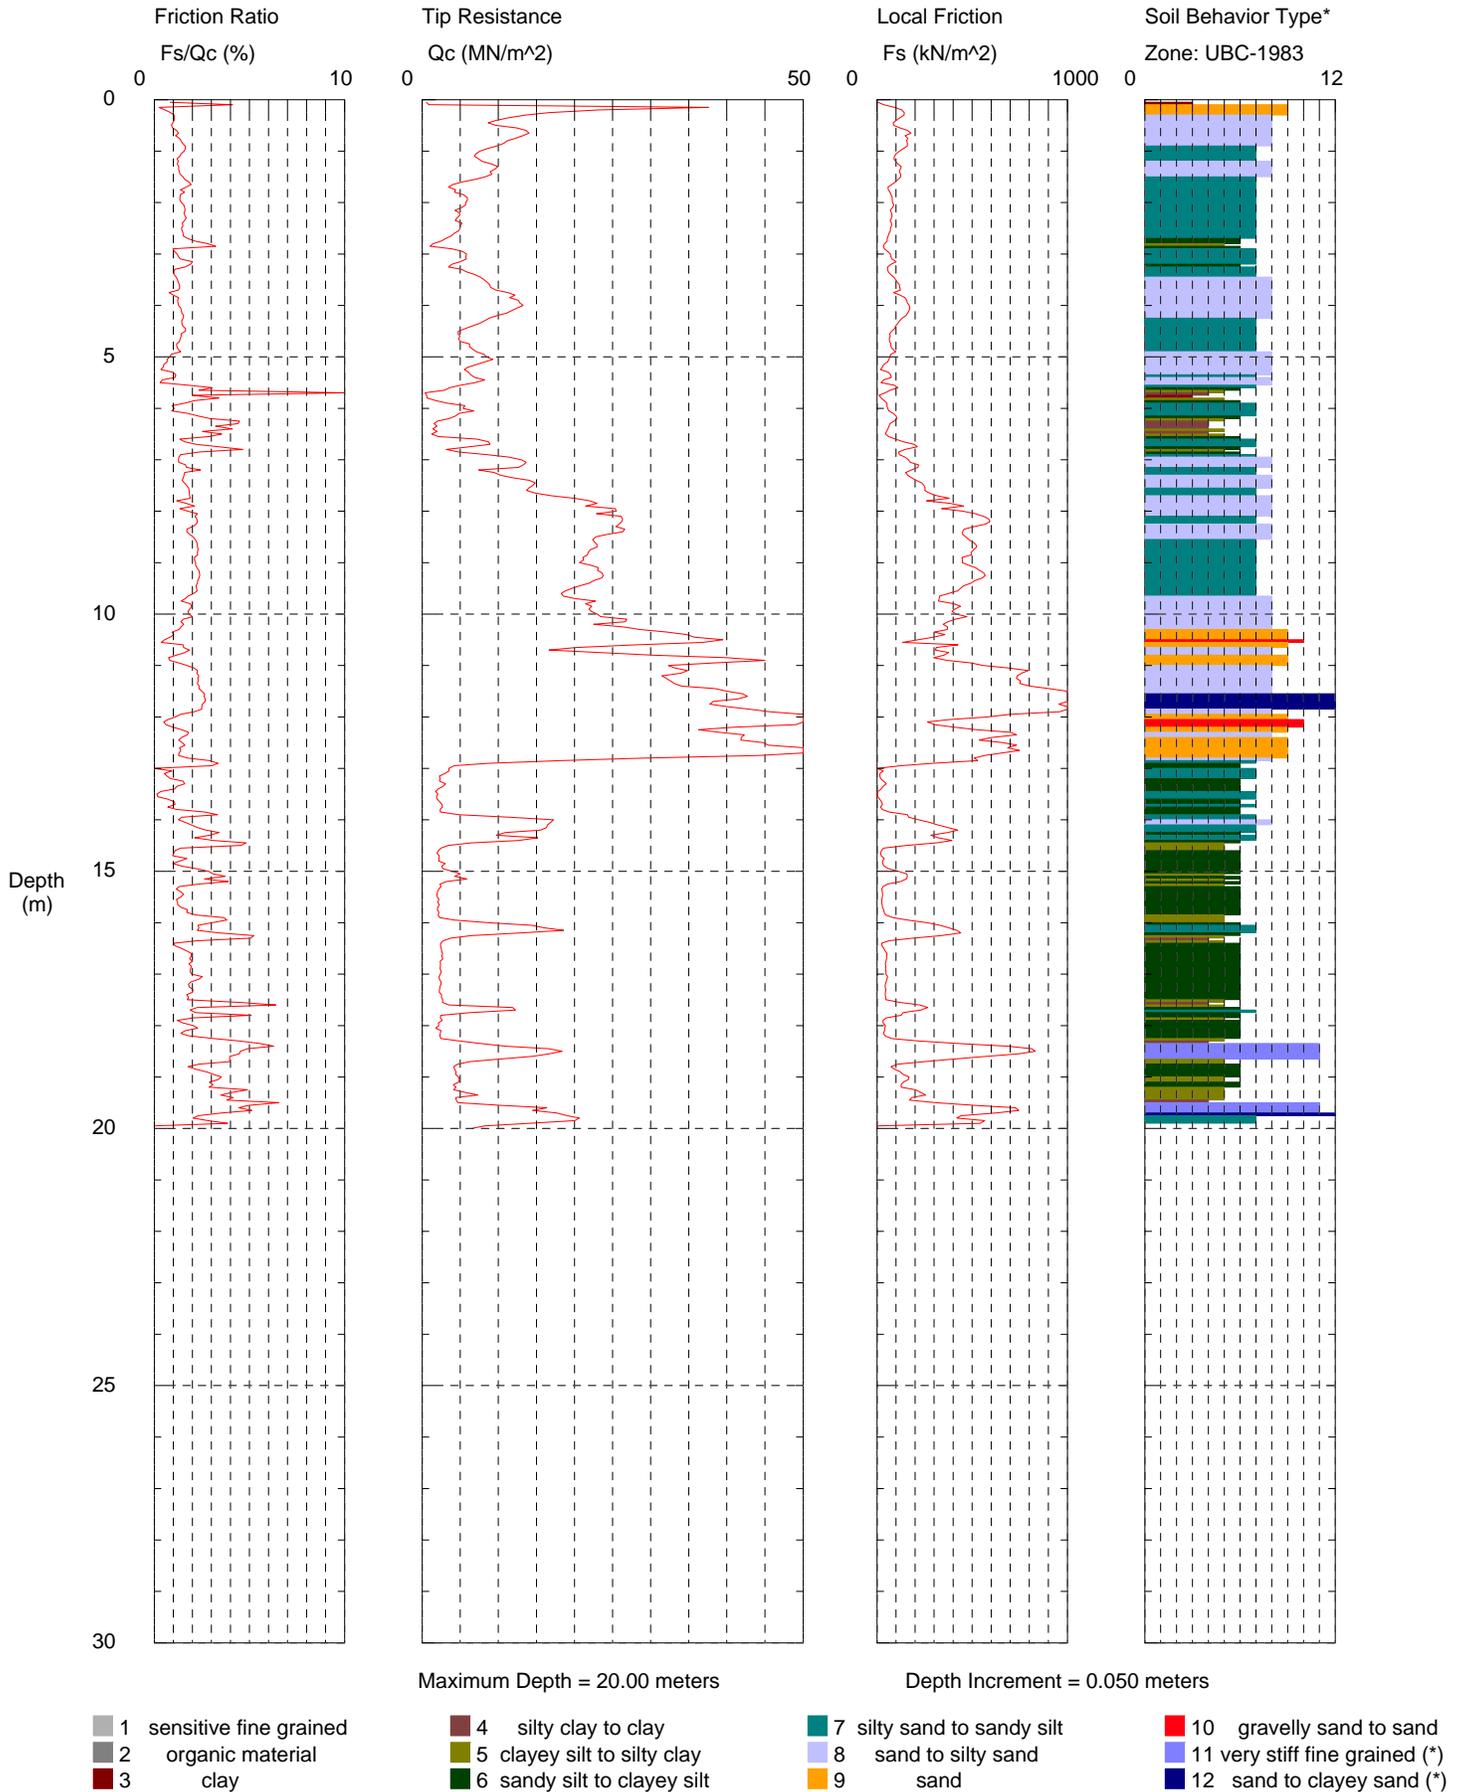
Operator: Tom Noce  
 Sounding: SOC030  
 Cone Used: 766tc

CPT Date/Time: 03-03-04 14:17  
 Location: Airpark Road Elk  
 Job Number: Oceano

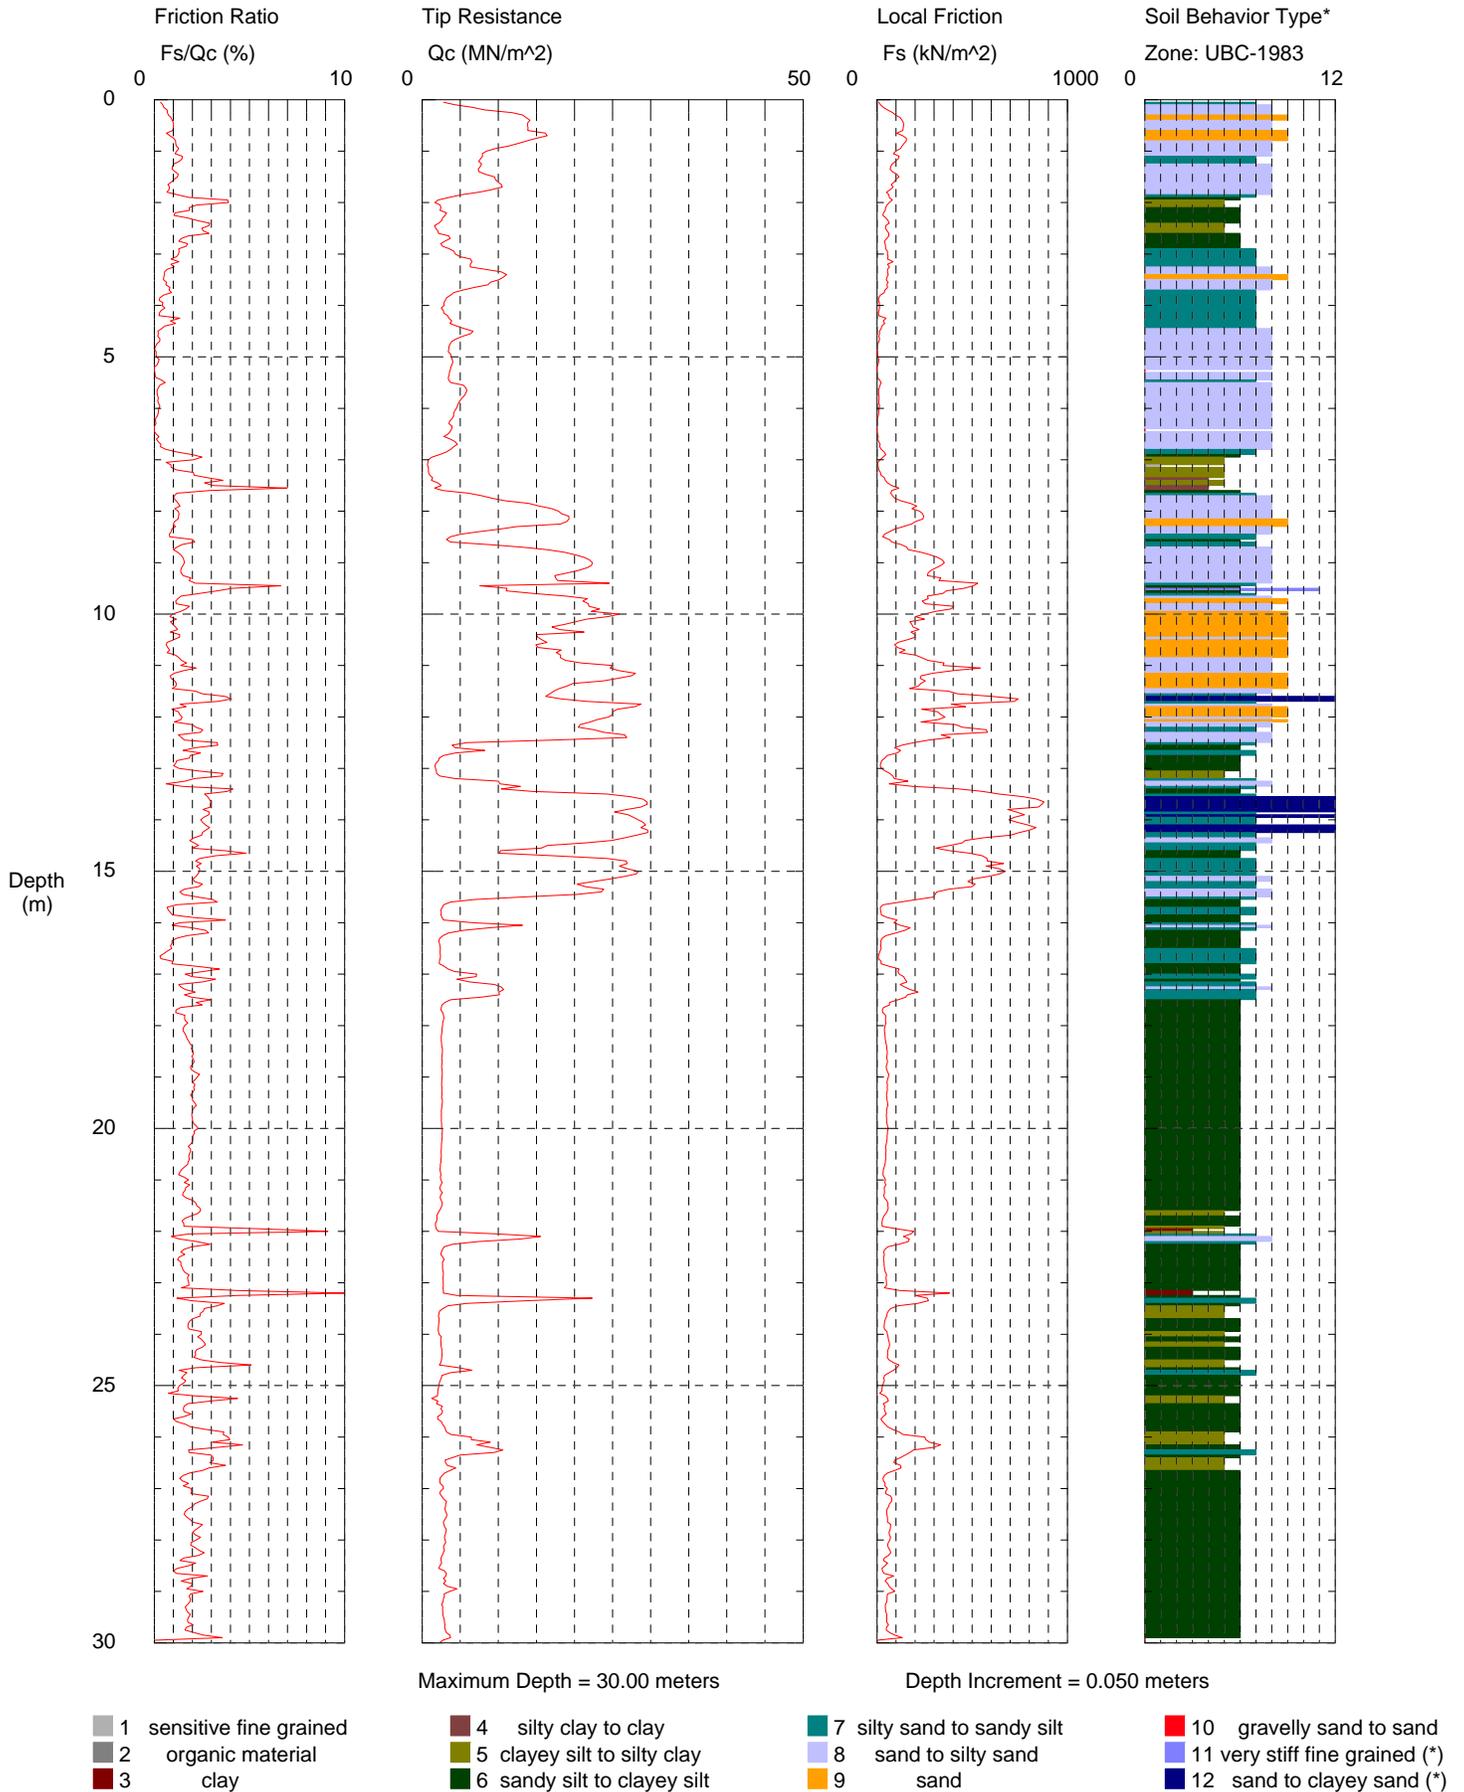
Operator: Tom Noce  
 Sounding: SOC035  
 Cone Used: 766tc

CPT Date/Time: 03-05-04 08:29  
 Location: Levee Center  
 Job Number: Oceano
