# MEADOW CREEK LAGOON HABITAT RESTORATION

**PRELIMINARY GEOTECHNICAL AND  
GEOLOGIC HAZARDS REPORT**

**Meadow Creek Lagoon Habitat Restoration  
San Luis Obispo County, California**

Yeh Project No.: 220-331

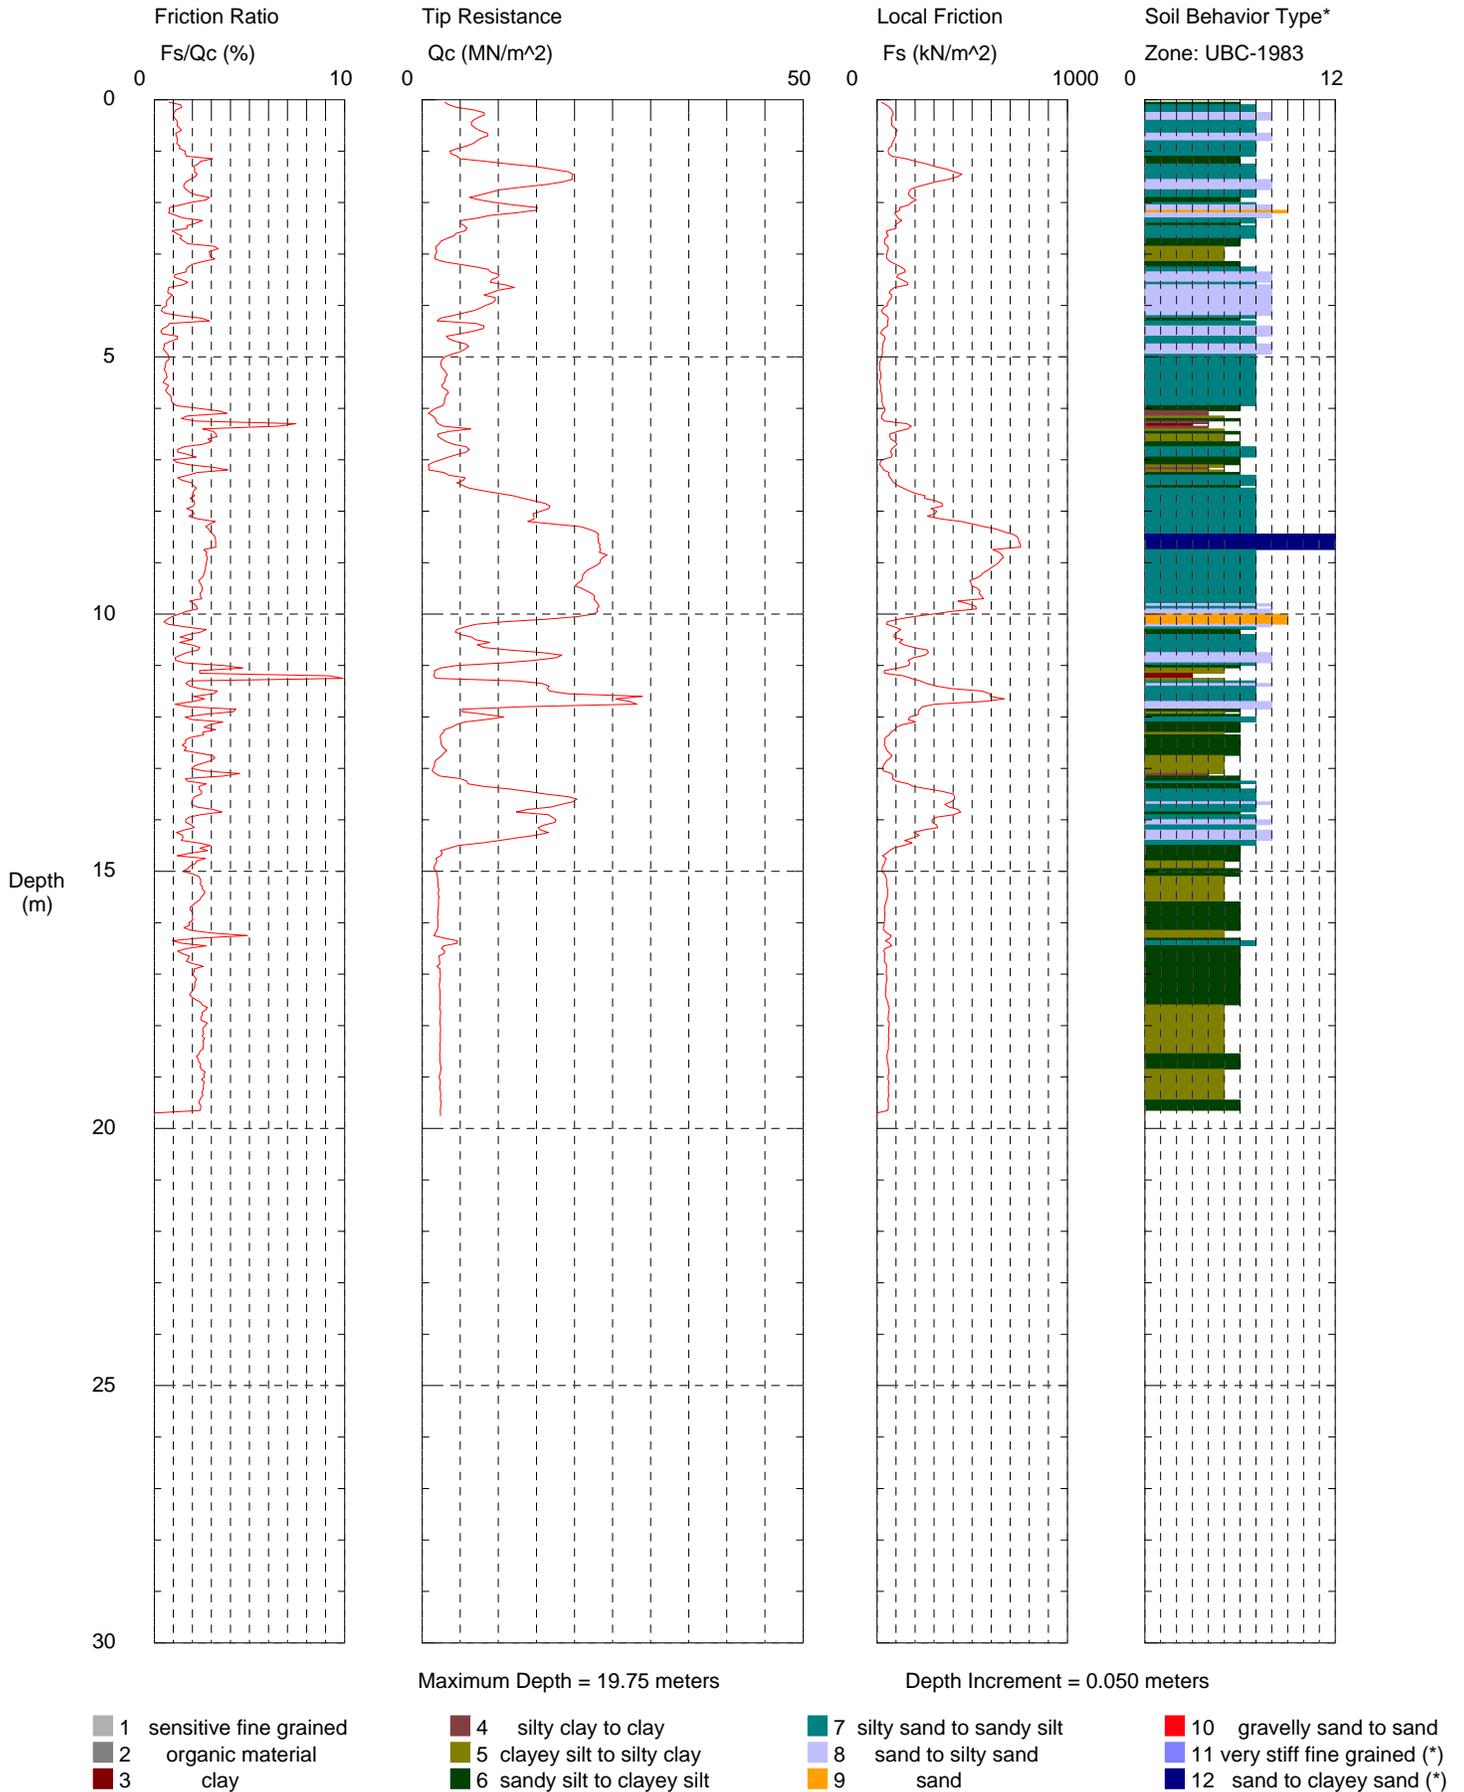
Operator: Tom Noce  
 Sounding: SOC036  
 Cone Used: 766tc

CPT Date/Time: 03-05-04 10:07  
 Location: Levee Northwest  
 Job Number: Oceano

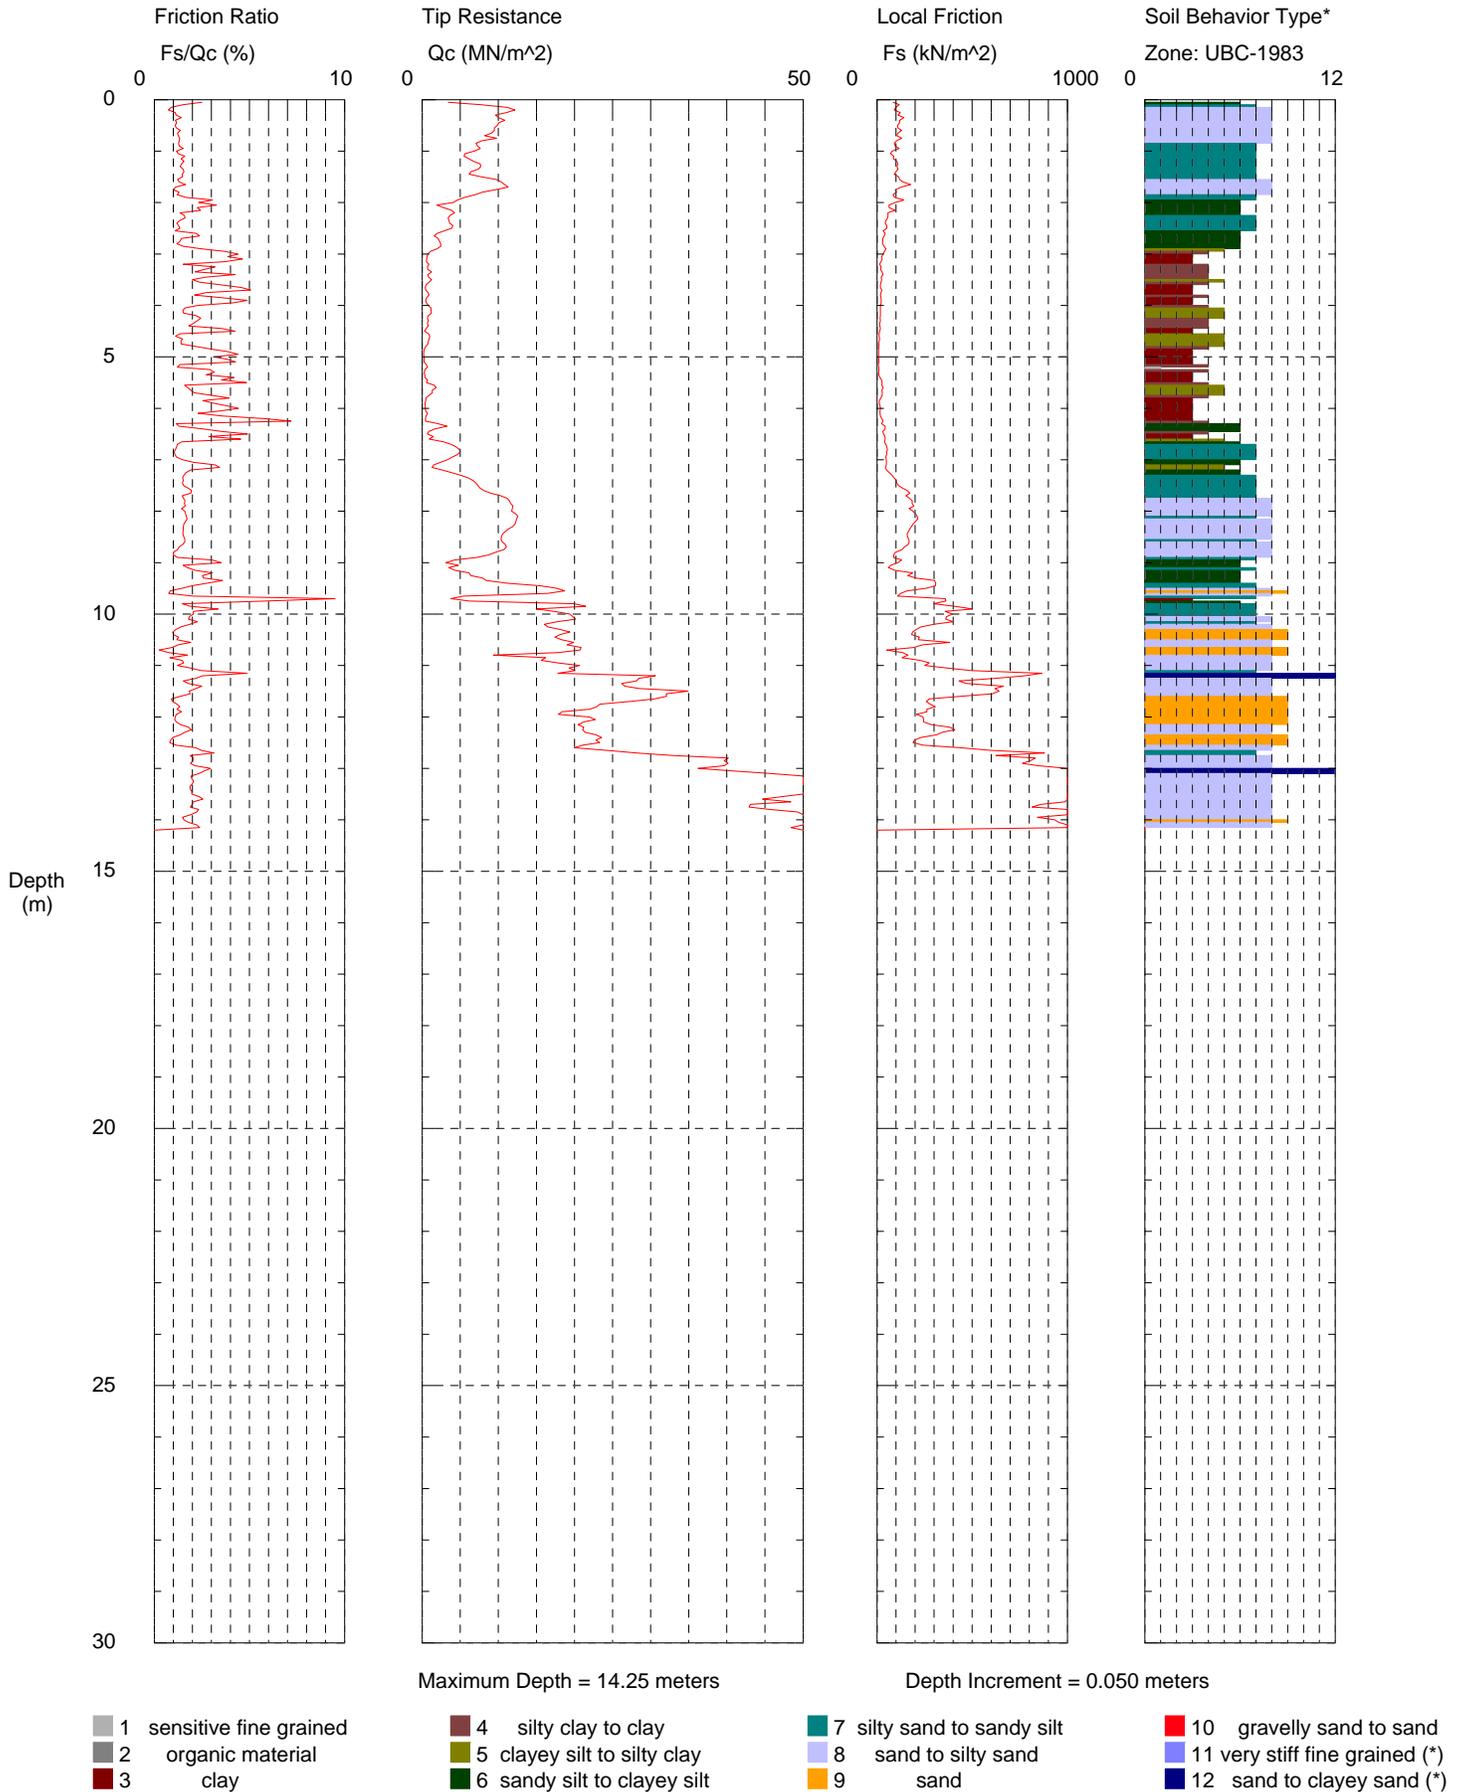
Operator: Tom Noce  
 Sounding: SOC037  
 Cone Used: 766tc

CPT Date/Time: 03-05-04 11:10  
 Location: Levee Southeast  
 Job Number: Oceano

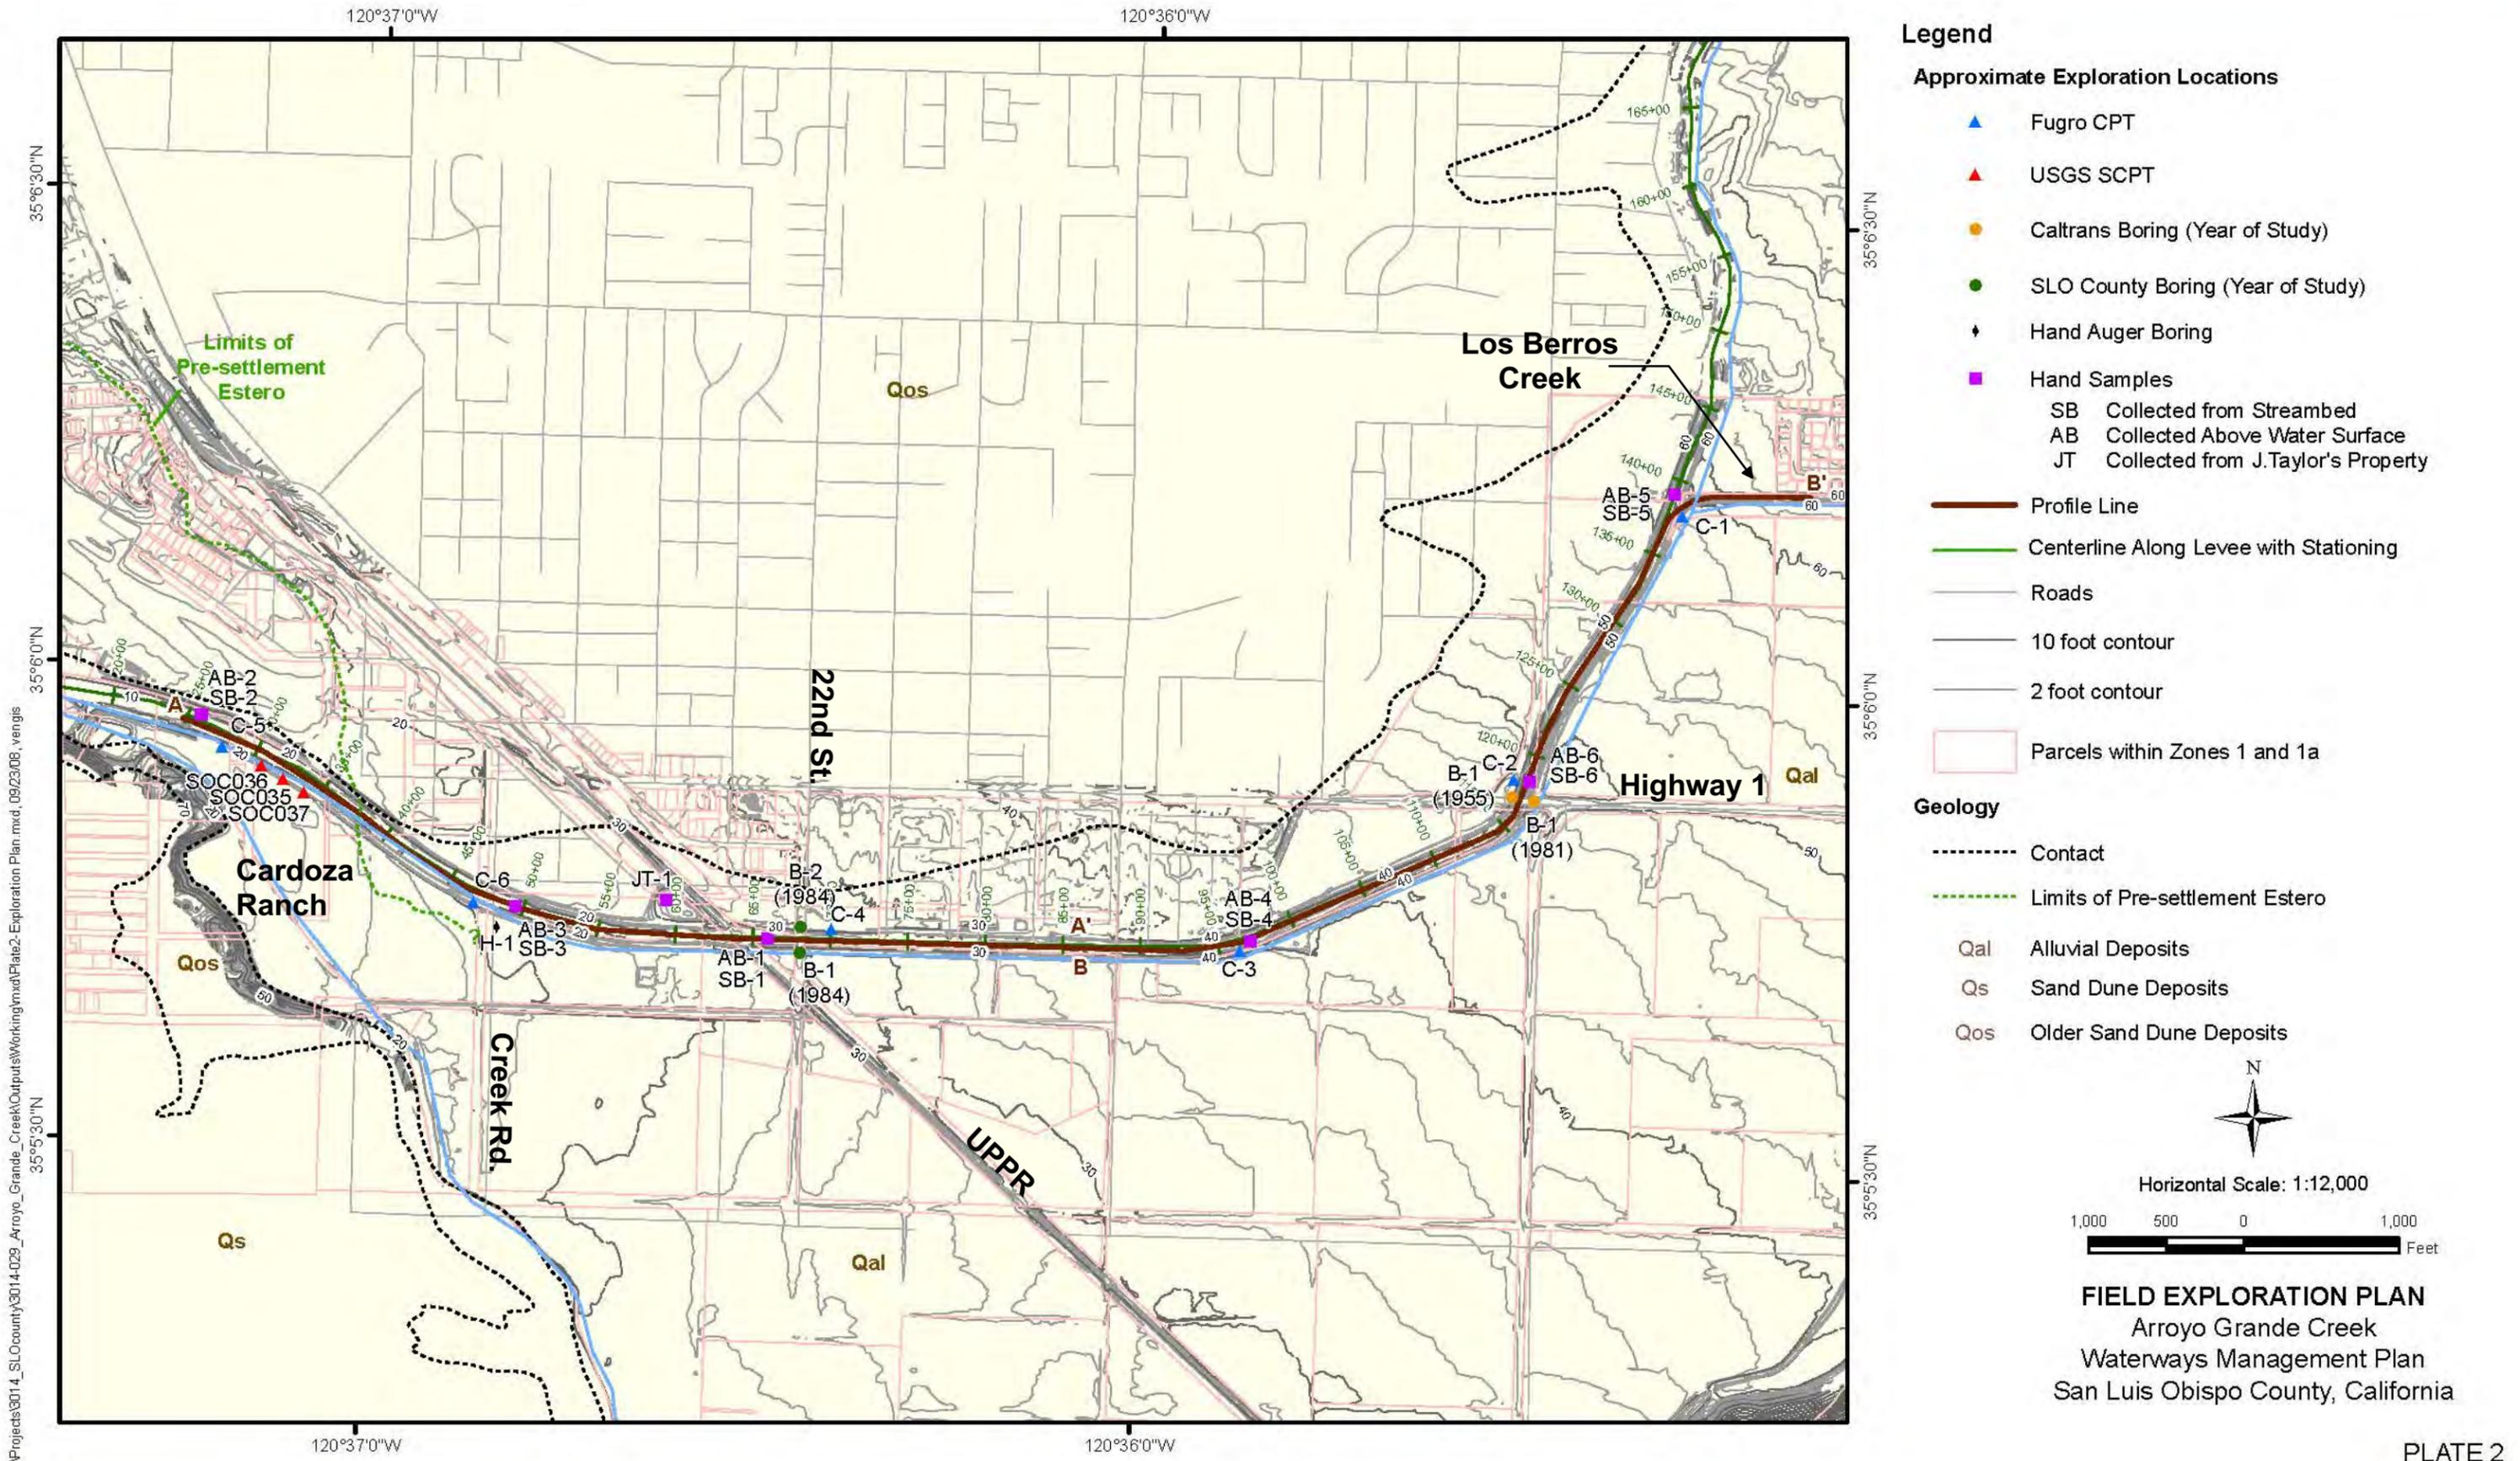
**FIELD EXPLORATION PLAN**  
Arroyo Grande Creek  
Waterways Management Plan  
San Luis Obispo County, California

- Legend**
- Approximate Exploration Locations**
- ▲ Fugro CPT
  - ▲ USGS SCPT
  - Caltrans Boring (Year of Study)
  - SLO County Boring (Year of Study)
  - ◆ Hand Auger Boring
  - Hand Samples
    - SB Collected from Streambed
    - AB Collected Above Water Surface
    - JT Collected from J. Taylor's Property
- Profile Line**
- Profile Line
  - Centerline Along Levee with Stationing
  - Roads
  - 10 foot contour
  - 2 foot contour
  - Parcels within Zones 1 and 1a
- Geology**
- - - Contact
  - - - Limits of Pre-settlement Estero
  - Qal Alluvial Deposits
  - Qs Sand Dune Deposits
  - Qos Older Sand Dune Deposits

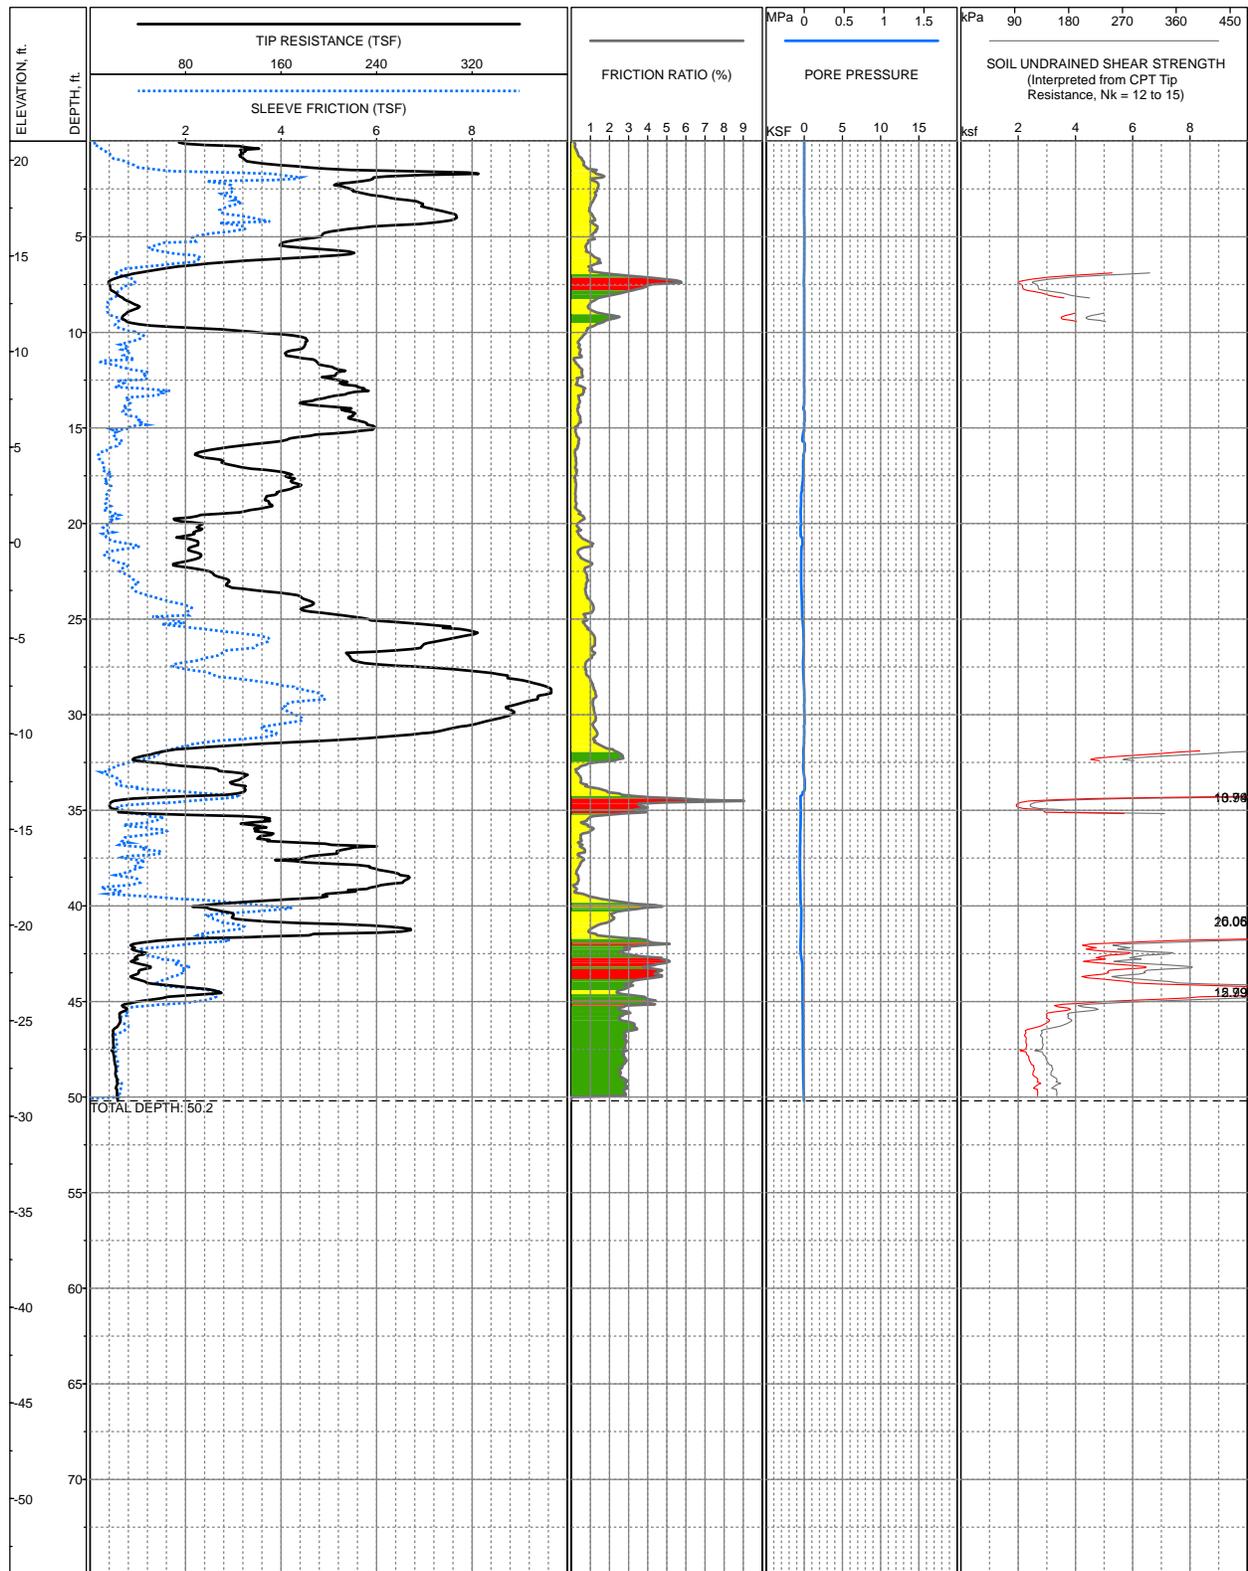
**LOG OF C-5**  
Arroyo Grande Creek Waterways Management Plan  
San Luis Obispo, California

COORDINATES: 2,232,390.00N 5,778,074.64W  
SURFACE EL: 21.0ft +/- (MSL)  
COMPLETION DEPTH: 50.2ft  
TESTDATE: 7/22/2008

EXPLORATION METHOD: Cone Penetrometer  
PERFORMED BY: Fugro Geosciences  
REVIEWED BY: J. Blanchard

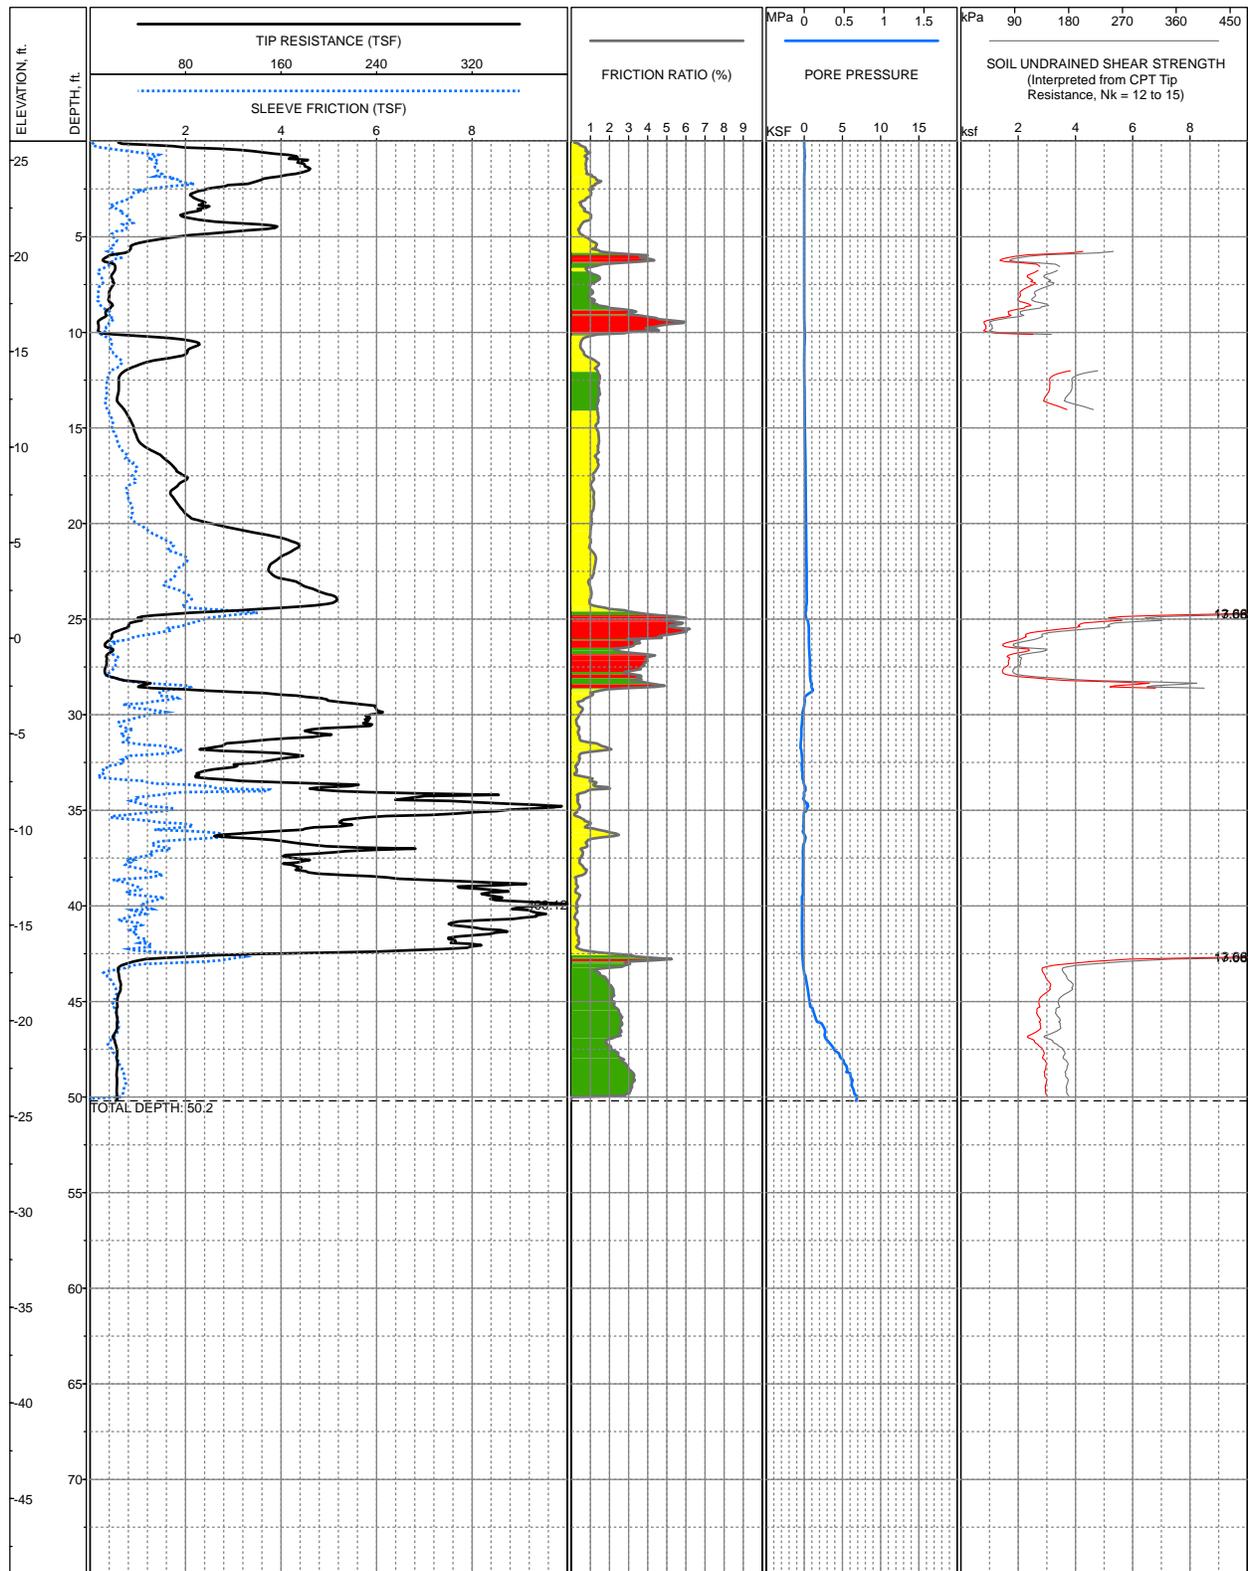
**LOG OF C-6**  
Arroyo Grande Creek Waterways Management Plan  
San Luis Obispo, California

COORDINATES: 2,231,397.63N 5,779,691.56W  
SURFACE EL: 26.0ft +/- (MSL)  
COMPLETION DEPTH: 50.2ft  
TESTDATE: 7/22/2008

EXPLORATION METHOD: Cone Penetrometer  
PERFORMED BY: Fugro Geosciences  
REVIEWED BY: J.Blanchard

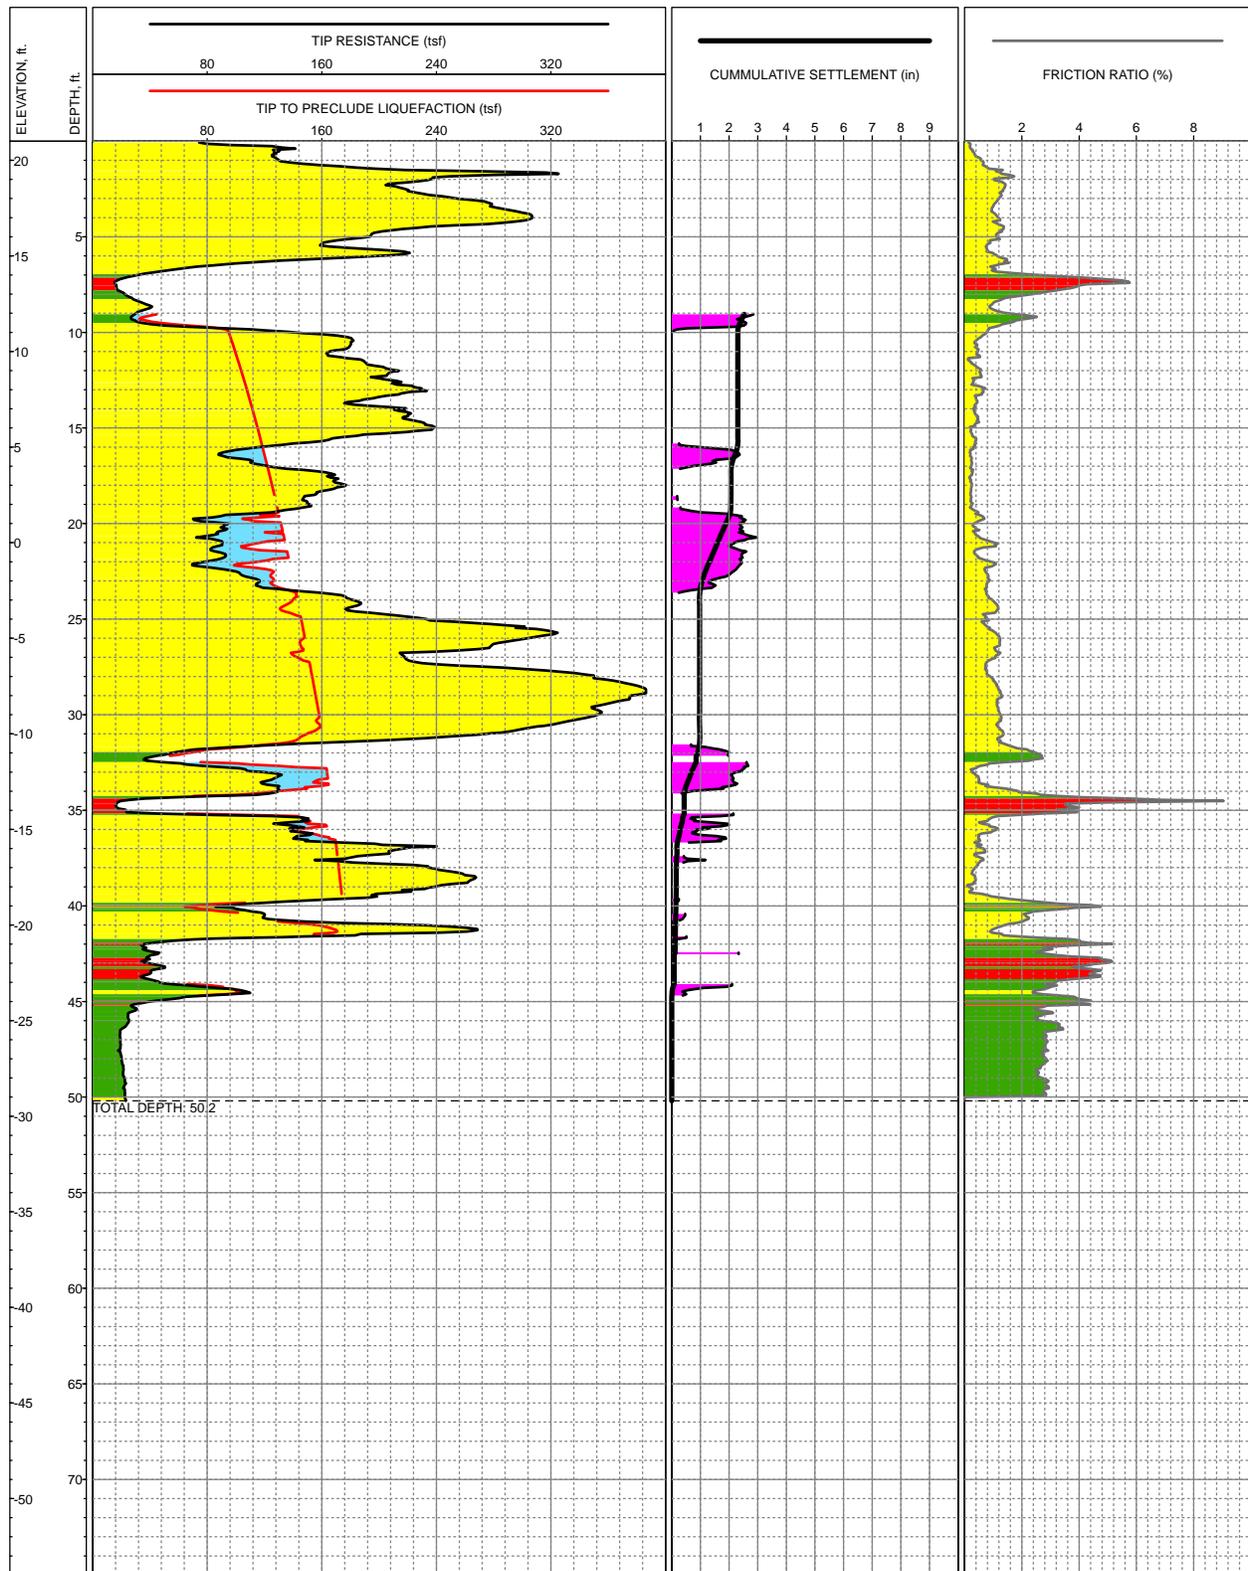
**LOG OF CPT C-5, M7.0, a=0.46**  
Arroyo Grande Creek Waterways Management Plan  
San Luis Obispo County, California

COORDINATES: 2,232,390.00N 5,778,074.64W  
SURFACE EL: 21.0ft +/- (MSL)  
COMPLETION DEPTH: 50.2ft  
TESTDATE: 7/22/2008

EXPLORATION METHOD: Cone Penetrometer  
PERFORMED BY: Fugro Geosciences  
REVIEWED BY: J Blanchard

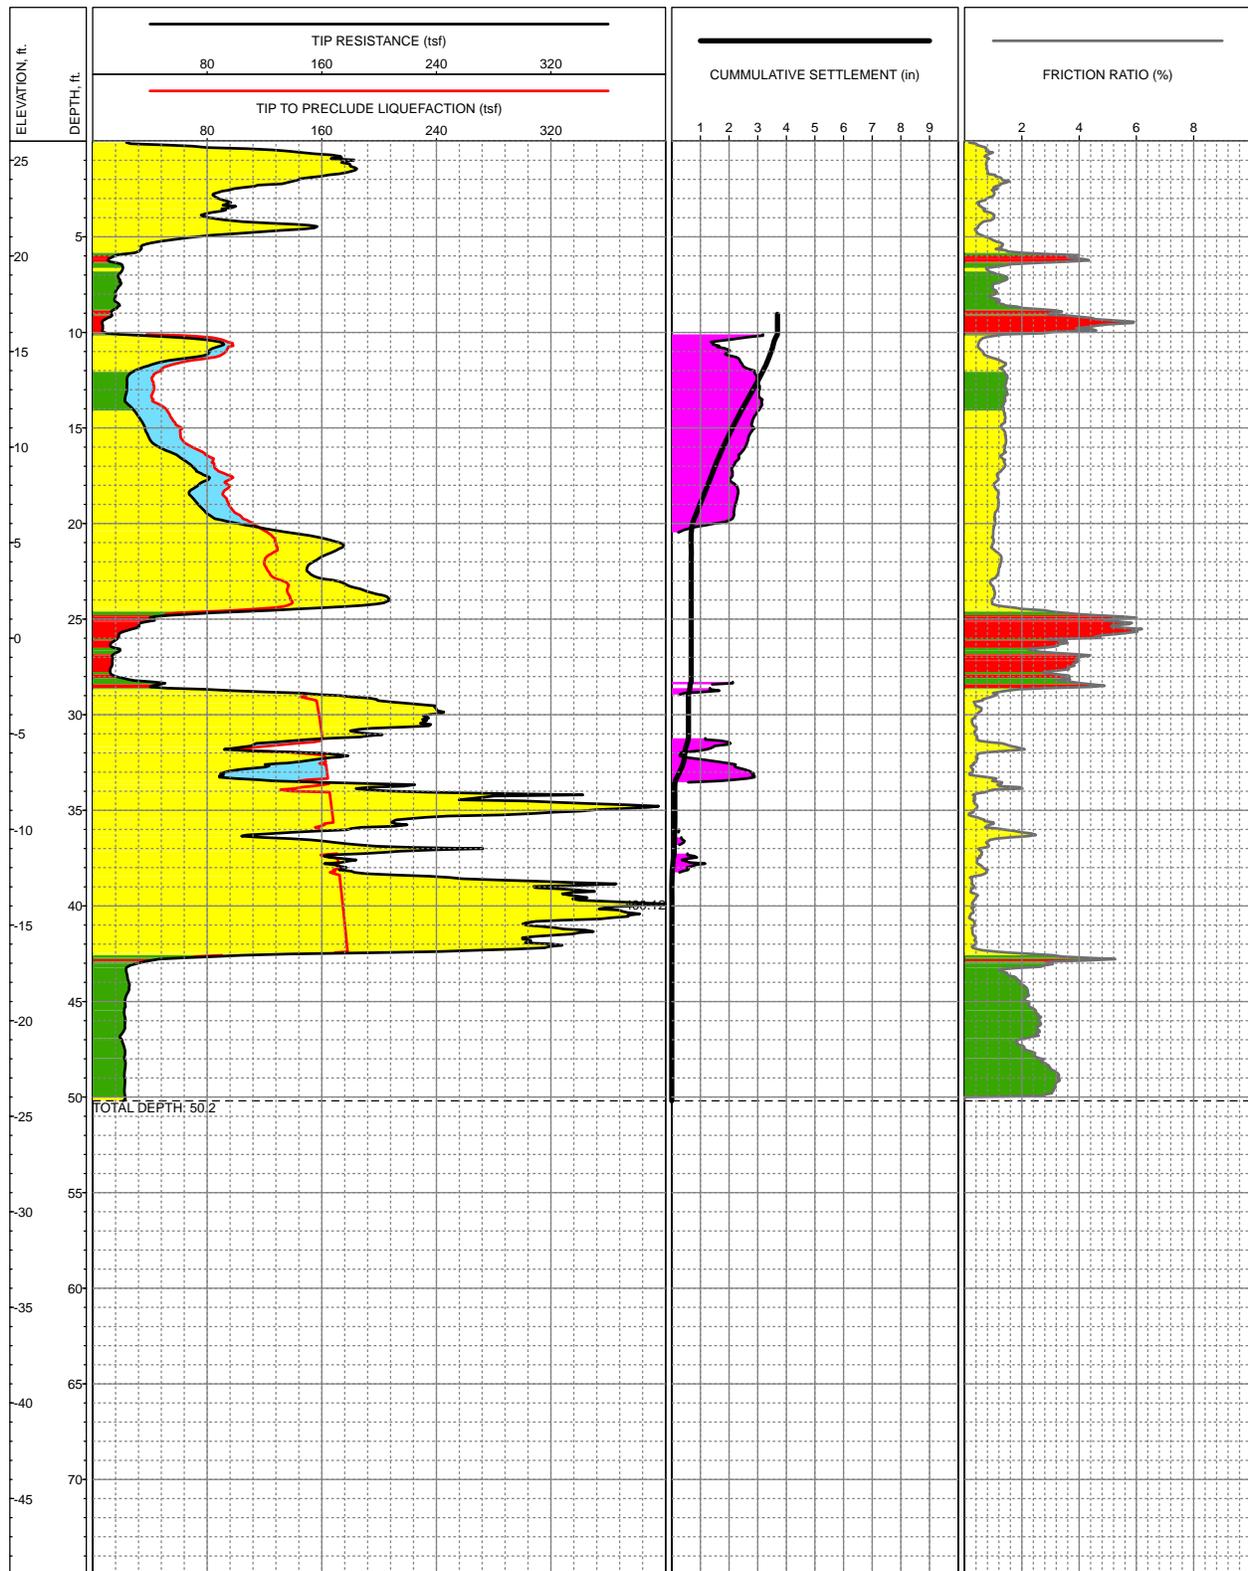
**LOG OF CPT C-6, M7.0, a=0.46**  
Arroyo Grande Creek Waterways Management Plan  
San Luis Obispo County, California

COORDINATES: 2,231,397.63N 5,779,691.56W  
SURFACE EL: 26.0ft +/- (MSL)  
COMPLETION DEPTH: 50.2ft  
TESTDATE: 7/22/2008

EXPLORATION METHOD: Cone Penetrometer  
PERFORMED BY: Fugro Geosciences  
REVIEWED BY: J Blanchard

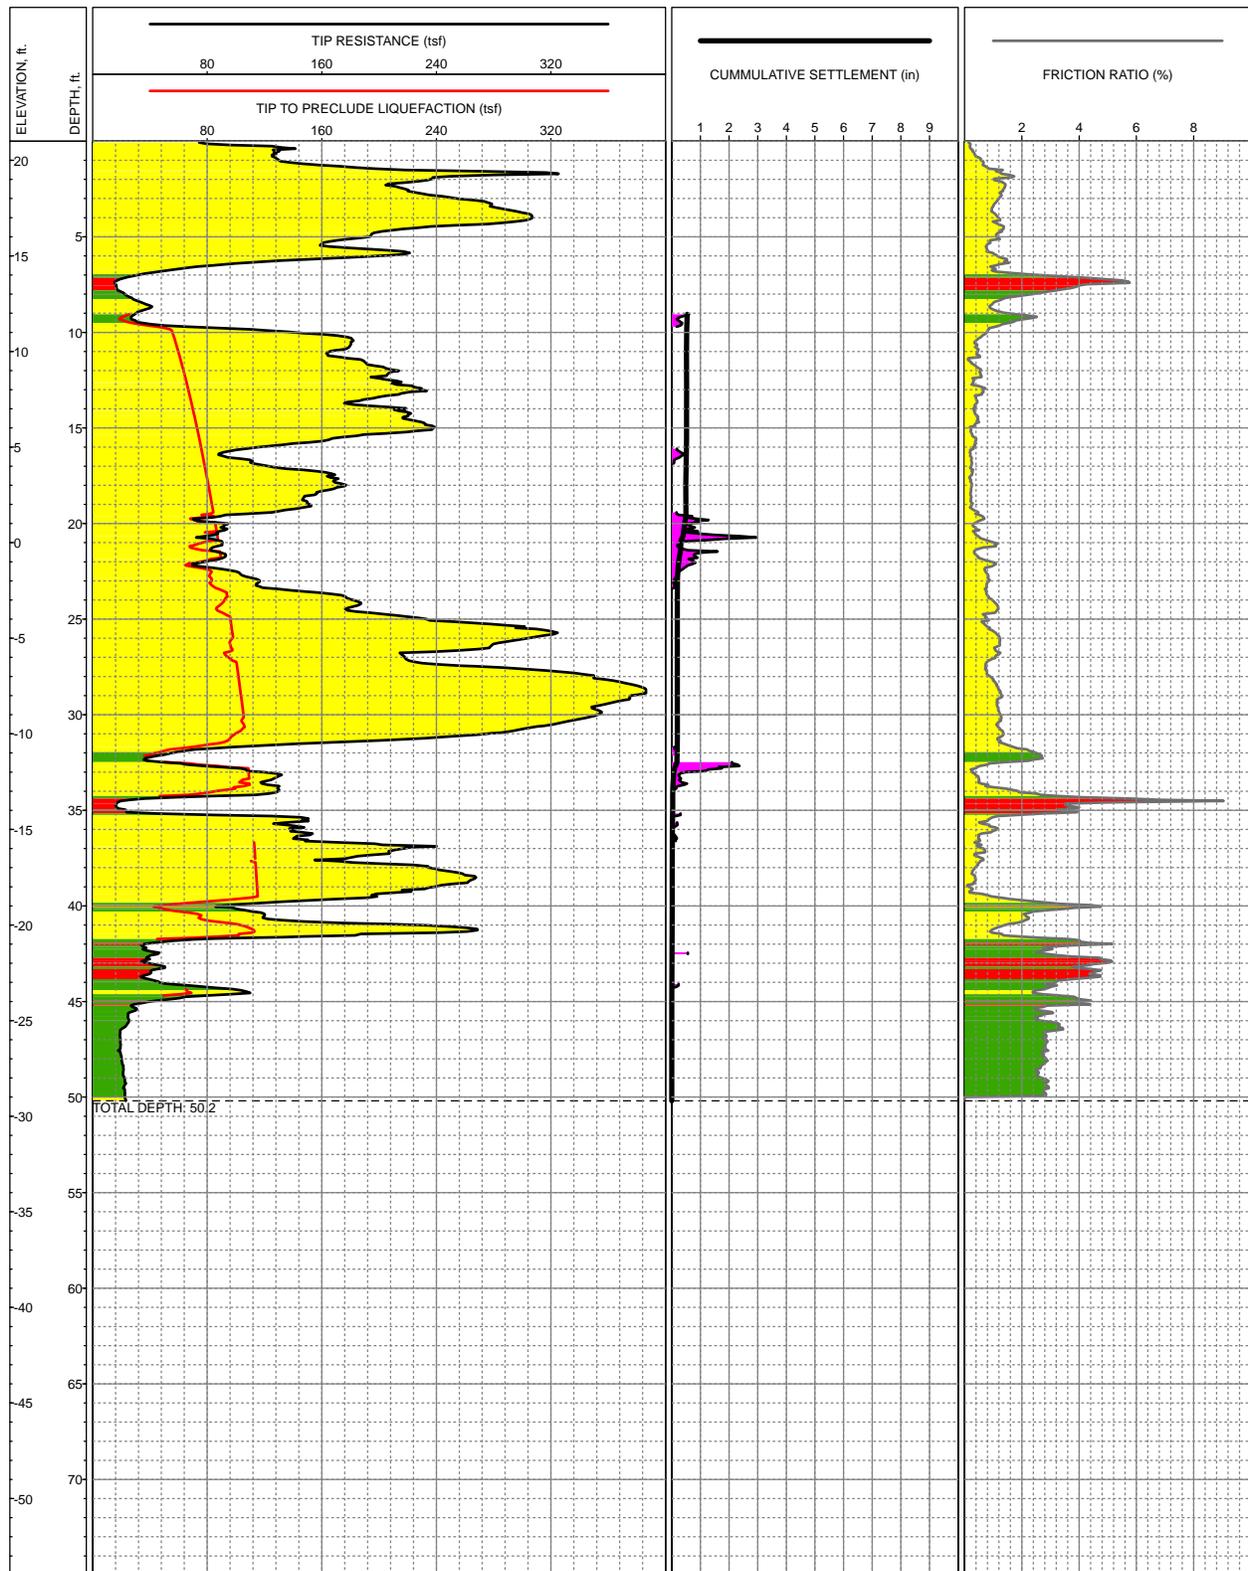
**LOG OF CPT C-5, M6.5, a=0.25**  
 Arroyo Grande Creek Waterways Management Plan  
 San Luis Obispo County, California

COORDINATES: 2,232,390.00N 5,778,074.64W  
 SURFACE EL: 21.0ft +/- (MSL)  
 COMPLETION DEPTH: 50.2ft  
 TESTDATE: 7/22/2008

EXPLORATION METHOD: Cone Penetrometer  
 PERFORMED BY: Fugro Geosciences  
 REVIEWED BY: J Blanchard

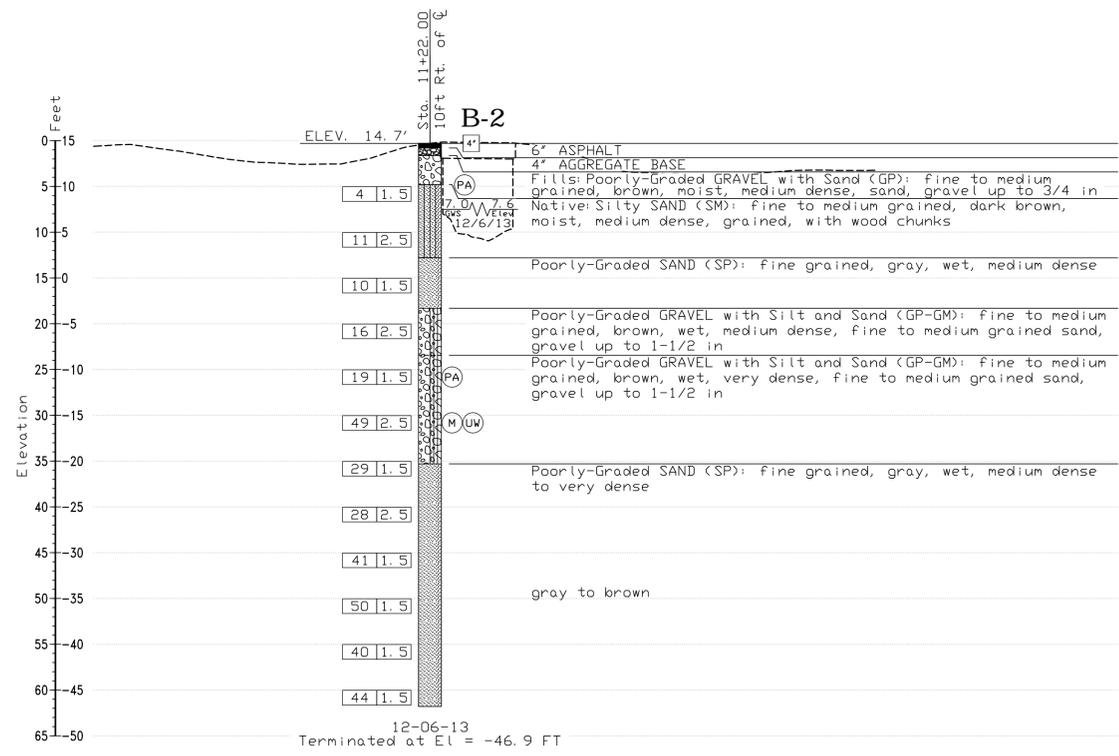
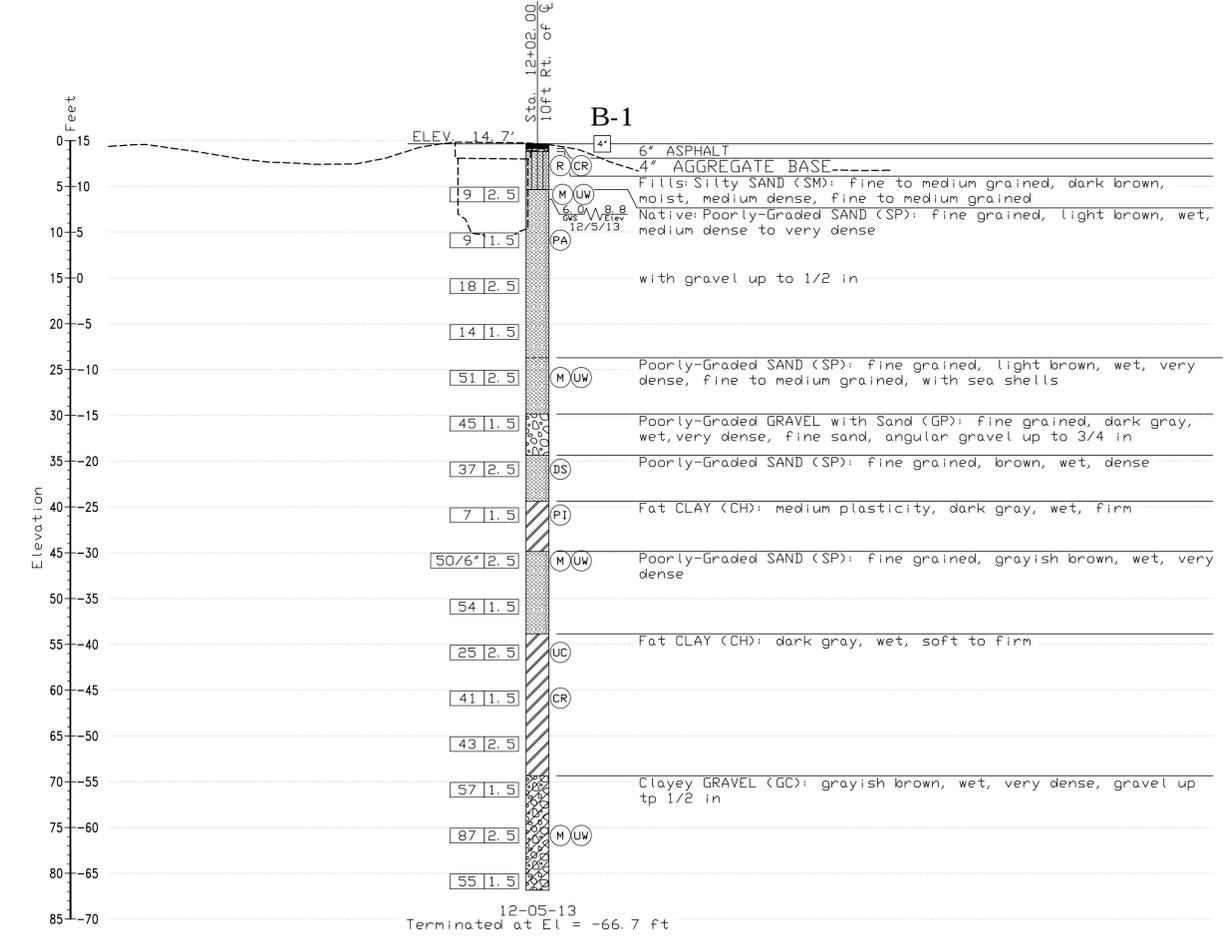
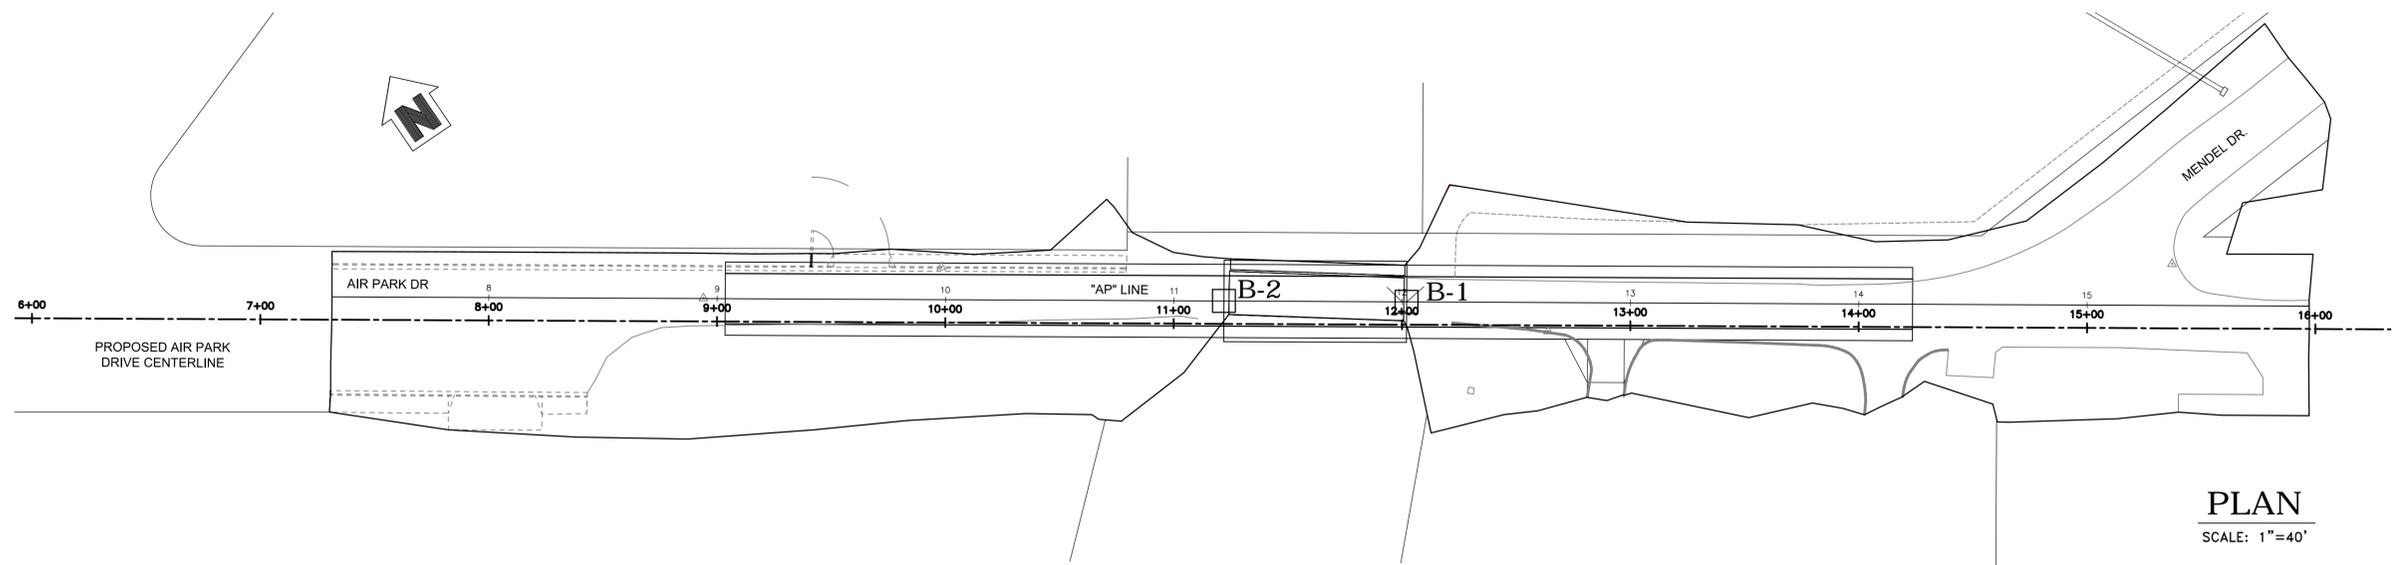
PROJECT NO.	137686	<b>LOG OF TEST BORINGS</b>	<b>PLATE 1</b>
DRAWN:	01/2014		
DRAWN BY:	MRG		
CHECKED BY:	NP		
137686p2_LOTB.dwg		AIR PARK DRIVE BRIDGE COUNTY OF SAN LUIS OBISPO OCEANO BEACH LAGOON, OCEANO, CALIFORNIA

1. TBM BB OF EXISTING BRIDGE, ELEVATION 100.0 FEET.
2. GROUNDWATER ENCOUNTERED AT DEPTHS INDICATED.
3. 1.5-INCH DIAMETER SAMPLES WERE TAKEN USING A STANDARD PENETRATION TEST (SPT) SPLIT BARREL SAMPLER WITH AN INSIDE DIAMETER (ID) OF 1.5 INCHES AND AN OUTSIDE DIAMETER (OD) OF 2.0 INCHES.
4. 2.5-INCH DIAMETER RING SAMPLES WERE TAKEN USING A CALIFORNIA SPLIT BARREL SAMPLER WITH AN ID OF 2.5 INCHES AND AN OD OF 3.0 INCHES.
5. ALL DRIVE SAMPLES WERE DRIVEN WITH 140 LB HAMMER WITH A FALLING HEIGHT OF 30 INCHES, WHICH WAS CALIBRATED AT 92% EFFICIENCY.

**PROFILE**  
SCALE: 1"=10' VERT.
