# MEADOW CREEK LAGOON HABITAT RESTORATION

**PRELIMINARY GEOTECHNICAL AND  
GEOLOGIC HAZARDS REPORT**

**Meadow Creek Lagoon Habitat Restoration  
San Luis Obispo County, California**

Yeh Project No.: 220-331

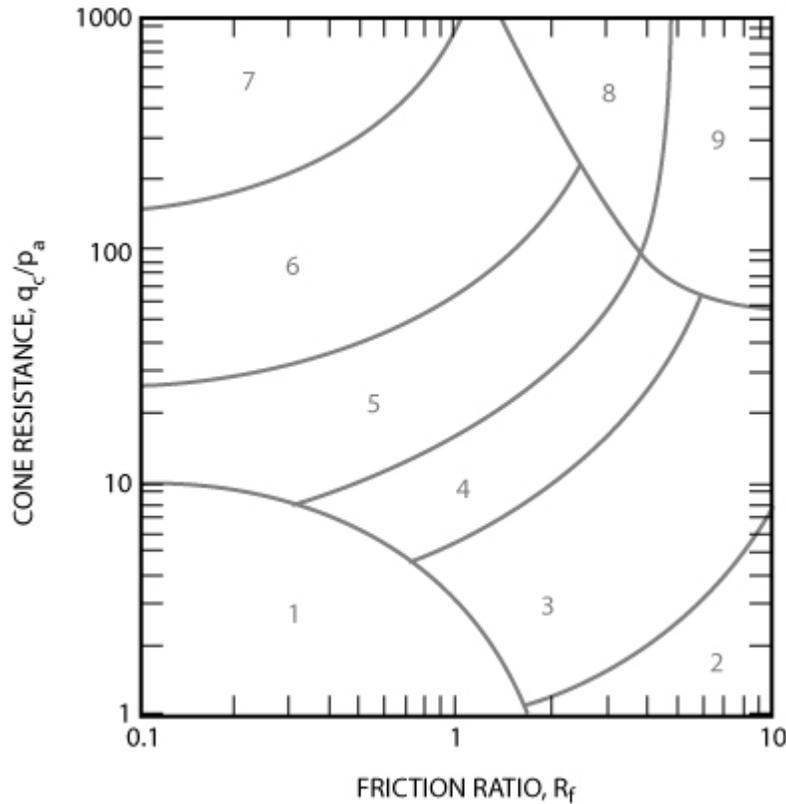
REPORT TITLE CPT SOIL BEHAVIOR CHART (SBT) LEGEND	
PROJECT NAME SSLOCSD - Redundancy Project	
DATE 9/25/2018	SHEET 1 of 1

Zone	Soil Behavior Type	USCS
1	Sensitive, fine grained	OL-CH
2	Organic soils - clay	OL-OH, CH
3	Clay – silty clay to clay	CL-CH
4	Silt mixtures – clayey silt to silty clay	MH-CL
5	Sand mixtures – silty sand to sandy silt	SM-ML
6	Sands – clean sand to silty sand	SW-SP
7	Gravelly sand to dense sand	SW-GW
8	Very stiff sand to clayey sand*	SC-SM
9	Very stiff fine grained*	CH-CL

\* Heavily overconsolidated or cemented

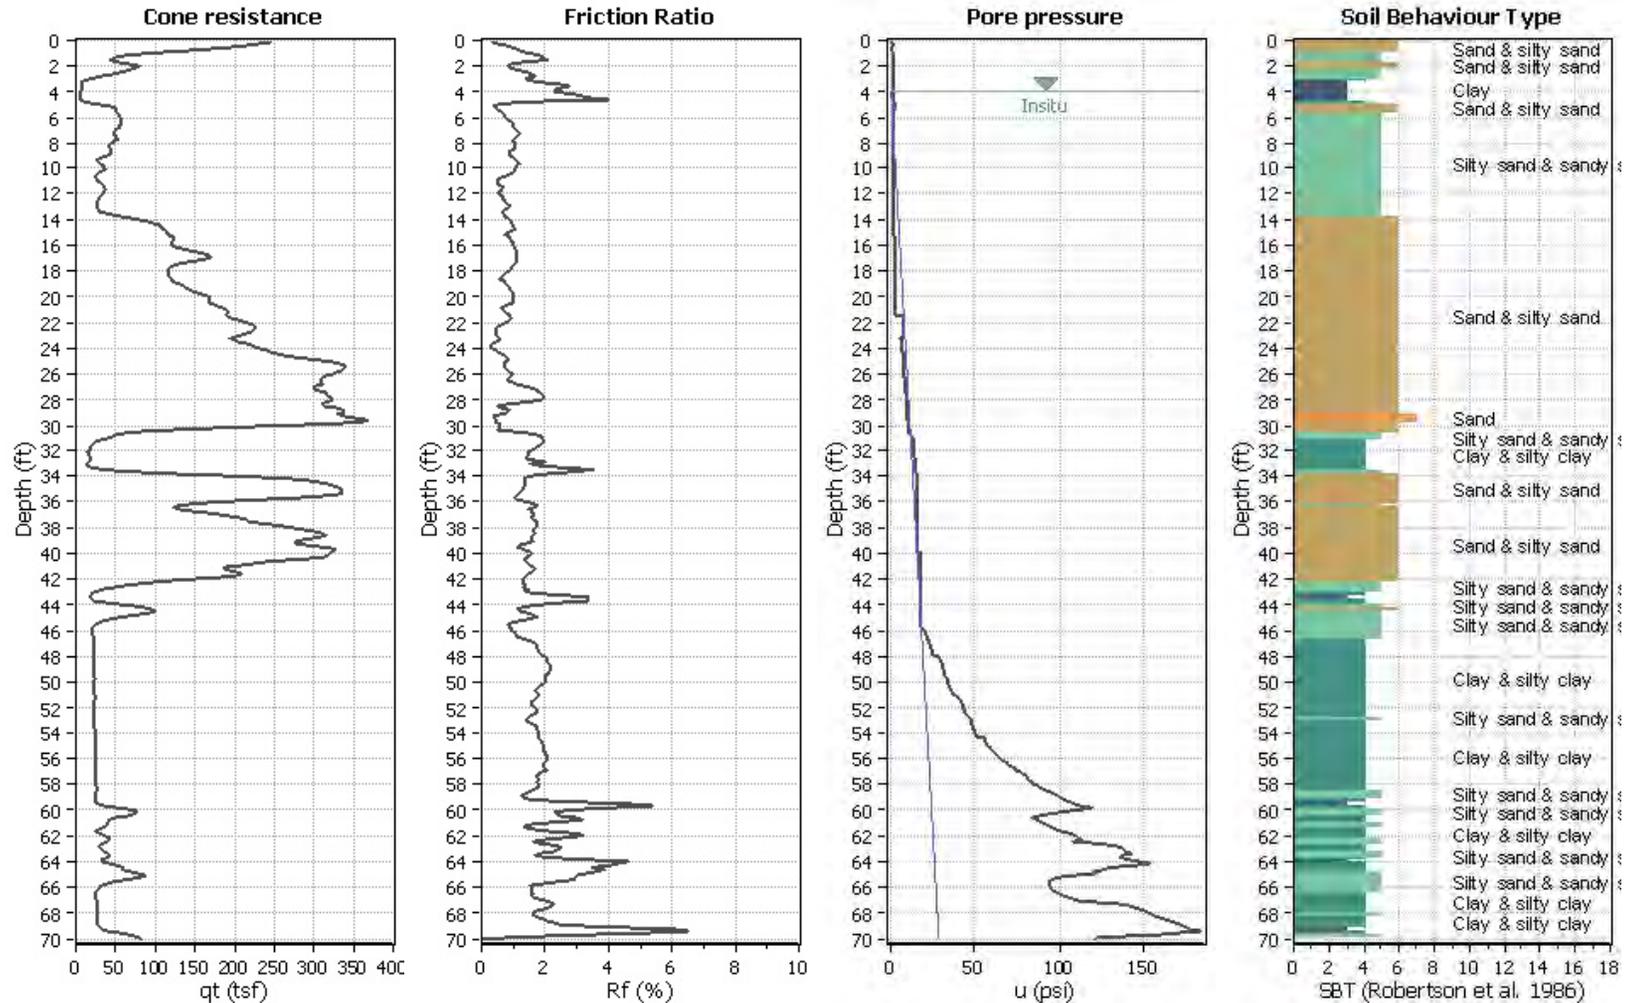
Analysis method:	NCEER (1998)	G.W.T. (in-situ):	4.00 ft	Use fill:	No	Clay like behavior	
Fines correction method:	NCEER (1998)	G.W.T. (earthq.):	0.00 ft	Fill height:	N/A	applied:	Sands only
Points to test:	Based on Ic value	Average results interval:	3	Fill weight:	N/A	Limit depth applied:	No
Earthquake magnitude $M_w$ :	6.70	Ic cut-off value:	2.40	Trans. detect. applied:	Yes	Limit depth:	N/A
Peak ground acceleration:	0.51	Unit weight calculation:	Based on SBT	$K_0$ applied:	Yes	MSF method:	Method based

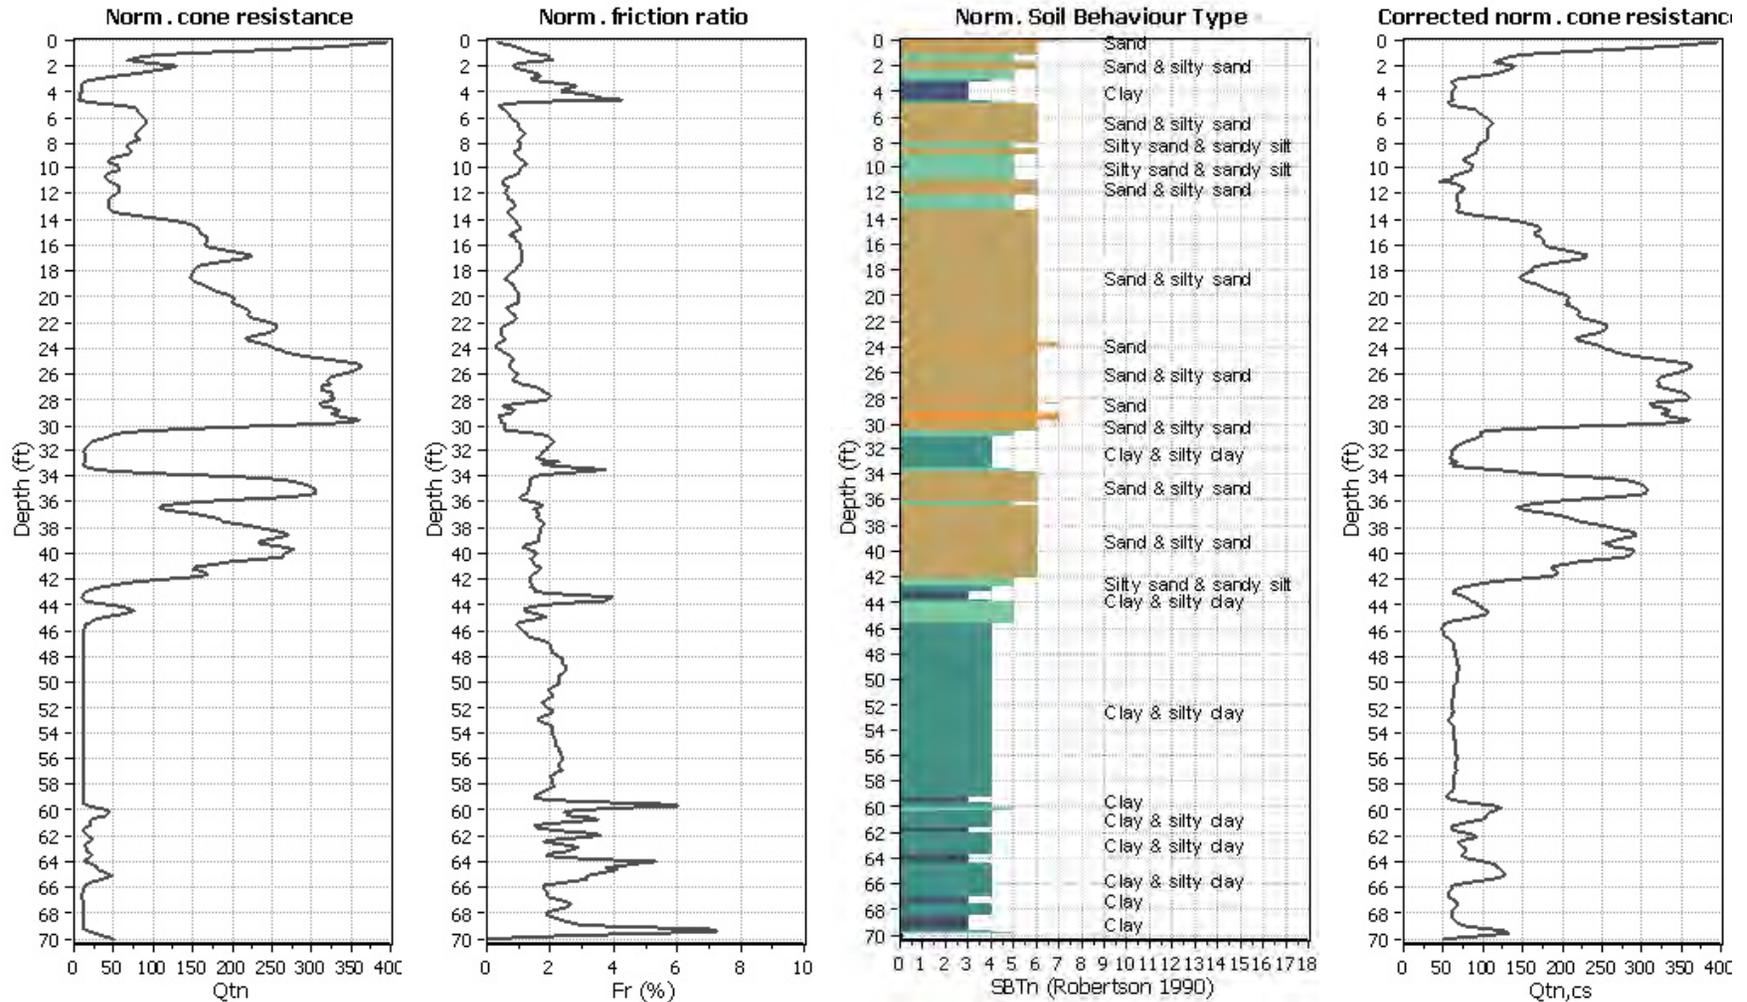
Analysis method:	NCEER (1998)	G.W.T. (in-situ):	4.00 ft	Use fill:	No	Clay like behavior	
Fines correction method:	NCEER (1998)	G.W.T. (earthq.):	0.00 ft	Fill height:	N/A	applied:	Sands only
Points to test:	Based on Ic value	Average results interval:	3	Fill weight:	N/A	Limit depth applied:	No
Earthquake magnitude $M_w$ :	6.70	Ic cut-off value:	2.40	Trans. detect. applied:	Yes	Limit depth:	N/A
Peak ground acceleration:	0.51	Unit weight calculation:	Based on SBT	$K_0$ applied:	Yes	MSF method:	Method based

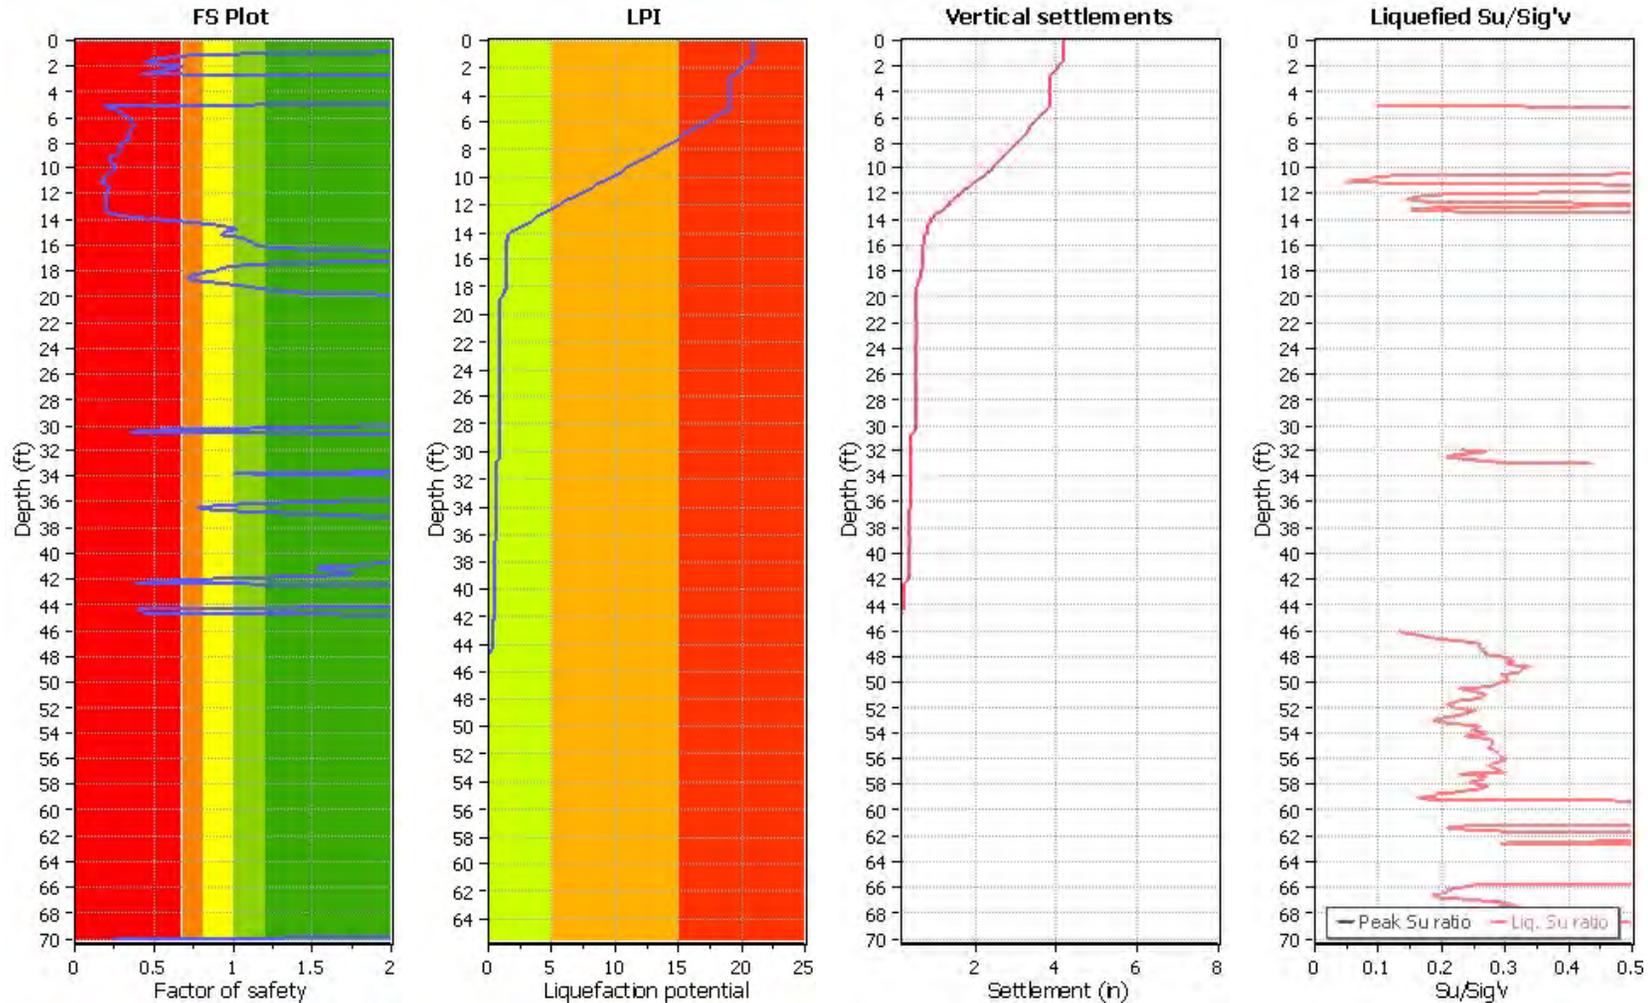
Analysis method:	NCEER (1998)	G.W.T. (in-situ):	4.00 ft	Use fill:	No	Clay like behavior	
Fines correction method:	NCEER (1998)	G.W.T. (earthq.):	0.00 ft	Fill height:	N/A	applied:	Sands only
Points to test:	Based on Ic value	Average results interval:	3	Fill weight:	N/A	Limit depth applied:	No
Earthquake magnitude $M_w$ :	6.70	Ic cut-off value:	2.40	Trans. detect. applied:	Yes	Limit depth:	N/A
Peak ground acceleration:	0.51	Unit weight calculation:	Based on SBT	$K_0$ applied:	Yes	MSF method:	Method based

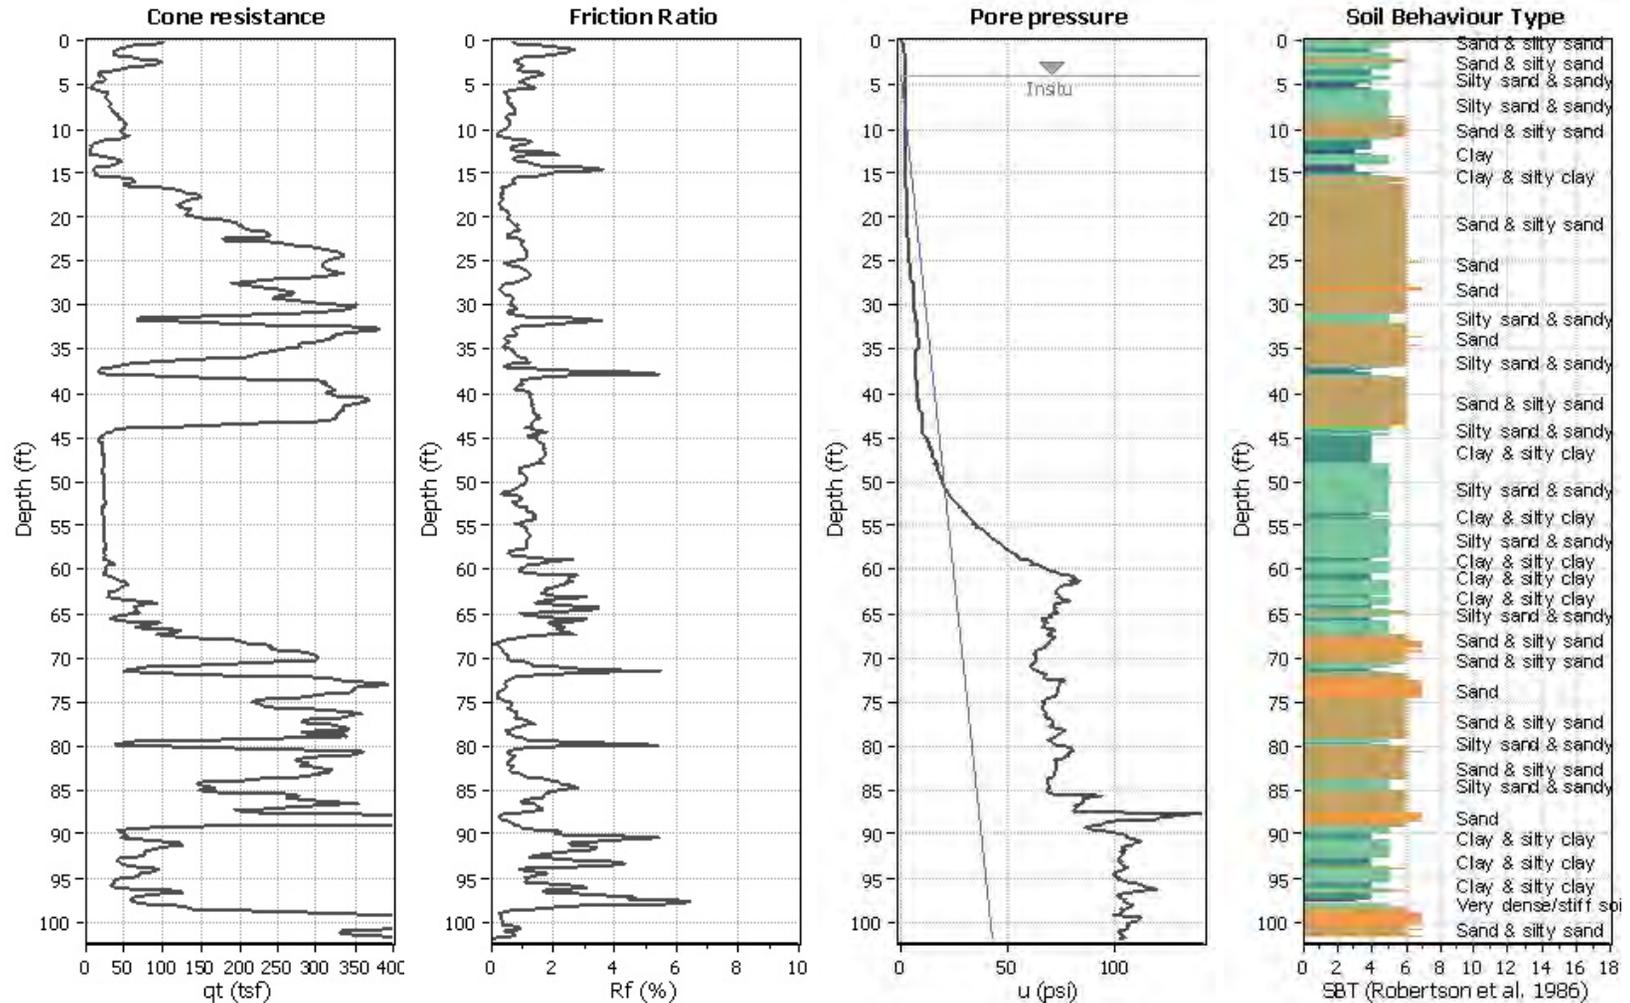
Analysis method:	NCEER (1998)	G.W.T. (in-situ):	4.00 ft	Use fill:	No	Clay like behavior applied:	Sands only
Fines correction method:	NCEER (1998)	G.W.T. (earthq.):	0.00 ft	Fill height:	N/A	Limit depth applied:	No
Points to test:	Based on Ic value	Average results interval:	3	Fill weight:	N/A	Limit depth:	N/A
Earthquake magnitude $M_w$ :	6.70	Ic cut-off value:	2.40	Trans. detect. applied:	Yes	MSF method:	Method based
Peak ground acceleration:	0.51	Unit weight calculation:	Based on SBT	$K_0$ applied:	Yes

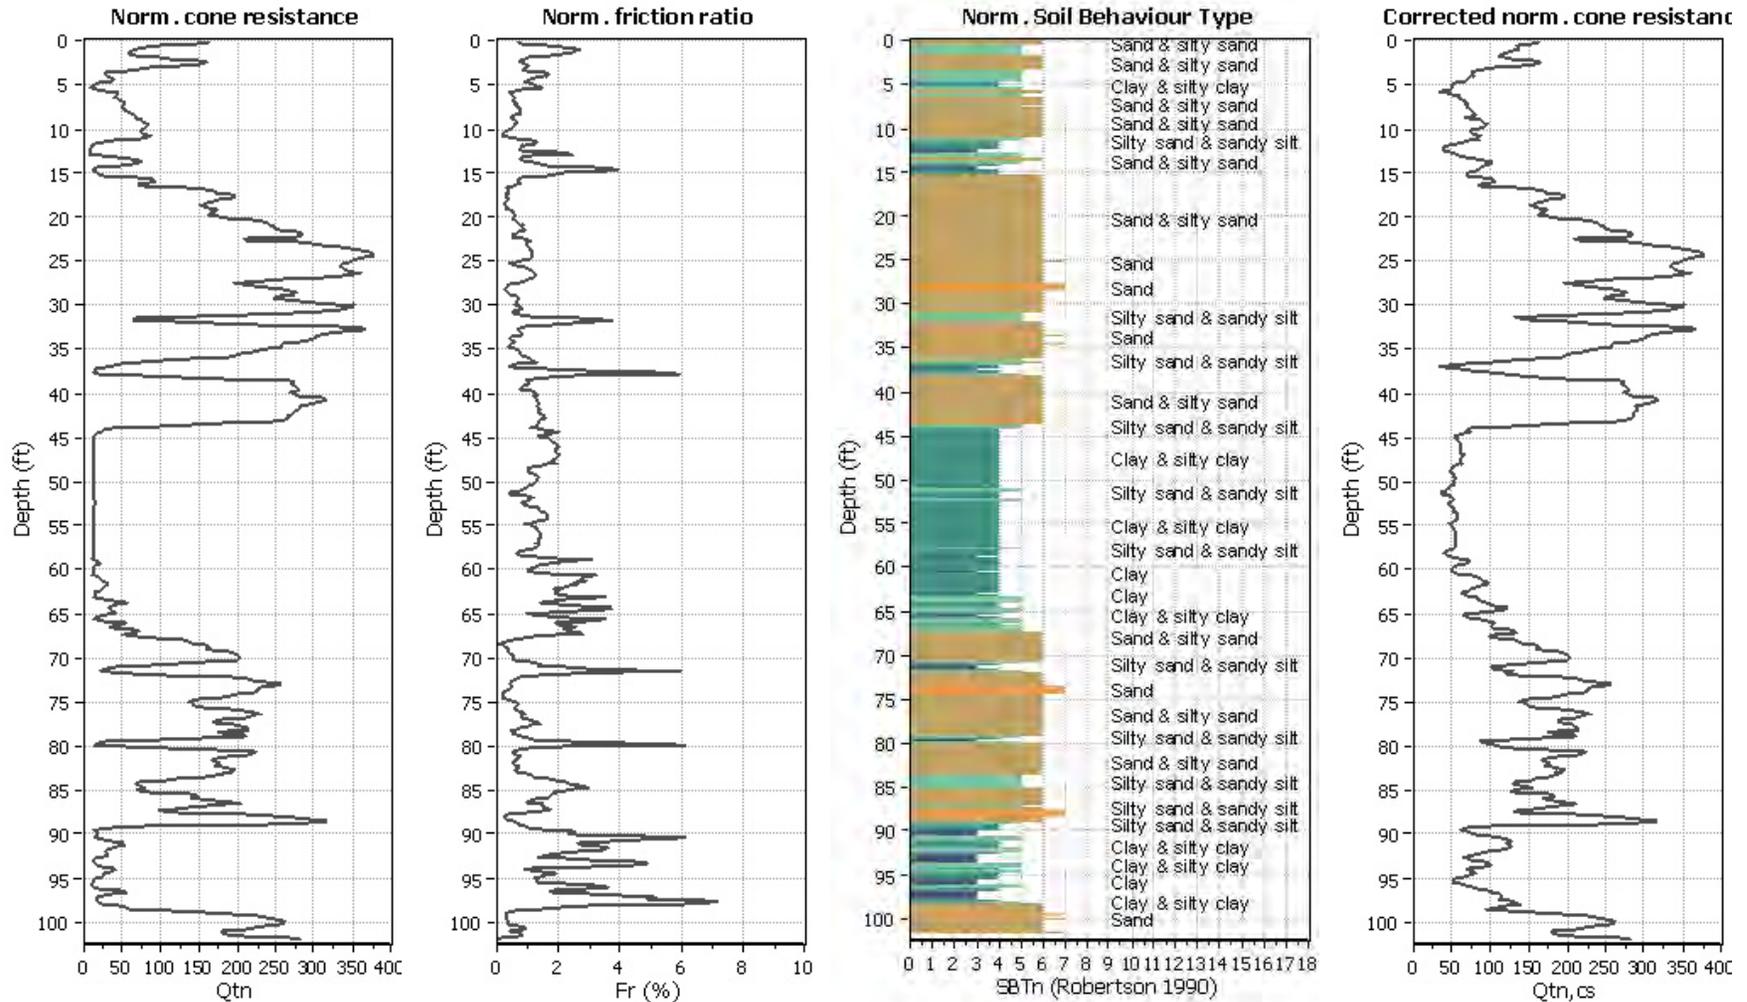
Analysis method:	NCEER (1998)	G.W.T. (in-situ):	4.00 ft	Use fill:	No	Clay like behavior	
Fines correction method:	NCEER (1998)	G.W.T. (earthq.):	0.00 ft	Fill height:	N/A	applied:	Sands only
Points to test:	Based on Ic value	Average results interval:	3	Fill weight:	N/A	Limit depth applied:	No
Earthquake magnitude $M_w$ :	6.70	Ic cut-off value:	2.40	Trans. detect. applied:	Yes	Limit depth:	N/A
Peak ground acceleration:	0.51	Unit weight calculation:	Based on SBT	$K_0$ applied:	Yes	MSF method:	Method based

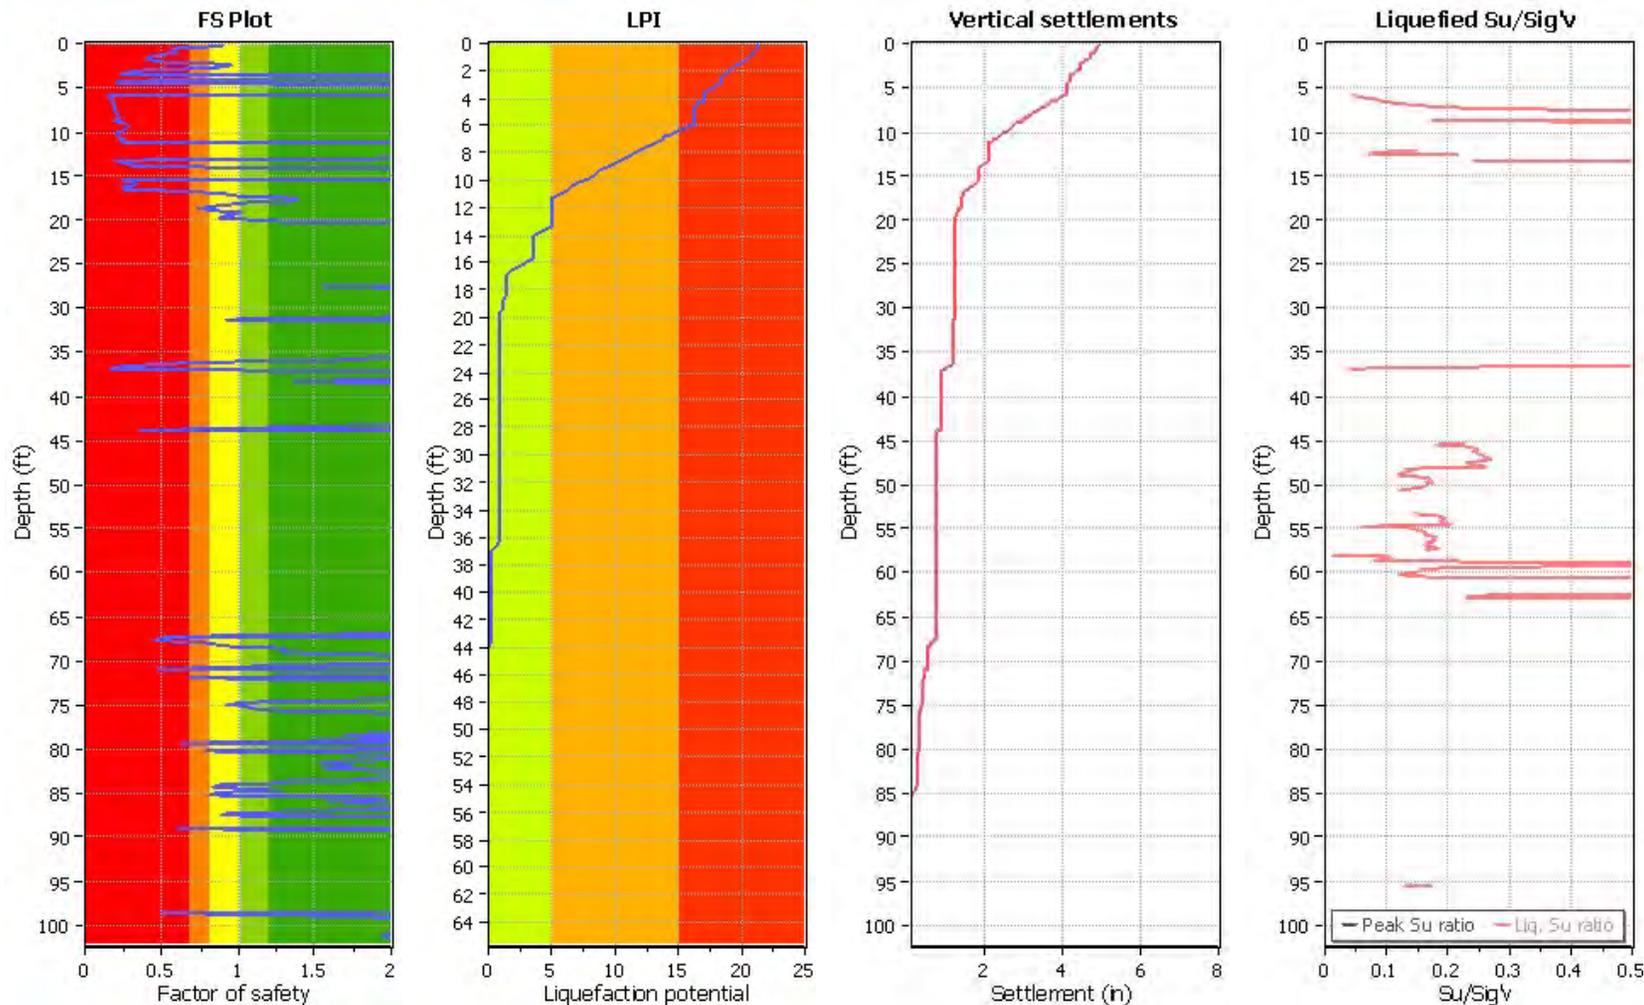
Analysis method:	NCEER (1998)	G.W.T. (in-situ):	4.00 ft	Use fill:	No	Clay like behavior applied:	Sands only
Fines correction method:	NCEER (1998)	G.W.T. (earthq.):	0.00 ft	Fill height:	N/A	Limit depth applied:	No
Points to test:	Based on Ic value	Average results interval:	3	Fill weight:	N/A	Limit depth:	N/A
Earthquake magnitude $M_w$ :	6.70	Ic cut-off value:	2.40	Trans. detect. applied:	Yes	MSF method:	Method based
Peak ground acceleration:	0.51	Unit weight calculation:	Based on SBT	$K_0$ applied:	Yes

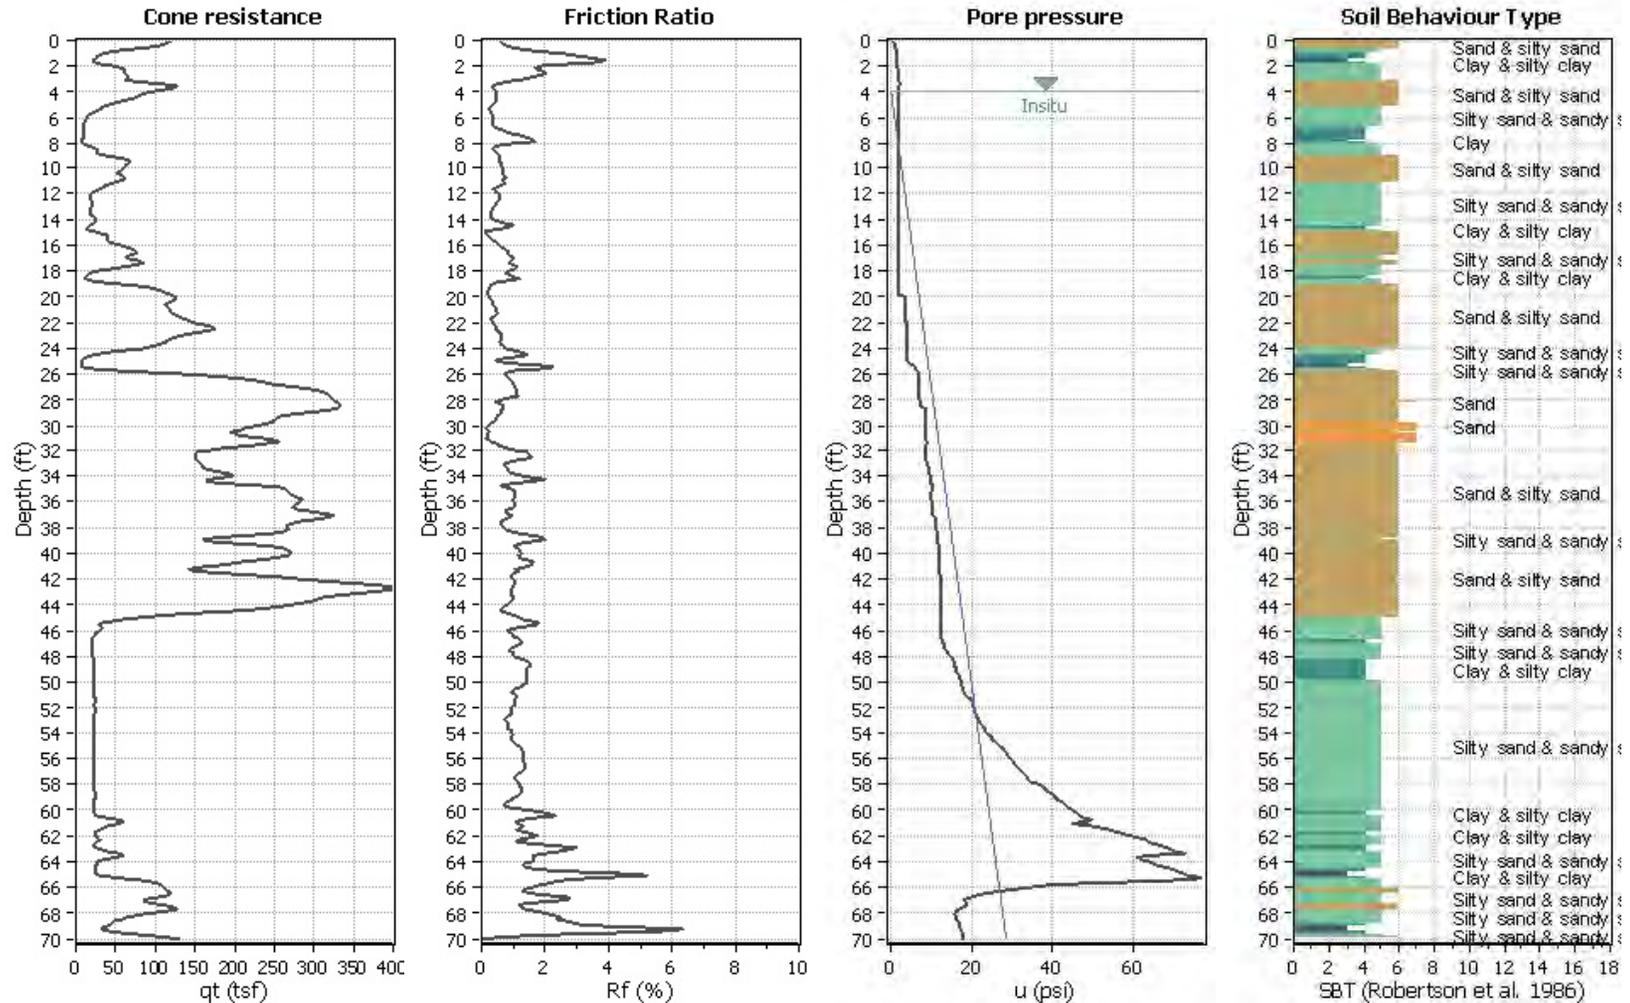
Analysis method:	NCEER (1998)	G.W.T. (in-situ):	4.00 ft	Use fill:	No	Clay like behavior	
Fines correction method:	NCEER (1998)	G.W.T. (earthq.):	0.00 ft	Fill height:	N/A	applied:	Sands only
Points to test:	Based on Ic value	Average results interval:	3	Fill weight:	N/A	Limit depth applied:	No
Earthquake magnitude $M_w$ :	6.70	Ic cut-off value:	2.40	Trans. detect. applied:	Yes	Limit depth:	N/A
Peak ground acceleration:	0.51	Unit weight calculation:	Based on SBT	$K_0$ applied:	Yes	MSF method:	Method based

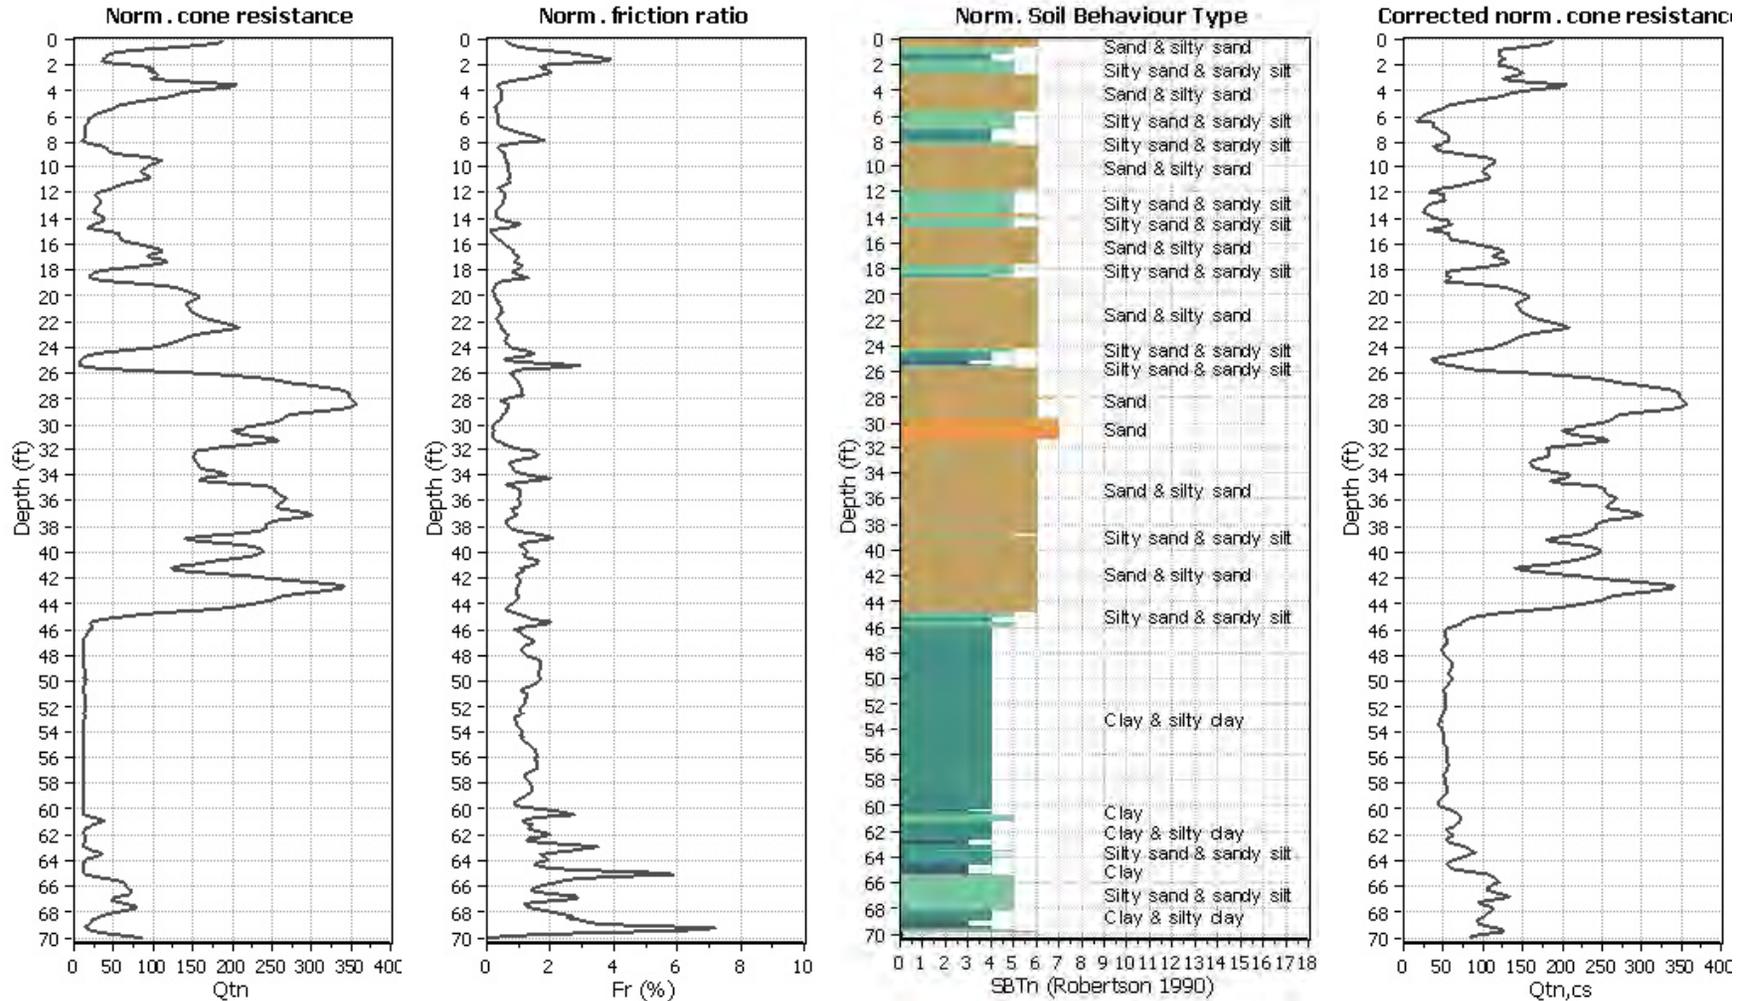
Analysis method:	NCEER (1998)	G.W.T. (in-situ):	4.00 ft	Use fill:	No	Clay like behavior	
Fines correction method:	NCEER (1998)	G.W.T. (earthq.):	0.00 ft	Fill height:	N/A	applied:	Sands only
Points to test:	Based on Ic value	Average results interval:	3	Fill weight:	N/A	Limit depth applied:	No
Earthquake magnitude $M_w$ :	6.70	Ic cut-off value:	2.40	Trans. detect. applied:	Yes	Limit depth:	N/A
Peak ground acceleration:	0.51	Unit weight calculation:	Based on SBT	$K_0$ applied:	Yes	MSF method:	Method based

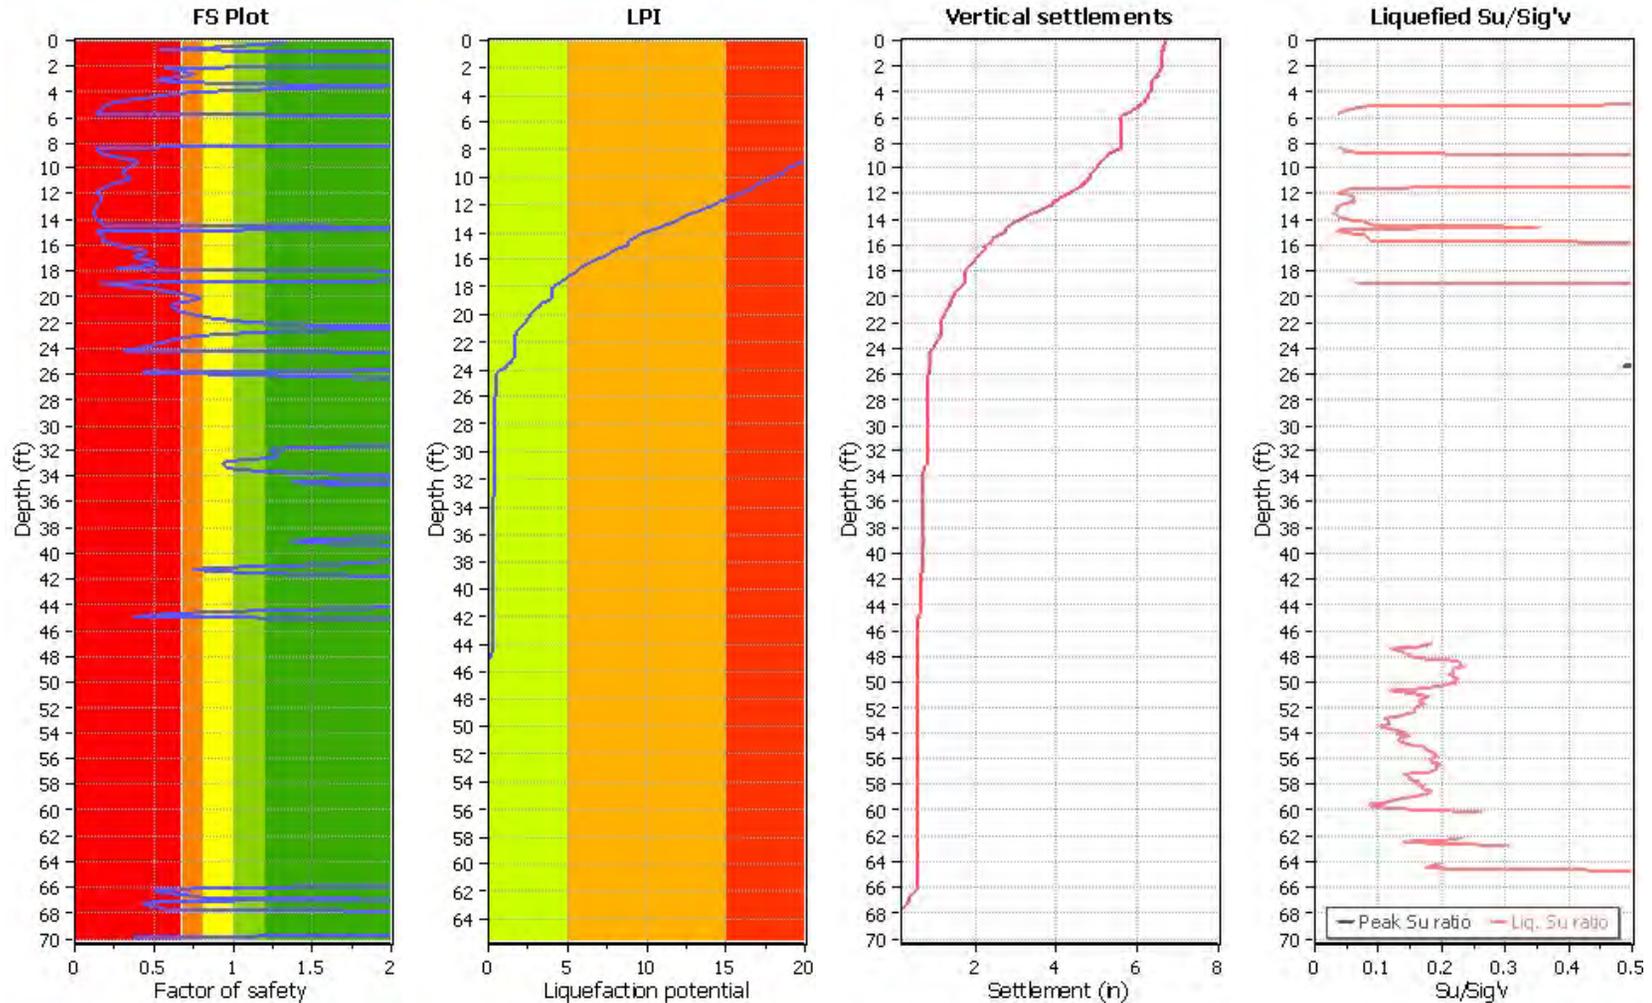
Analysis method:	NCEER (1998)	G.W.T. (in-situ):	4.00 ft	Use fill:	No	Clay like behavior applied:	Sands only
Fines correction method:	NCEER (1998)	G.W.T. (earthq.):	0.00 ft	Fill height:	N/A	Limit depth applied:	No
Points to test:	Based on Ic value	Average results interval:	3	Fill weight:	N/A	Limit depth:	N/A
Earthquake magnitude $M_w$ :	6.70	Ic cut-off value:	2.40	Trans. detect. applied:	Yes	MSF method:	Method based
Peak ground acceleration:	0.51	Unit weight calculation:	Based on SBT	$K_0$ applied:	Yes

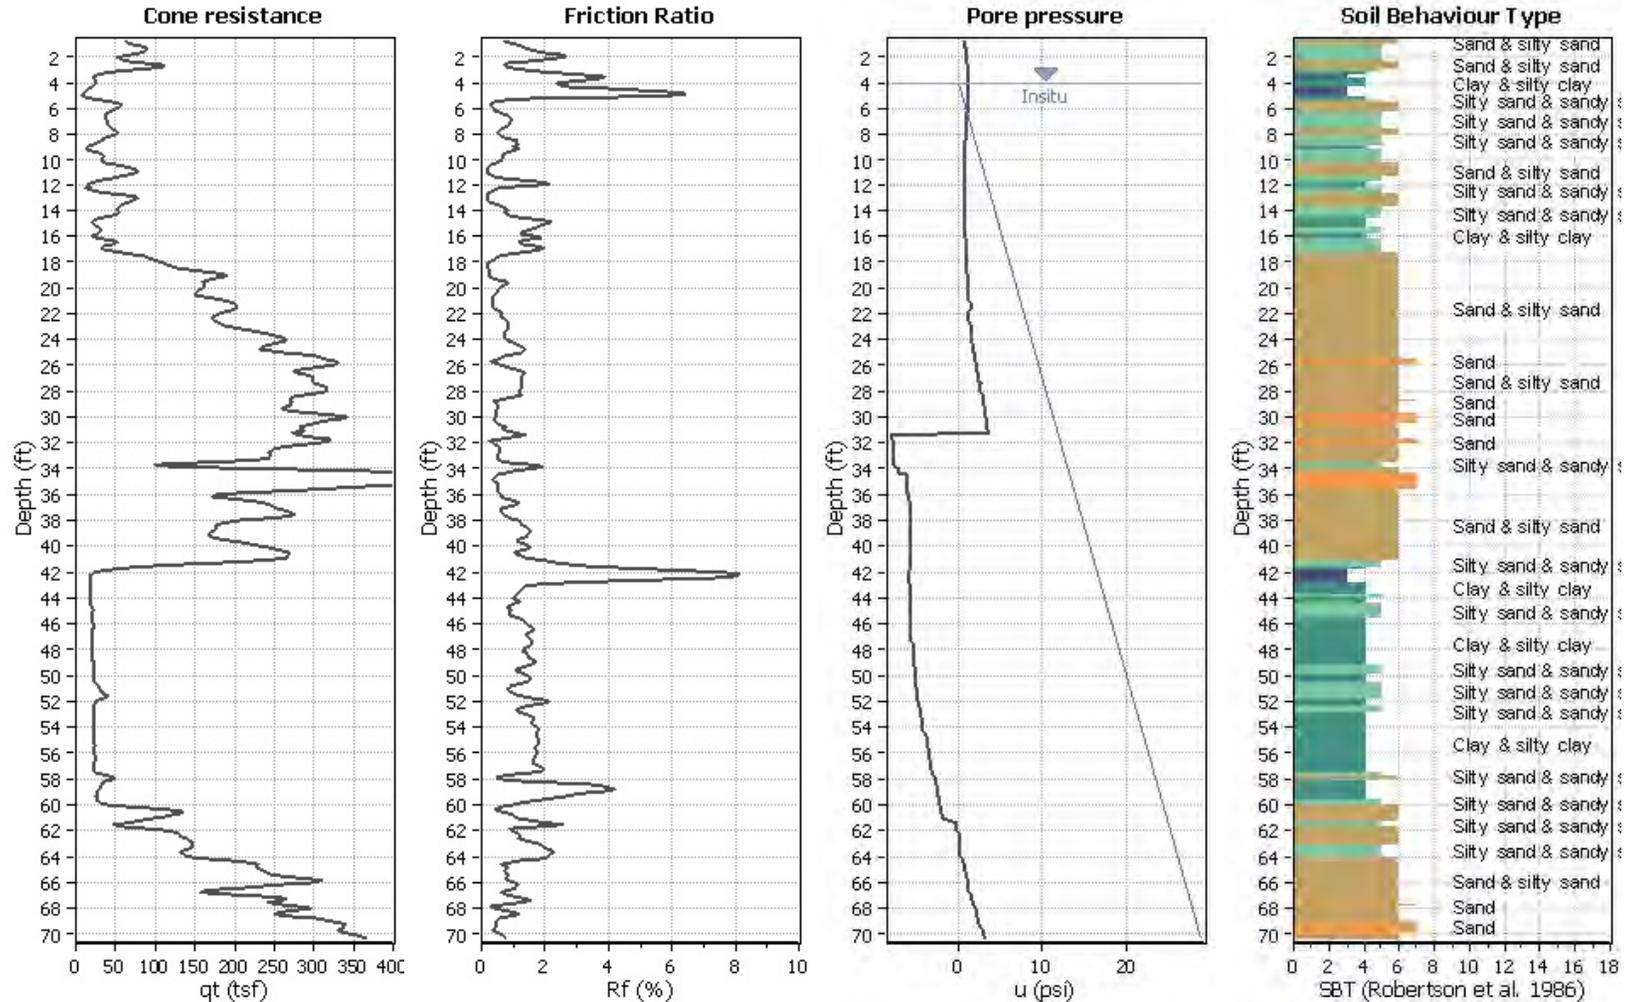
Analysis method:	NCEER (1998)	G.W.T. (in-situ):	4.00 ft	Use fill:	No	Clay like behavior	
Fines correction method:	NCEER (1998)	G.W.T. (earthq.):	0.00 ft	Fill height:	N/A	applied:	Sands only
Points to test:	Based on Ic value	Average results interval:	3	Fill weight:	N/A	Limit depth applied:	No
Earthquake magnitude $M_w$ :	6.70	Ic cut-off value:	2.40	Trans. detect. applied:	Yes	Limit depth:	N/A
Peak ground acceleration:	0.51	Unit weight calculation:	Based on SBT	$K_0$ applied:	Yes	MSF method:	Method based

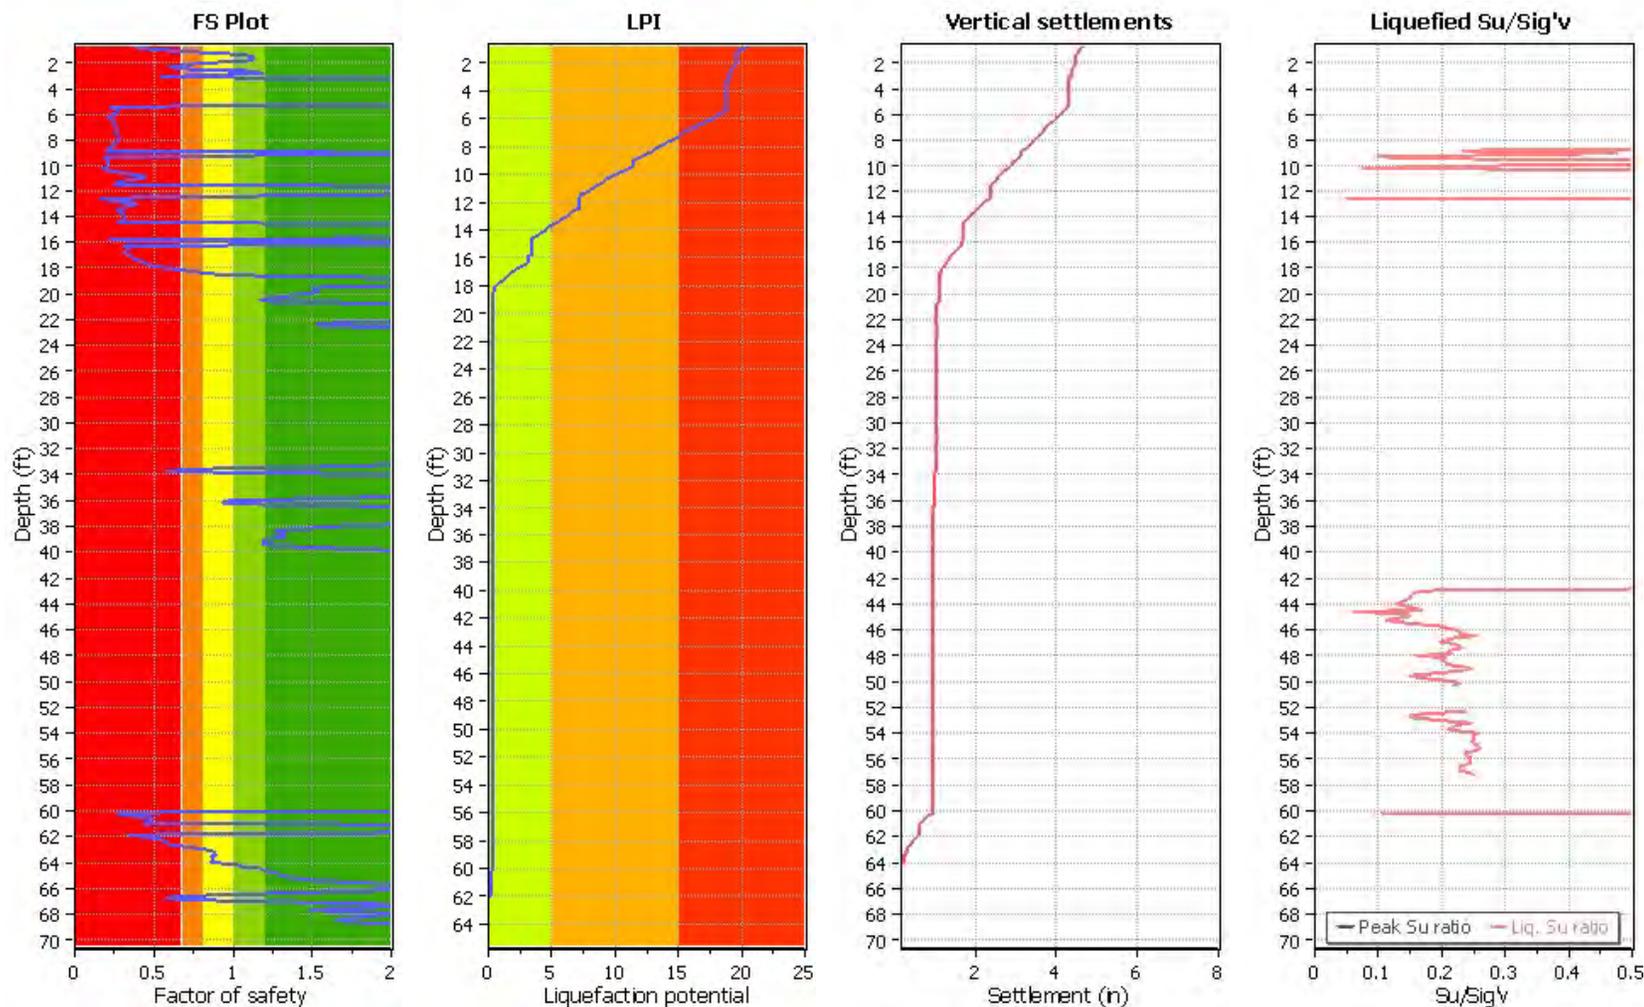
Analysis method:	NCEER (1998)	G.W.T. (in-situ):	4.00 ft	Use fill:	No	Clay like behavior applied:	Sands only
Fines correction method:	NCEER (1998)	G.W.T. (earthq.):	0.00 ft	Fill height:	N/A	Limit depth applied:	No
Points to test:	Based on Ic value	Average results interval:	3	Fill weight:	N/A	Limit depth:	N/A
Earthquake magnitude $M_w$ :	6.70	Ic cut-off value:	2.40	Trans. detect. applied:	Yes	MSF method:	Method based
Peak ground acceleration:	0.51	Unit weight calculation:	Based on SBT	$K_0$ applied:	Yes

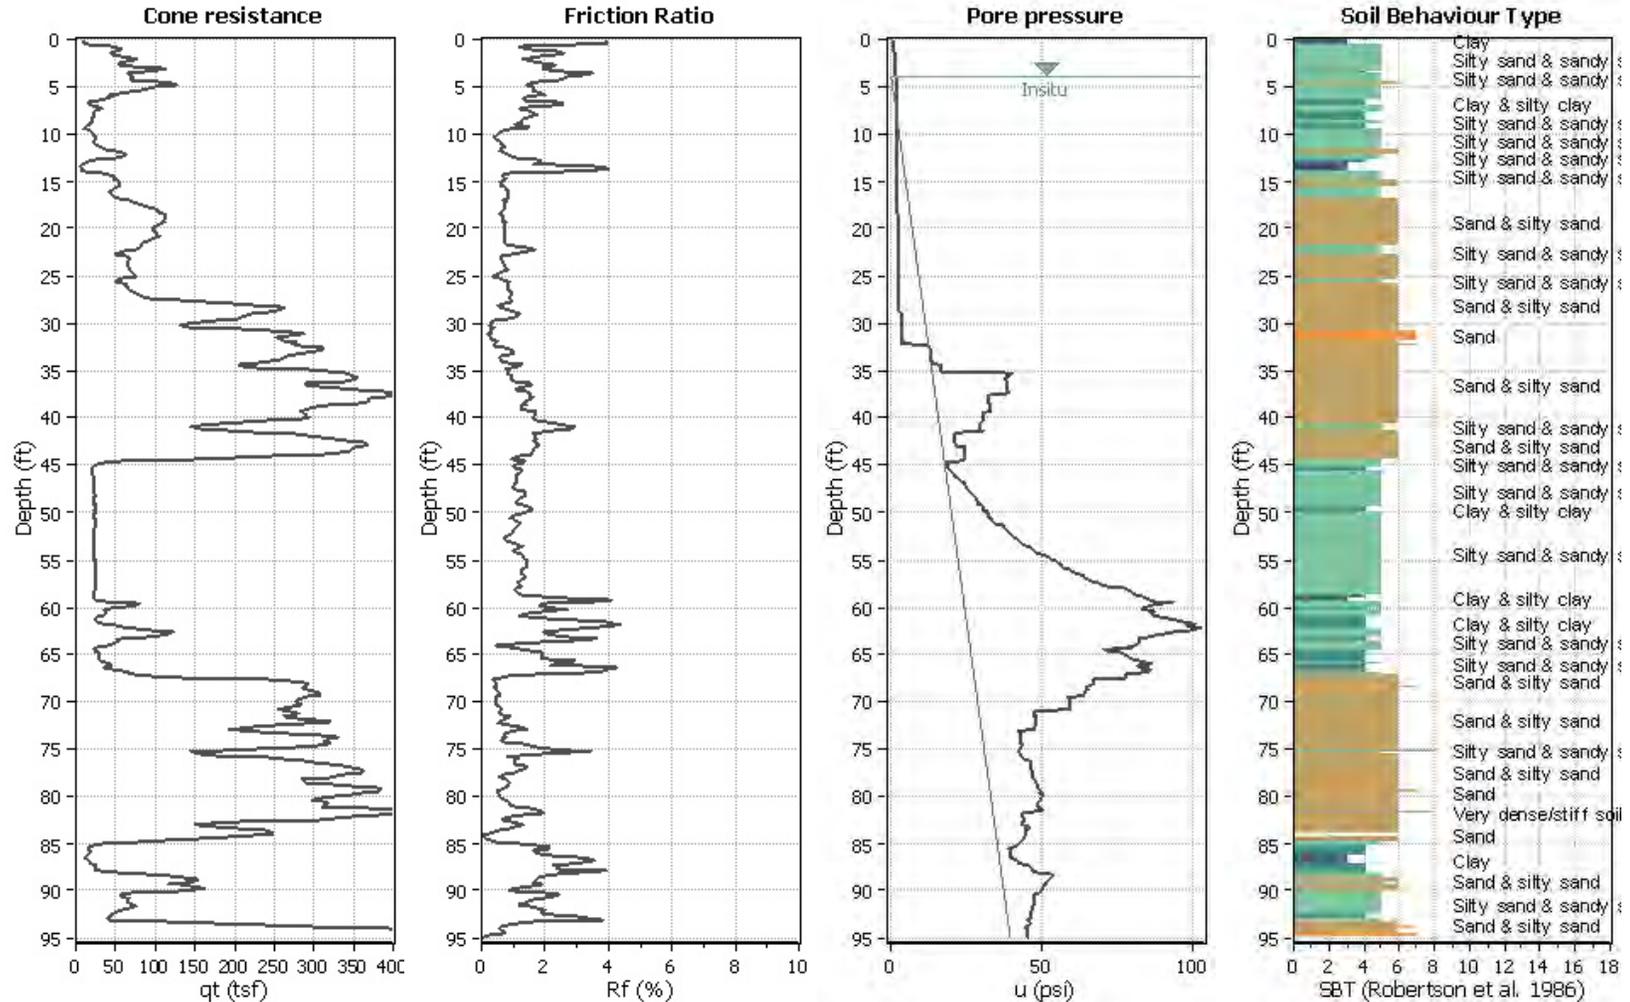
Analysis method:	NCEER (1998)	G.W.T. (in-situ):	4.00 ft	Use fill:	No	Clay like behavior applied:	Sands only
Fines correction method:	NCEER (1998)	G.W.T. (earthq.):	0.00 ft	Fill height:	N/A	Limit depth applied:	No
Points to test:	Based on Ic value	Average results interval:	3	Fill weight:	N/A	Limit depth:	N/A
Earthquake magnitude $M_w$ :	6.70	Ic cut-off value:	2.40	Trans. detect. applied:	Yes	MSF method:	Method based
Peak ground acceleration:	0.51	Unit weight calculation:	Based on SBT	$K_0$ applied:	Yes
