# MEADOW CREEK LAGOON HABITAT RESTORATION

**PRELIMINARY GEOTECHNICAL AND  
GEOLOGIC HAZARDS REPORT**

**Meadow Creek Lagoon Habitat Restoration  
San Luis Obispo County, California**

Yeh Project No.: 220-331

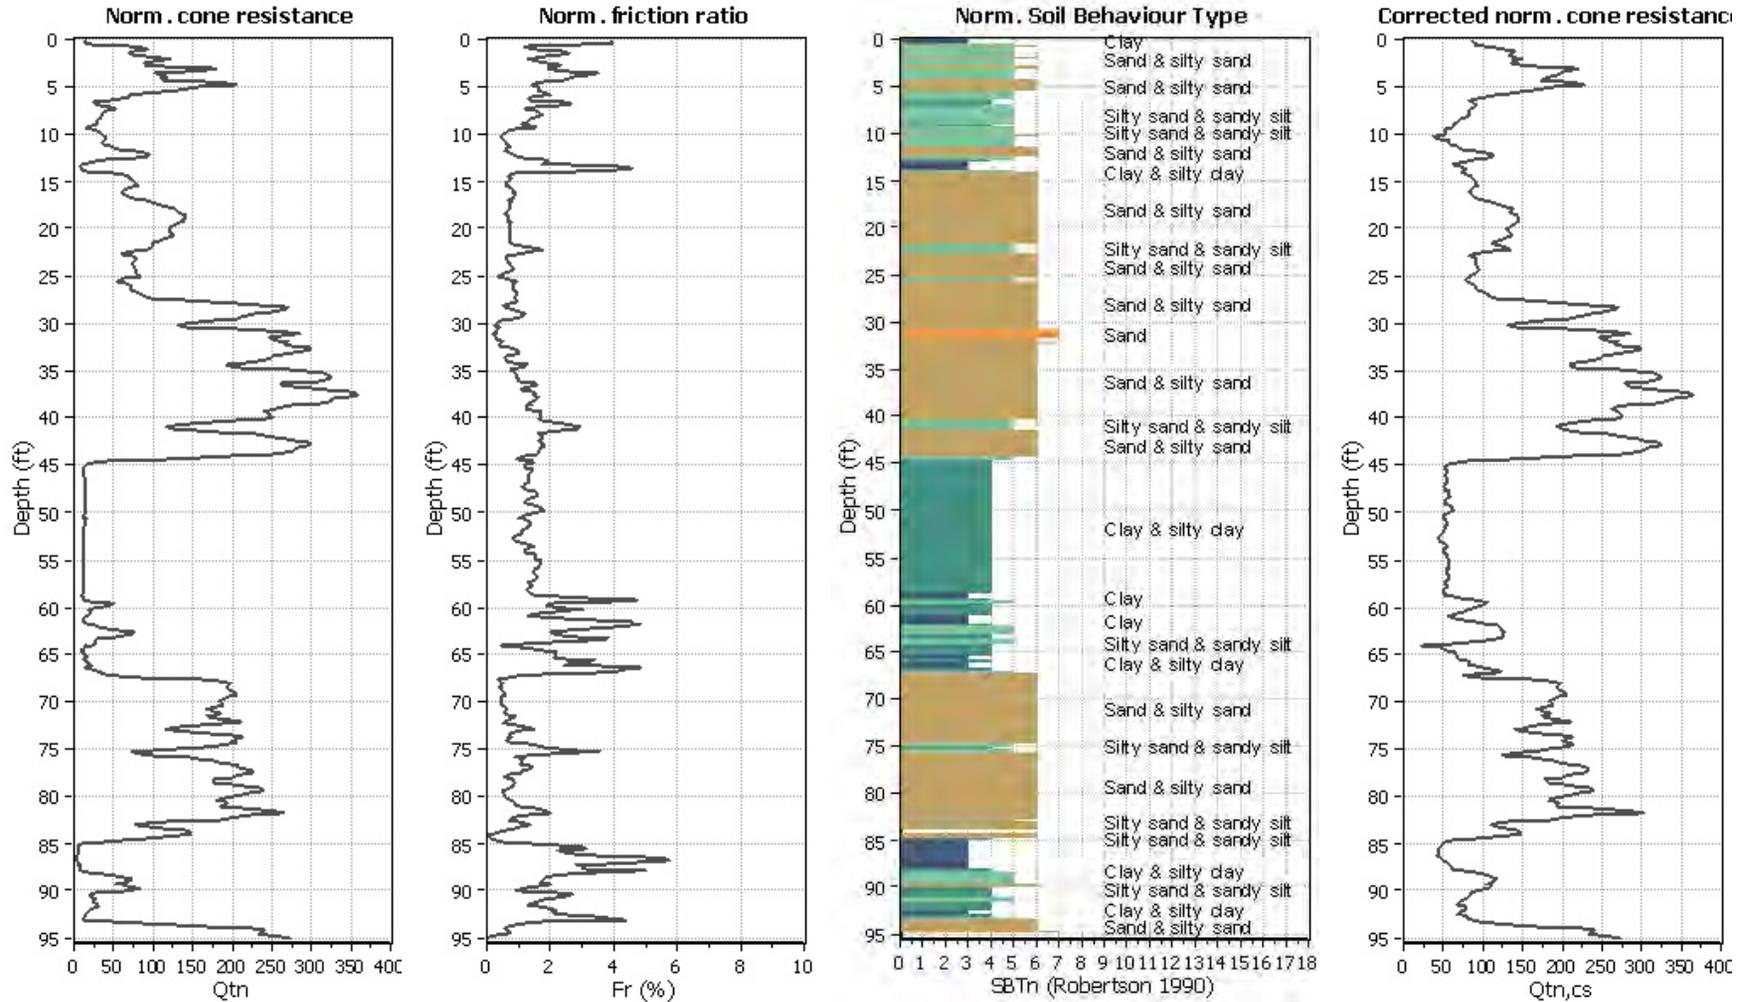
Analysis method:	NCEER (1998)	G.W.T. (in-situ):	4.00 ft	Use fill:	No	Clay like behavior applied:	Sands only
Fines correction method:	NCEER (1998)	G.W.T. (earthq.):	0.00 ft	Fill height:	N/A	Limit depth applied:	No
Points to test:	Based on Ic value	Average results interval:	3	Fill weight:	N/A	Limit depth:	N/A
Earthquake magnitude $M_w$ :	6.70	Ic cut-off value:	2.40	Trans. detect. applied:	Yes	MSF method:	Method based
Peak ground acceleration:	0.51	Unit weight calculation:	Based on SBT	$K_0$ applied:	Yes

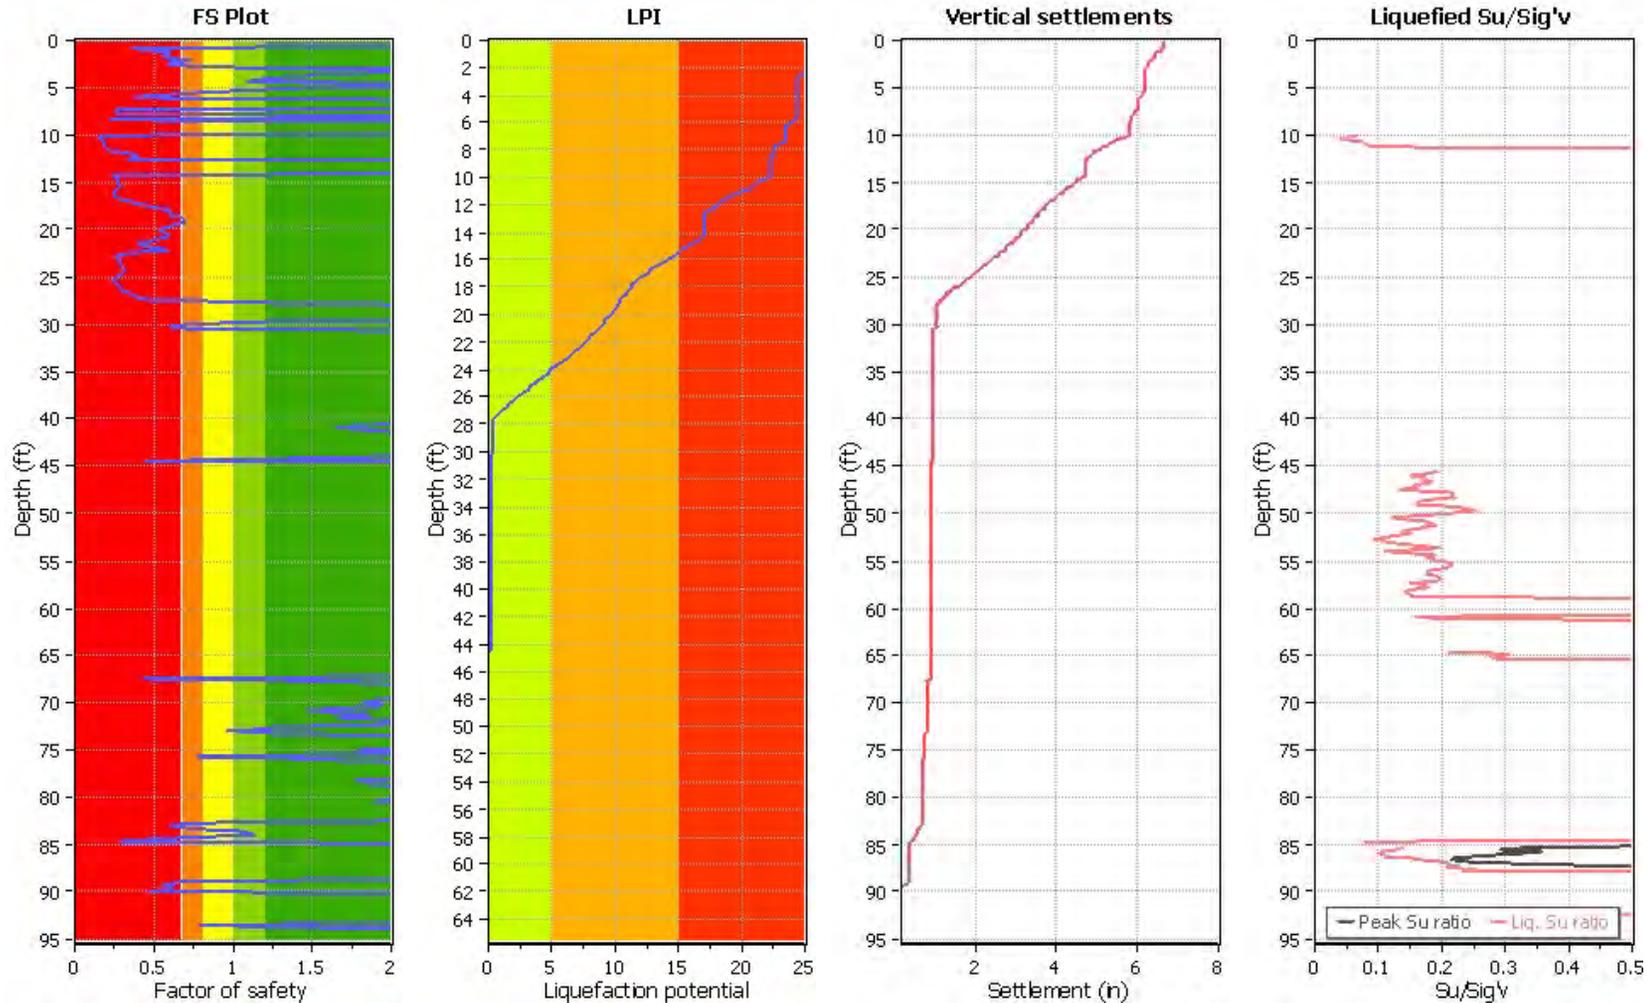
Analysis method:	NCEER (1998)	G.W.T. (in-situ):	4.00 ft	Use fill:	No	Clay like behavior	
Fines correction method:	NCEER (1998)	G.W.T. (earthq.):	0.00 ft	Fill height:	N/A	applied:	Sands only
Points to test:	Based on Ic value	Average results interval:	3	Fill weight:	N/A	Limit depth applied:	No
Earthquake magnitude $M_w$ :	6.70	Ic cut-off value:	2.40	Trans. detect. applied:	Yes	Limit depth:	N/A
Peak ground acceleration:	0.51	Unit weight calculation:	Based on SBT	$K_0$ applied:	Yes	MSF method:	Method based

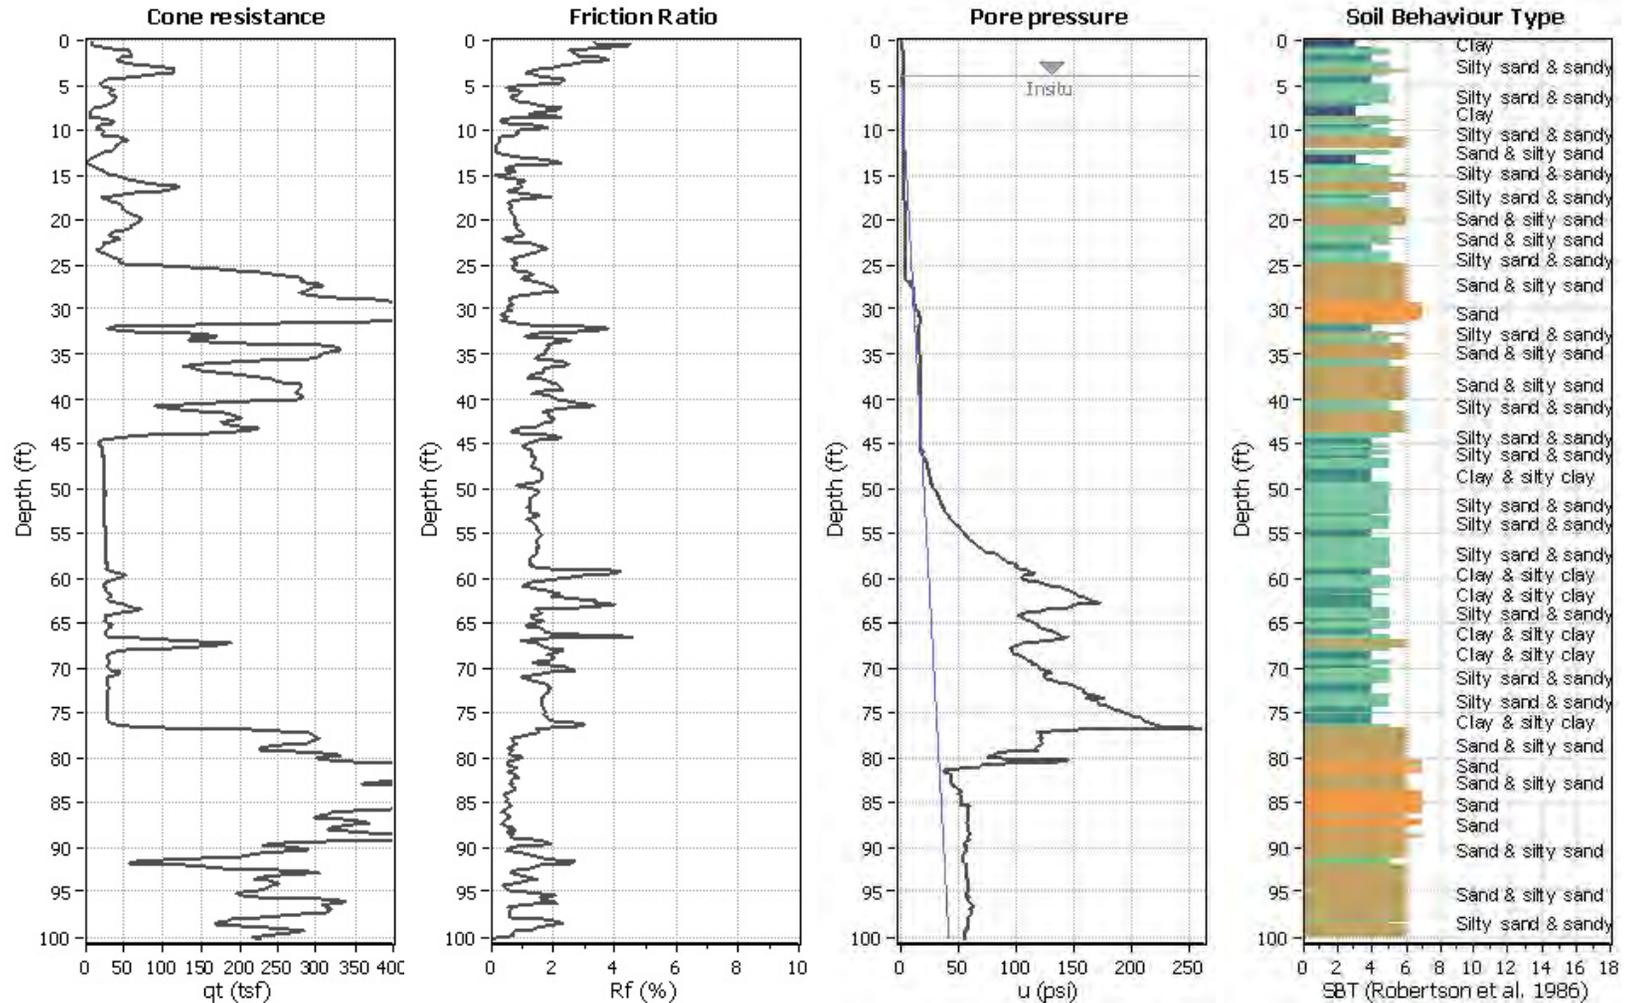
Analysis method:	NCEER (1998)	G.W.T. (in-situ):	4.00 ft	Use fill:	No	Clay like behavior applied:	Sands only
Fines correction method:	NCEER (1998)	G.W.T. (earthq.):	0.00 ft	Fill height:	N/A	Limit depth applied:	No
Points to test:	Based on Ic value	Average results interval:	3	Fill weight:	N/A	Limit depth:	N/A
Earthquake magnitude $M_w$ :	6.70	Ic cut-off value:	2.40	Trans. detect. applied:	Yes	MSF method:	Method based
Peak ground acceleration:	0.51	Unit weight calculation:	Based on SBT	$K_0$ applied:	Yes

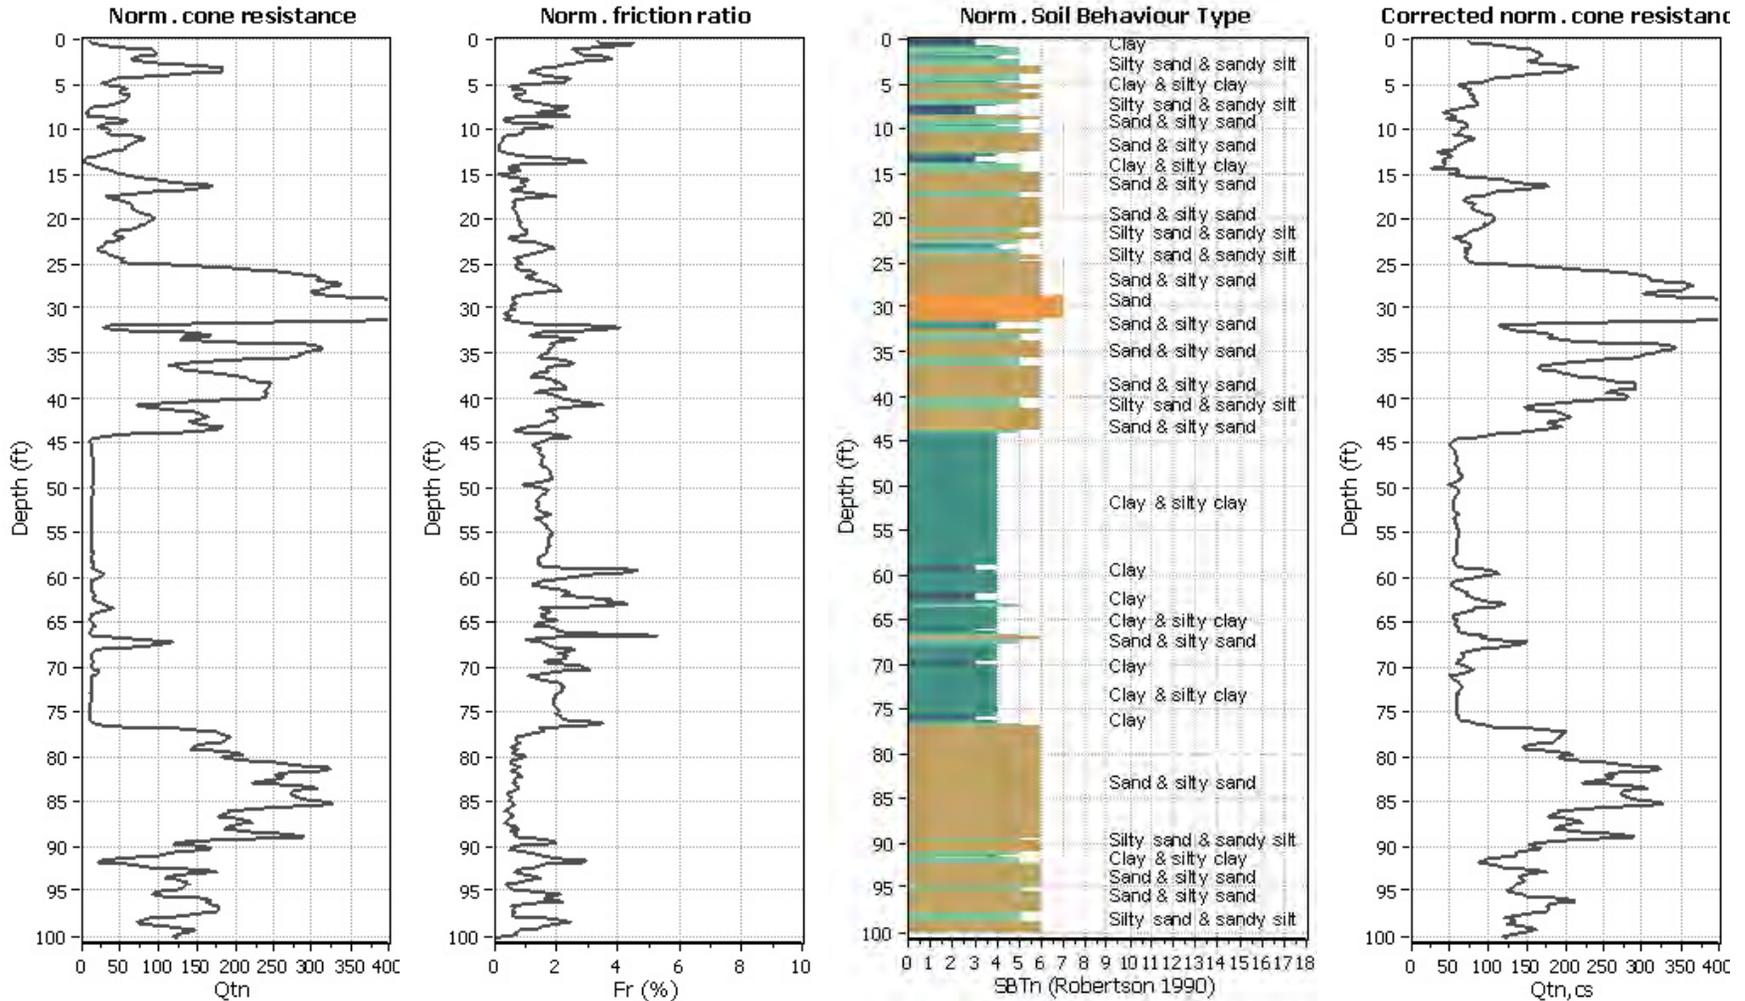
Analysis method:	NCEER (1998)	G.W.T. (in-situ):	4.00 ft	Use fill:	No	Clay like behavior	
Fines correction method:	NCEER (1998)	G.W.T. (earthq.):	0.00 ft	Fill height:	N/A	applied:	Sands only
Points to test:	Based on Ic value	Average results interval:	3	Fill weight:	N/A	Limit depth applied:	No
Earthquake magnitude $M_w$ :	6.70	Ic cut-off value:	2.40	Trans. detect. applied:	Yes	Limit depth:	N/A
Peak ground acceleration:	0.51	Unit weight calculation:	Based on SBT	$K_0$ applied:	Yes	MSF method:	Method based

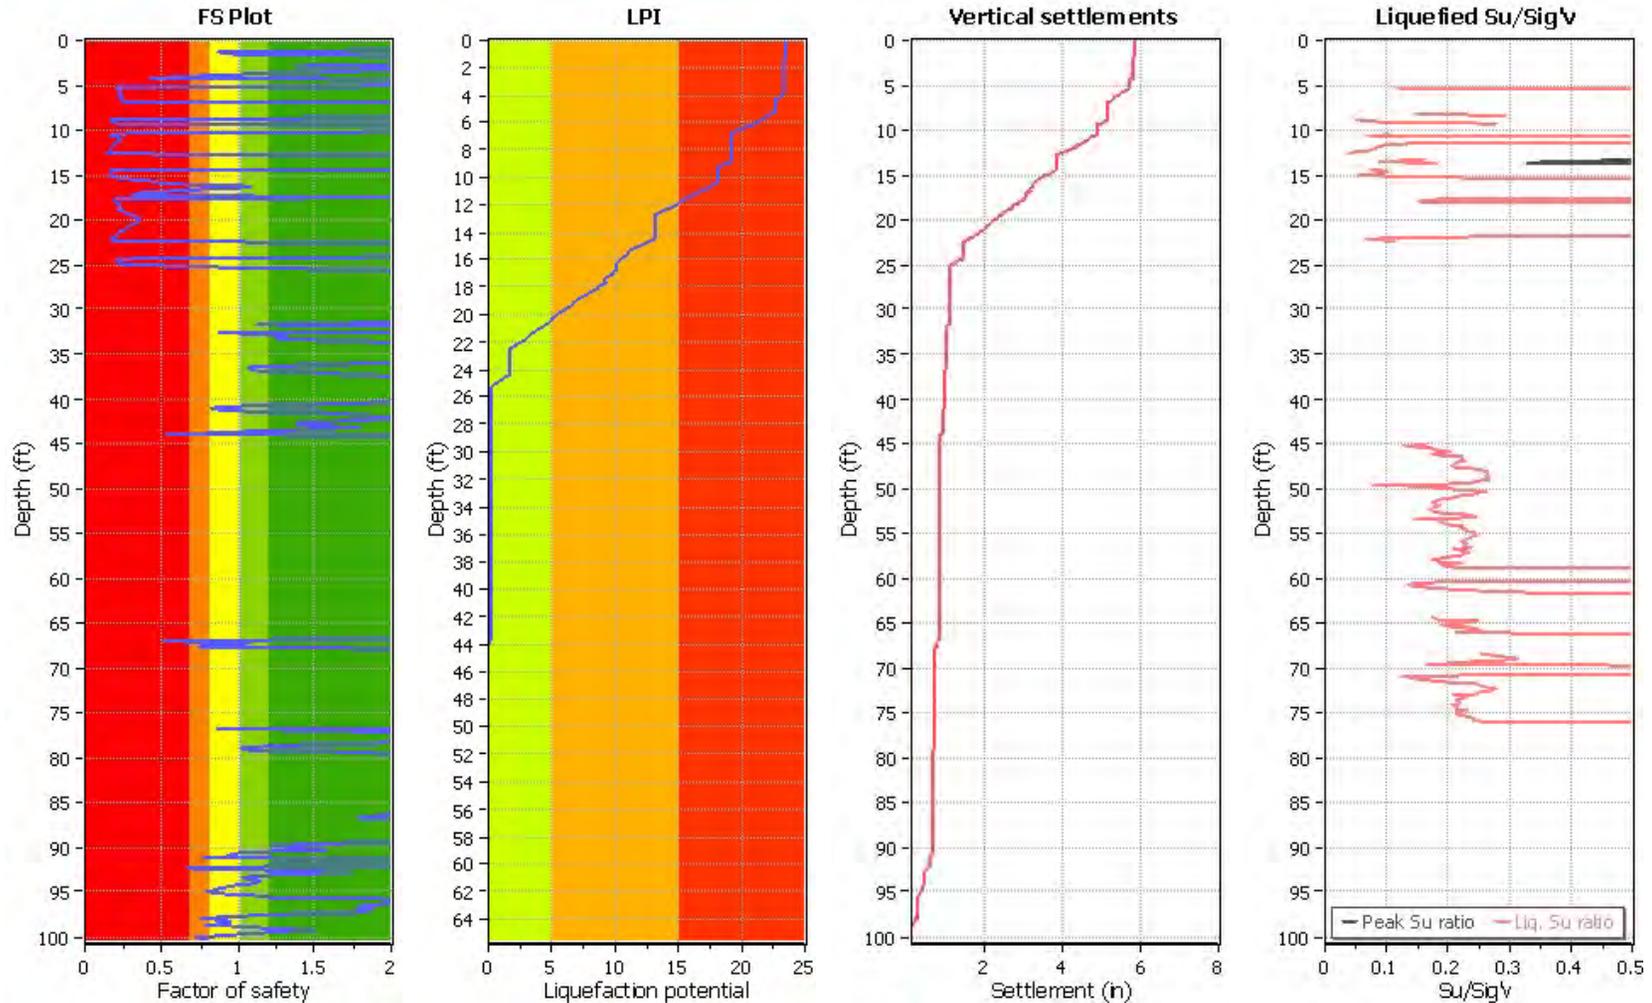
Analysis method:	NCEER (1998)	G.W.T. (in-situ):	4.00 ft	Use fill:	No	Clay like behavior	
Fines correction method:	NCEER (1998)	G.W.T. (earthq.):	0.00 ft	Fill height:	N/A	applied:	Sands only
Points to test:	Based on Ic value	Average results interval:	3	Fill weight:	N/A	Limit depth applied:	No
Earthquake magnitude $M_w$ :	6.70	Ic cut-off value:	2.40	Trans. detect. applied:	Yes	Limit depth:	N/A
Peak ground acceleration:	0.51	Unit weight calculation:	Based on SBT	$K_0$ applied:	Yes	MSF method:	Method based

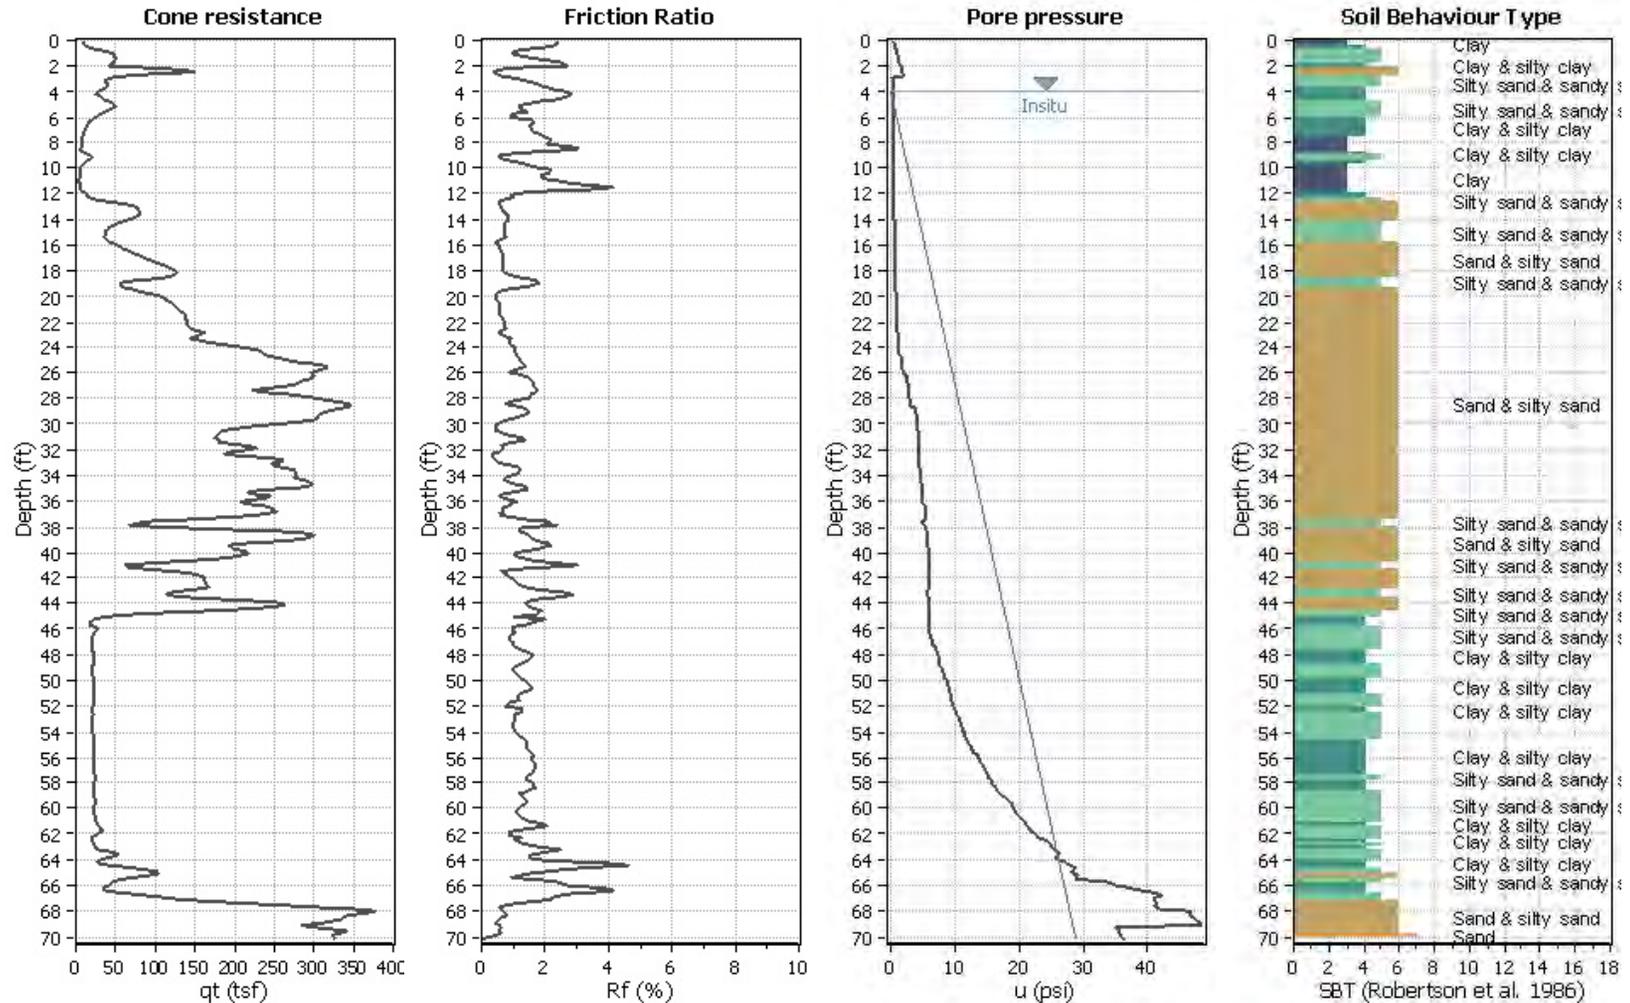
Analysis method:	NCEER (1998)	G.W.T. (in-situ):	4.00 ft	Use fill:	No	Clay like behavior applied:	Sands only
Fines correction method:	NCEER (1998)	G.W.T. (earthq.):	0.00 ft	Fill height:	N/A	Limit depth applied:	No
Points to test:	Based on Ic value	Average results interval:	3	Fill weight:	N/A	Limit depth:	N/A
Earthquake magnitude $M_w$ :	6.70	Ic cut-off value:	2.40	Trans. detect. applied:	Yes	MSF method:	Method based
Peak ground acceleration:	0.51	Unit weight calculation:	Based on SBT	$K_0$ applied:	Yes

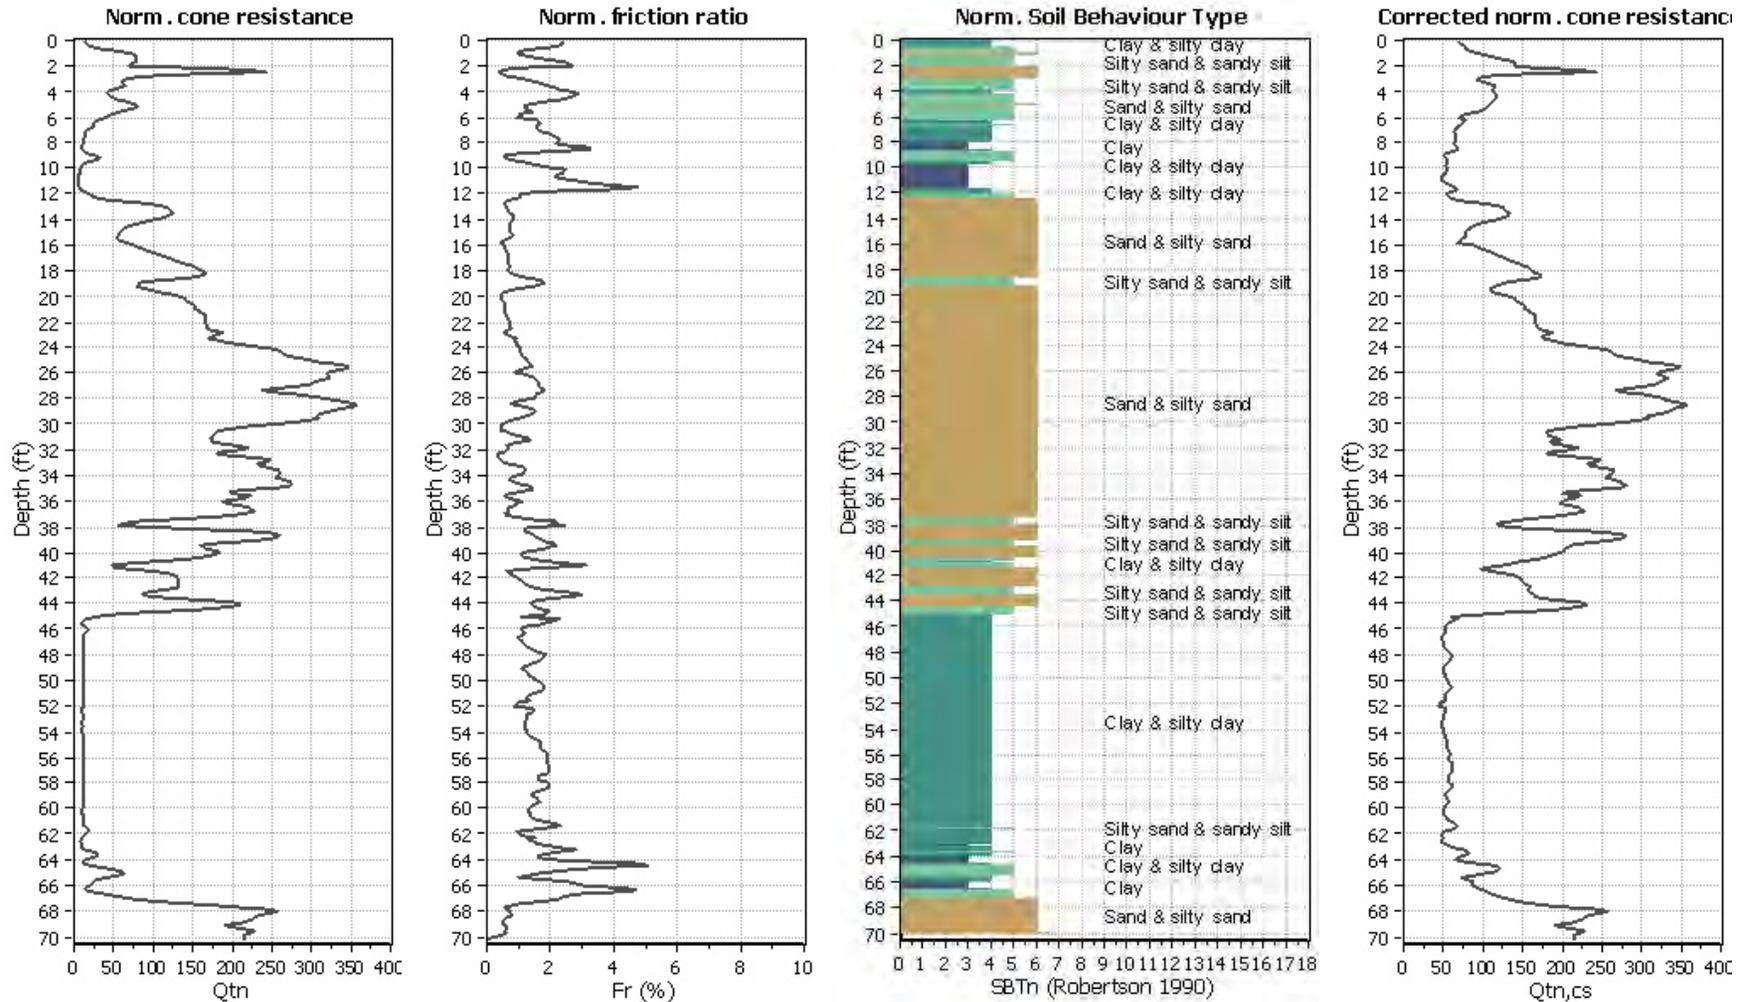
Analysis method:	NCEER (1998)	G.W.T. (in-situ):	4.00 ft	Use fill:	No	Clay like behavior	
Fines correction method:	NCEER (1998)	G.W.T. (earthq.):	0.00 ft	Fill height:	N/A	applied:	Sands only
Points to test:	Based on Ic value	Average results interval:	3	Fill weight:	N/A	Limit depth applied:	No
Earthquake magnitude $M_w$ :	6.70	Ic cut-off value:	2.40	Trans. detect. applied:	Yes	Limit depth:	N/A
Peak ground acceleration:	0.51	Unit weight calculation:	Based on SBT	$K_0$ applied:	Yes	MSF method:	Method based

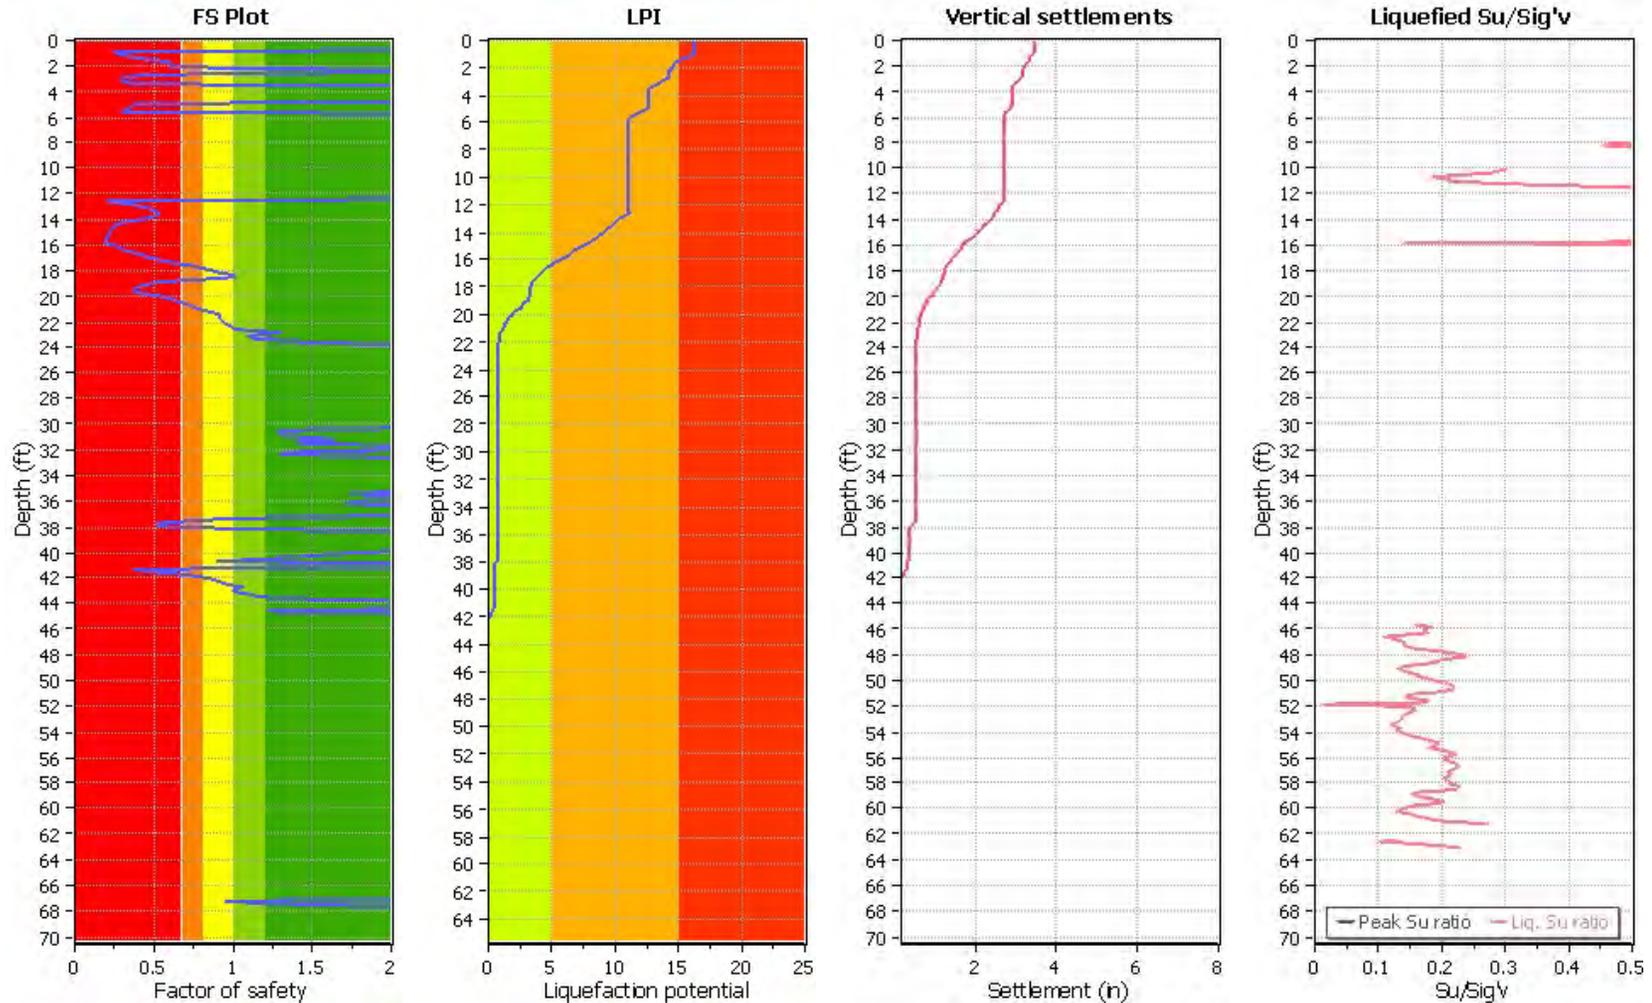
Analysis method:	NCEER (1998)	G.W.T. (in-situ):	4.00 ft	Use fill:	No	Clay like behavior	
Fines correction method:	NCEER (1998)	G.W.T. (earthq.):	0.00 ft	Fill height:	N/A	applied:	Sands only
Points to test:	Based on Ic value	Average results interval:	3	Fill weight:	N/A	Limit depth applied:	No
Earthquake magnitude $M_w$ :	6.70	Ic cut-off value:	2.40	Trans. detect. applied:	Yes	Limit depth:	N/A
Peak ground acceleration:	0.51	Unit weight calculation:	Based on SBT	$K_0$ applied:	Yes	MSF method:	Method based

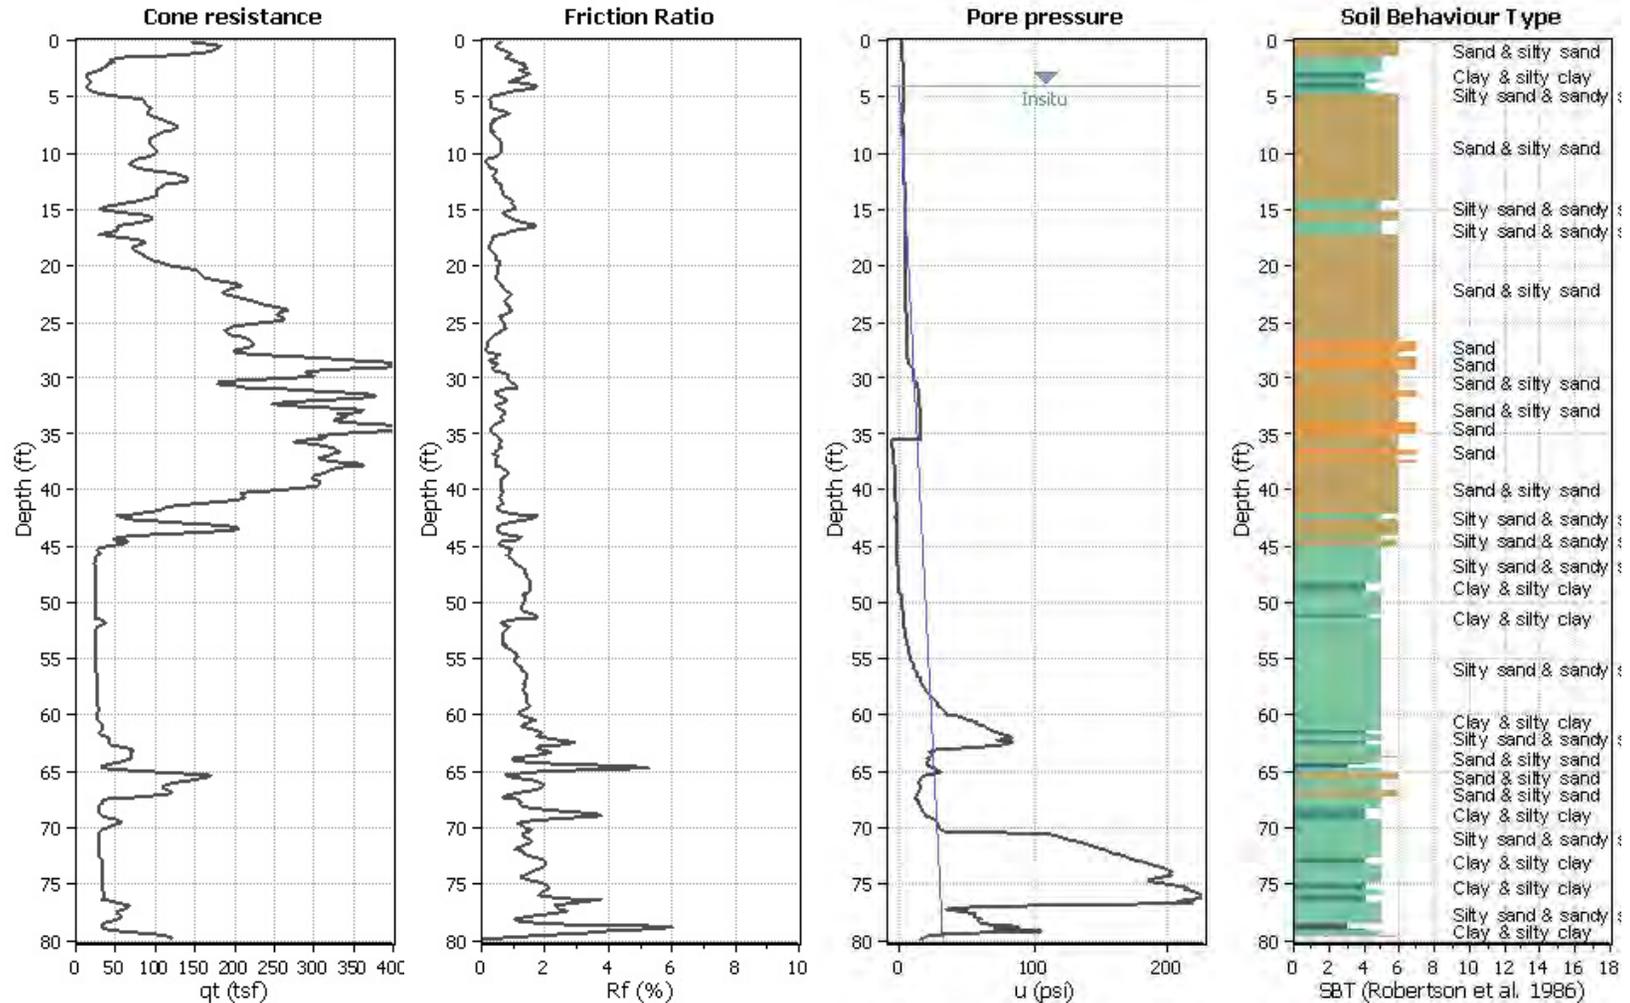
Analysis method:	NCEER (1998)	G.W.T. (in-situ):	4.00 ft	Use fill:	No	Clay like behavior	
Fines correction method:	NCEER (1998)	G.W.T. (earthq.):	0.00 ft	Fill height:	N/A	applied:	Sands only
Points to test:	Based on Ic value	Average results interval:	3	Fill weight:	N/A	Limit depth applied:	No
Earthquake magnitude $M_w$ :	6.70	Ic cut-off value:	2.40	Trans. detect. applied:	Yes	Limit depth:	N/A
Peak ground acceleration:	0.51	Unit weight calculation:	Based on SBT	$K_0$ applied:	Yes	MSF method:	Method based

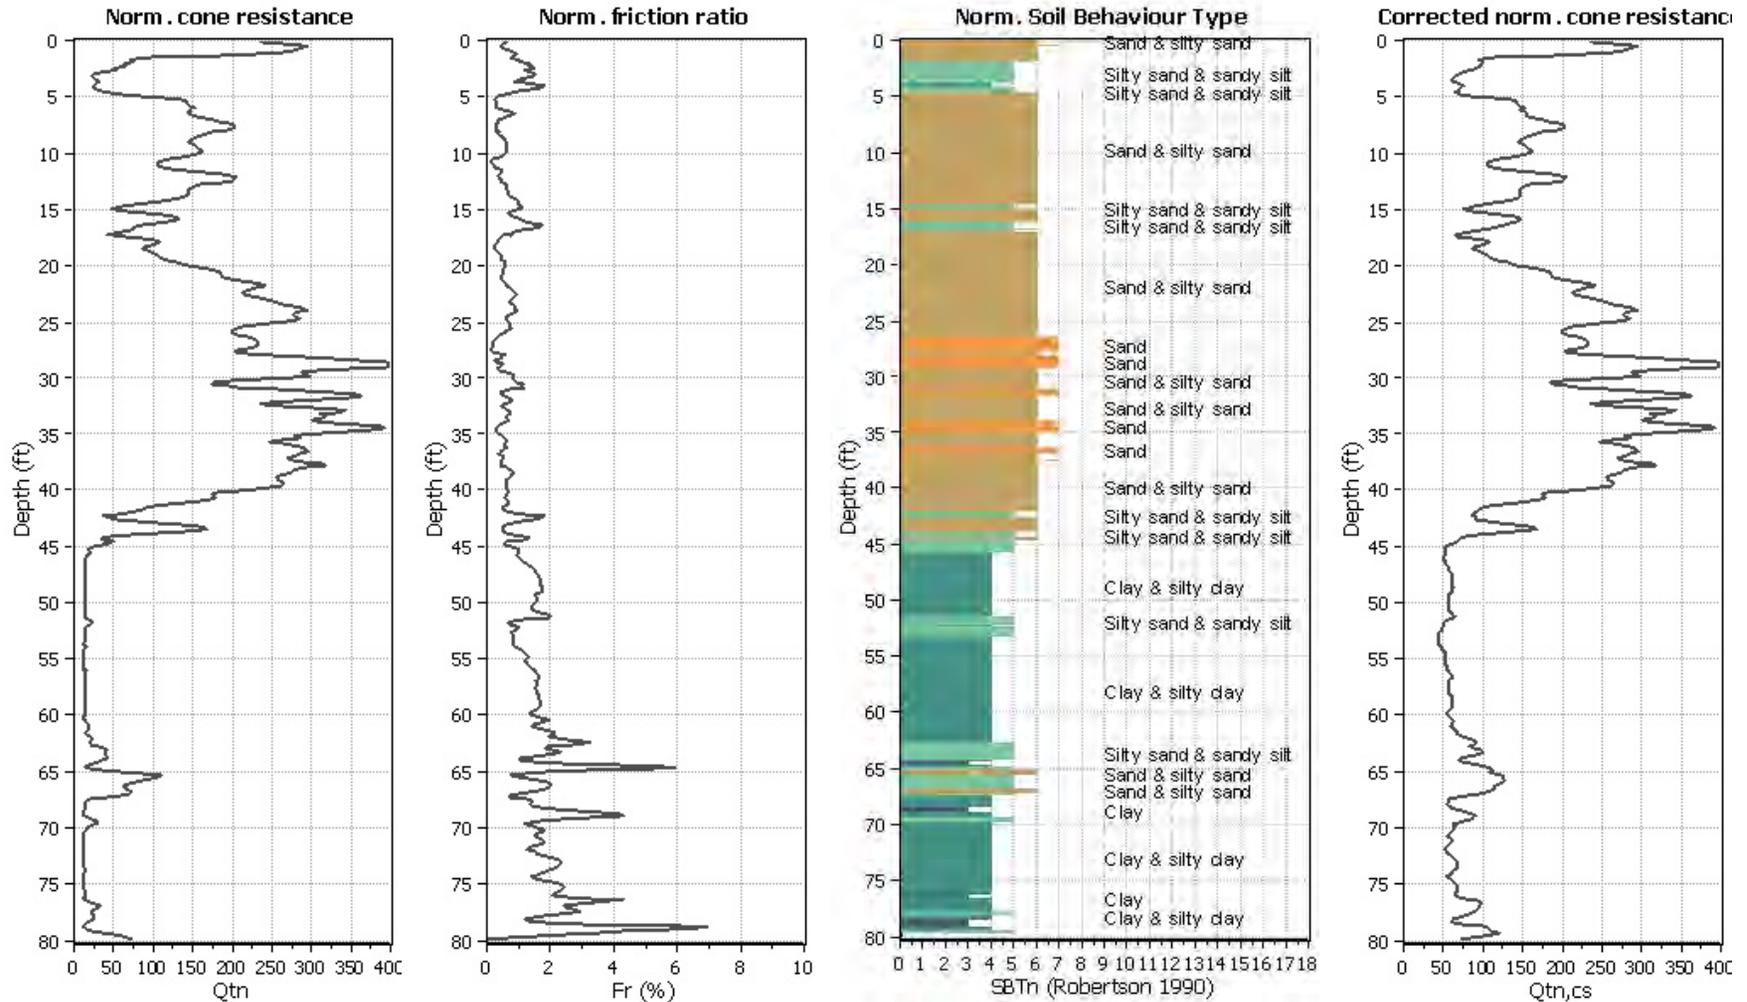
Analysis method:	NCEER (1998)	G.W.T. (in-situ):	4.00 ft	Use fill:	No	Clay like behavior applied:	Sands only
Fines correction method:	NCEER (1998)	G.W.T. (earthq.):	0.00 ft	Fill height:	N/A	Limit depth applied:	No
Points to test:	Based on Ic value	Average results interval:	3	Fill weight:	N/A	Limit depth:	N/A
Earthquake magnitude $M_w$ :	6.70	Ic cut-off value:	2.40	Trans. detect. applied:	Yes	MSF method:	Method based
Peak ground acceleration:	0.51	Unit weight calculation:	Based on SBT	$K_0$ applied:	Yes

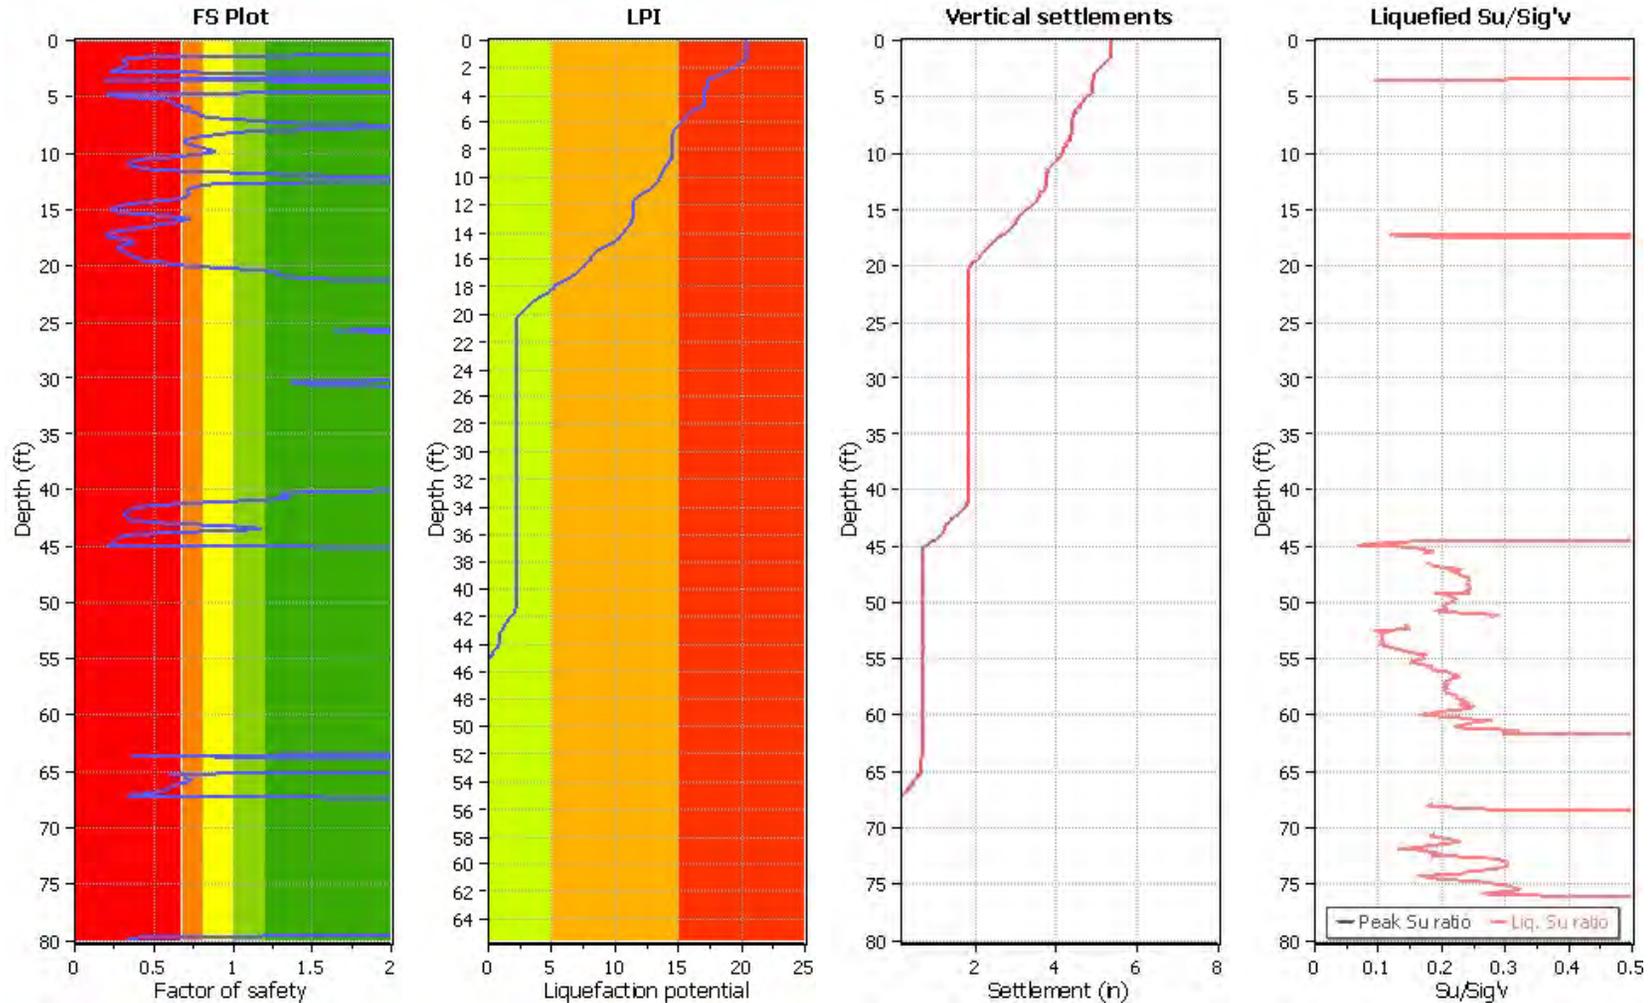
Analysis method:	NCEER (1998)	G.W.T. (in-situ):	4.00 ft	Use fill:	No	Clay like behavior	
Fines correction method:	NCEER (1998)	G.W.T. (earthq.):	0.00 ft	Fill height:	N/A	applied:	Sands only
Points to test:	Based on Ic value	Average results interval:	3	Fill weight:	N/A	Limit depth applied:	No
Earthquake magnitude $M_w$ :	6.70	Ic cut-off value:	2.40	Trans. detect. applied:	Yes	Limit depth:	N/A
Peak ground acceleration:	0.51	Unit weight calculation:	Based on SBT	$K_0$ applied:	Yes	MSF method:	Method based

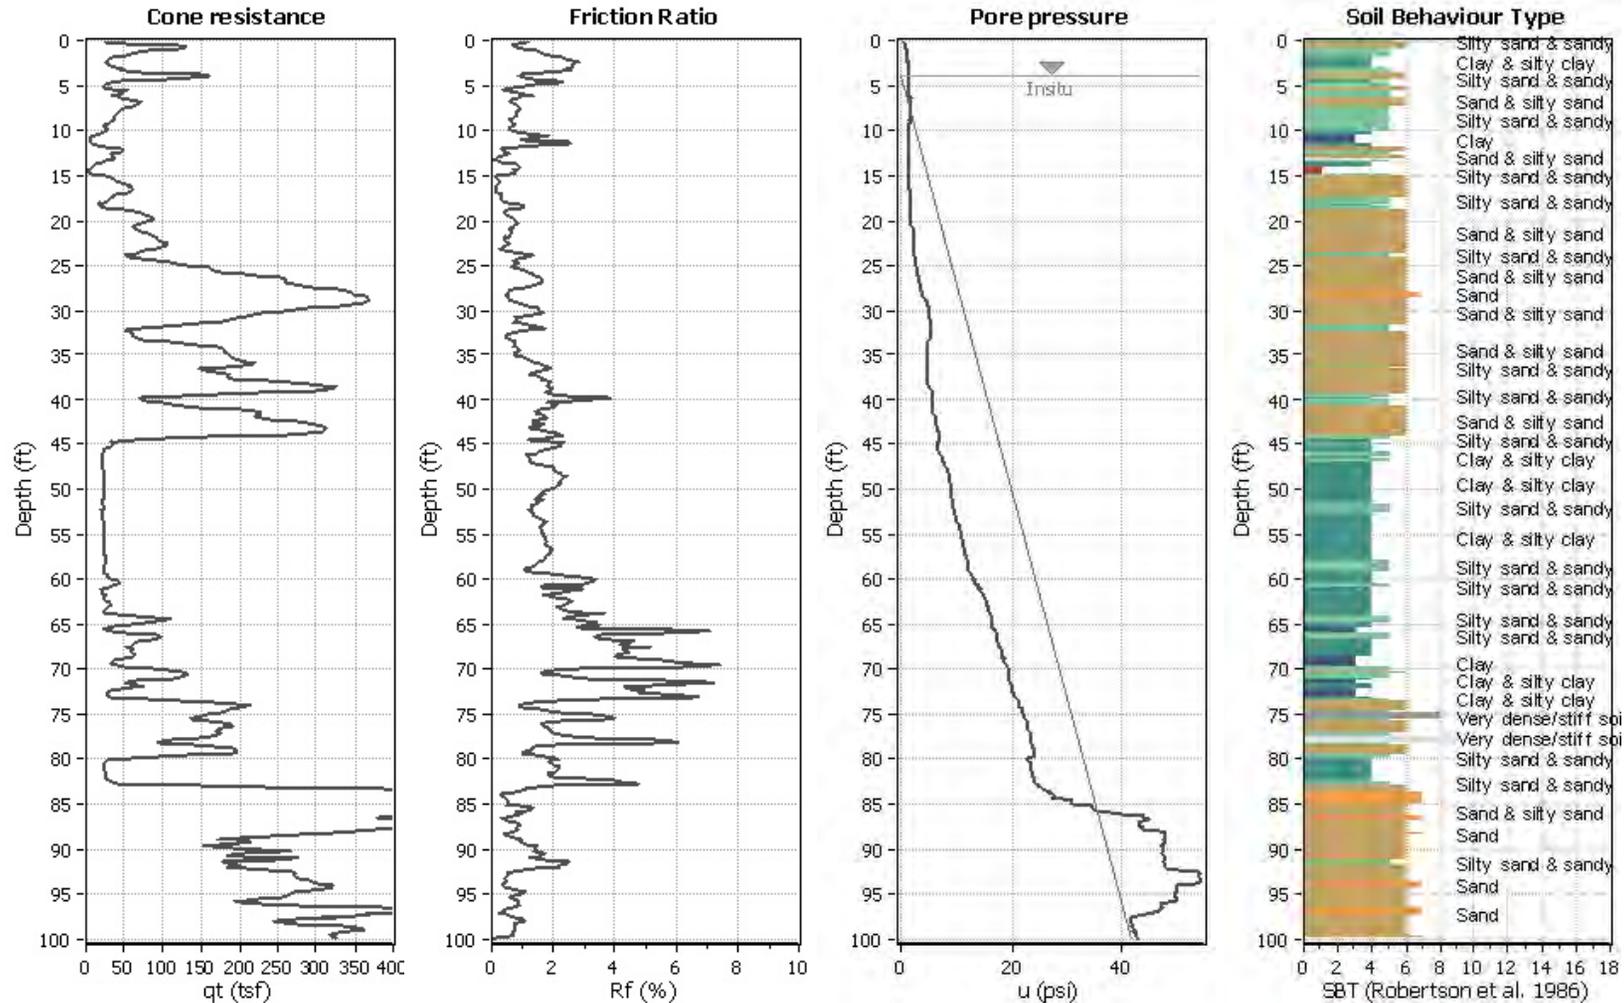
Analysis method:	NCEER (1998)	G.W.T. (in-situ):	4.00 ft	Use fill:	No	Clay like behavior applied:	Sands only
Fines correction method:	NCEER (1998)	G.W.T. (earthq.):	0.00 ft	Fill height:	N/A	Limit depth applied:	No
Points to test:	Based on Ic value	Average results interval:	3	Fill weight:	N/A	Limit depth:	N/A
Earthquake magnitude $M_w$ :	6.70	Ic cut-off value:	2.40	Trans. detect. applied:	Yes	MSF method:	Method based
Peak ground acceleration:	0.51	Unit weight calculation:	Based on SBT	$K_0$ applied:	Yes
