# MEADOW CREEK LAGOON HABITAT RESTORATION

**PRELIMINARY GEOTECHNICAL AND  
GEOLOGIC HAZARDS REPORT**

**Meadow Creek Lagoon Habitat Restoration  
San Luis Obispo County, California**

Yeh Project No.: 220-331

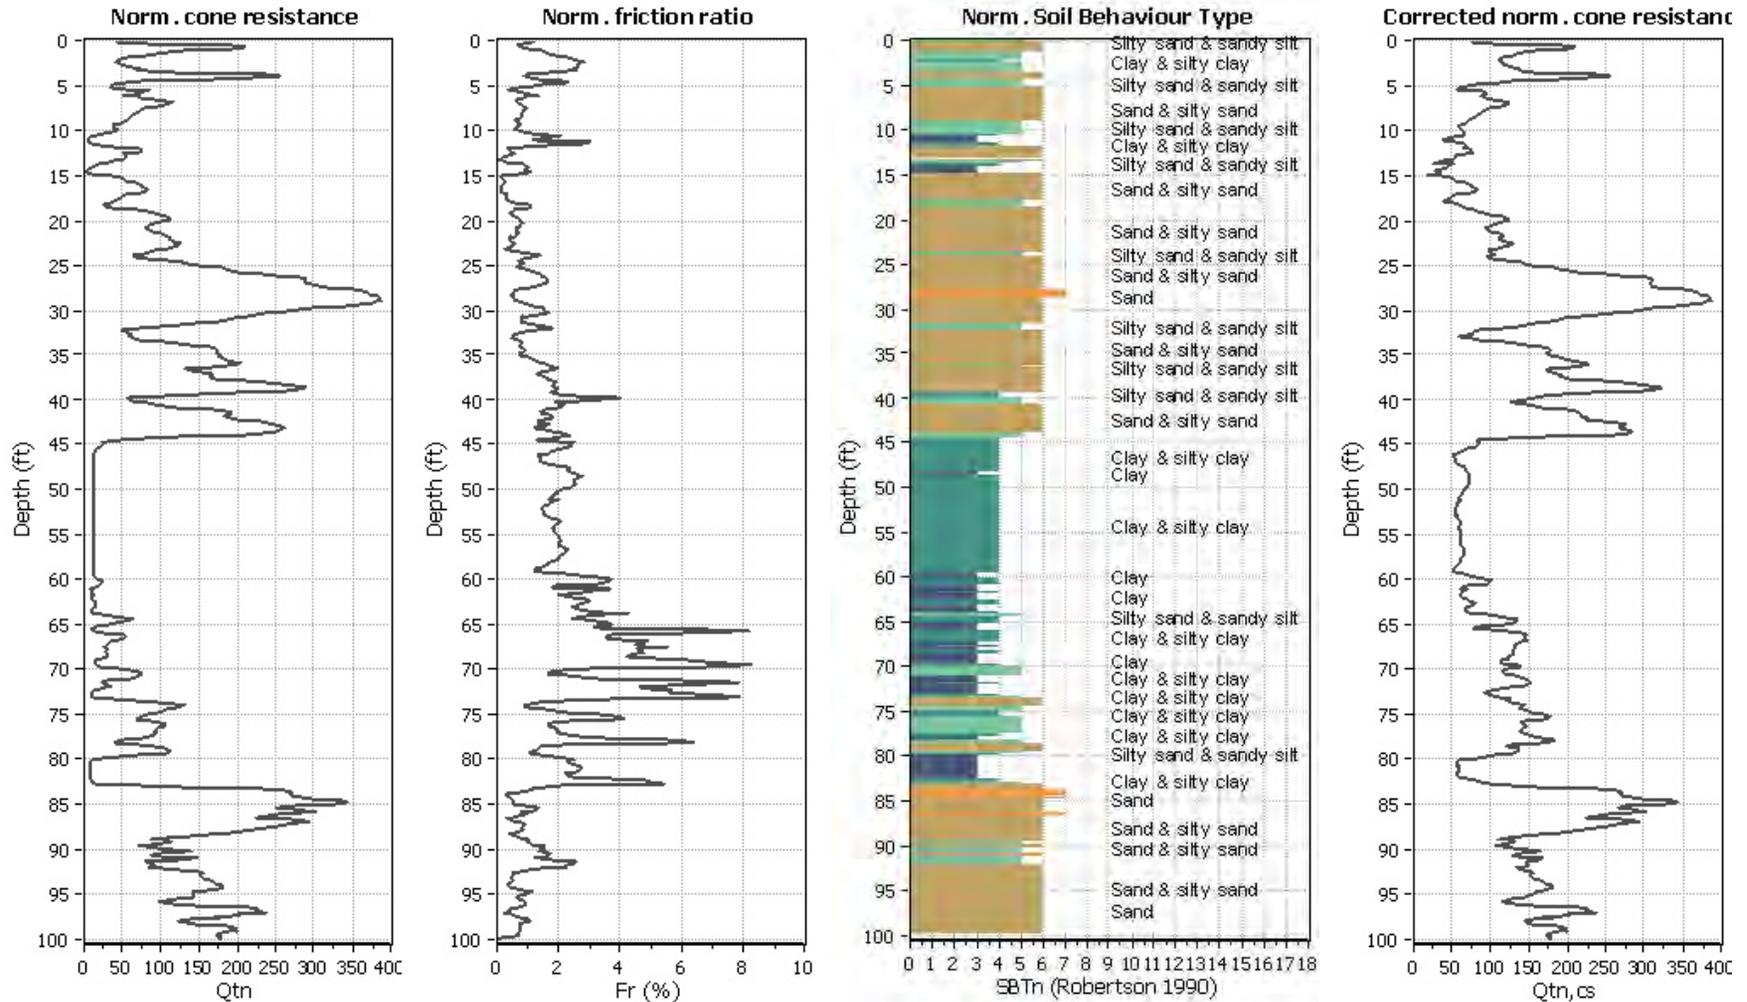
Analysis method:	NCEER (1998)	G.W.T. (in-situ):	4.00 ft	Use fill:	No	Clay like behavior	
Fines correction method:	NCEER (1998)	G.W.T. (earthq.):	0.00 ft	Fill height:	N/A	applied:	Sands only
Points to test:	Based on Ic value	Average results interval:	3	Fill weight:	N/A	Limit depth applied:	No
Earthquake magnitude $M_w$ :	6.70	Ic cut-off value:	2.40	Trans. detect. applied:	Yes	Limit depth:	N/A
Peak ground acceleration:	0.51	Unit weight calculation:	Based on SBT	$K_0$ applied:	Yes	MSF method:	Method based

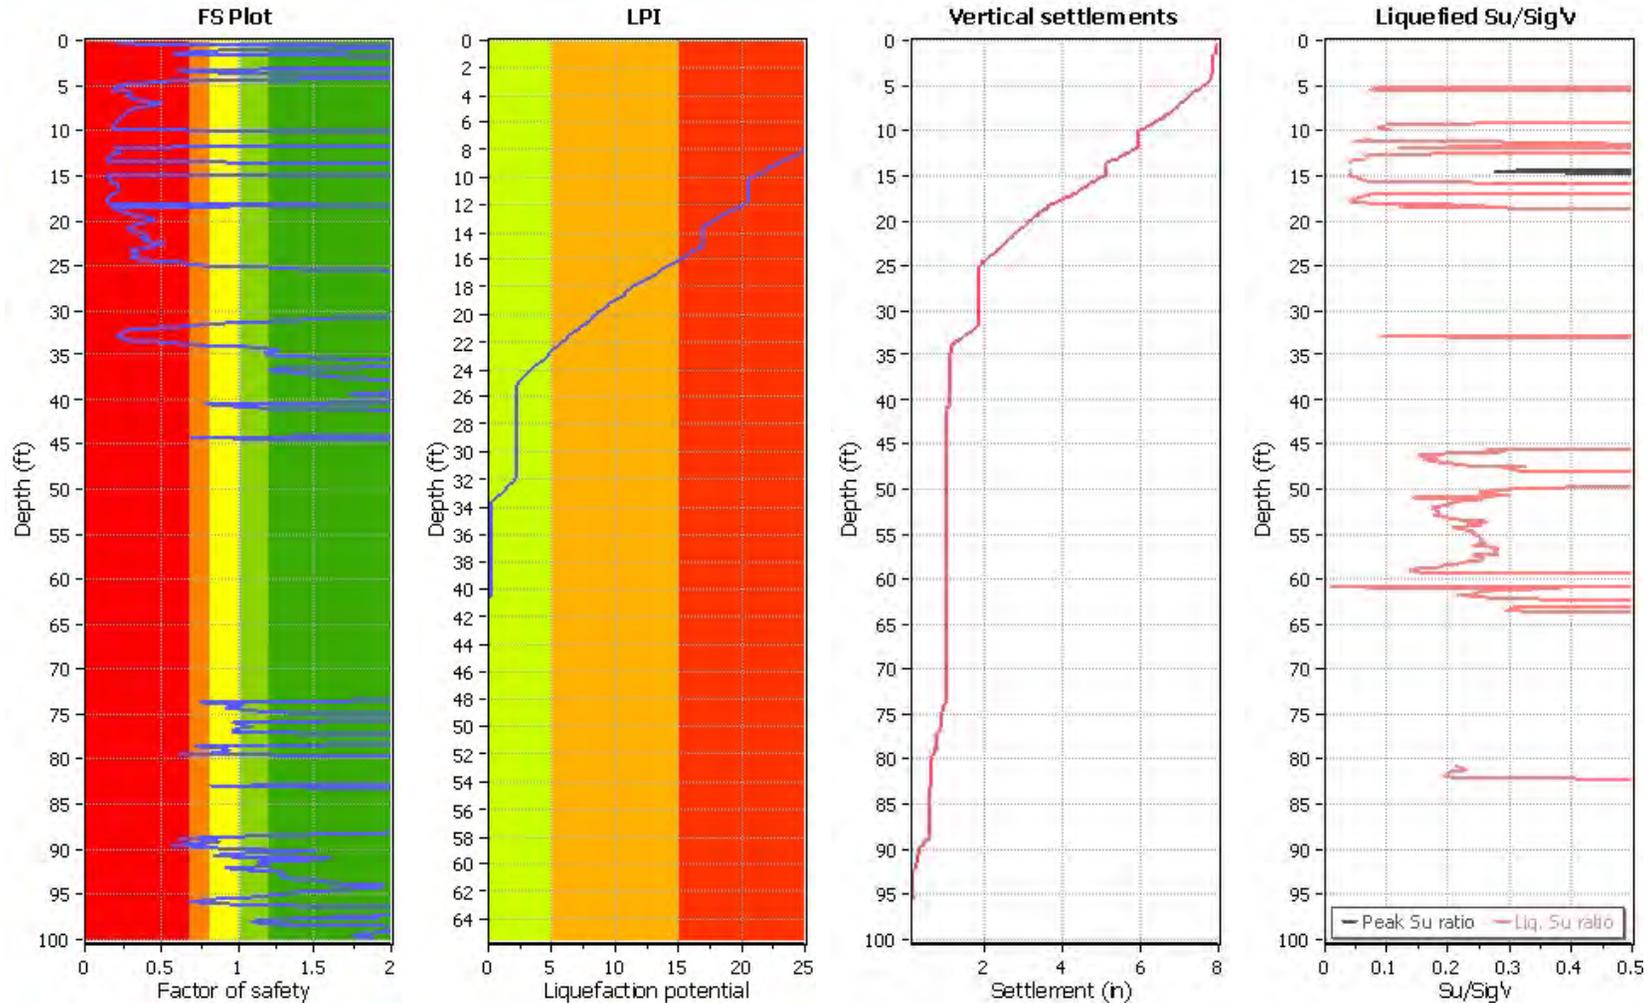
Analysis method:	NCEER (1998)	G.W.T. (in-situ):	4.00 ft	Use fill:	No	Clay like behavior	
Fines correction method:	NCEER (1998)	G.W.T. (earthq.):	0.00 ft	Fill height:	N/A	applied:	Sands only
Points to test:	Based on Ic value	Average results interval:	3	Fill weight:	N/A	Limit depth applied:	No
Earthquake magnitude $M_w$ :	6.70	Ic cut-off value:	2.40	Trans. detect. applied:	Yes	Limit depth:	N/A
Peak ground acceleration:	0.51	Unit weight calculation:	Based on SBT	$K_0$ applied:	Yes	MSF method:	Method based
