Lopez Dam Breach Inundation Study Comparison – 1999 Vs 2017

San Luis Obispo County, California

May 2019
Project 1705077

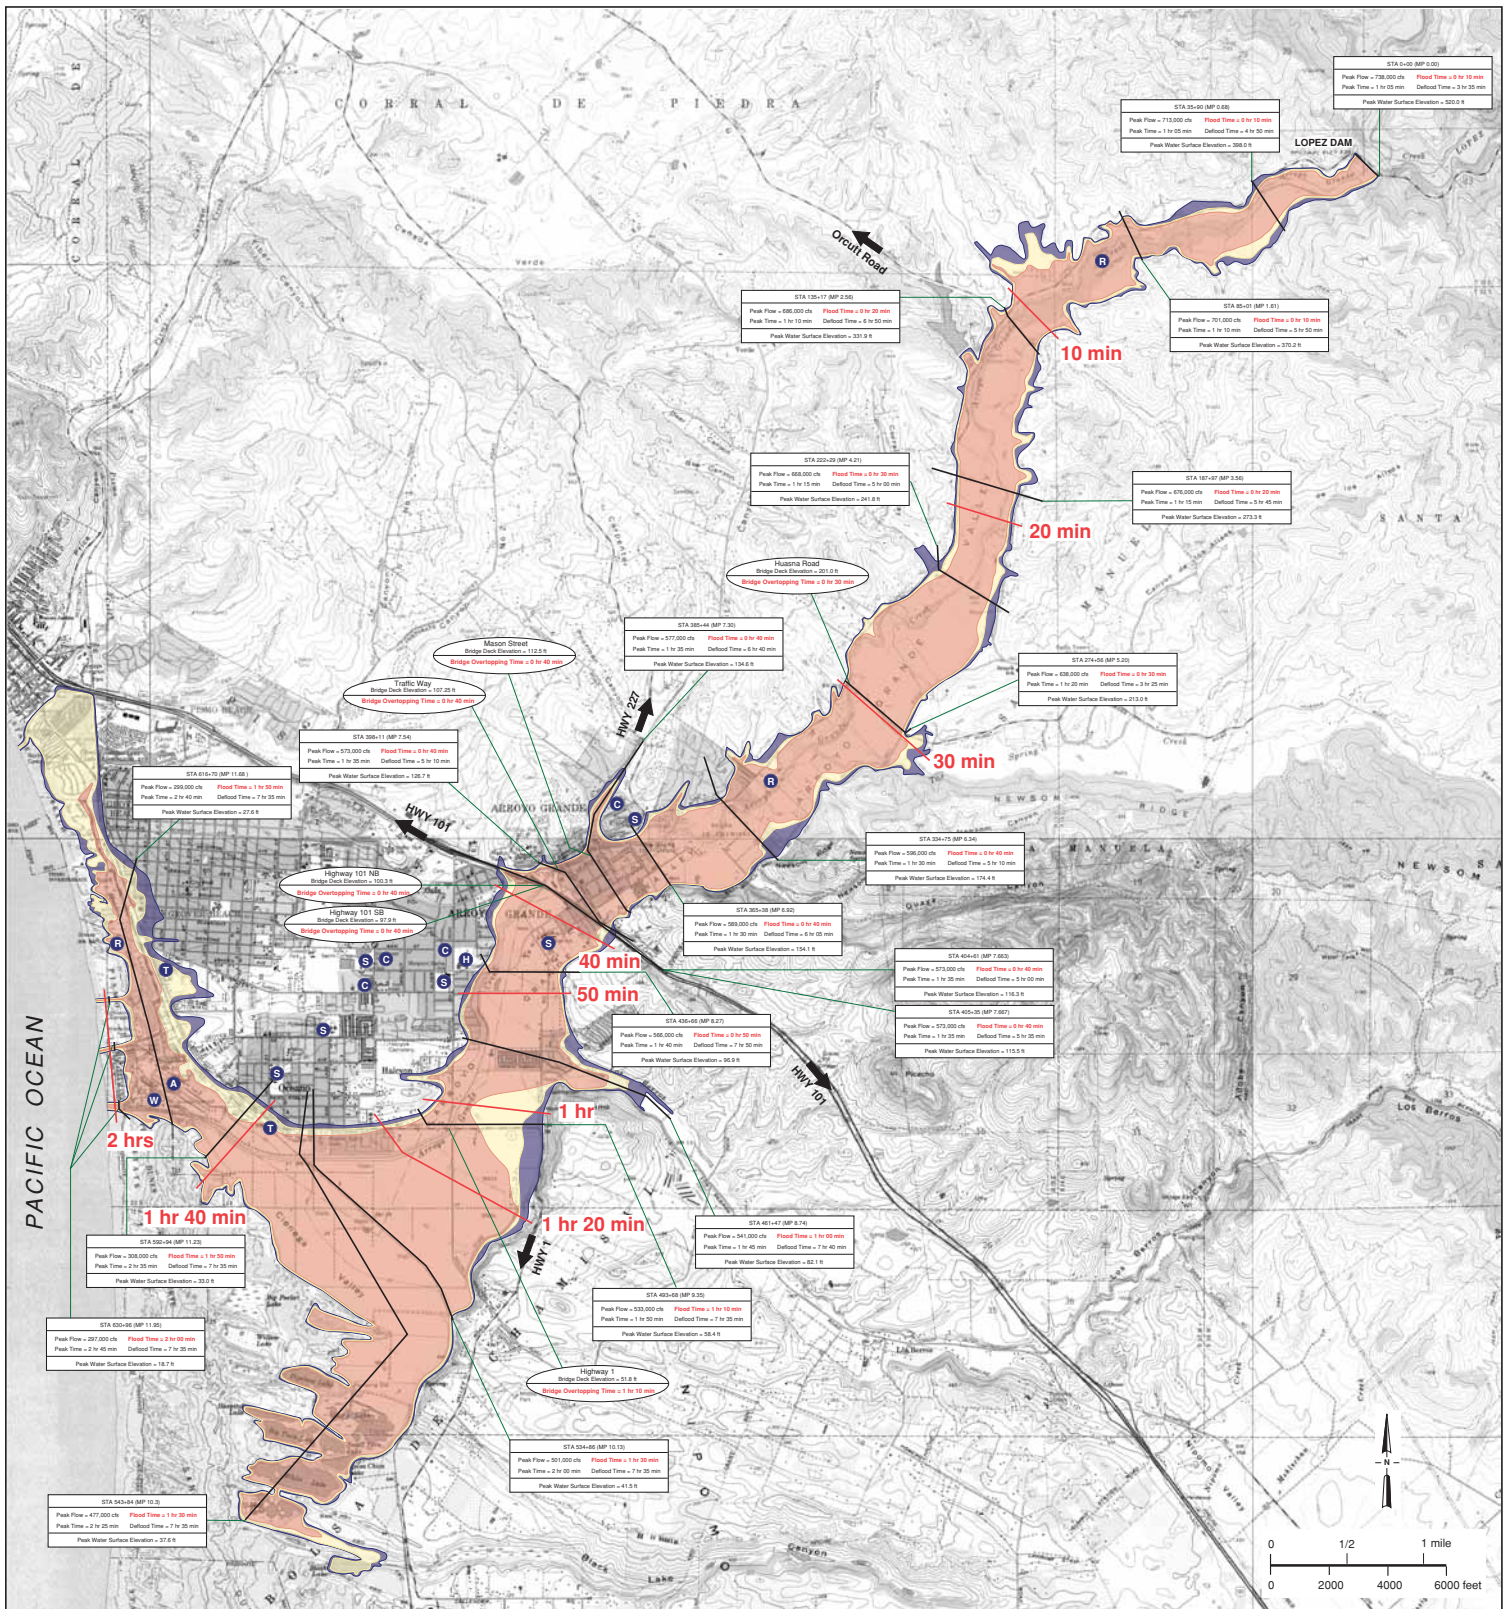
SAN LUIS OBISPO COUNTY Sheet No. 1 of 1

- LIMITATIONS/ASSUMPTIONS:**
- The flood characteristics presented on this map are based on the methodology, assumptions and limitations presented in the accompanying report (Downstream Flooding due to the Hypothetical Failure of Lopez Dam, February 1999 - URS Greiner Woodward Clyde).
 - Inundation depths are provided for informational purposes only.
 - Inundation depths may vary ±5 feet upstream of Station 85+01.
 - Inundation depths may vary ±2 feet downstream of Station 85+01.
 - Peak, flood and bridge overtopping times may vary ±5 minutes.
 - Deflood times may vary ±15 minutes.
 - Initial reservoir storage is 100% full (reservoir elevation 520.0 ft).

STA (MP) [Distance in feet (miles) downstream from Lopez Dam]
Peak Flow (maximum discharge rate in cubic feet per second)
Peak Time (time of maximum flood inundation)*
Flood Time (time when flood flows overlap channel banks, levees or flood walls)*
Deflood Time (time when flows recede to channel banks)*
Peak Water Surface Elevation (maximum water elevation)

INUNDATION MAP 1999
GIVEN THE HYPOTHETICAL FAILURE OF LOPEZ DAM
California Dam No. 1055-000
DWR Registry No. CA 00887

- 1999 Dam Breach Inundation Study Map
- 2017 Dam Breach Inundation Study Map
