Jack Ranch San Luis Obispo Agricultural Cluster Project

Appendices for the Final Environmental Impact Report

SCH#2016-051012

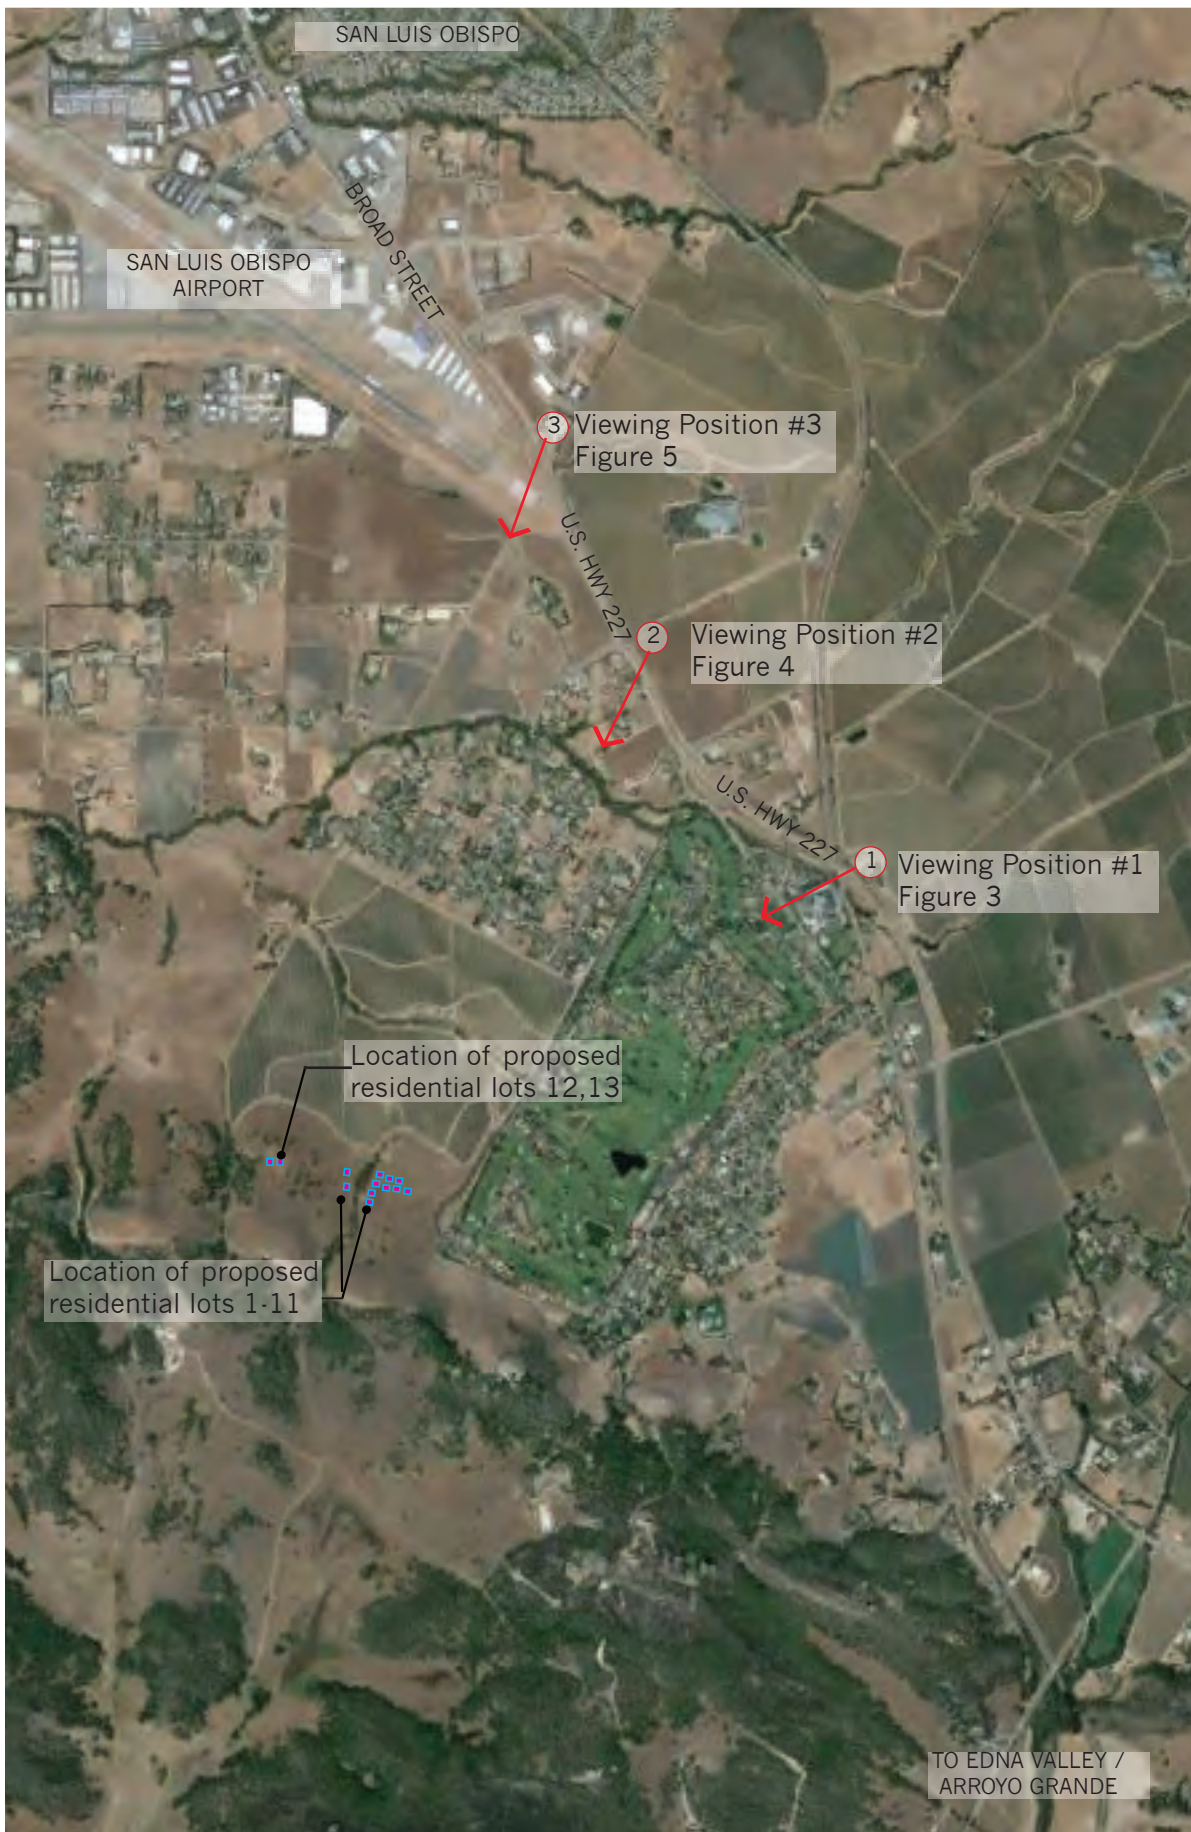
**Distant view showing general location of proposed lots
Pylons not visible**

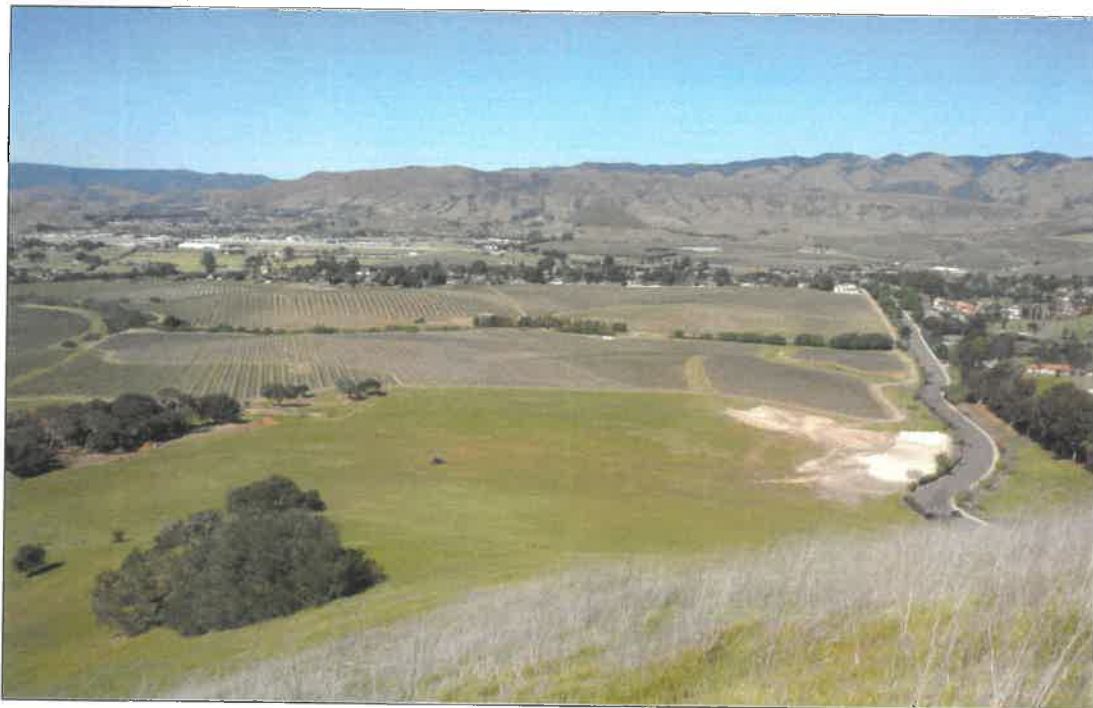
Figure 2-2. Photograph of Jack Ranch Property.

View toward NE from southern hillside. Greystone Place and golf course are on the right (east). Lots 1-9 are sited in grassy area in foreground. Lots 10-13 are located outside the photo and left (west) of central drainage gully (tree line on left). Vineyard in background is the northern portion of the property.
