ARROYO GRANDE CREEK CHANNEL WATERWAY MANAGEMENT PROGRAM

FINAL REPORT

for San Luis Obispo County Flood Control and Water Conservation
District Zones 1 and 1A Flood Control District

October 2010

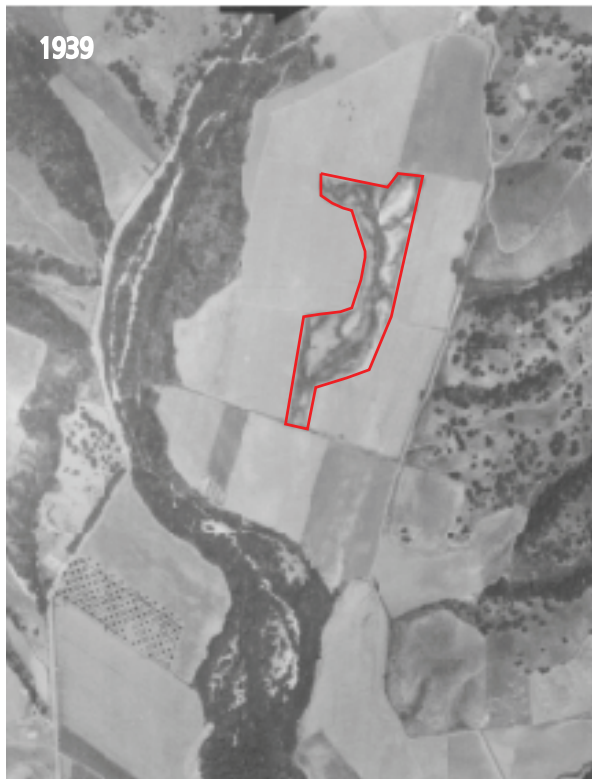
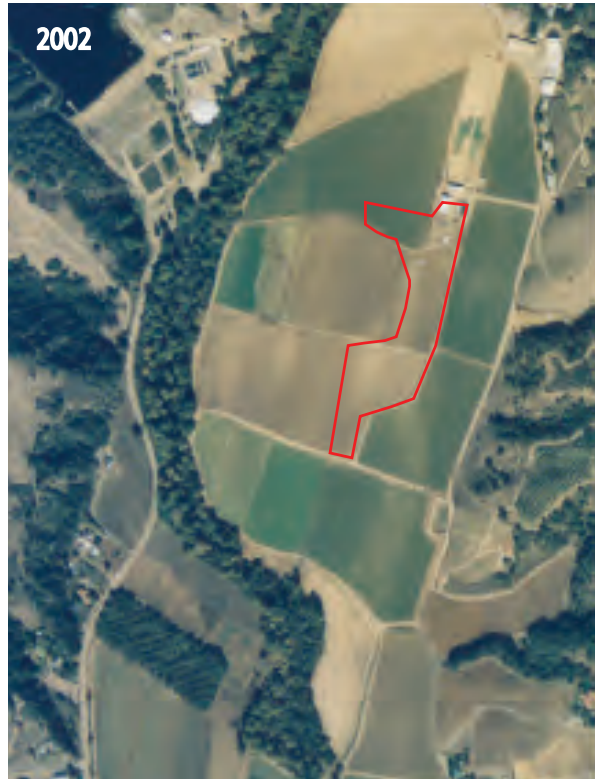
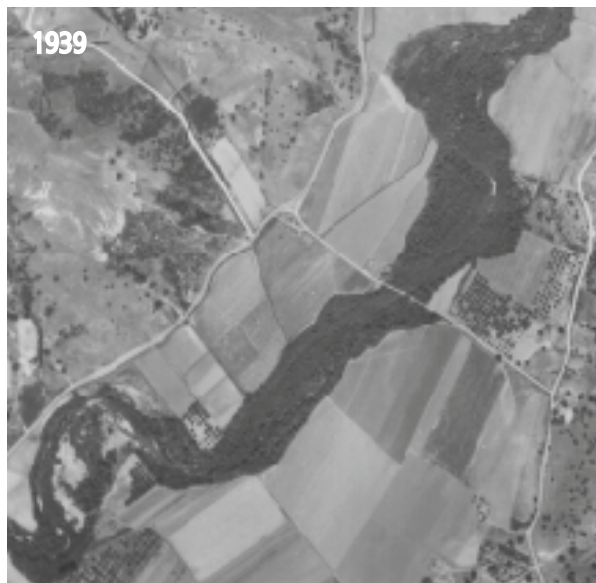
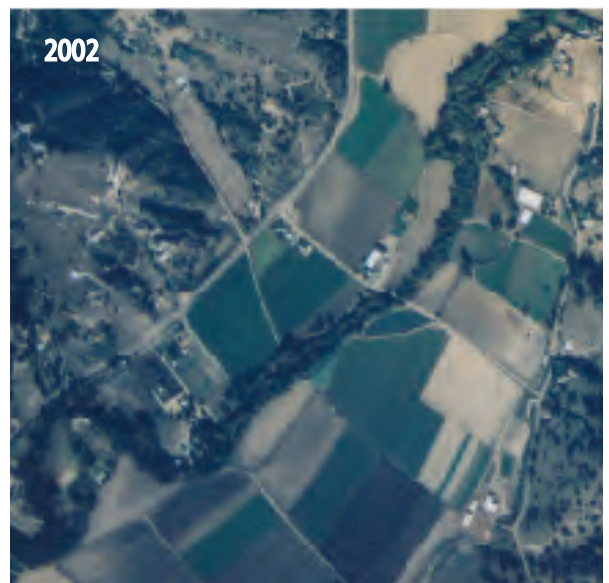
A: Remnant riparian area evident in 1939 aerial photo, (highlighted in red), no longer exists in 2002 aerial photo.

B: Wide floodplain / riparian area evident in 1939 aerial photo, in 2002 aerial photo riparian area is confined by agricultural fields.

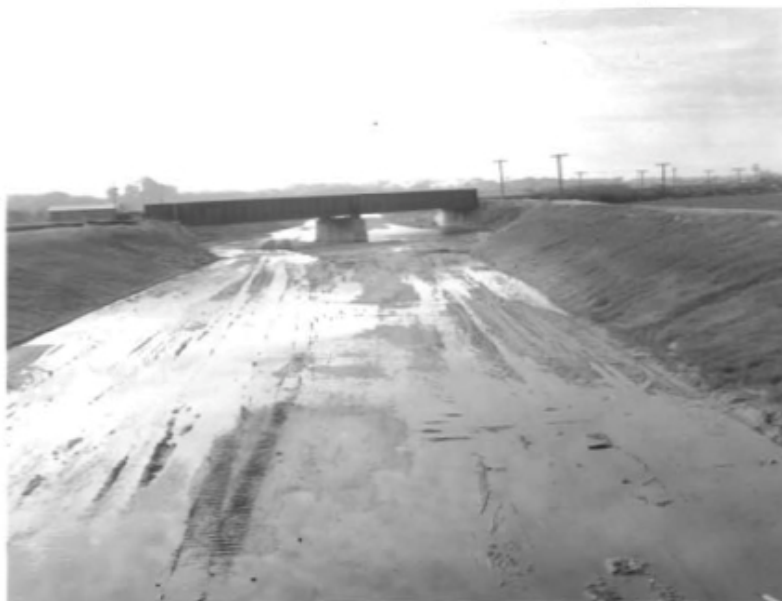
Photo 1. Constructed trapezoidal channel at UPRR bridge in 1958.

The original flood control channel was built in 1959 and was designed to carry a discharge of 10,120 cubic feet per second (cfs), which, at the time of the analysis, was determined to have a recurrence of once every 100 years. Maintenance of the flood control channel as required by the 1959 Operation and Maintenance Agreement between the District, NRCS, and the CSLRCD (1959 Agreement), consisted primarily of vegetation and sediment removal to maintain the design geometry and capacity of the channel and routine maintenance of the levee system and associated infrastructure. Maintenance activities in recent years were restricted by a combination of lack of funding (Zone 1/1A maintenance funds had not risen appreciably since the creation of the special district) and environmental concerns

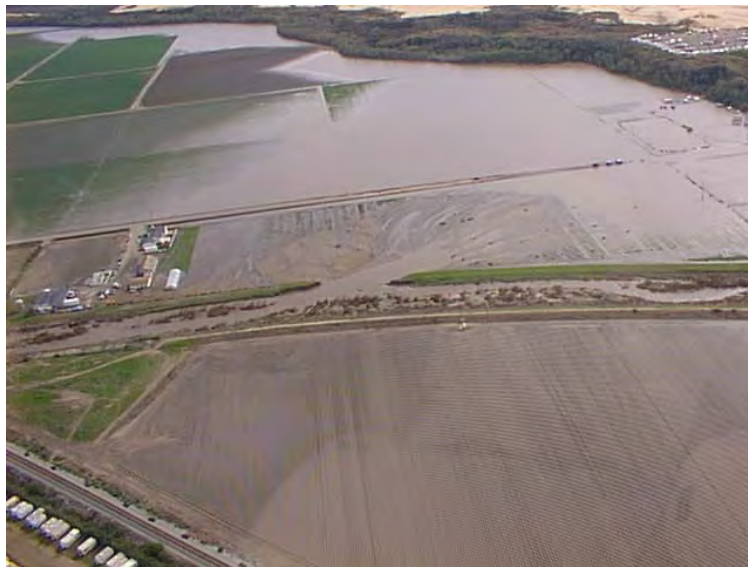
Photo 2. Oblique photo of flooding in the Cienega Valley following the levee breach of March 2001 (looking south).

On March 5, 2001, during a high intensity rain event, the levee was breached on the south side between the mouth and the Union Pacific railroad bridge (Photos 2 and 3). It was estimated by observers in the field at the time of the levee breach that the levee would have overtopped upstream of the 22nd Street bridge had the levee not breached and lowered the overall water surface. Hundreds of acres of farmland and several residences were flooded in La Cienega Valley. Impacts from the flooding persisted beyond the winter season as many of the lower lying areas with clay soils located in the southern portion of the valley remained saturated. The northern levee remained intact, thereby protecting several residential developments, the Oceano Airport, and the regional wastewater treatment plant that services the communities of Arroyo Grande, Oceano and Grover Beach.

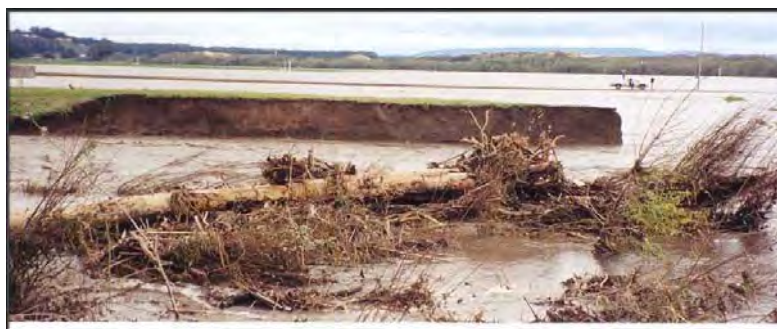
Photo 3. Close-up view of the levee breach and flooding of farmland in March 2001 (looking at south levee from north levee).

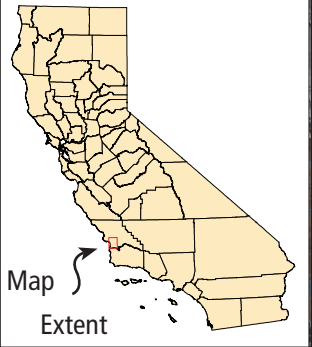
FIGURE 3: Study area for the WMP. The WMP includes the levees, channel and riparian areas on lower Arroyo Grande Creek and lower Los Berros Creek within the Zone 1/1A Flood Control District.

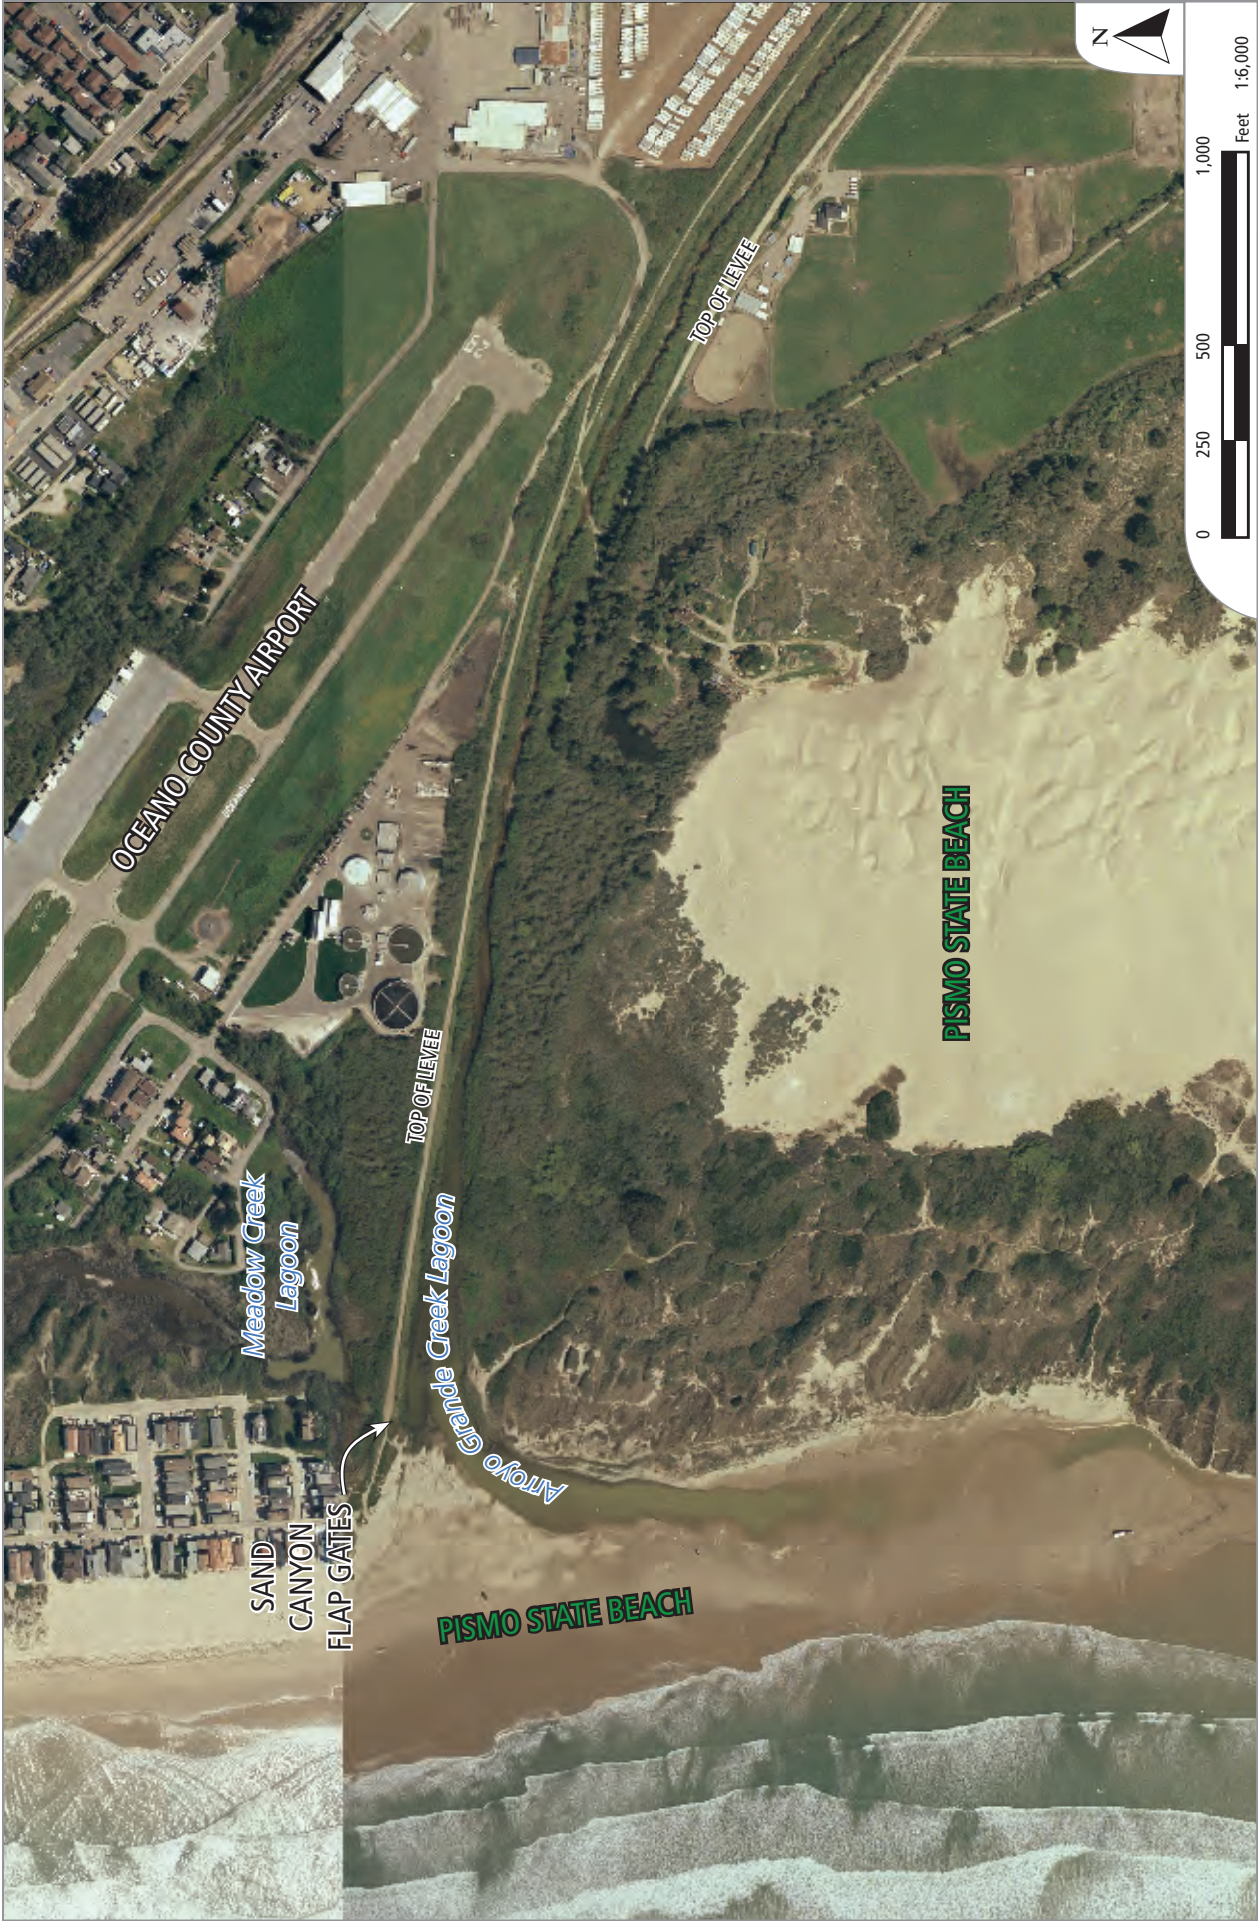
FIGURE 4: Lagoon and flaggate locations.

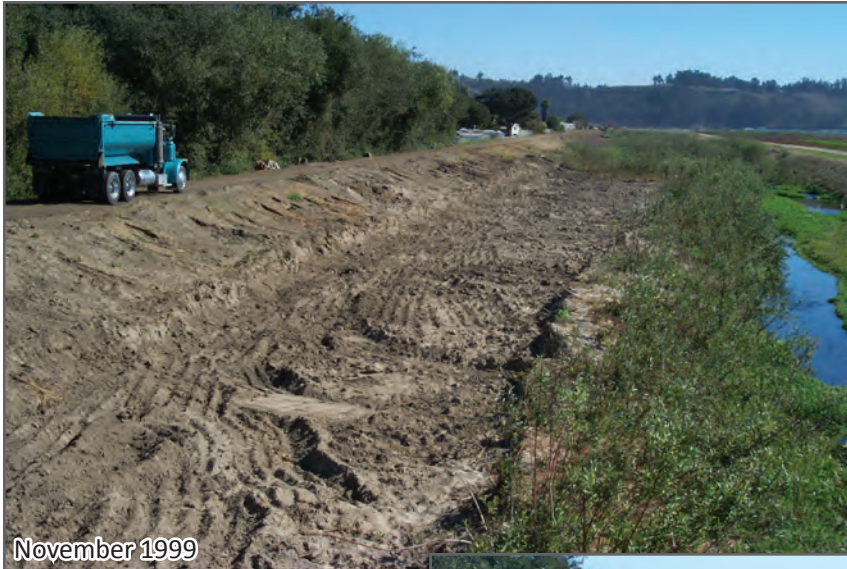
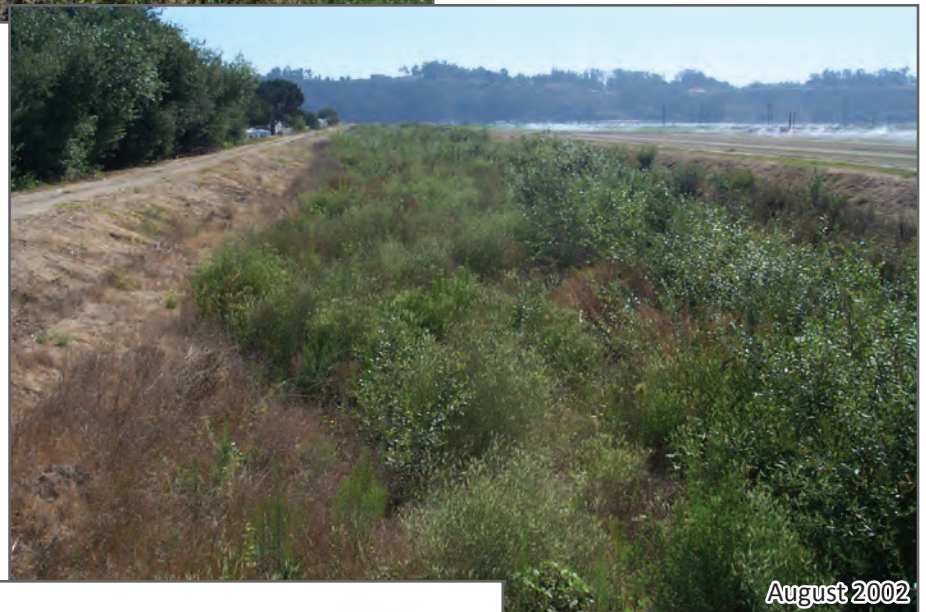
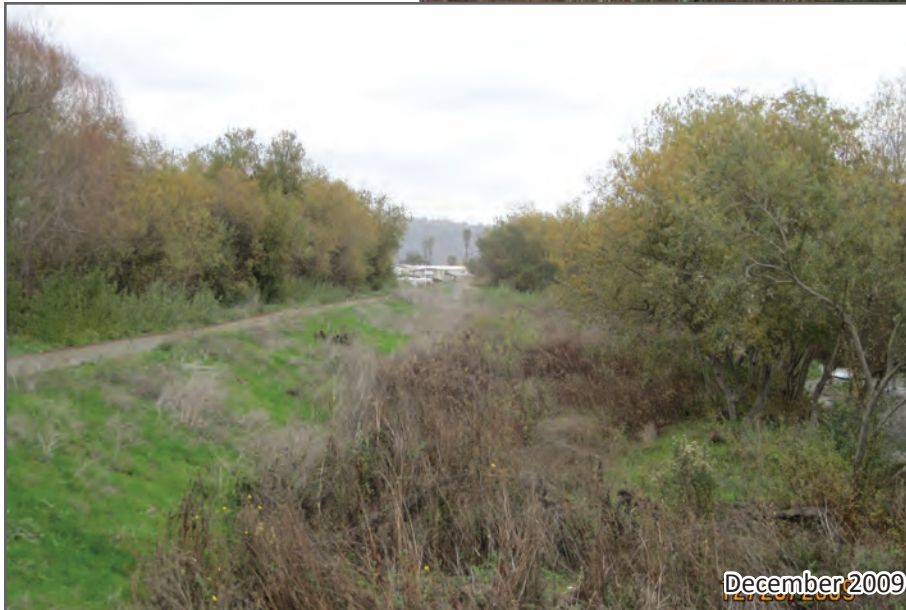
November 1999

August 2002

December 2009

roughness, and invasive removal. In 2007 the RCD received a permit, on behalf of the District, from the Coastal Commission to extend the vegetation management program within the Coastal Zone from the Union Pacific Railroad Bridge to just downstream of Guitton's Crossing. Vegetation management activities utilizing these principles has greatly improved the riparian canopy and complexity throughout the Arroyo Grande Creek Channel while at the same time providing increased flood protection. Improvements in the riparian canopy conditions are illustrated in Photos 4-9.

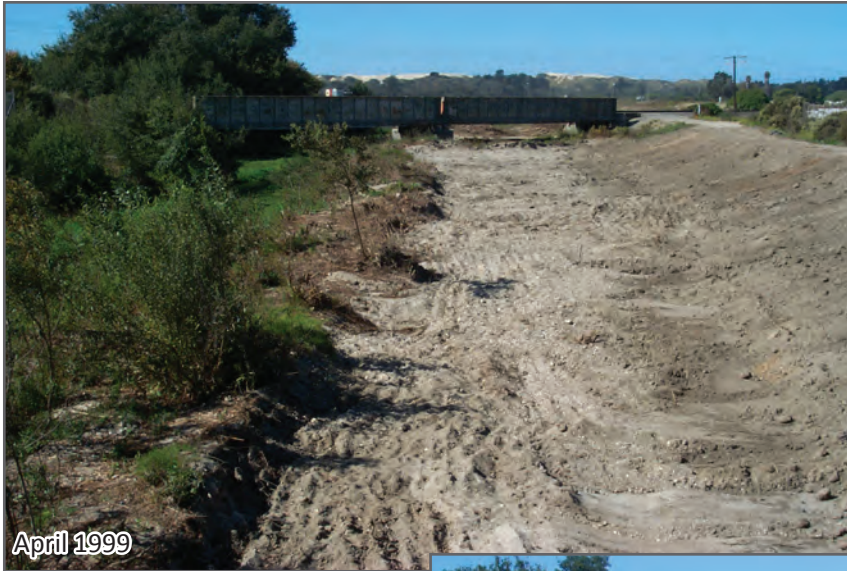
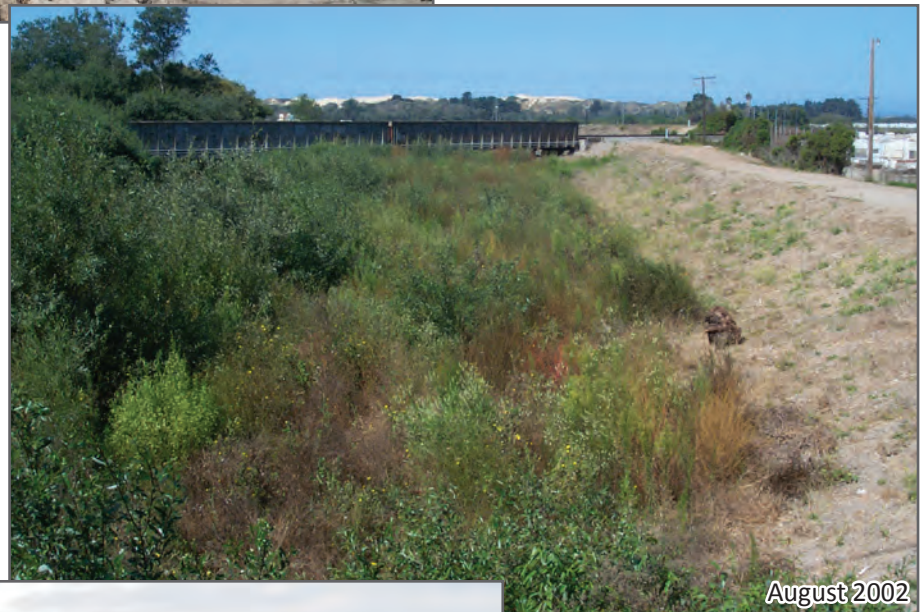
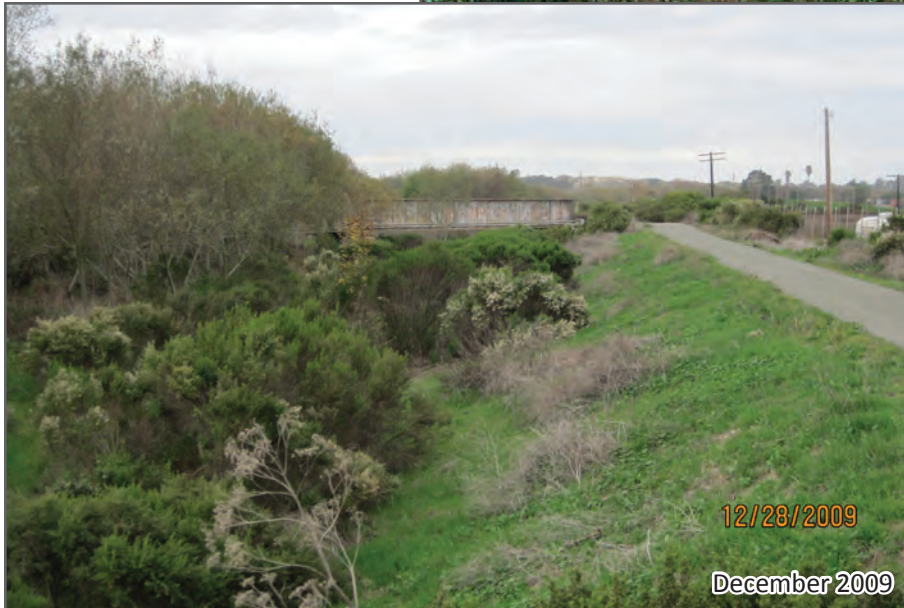
April 1999

August 2002

December 2009

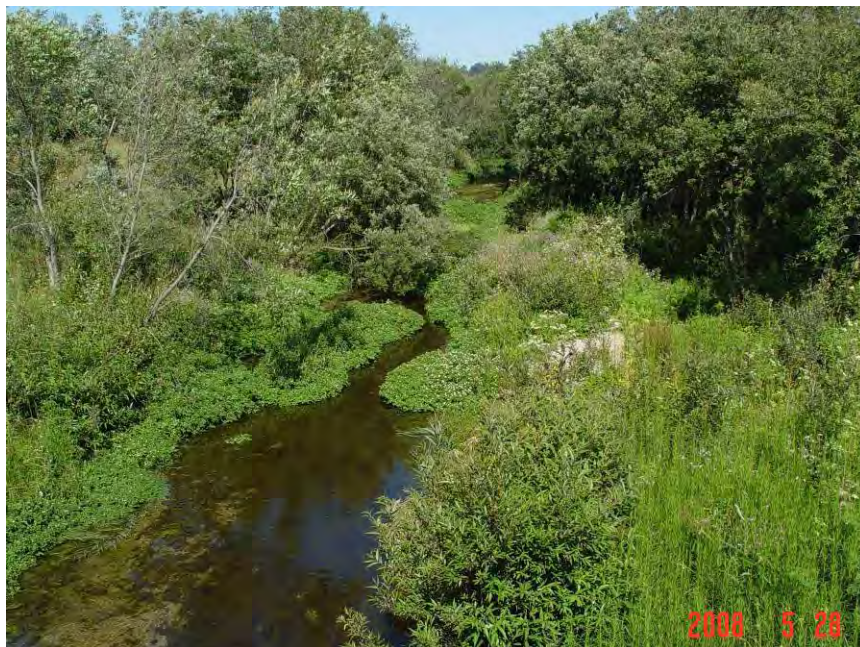
Photo 10. Spring/early summer regrowth of vegetation in the flood control channel just upstream of the 22nd St Bridge.

have occurred over the last four years, regrowth of managed vegetation during the spring and summer is heavy, requiring annual maintenance.

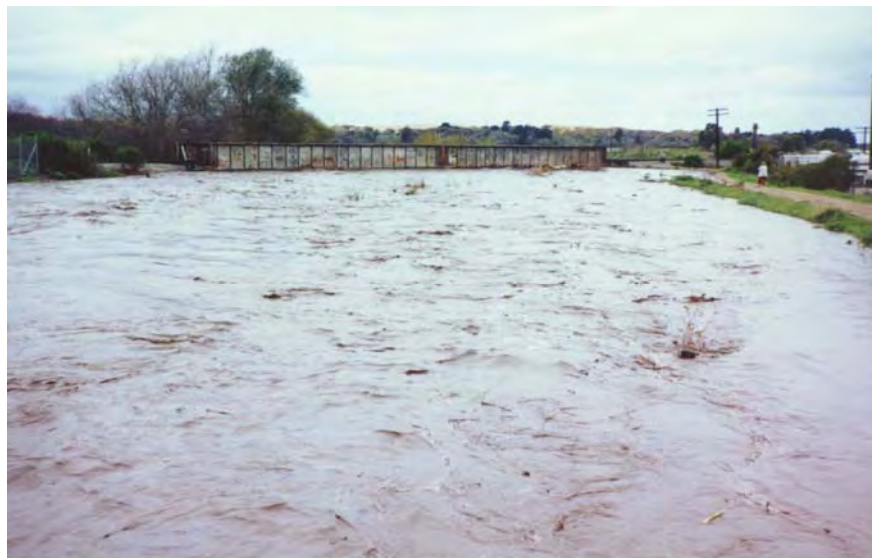
Photo 11. Union Pacific Railroad (UPRR) bridge during the 2001 flood.

The Union Pacific Railroad (UPRR) Bridge, located near the downstream end of the flood control reach, presents an obstruction to flow under current conditions (Photo 11). In addition, the bridge does not cross at a 90 degree angle to the flood control channel and the abutments do not run parallel to the flow path of Arroyo Grande Creek. Under the proposal to raise the adjacent levees to provide 20-year flood protection, the UPRR Bridge would need to be modified, raised, or replaced to enable the levee raise. The UPRR Bridge does not need to be modified for the smaller (10-year protection) levee raise project. Given funding issues, it is unclear when the bridge would be modified, raised, or replaced in relation to the proposed levee raise.

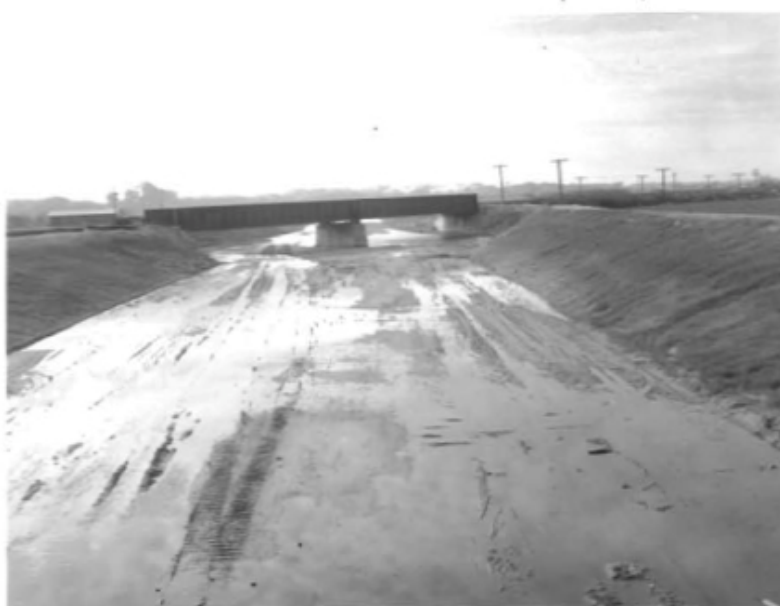
Photo 1. Constructed trapezoidal channel at UPRR bridge in 1958.

The original flood control channel was built in 1959 and was designed to carry a discharge of 7,500 cubic feet per second, which, at the time of the analysis, was determined to have a recurrence of once every 50 years. Maintenance of the flood control channel by the District, RCD, and NRCS since completion of the project in 1961 consisted primarily of vegetation and sediment removal to maintain the design geometry and capacity of the channel and routine maintenance of the levee system and associated infrastructure. The frequency of maintenance varied depending on rainfall and runoff conditions that preceded maintenance. Maintenance activities in recent years was restricted by a combination of lack of funding (Zone 1/1A maintenance funds had not risen appreciably since the creation of the special

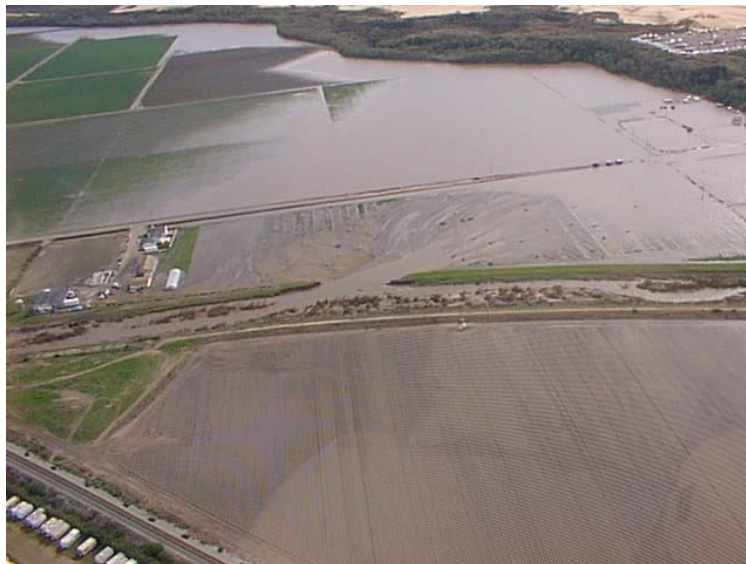
Photo 2. Oblique photo of flooding in the Cienega Valley following the levee breach of March 2001 (looking south).

On March 5, 2001, during a high intensity rain event, the levee was breached on the south side between the mouth and the Union Pacific railroad bridge (Photos 2 and 3). It was estimated by observers in the field at the time of the levee breach that the levee would have overtopped upstream of the 22nd Street bridge had the levee not breached and lowered the overall water surface. Hundreds of acres of farmland and several residences were flooded in the La Cienega Valley. Impacts from the flooding persisted beyond the winter season as many of the lower lying areas with clay soils located in the southern portion of the valley remained saturated. The northern levee remained intact, thereby protecting several residential developments, the Oceano Airport, and the regional wastewater treatment plant that services the communities of Arroyo Grande, Oceano and Grover Beach.

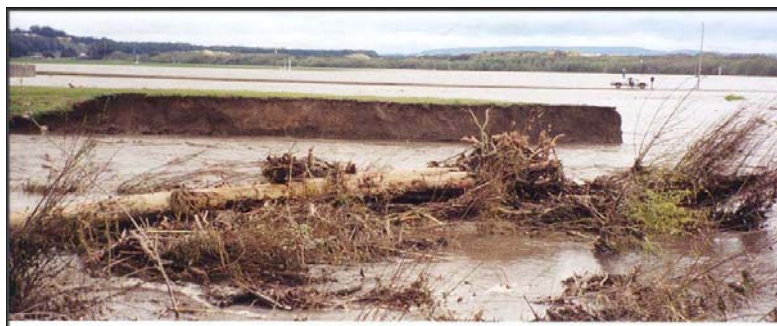
Photo 3. Close-up view of the levee breach and flooding of farmland in March 2001 (looking at south levee from north levee).
