# San Luis Obispo County Watersheds Management Plan

## Phase I – Vision, Framework & Methodology Development

# San Luis Obispo County Regional Instream Flow Assessment

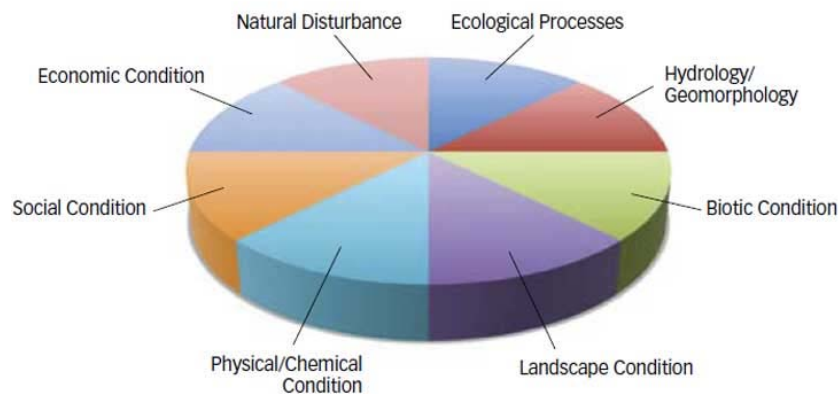
FIGURE 12. CA WATERSHED ASSESSMENT FRAMEWORK SHOWING ESSENTIAL WATERSHED ATTRIBUTES  
**Watershed Assessment Framework**

Indicators and metrics will be reviewed at the sub-region scale to ensure these criteria are met. “Indicator” is the term used to show what conditions are. “Metric” is the term used to measure the influence of a factor in the conditions of a watershed.

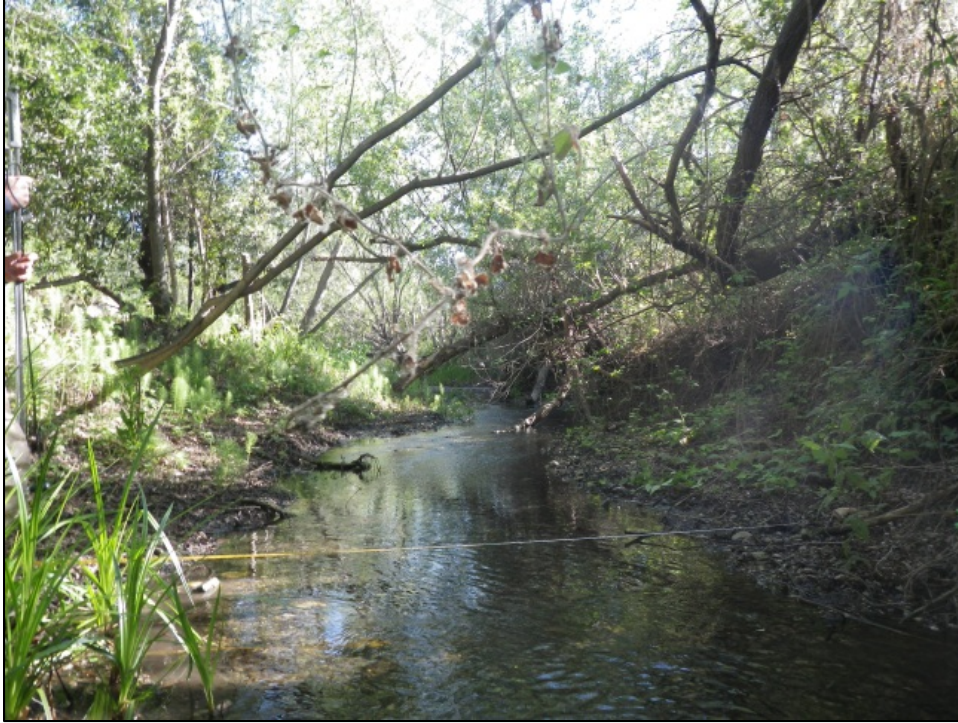
Figure 8. San Luisito Creek, with nearly sufficient flows to provide steelhead habitat during spring 2013.

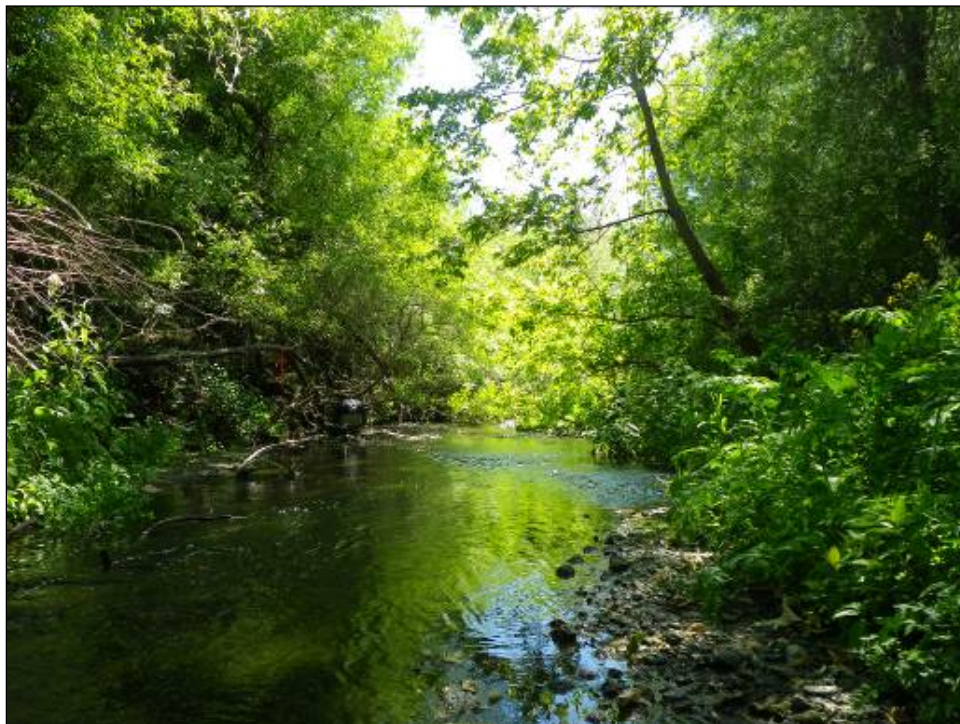
Figure 9. Lower San Luis Obispo Creek, with sufficient flows to provide steelhead habitat during spring 2013. Note that flows are dominated by San Luis Obispo's Water Reclamation Facility releases.

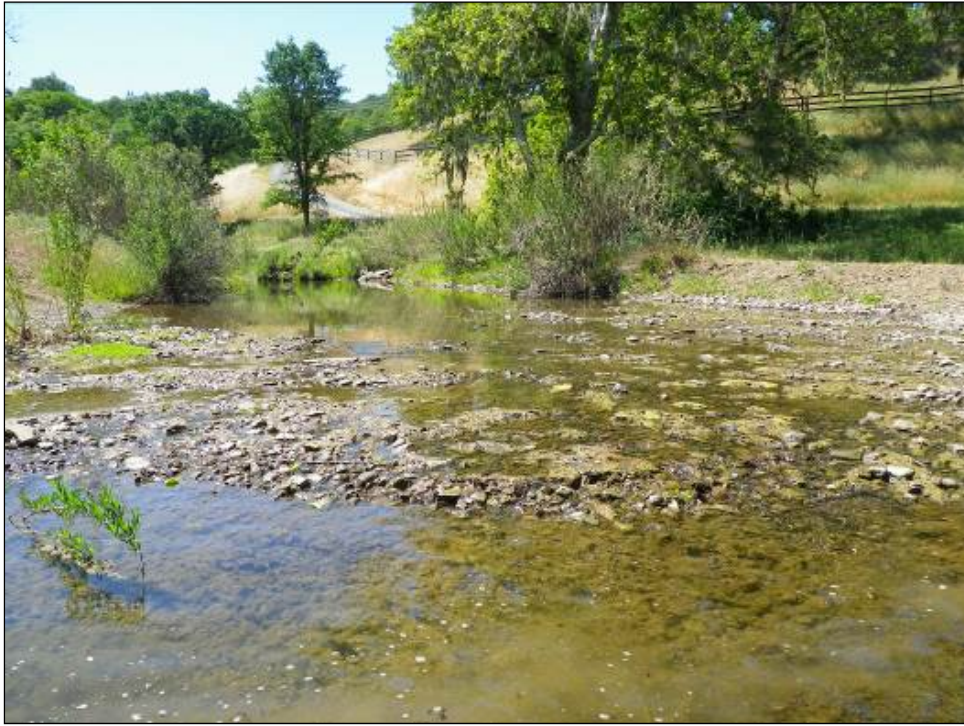
Figure 10. Middle Atascadero Creek, with insufficient flows to provide steelhead habitat during spring 2013. Note that 2013 was an extreme drought in the County.

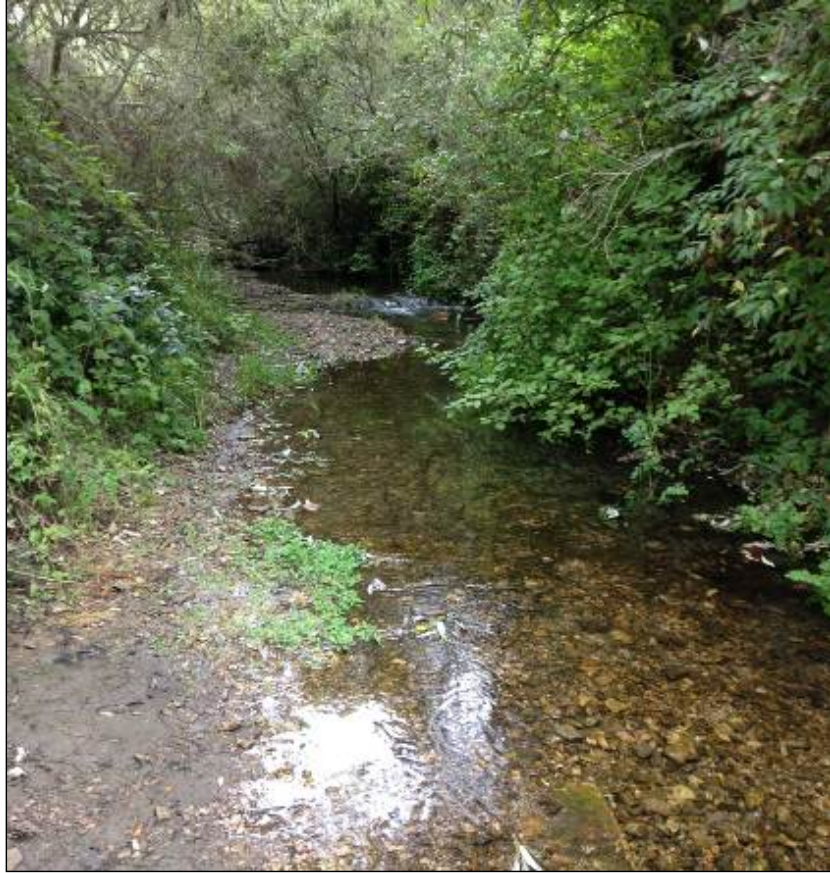
Figure 11. Lower Islay Creek, with sufficient flows to provide steelhead habitat during summer 2013.

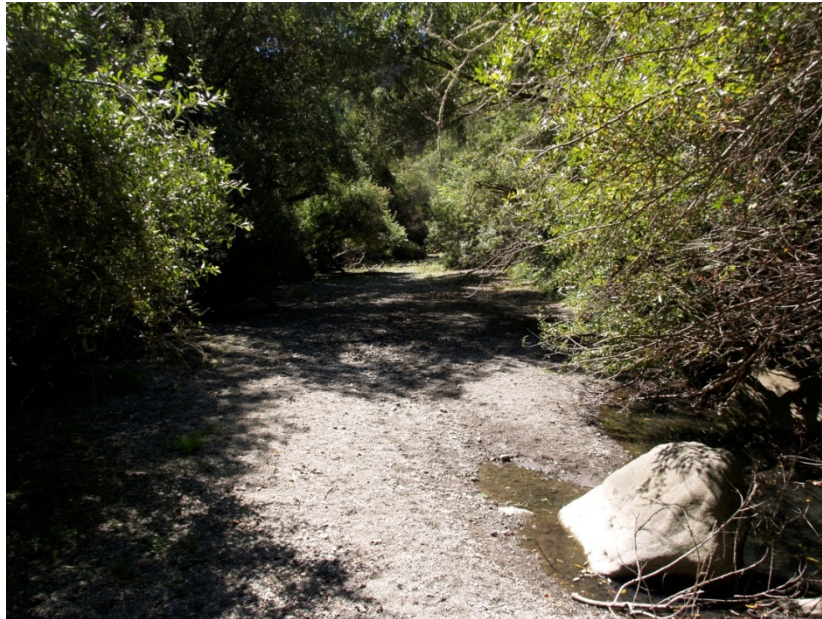
Figure 12. Lower Santa Rosa Creek, with no flow and thus no steelhead habitat during summer 2013. Note that 2013 was an extreme drought in the County.

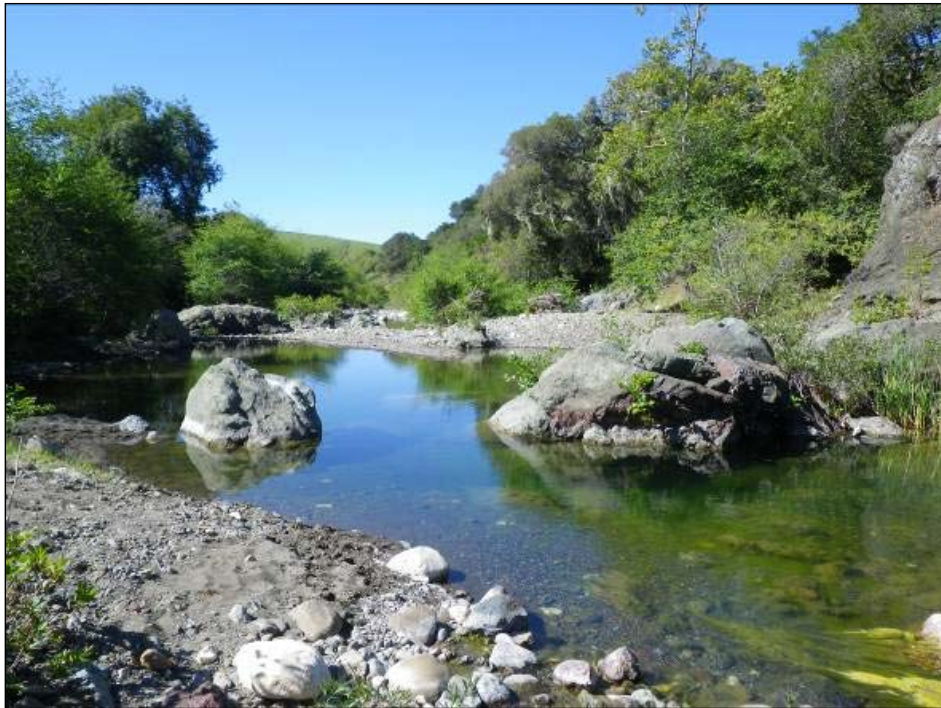
Figure 15. San Simeon Creek with a large drainage area, low gradient, and broad channel; it requires more flow to provide sufficient velocity to meet minimum habitat requirements.

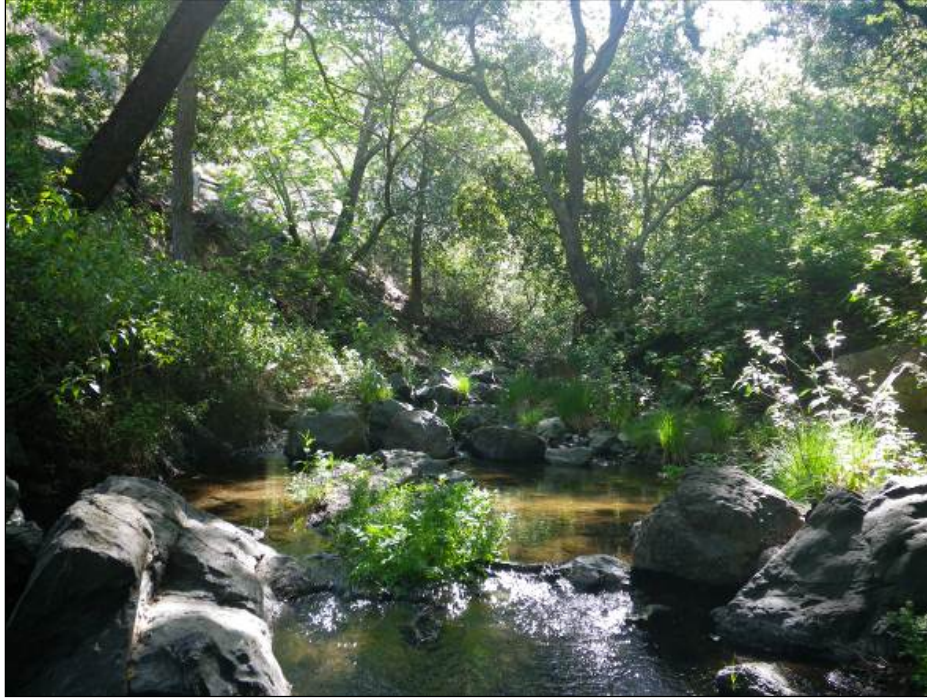
Figure 16. Upper Morro Creek with a small drainage area, high gradient, and confined channel; it requires less flow to provide sufficient depth to meet minimum habitat requirements.

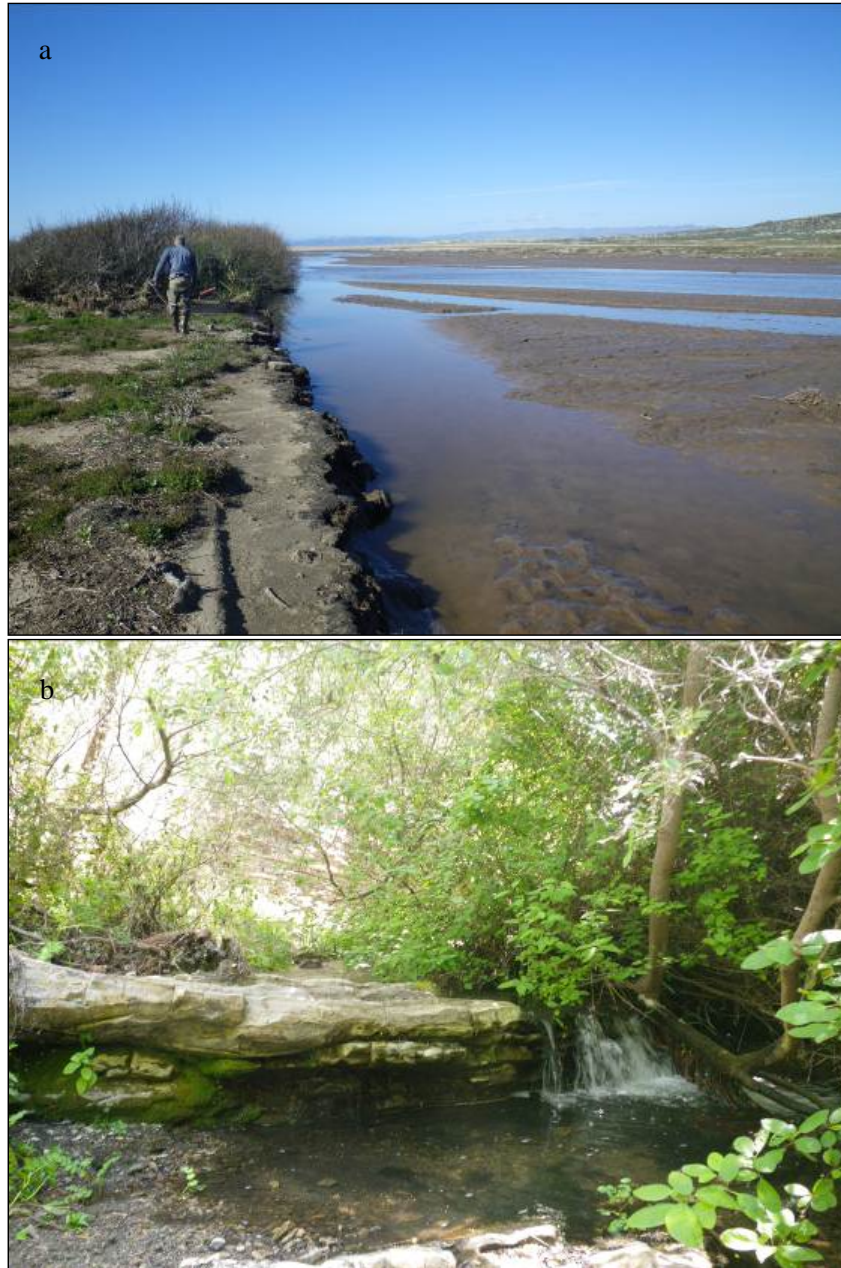
Figure 17. Flow-related critical fish passage features from (a) low-gradient shallow riffles, and (b) high-gradient features.

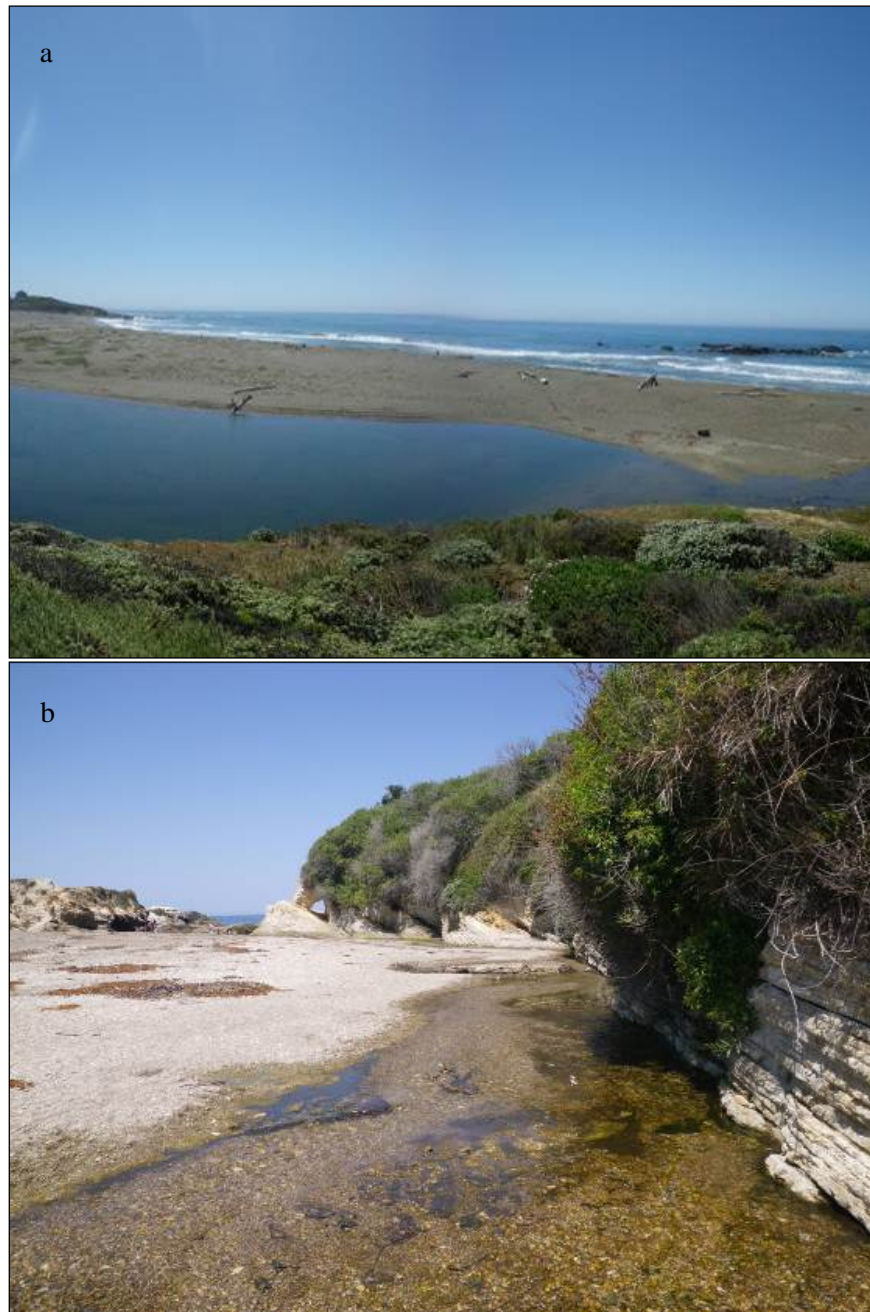
Figure 18. Lagoon sandbars at (a) Santa Rosa Lagoon, annually closed, and (b) Islay Creek Lagoon, perennially open.

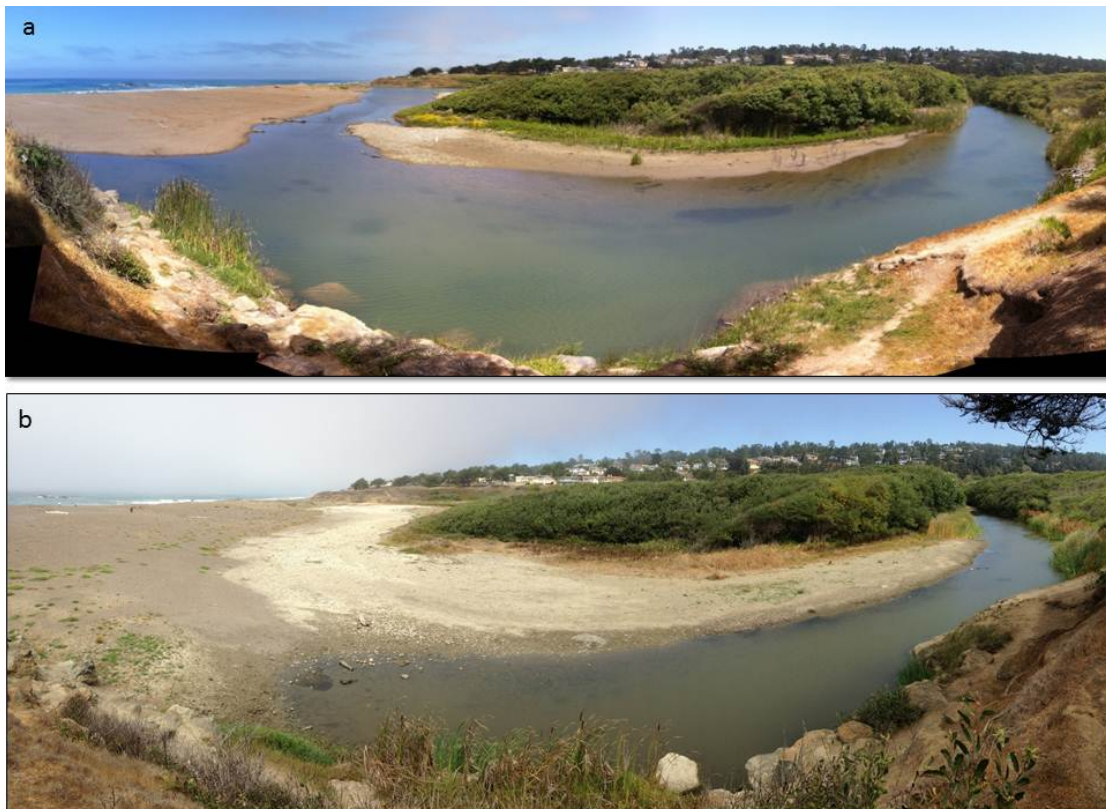
Figure 19. Santa Rosa Lagoon in (a) June and (b) September.
