Nacimiento Water Project Initial Watershed Sanitary Survey

San Luis Obispo County
Flood Control and Water Conservation District

California Department of Public Health
Division of Drinking Water and Environmental Management
Drinking Water Program District 06 – Santa Barbara
January 2014

County of San Luis Obispo
Flood Control and Water Conservation District
Department of Public Works and Transportation
Water Quality Laboratory

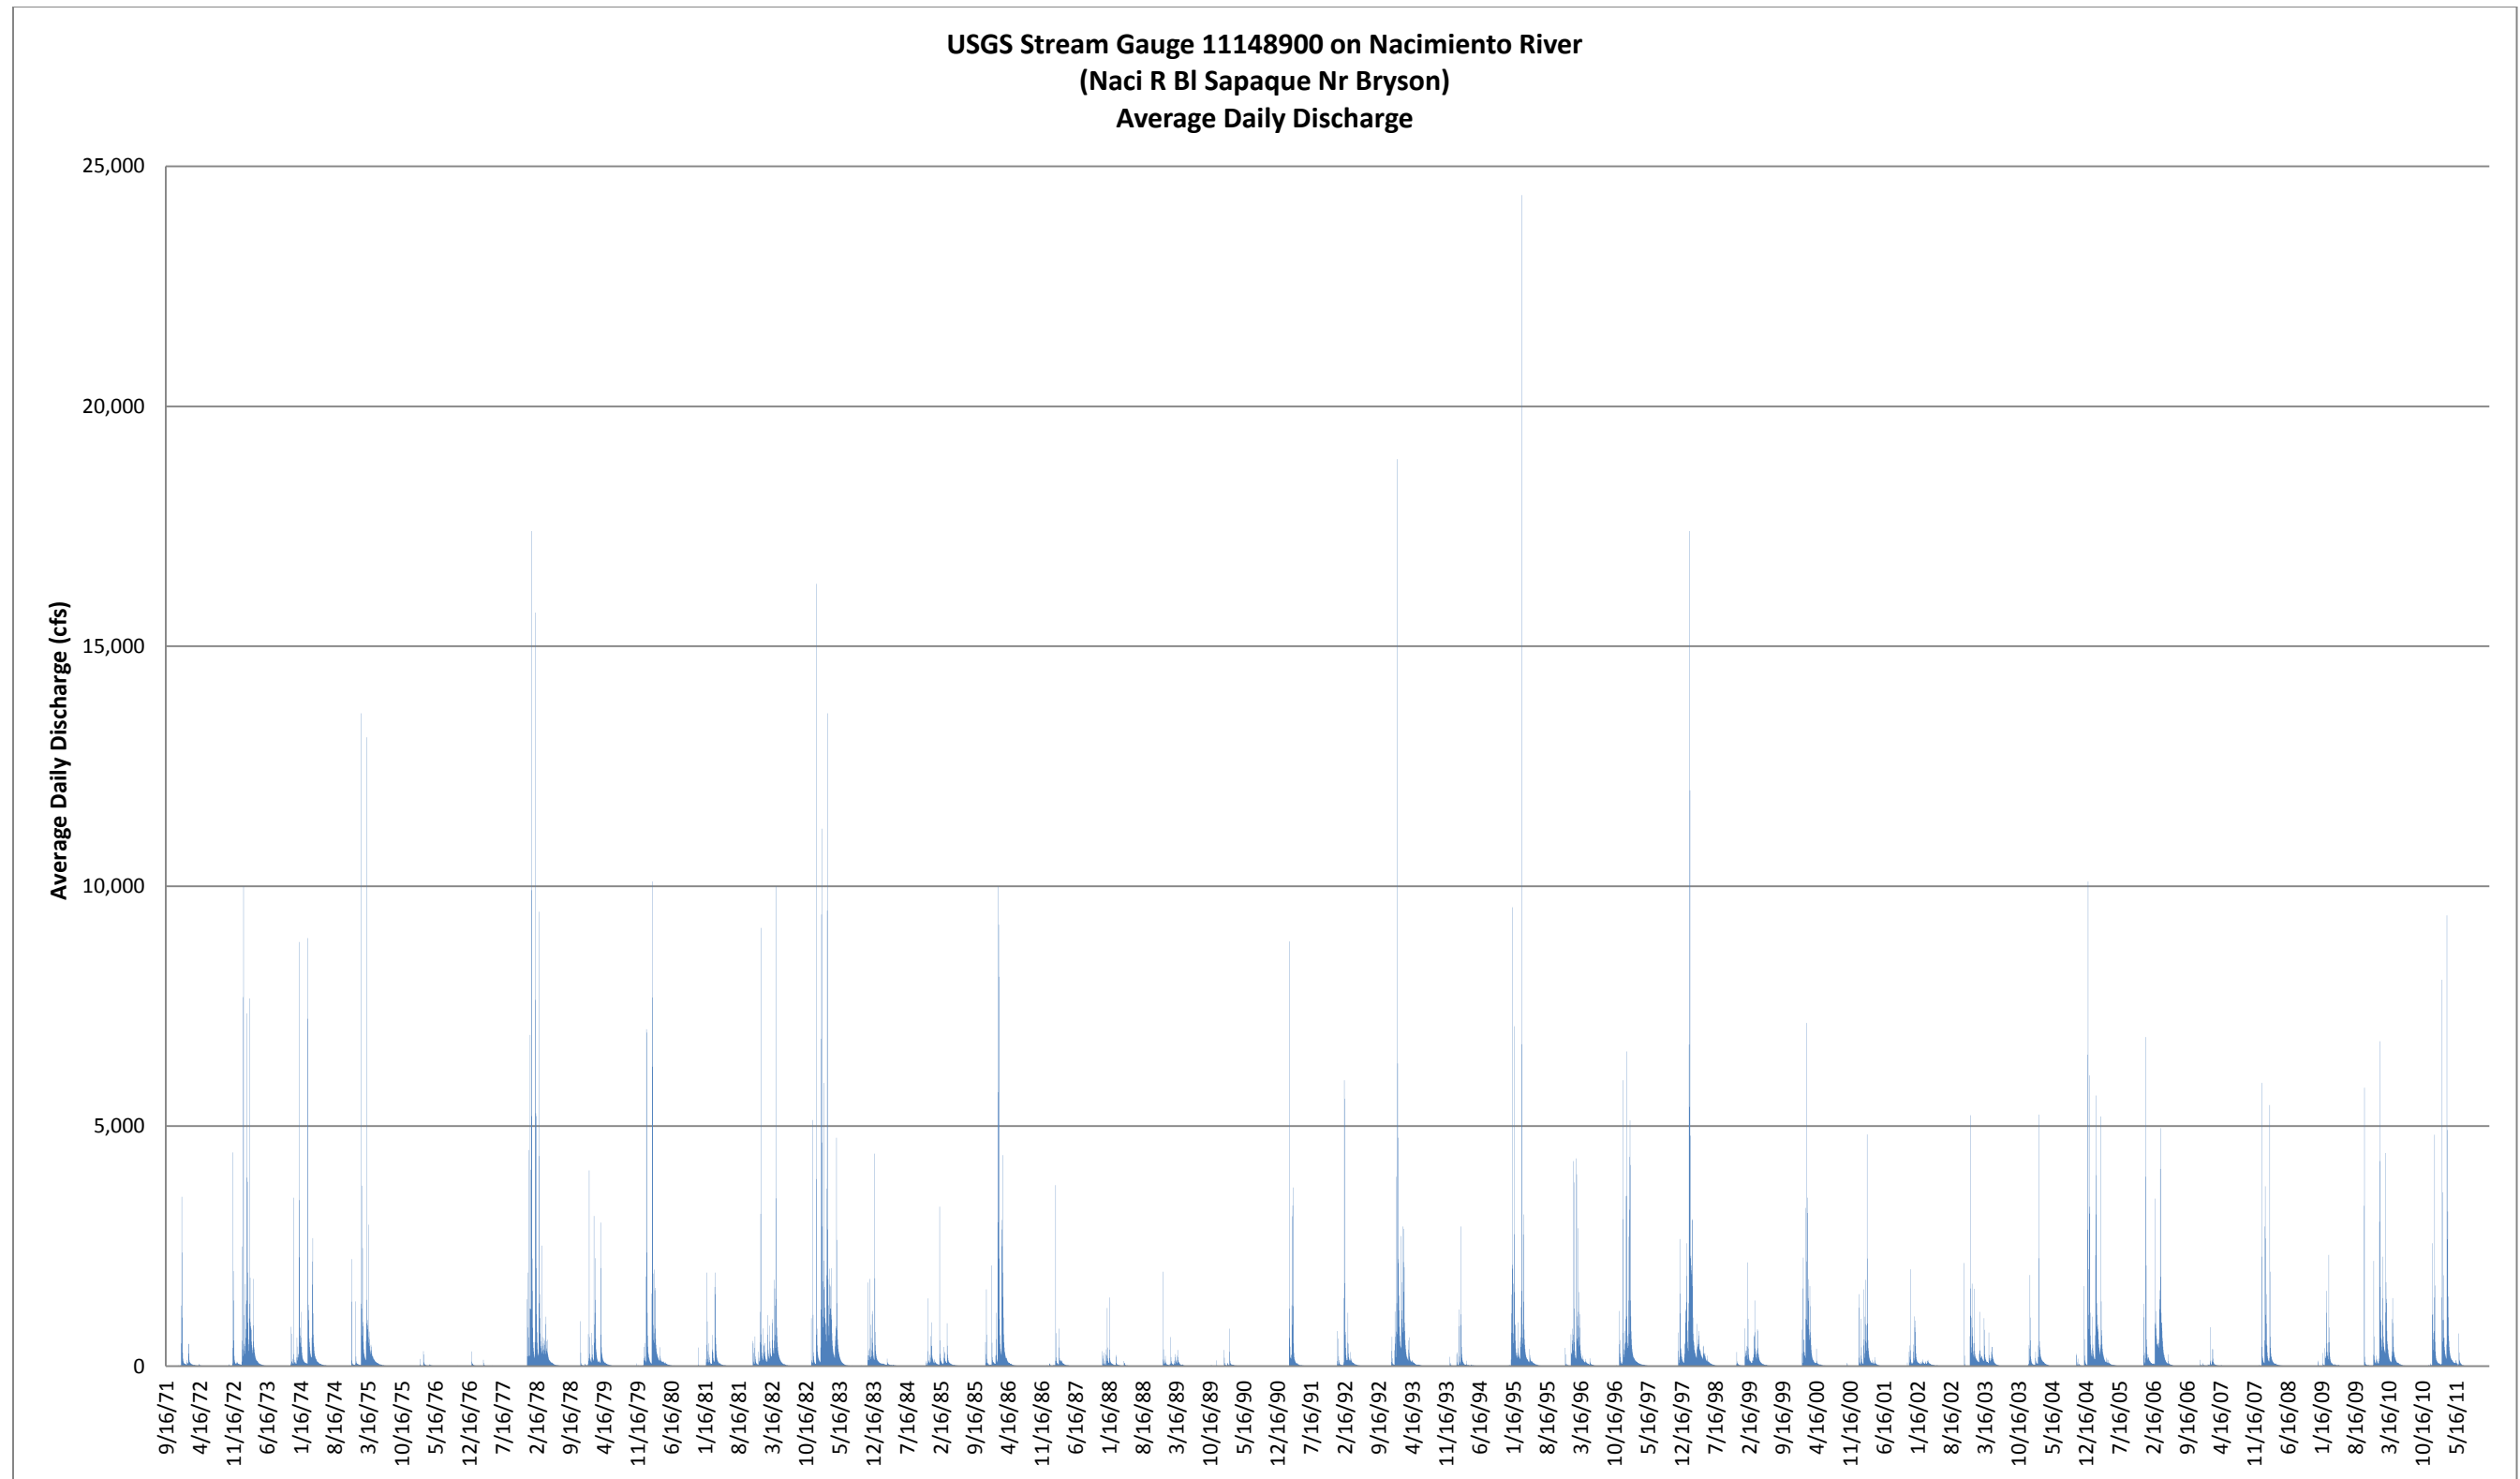
Figure 26: Nacimiento River Flows

The Nacimiento River is the only tributary to Nacimiento Reservoir that has a stream gauge. Located at the 800' elevation (NGVD 29), this gauge is operated by the United States Geological Survey (Figure 25). Because the greatest rainfall occurs in the steepest mountain areas and is the result of storm activity, runoff is rapid, and river flow both increases and decreases dramatically during the rainy season (Figure 26). Typical summer flows at the gauge are 0 cfs/min; winter flows often exceed 5,000 cfs. The maximum flow recorded since data gathering began in 1971 is 24,400 cfs in March 1995. (USGS)

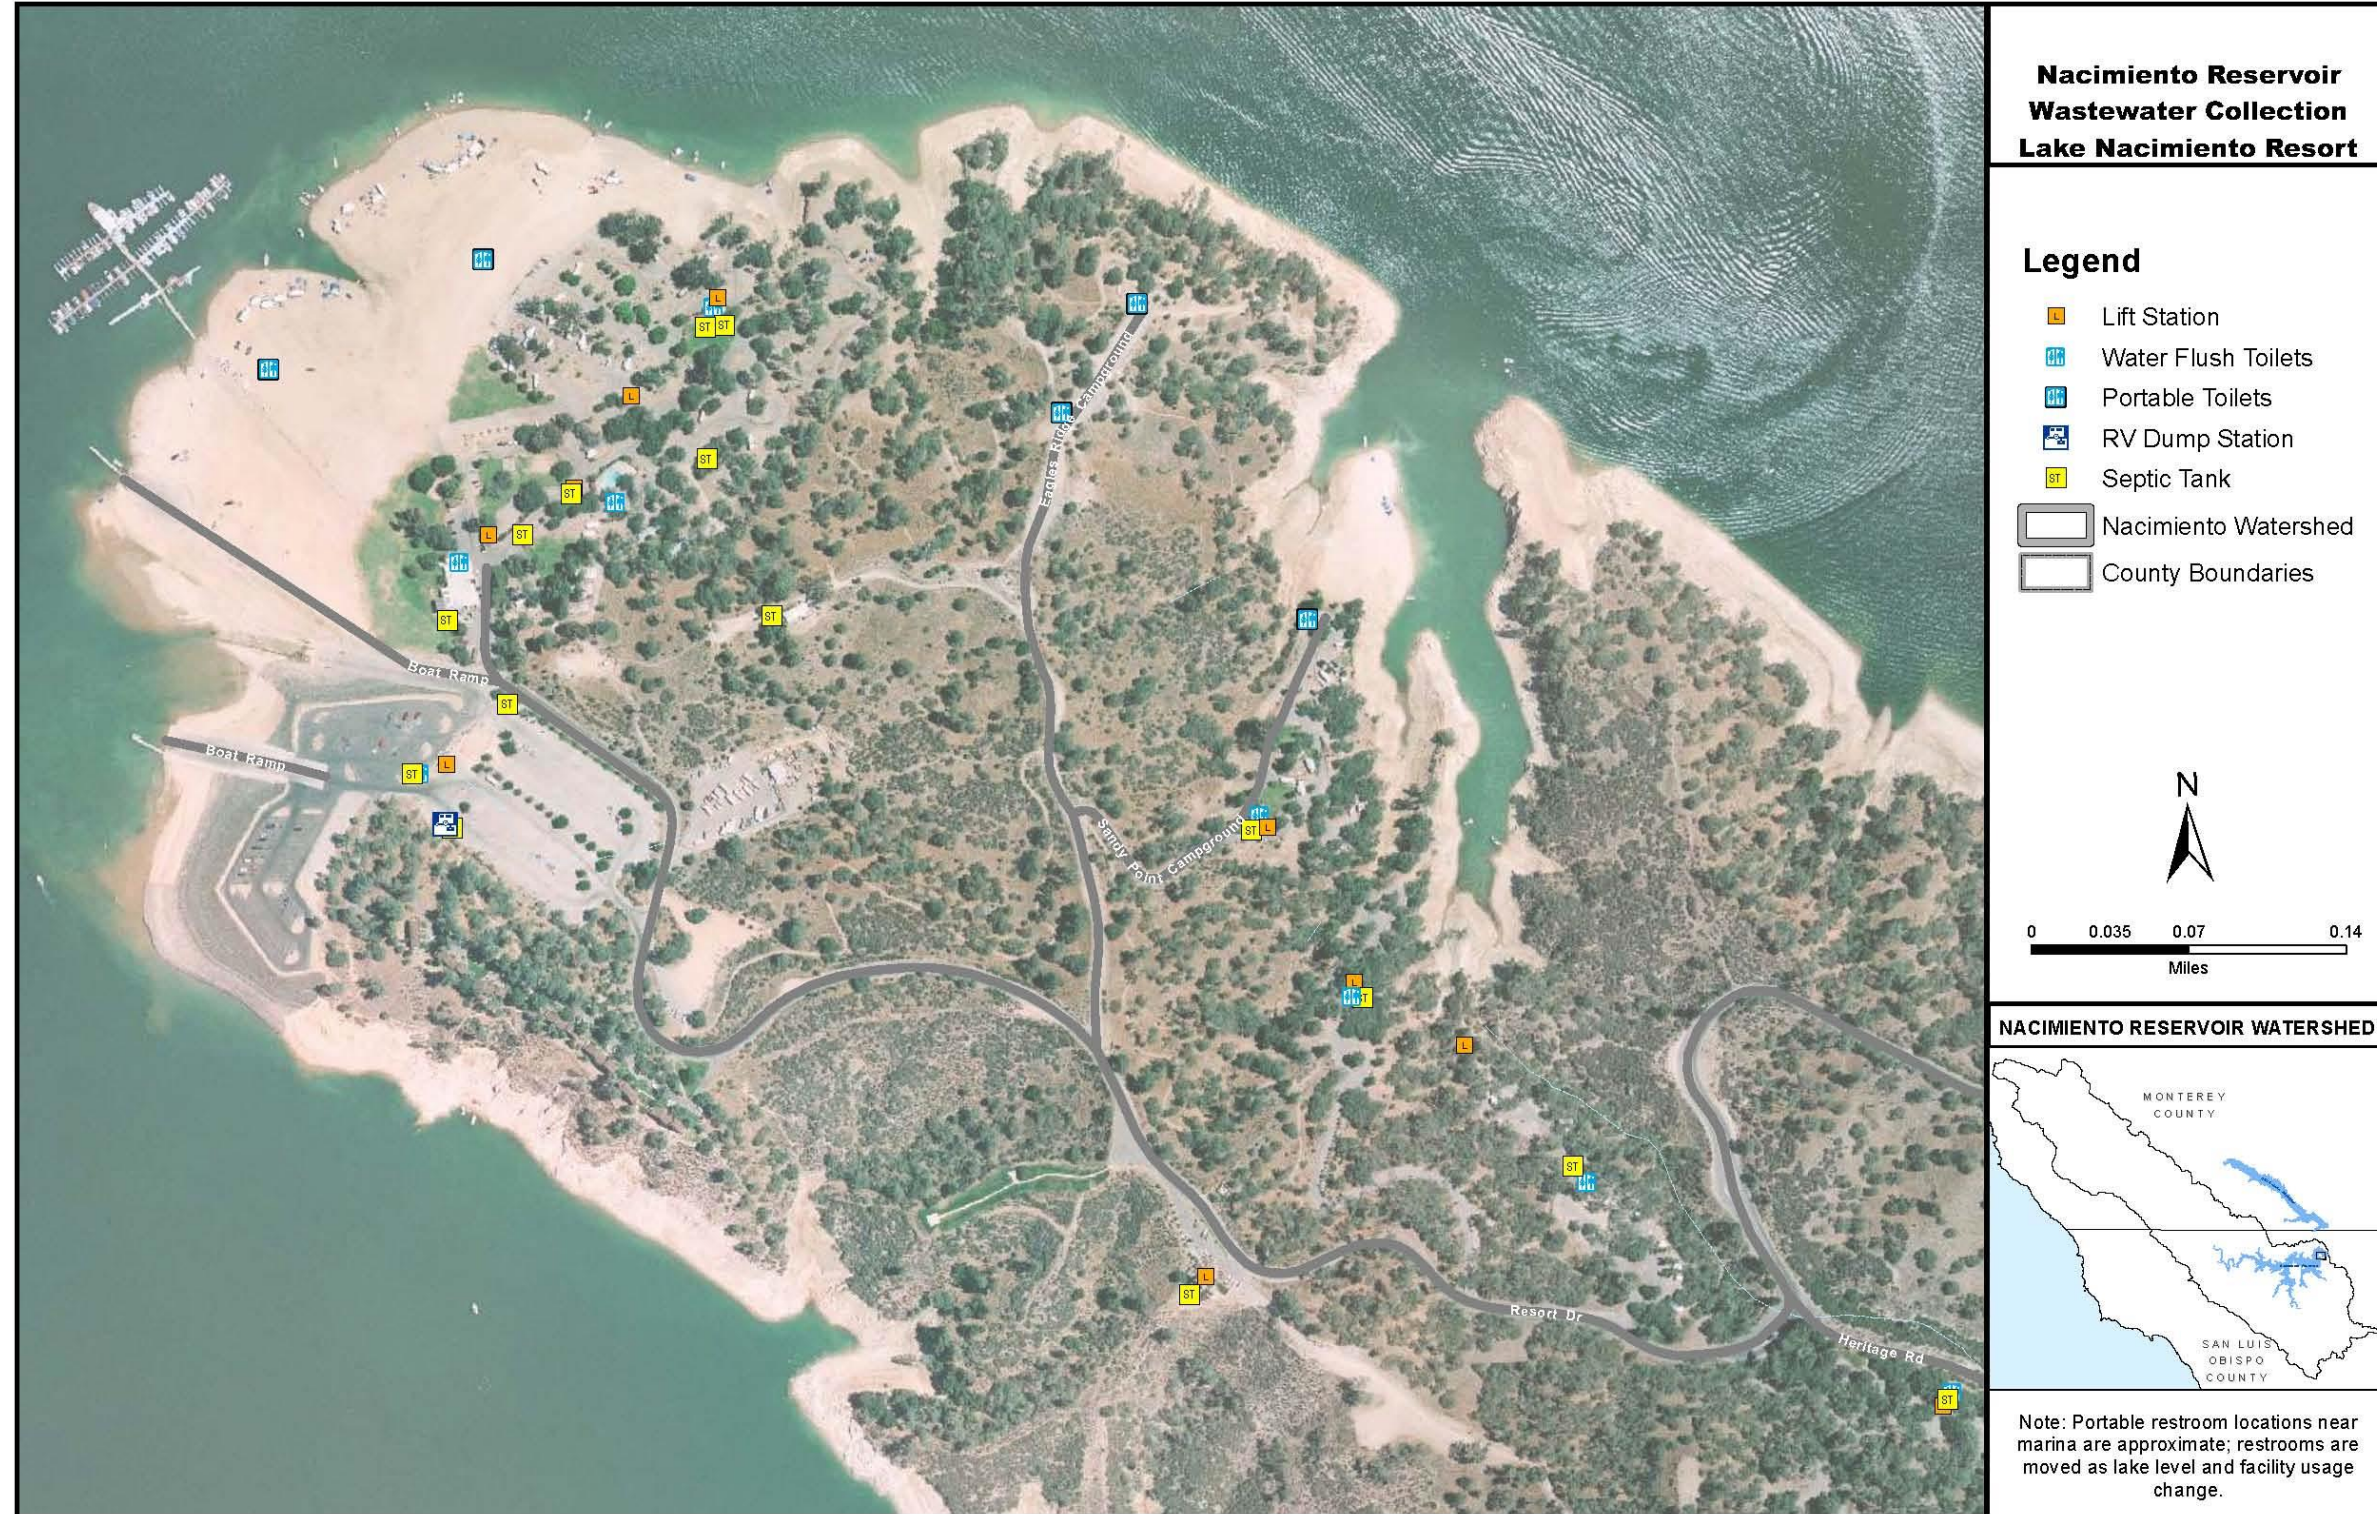
Figure 46: Lake Nacimiento Resort Wastewater System

no publicly available data could be found on the collection system's spill history for the last five years.

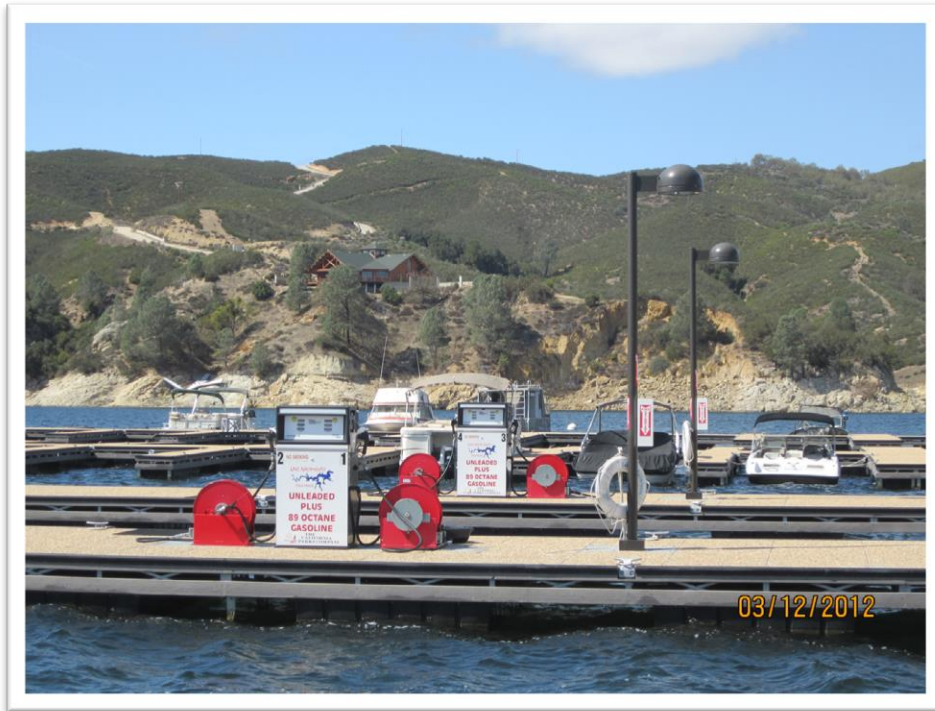
Photo: San Luis Obispo County Public Works Department
Figure 76: Fuel pumps on Lake Nacimiento Resort docks

The Lake Nacimiento Resort public recreation area has a fueling station for boats that is located on the reservoir. Two fuel pumps are located on the docks at the resort marina (Figure 76). Two double-walled 12,000 gallon underground storage tanks that service these pumps are located beneath the marina parking lot; these tanks were installed in 1988 (Figure 77). A double-walled pipeline runs underground from the storage tanks for approximately 100 yards to a junction box (Figure 78). A flexible triple-walled fuel line runs above ground from the junction box along the shore to the fuel pumps on the dock (Figure 80, Figure 79). The distance from the junction box to the pumps varies as the lake elevation changes; it can range from less than 25 yards to approximately 400 yards. Boaters fill their vessels over open water.

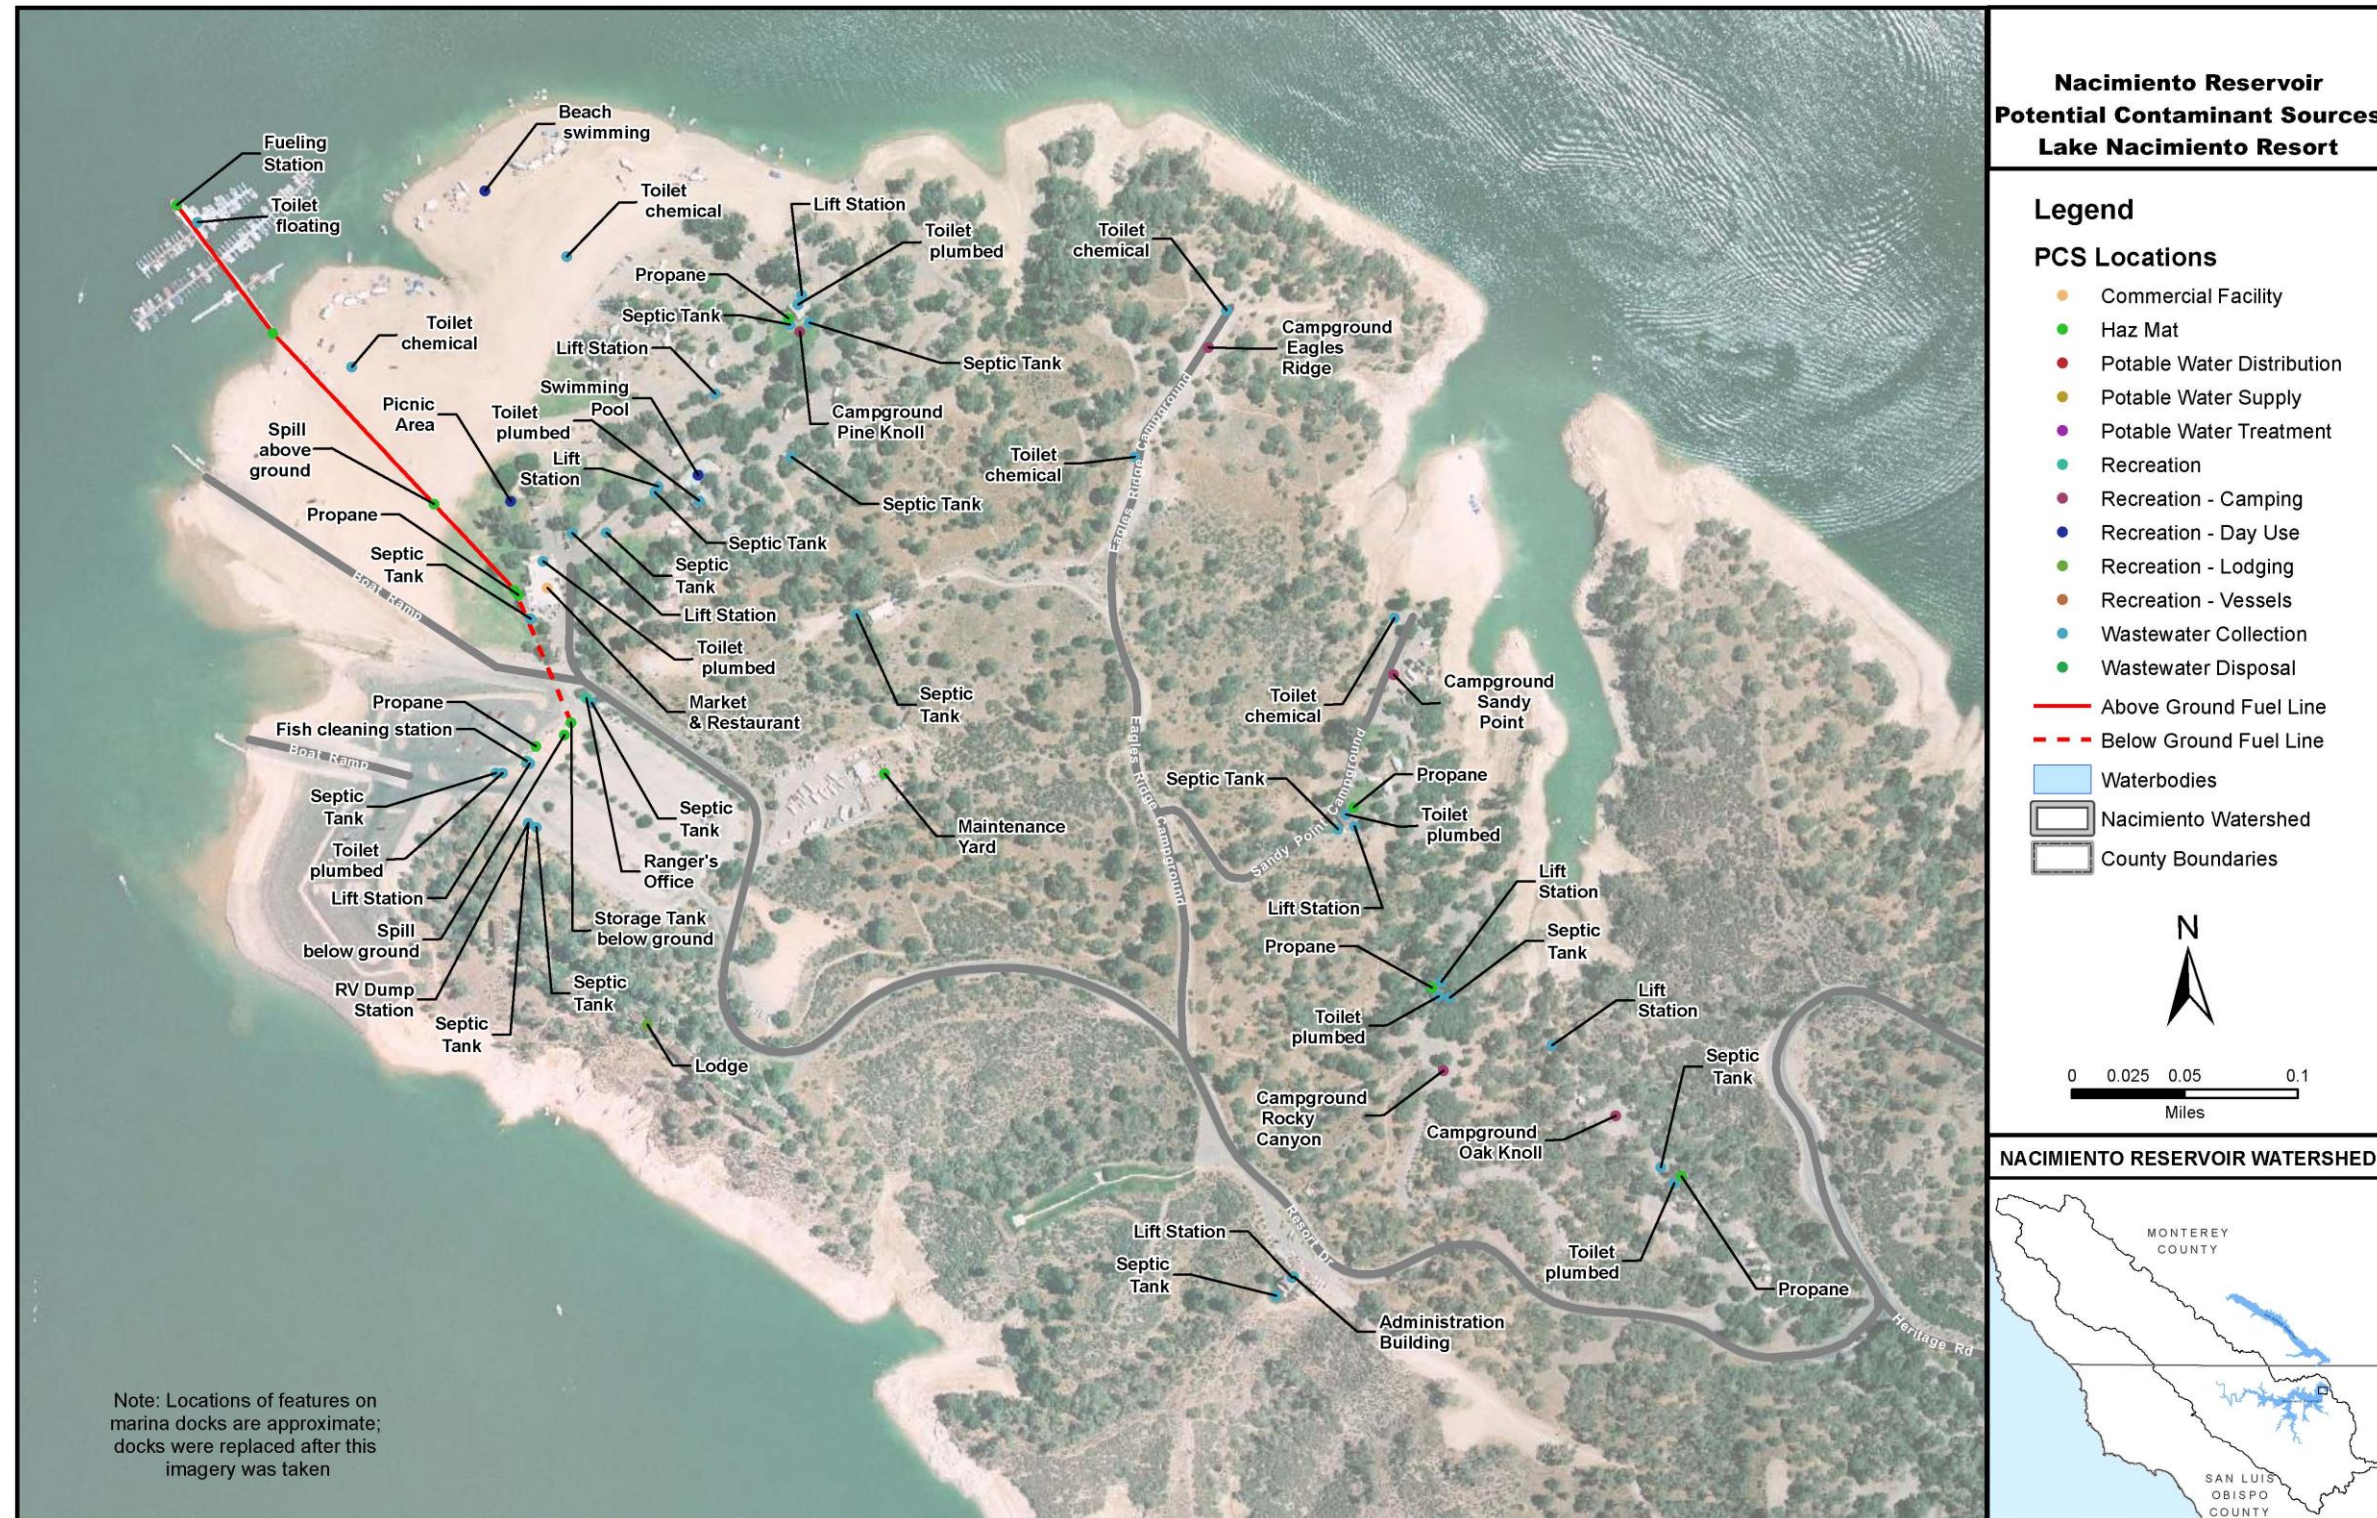
Figure 80: Lake Nacimiento Resort Fuel Line to Docks

A new above ground fuel line was installed in spring 2010; it is triple walled and is sectioned into 250 ft. lengths. At each junction there is a sump with a leak detector that is part of an automatic shutoff system that includes both visual and audible alarms (Figure 81). When the lake level is low, MCPD installs barriers along the length of the above ground fuel line on both sides to reduce the risk of vehicles driving over it. The lines are inspected at least daily, and the entire system is inspected monthly.
